**Docket No. 217 – Development and Management Plan Inspection**

Northeast Utilities Service Company Certificate of Environmental Compatibility and Public Need for the construction of a 345-kV electric transmission line and reconstruction of an existing 115-kV electric transmission line between Connecticut Light and Power Company’s Plumtree Substation in Bethel, through the towns of Redding, Weston, and Wilton, and to the Norwalk Substation in Norwalk, Connecticut.

**Date:** June 24, 2004

**Location:** Norwalk Substation Expansion

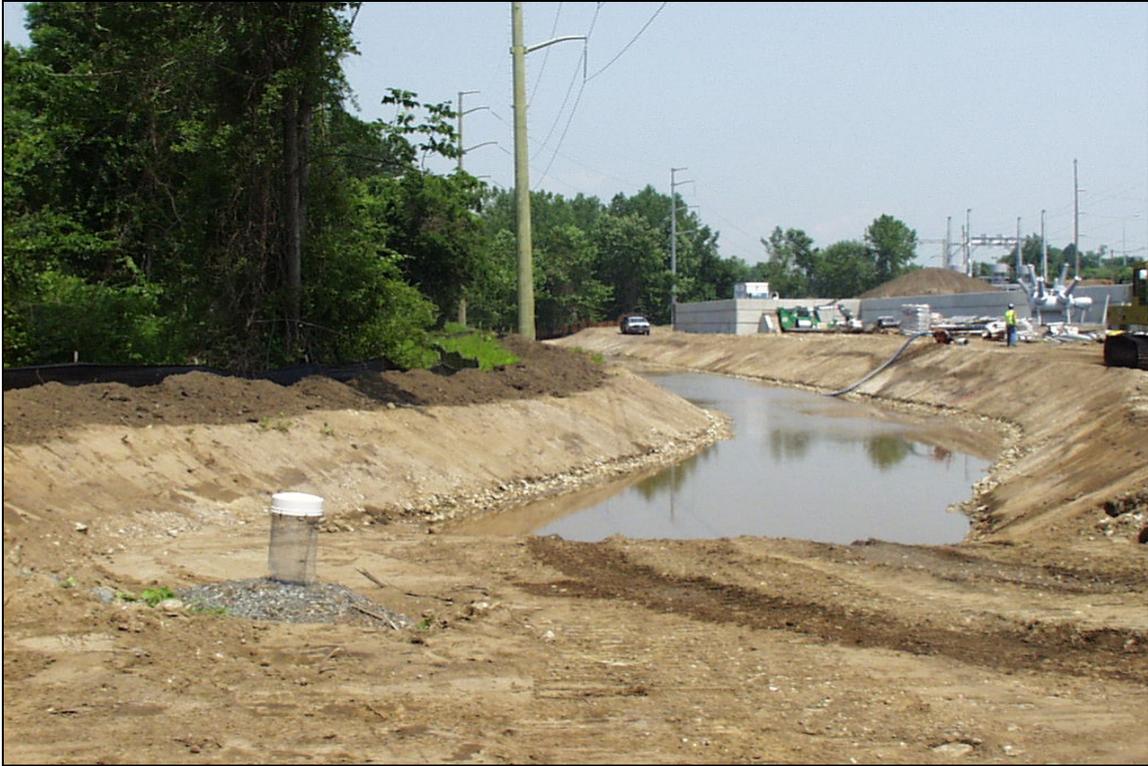
The excavation has continued within the sediment basin to create the overflow channel. All areas are well contained at this time. 6/24/04

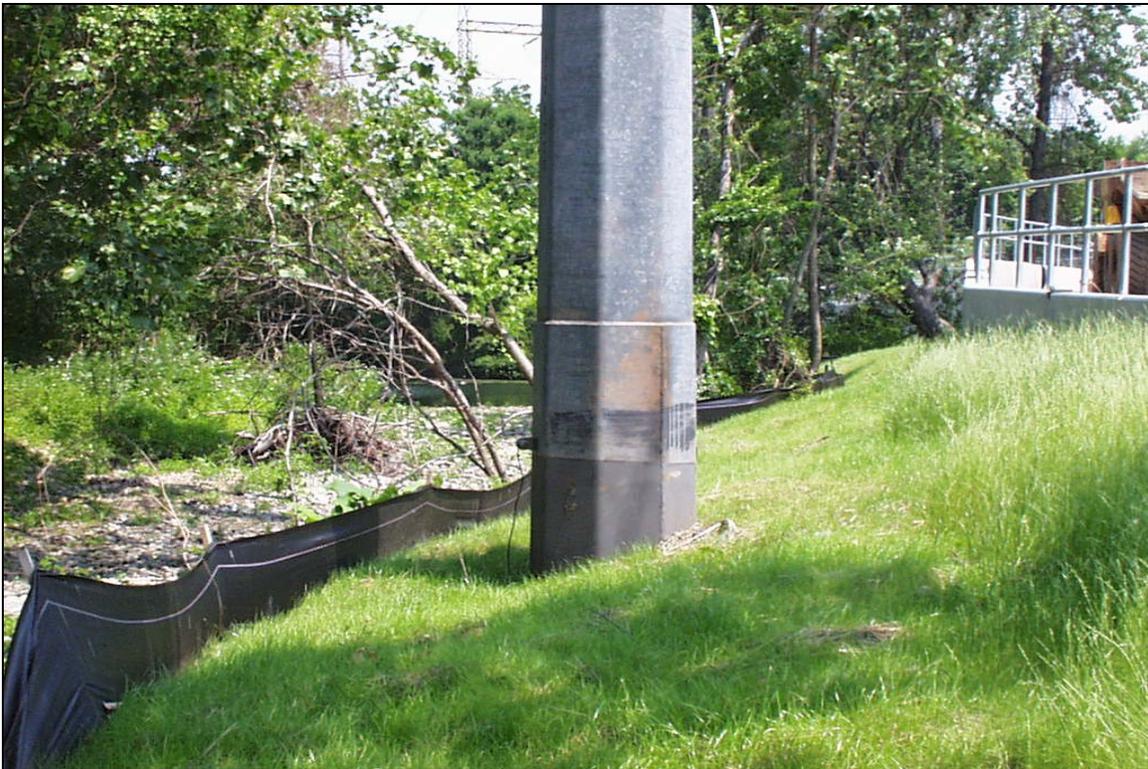
View along wall #5 where the previously scoured area was located. Vegetative growth continues to come in well following the repairs. 6/24/04

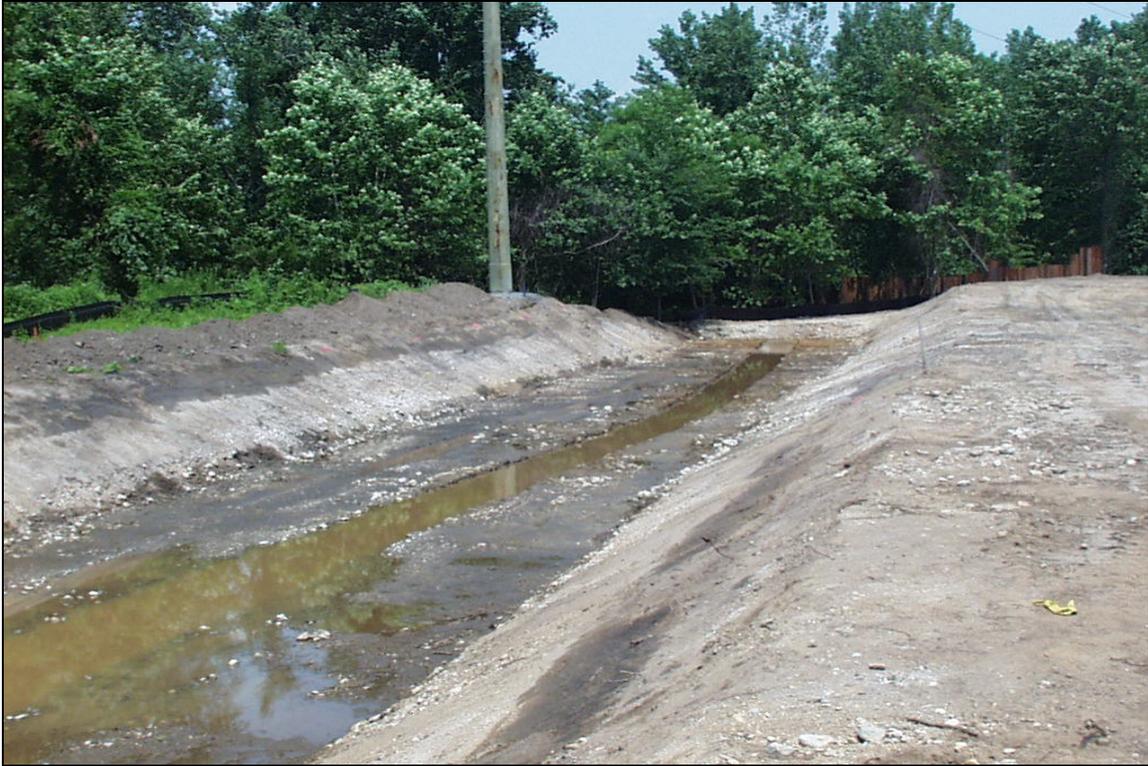
The center meandering channel is being excavated within the main overflow channel at this time. 6/24/04

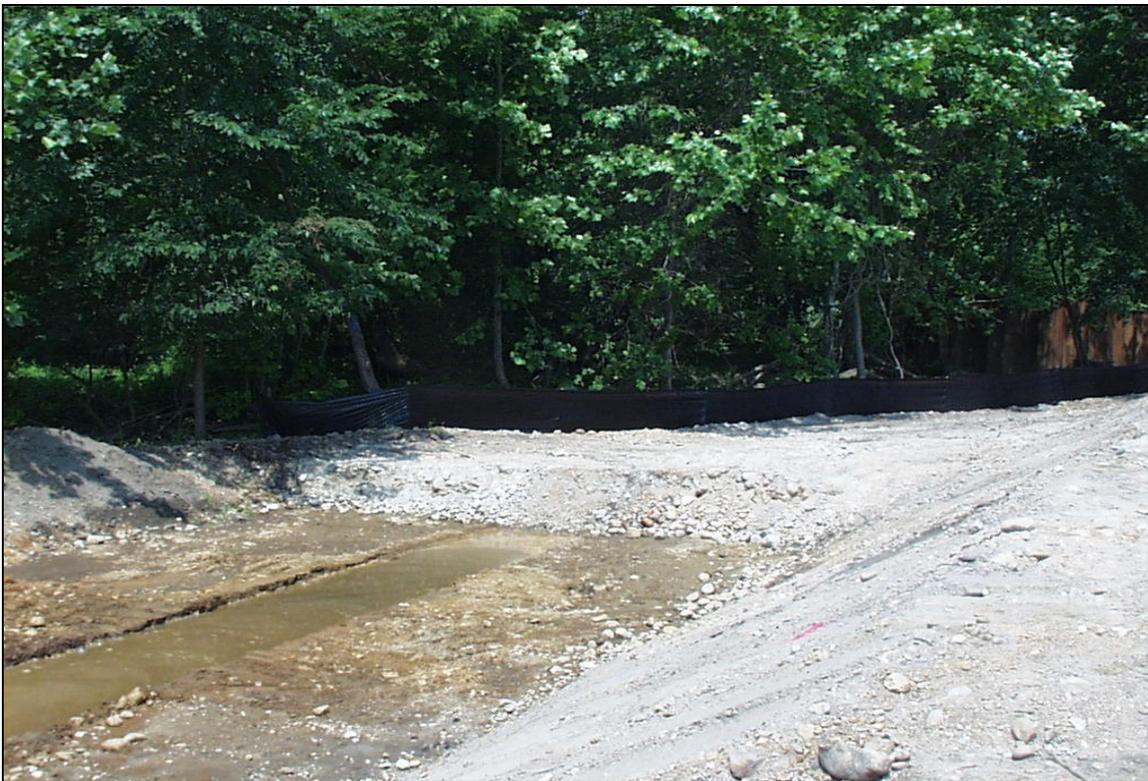
View of the end of the overflow channel at this time. The channel has not been connected to the river yet and conditions will likely remain dry during this activity. 6/24/04

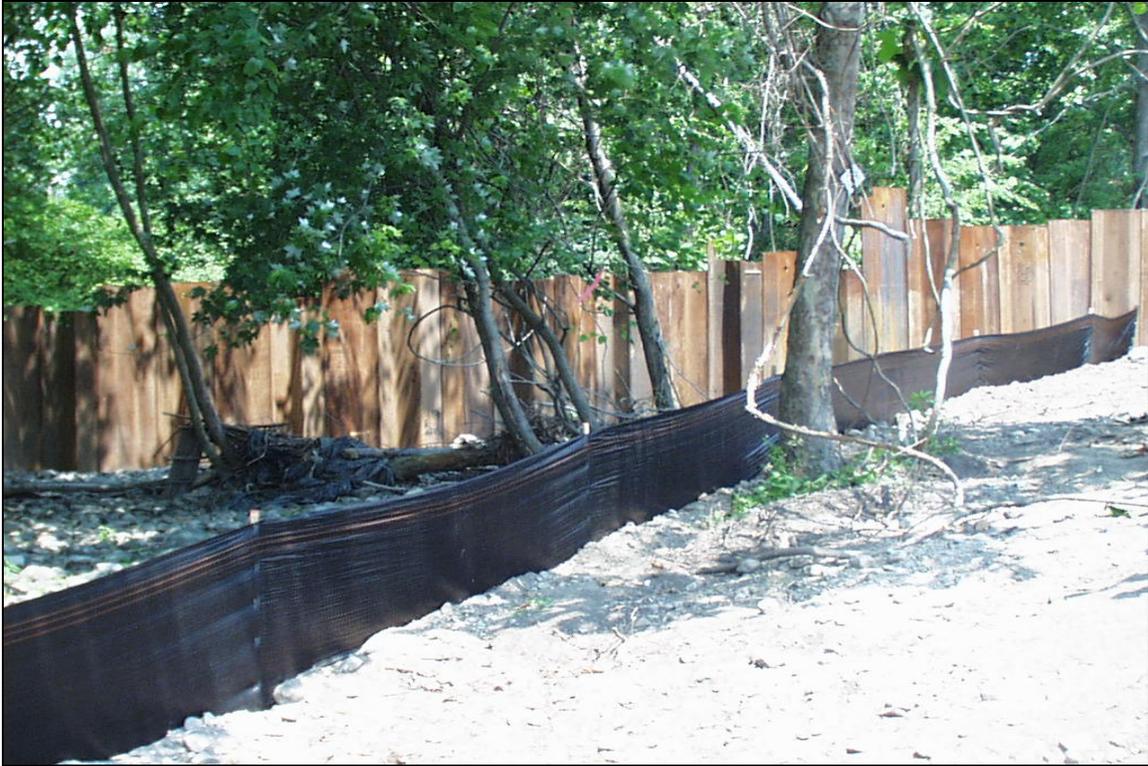
View of the sheet piling cofferdam which was installed in a dry portion of the streambed. The sheet piling was well installed with as little disturbance as possible. 6/24/04

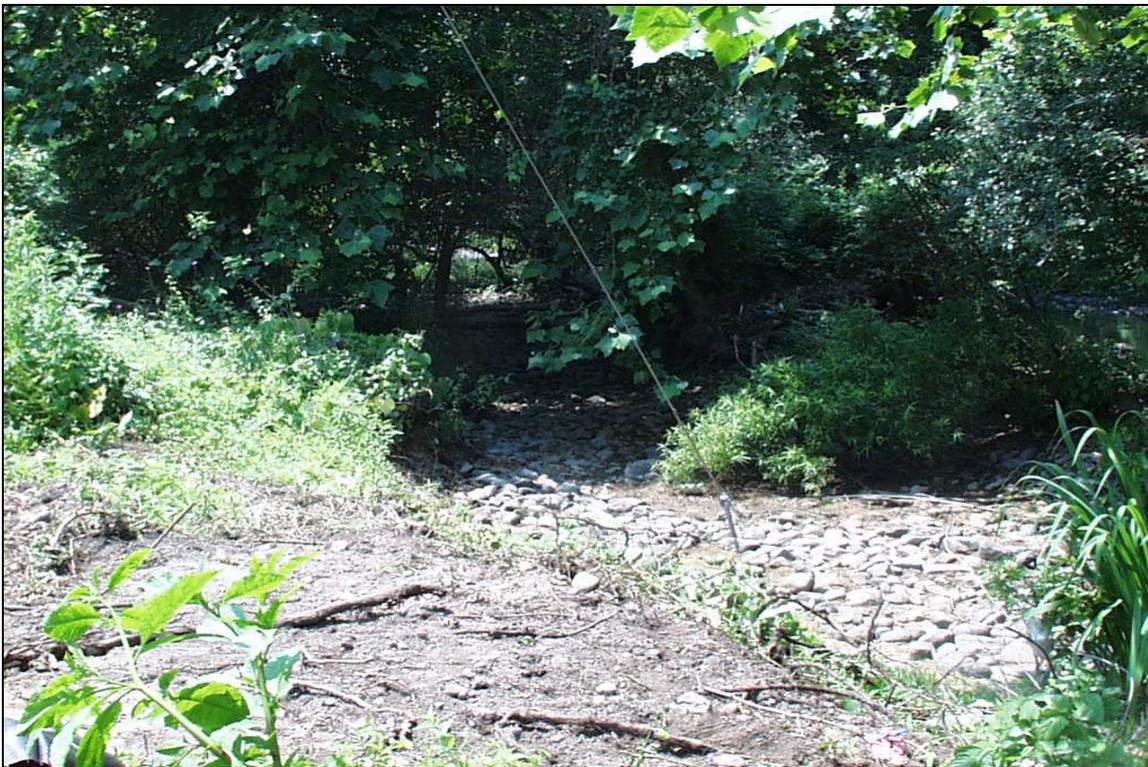
Area where the guy wire and anchor had to be installed to provide resistance for the temporary pole. The silt fence will be replaced in this area. 6/24/04
