**Docket No. 217 – Development and Management Plan Inspection**

Northeast Utilities Service Company Certificate of Environmental Compatibility and Public Need for the construction of a 345-kV electric transmission line and reconstruction of an existing 115-kV electric transmission line between Connecticut Light and Power Company's Plumtree Substation in Bethel, through the towns of Redding, Weston, and Wilton, and to the Norwalk Substation in Norwalk, Connecticut.

**Norwalk Substation**

**Date:** July 12, 2006

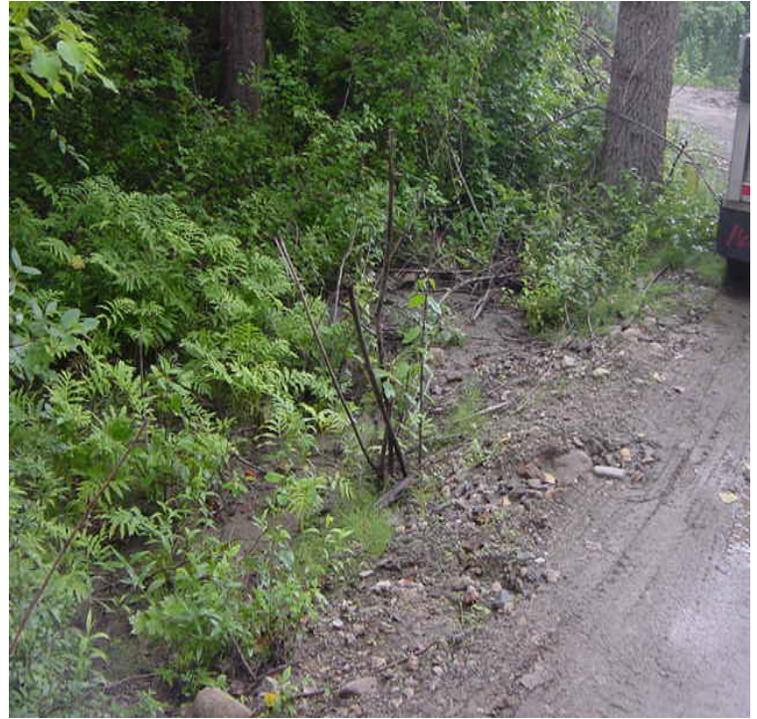
Areas of Inspection	Observation	Recommended Action	Corrected Action
Access Roads	<ul style="list-style-type: none"> <li>- Work has returned to the substation so the drive is again in use for this equipment. 7/12/06.</li> <li>-Turbid water was noted pooling in the wetland swales adjacent to the access road. Some sediment was noted as well. 7/5-7/12/06</li> </ul>	<ul style="list-style-type: none"> <li>- None at this time. 7/12/06.</li> <li>- This is likely a pre-existing condition and not directly related to the expansion work. However if the road can be further stabilized, this may help the situation. 7/12/06</li> </ul>	<ul style="list-style-type: none"> <li>-N/A.</li> <li>- Needs evaluation</li> </ul>
Foundation construction	<ul style="list-style-type: none"> <li>- Some site work was ongoing at the time of inspection. 7/12/06.</li> </ul>	<ul style="list-style-type: none"> <li>- Remain aware the perimeter of the yard is surrounded by wetlands. See erosion control section. 3/15-7/12/06.</li> </ul>	<ul style="list-style-type: none"> <li>-N/A at this time.</li> </ul>

Norwalk Substation: Photo on the left shows the recently hydroseeded and landscaped area near the GIS building. Plumtree Substation: Photo on the right shows turbid water pooled in the wetland adjacent to the access drive. This was likely not directly resulting from the project but due to the dirt road. 7/12/06

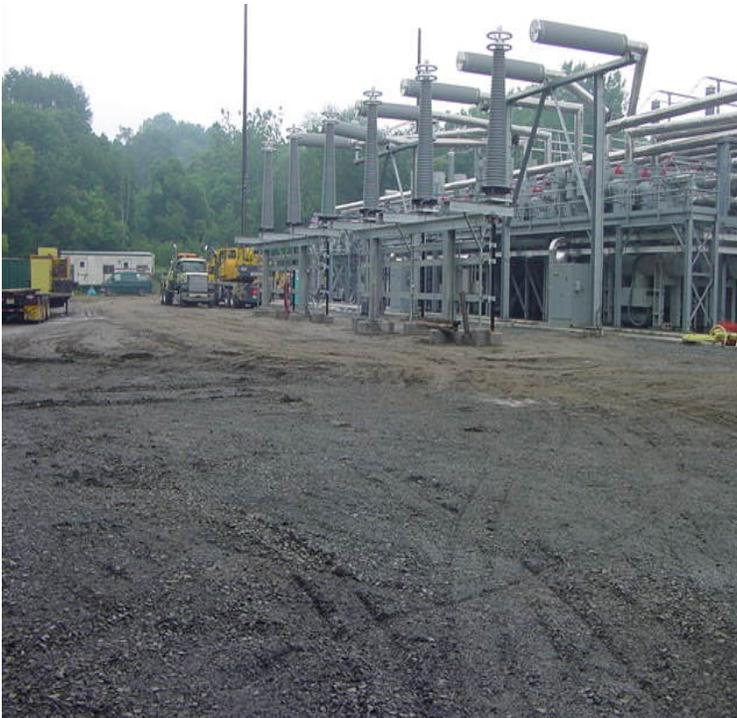
:Photo on the left shows an overview of the yard with some of the new structures off the slab. Photo on the right shows the new slab in place at the rear of the site. 7/12/06
