Docket No. 217 – Development and Management Plan Inspection

Northeast Utilities Service Company Certificate of Environmental Compatibility and Public Need for the construction of a 345-kV electric transmission line and reconstruction of an existing 115-kV electric transmission line between Connecticut Light and Power Company's Plumtree Substation in Bethel, through the towns of Redding, Weston, and Wilton, and to the Norwalk Substation in Norwalk, Connecticut.

Date: July 14, 2005

Location: Norwalk Substation Expansion

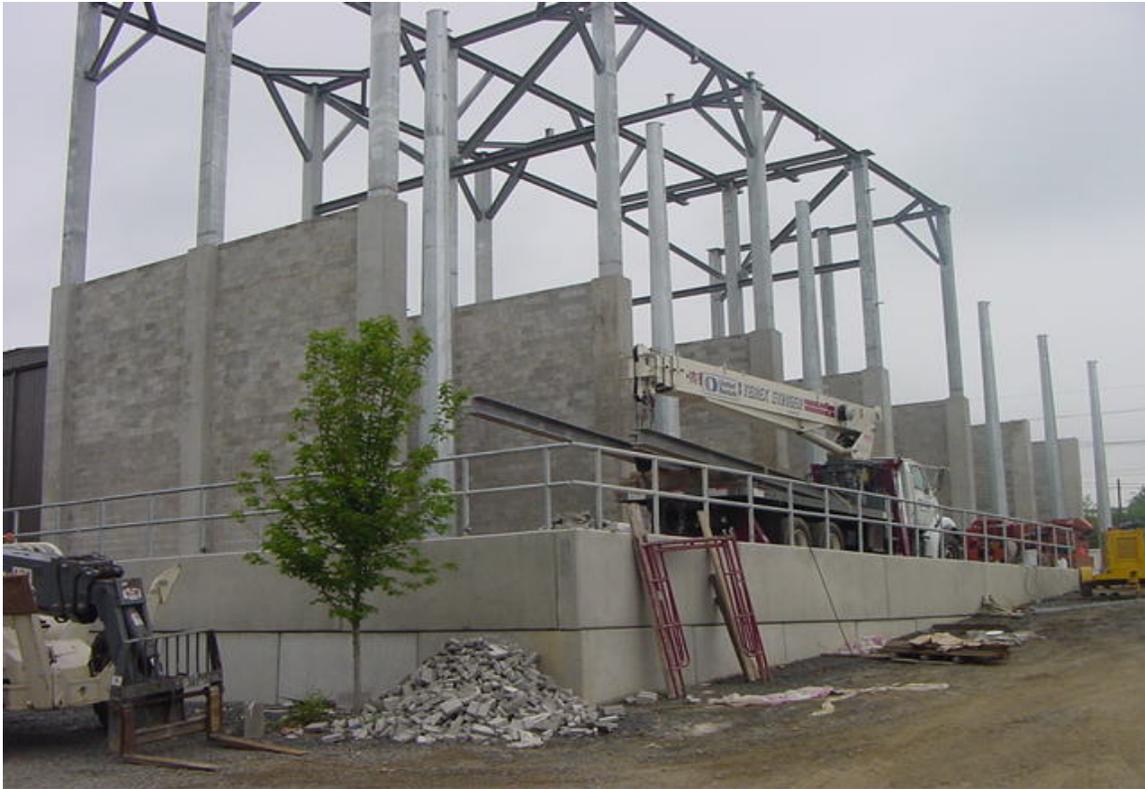
Norwalk Substation: Masonry work is completed and steel construction is ongoing in front of the GIS building. (7/14/05)

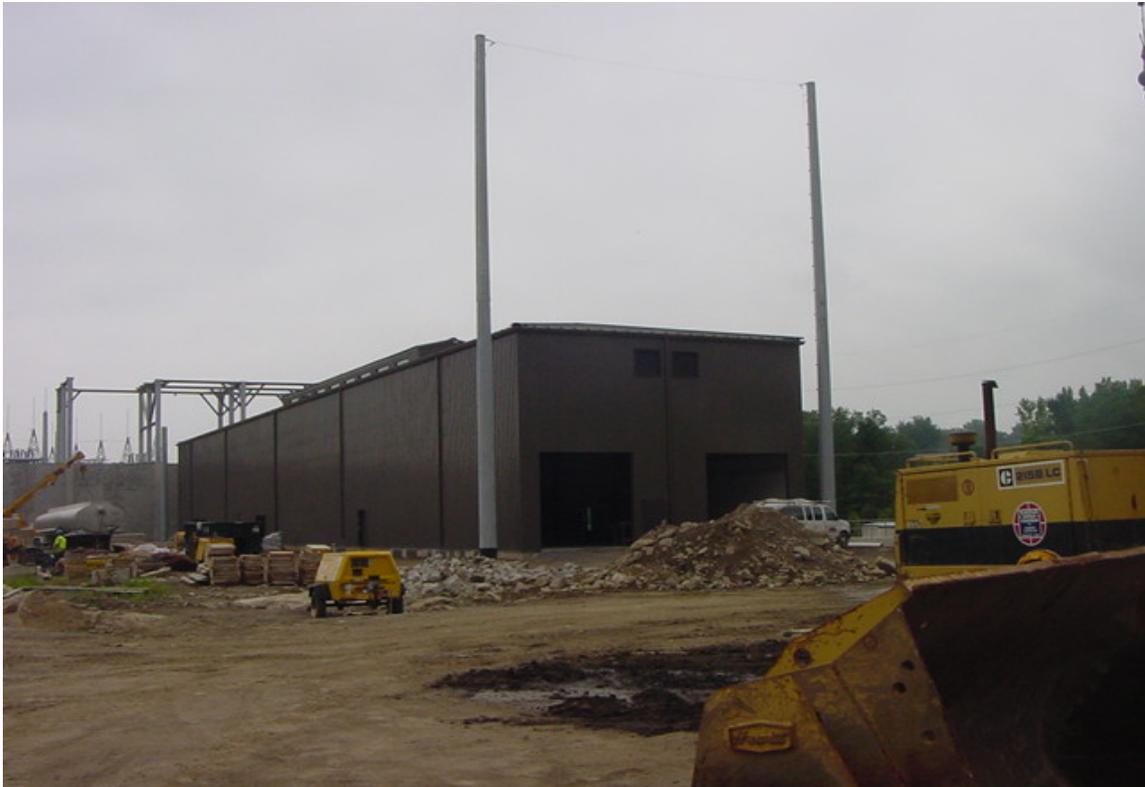
View of the rear of the GIS building showing the recently placed steel structures. (7/14/05)

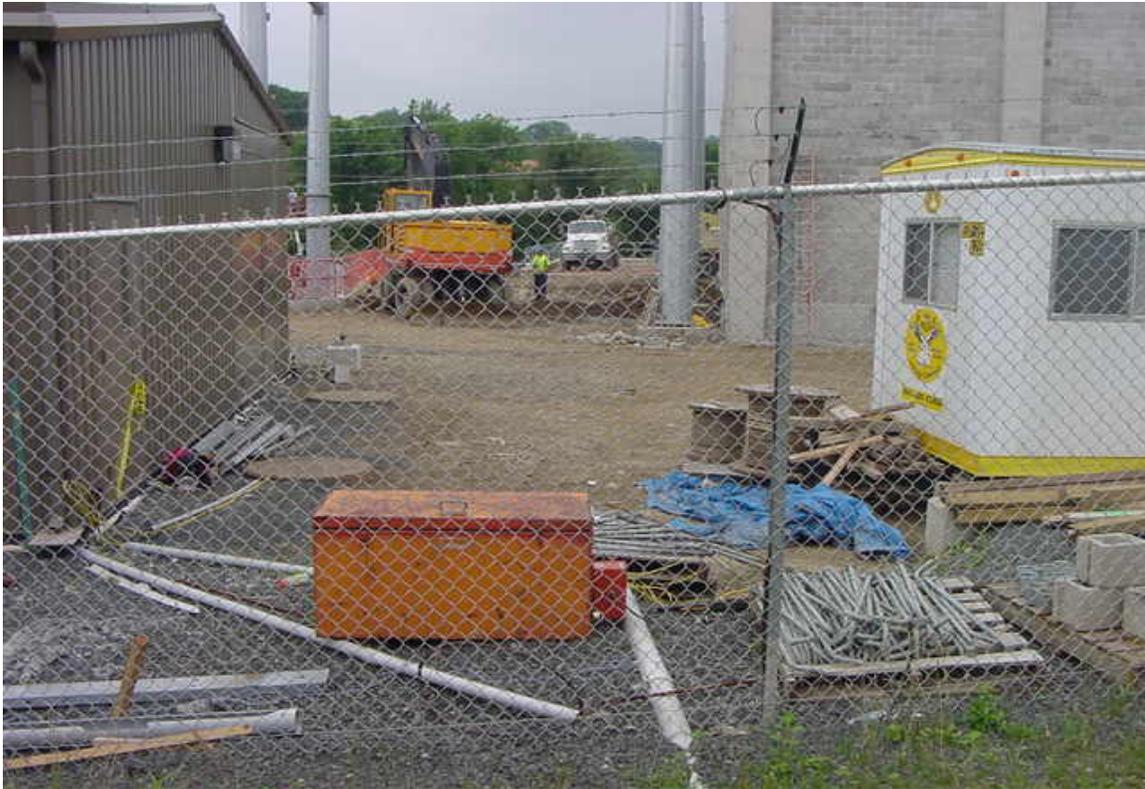
An excavation for a manhole is ongoing between the live yard area and GIS building. (7/14/05)

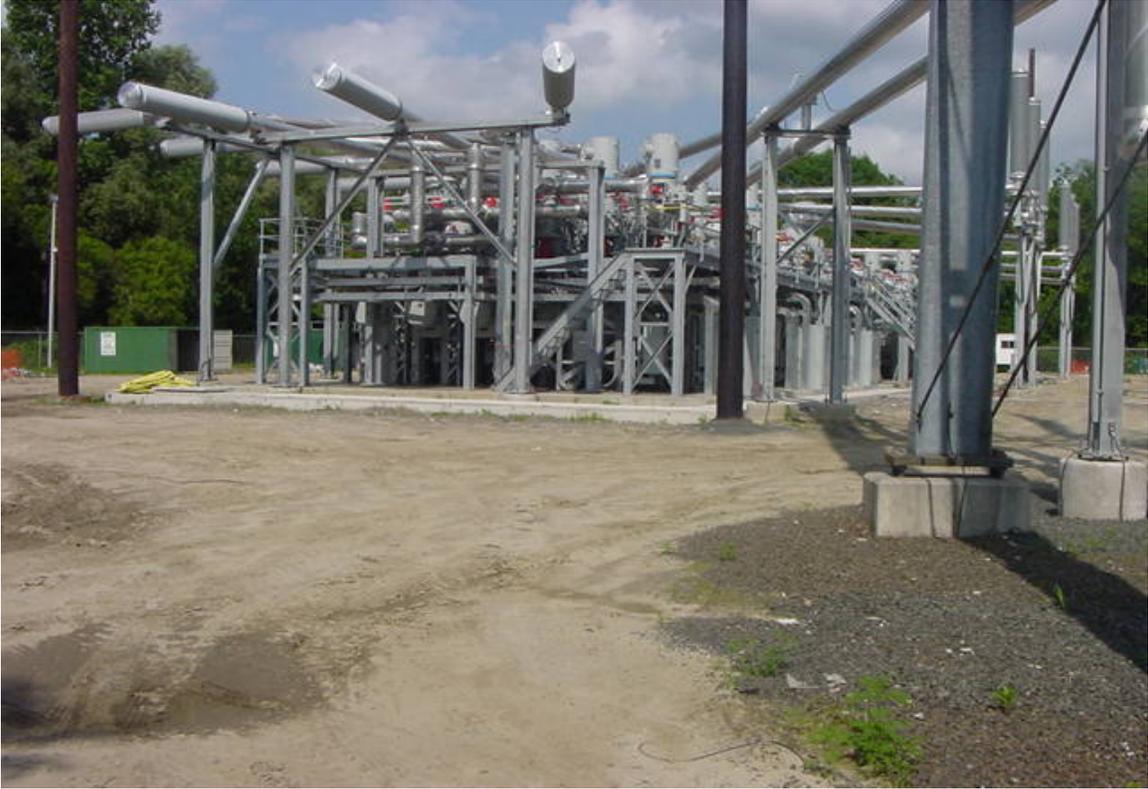
Plumtree Substation: All work is currently internal to the slab. (7/14/05)
