Docket No. 217 – Development and Management Plan Inspection

Northeast Utilities Service Company Certificate of Environmental Compatibility and Public Need for the construction of a 345-kV electric transmission line and reconstruction of an existing 115-kV electric transmission line between Connecticut Light and Power Company's Plumtree Substation in Bethel, through the towns of Redding, Weston, and Wilton, and to the Norwalk Substation in Norwalk, Connecticut.

Date: July 22, 2005

Location: Norwalk Substation Expansion

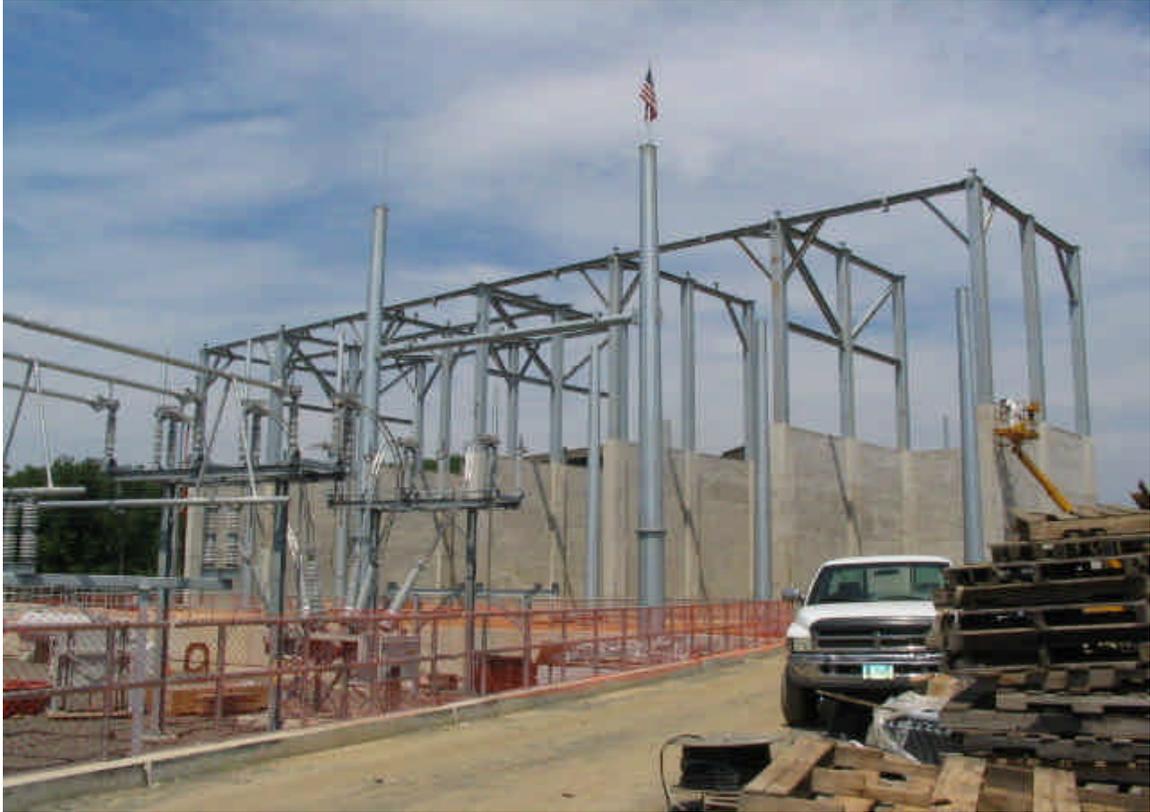
Norwalk Substation: Steel work is ongoing around the GIS building. (7/22/05)

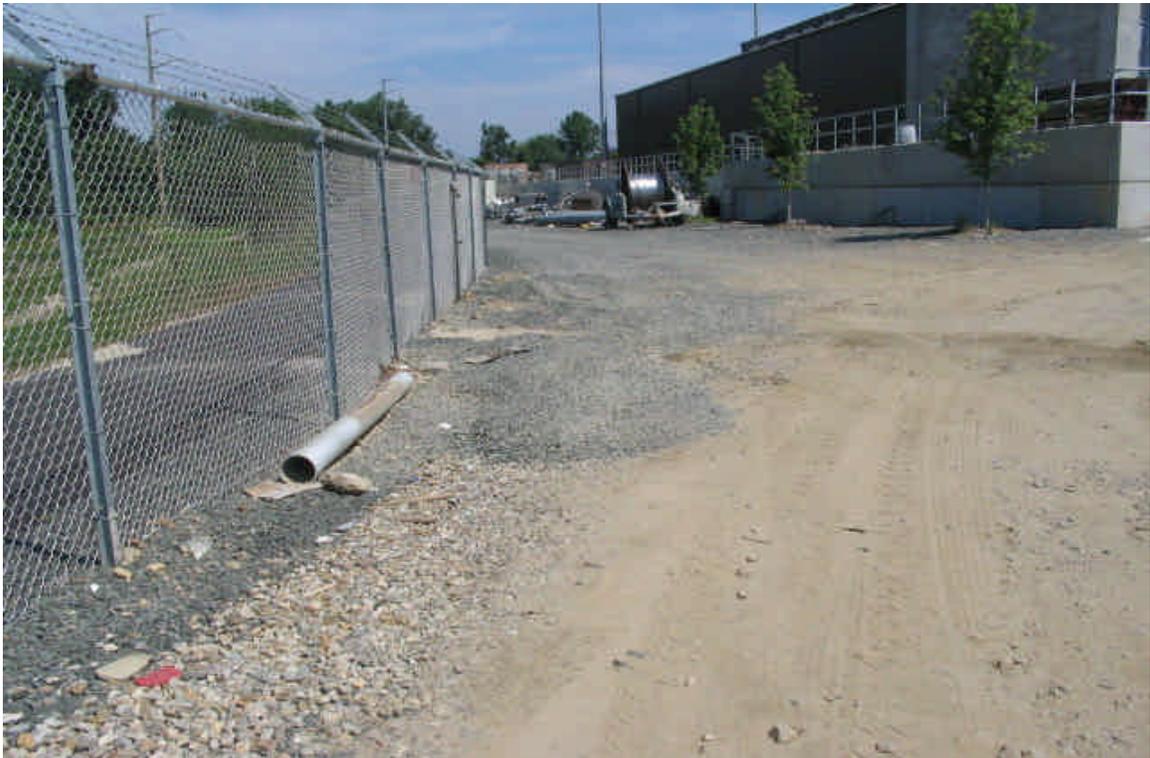
View of the stone placed at the perimeter of the yard where the sedimentation from the access road had been pooling. (7/22/05)

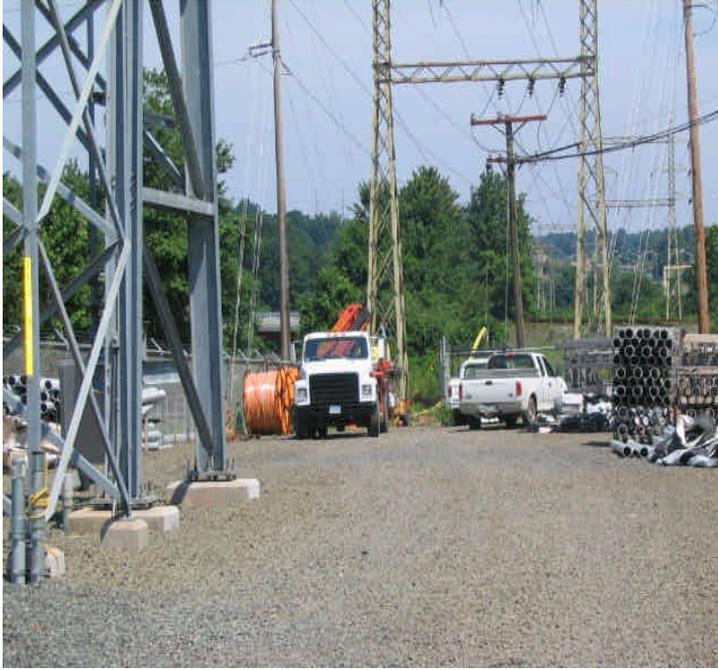
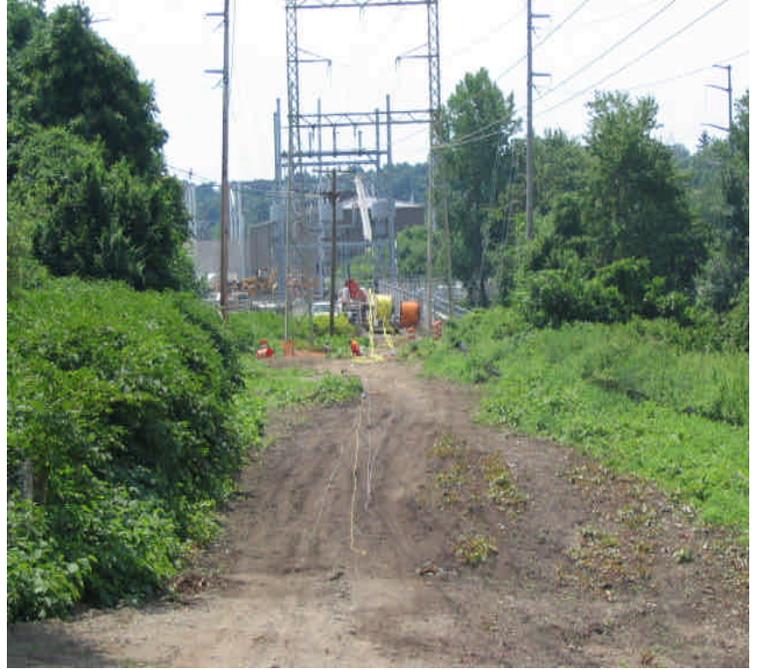
Equipment is in place to pull cable into the yard from the conduit recently installed in the ROW. (7/22/05)

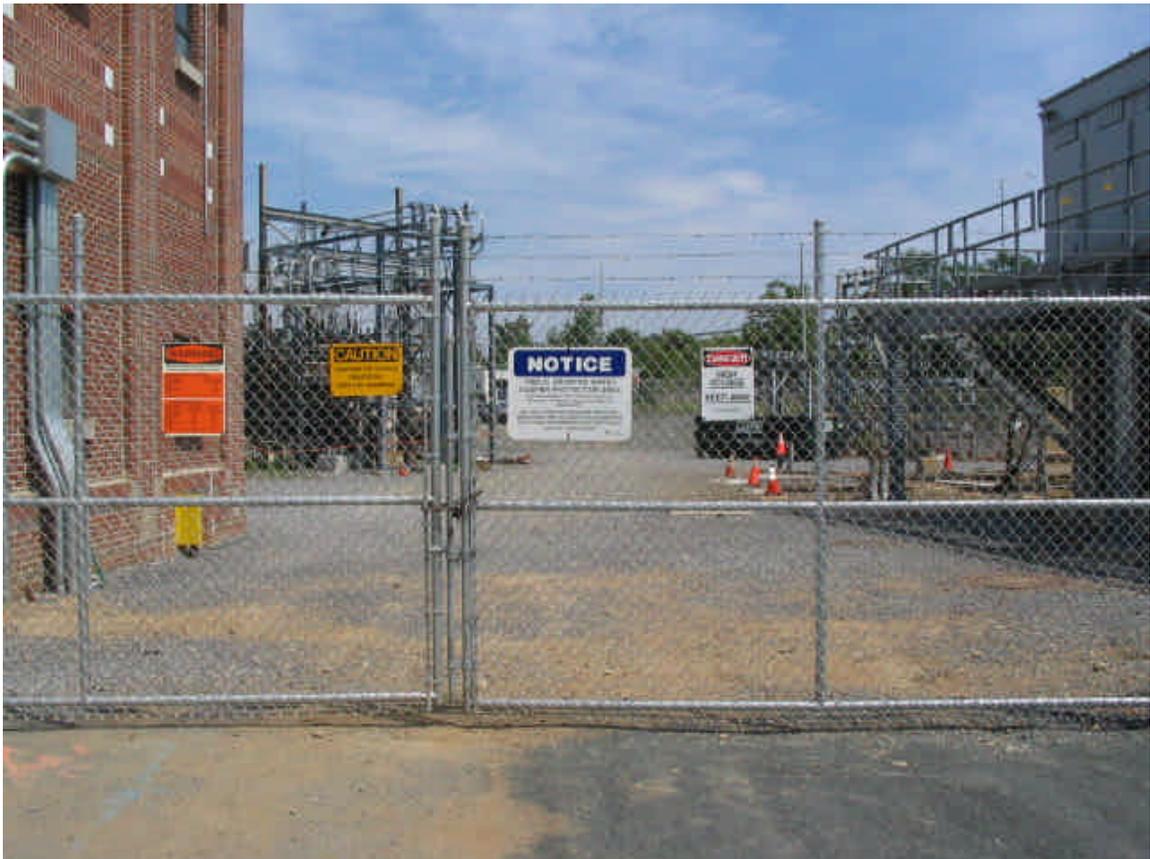
View into the yard from New Canaan Ave where old structures are being removed. (7/22/05)

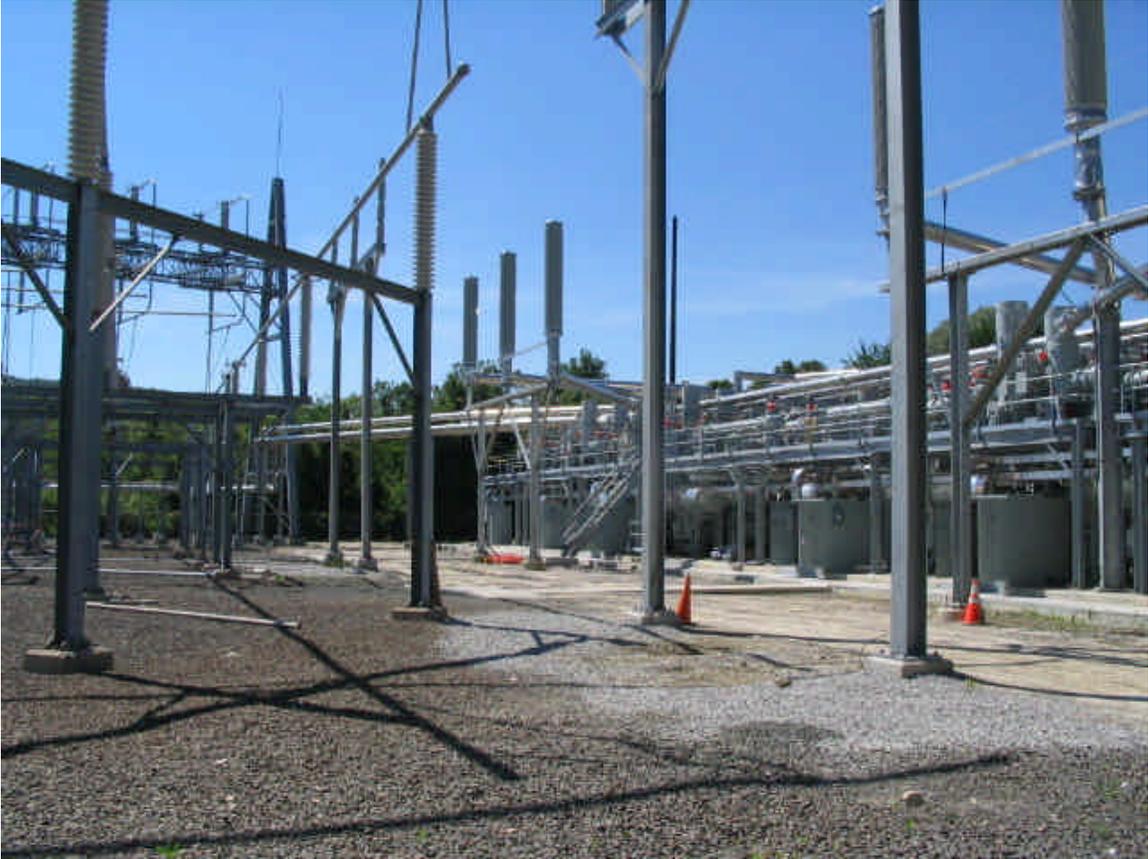
Plumtree Substation: General overview of the yard. No work involving soil disturbance is occurring. (7/22/05)
