Docket No. 217 – Development and Management Plan Inspection

Northeast Utilities Service Company Certificate of Environmental Compatibility and Public Need for the construction of a 345-kV electric transmission line and reconstruction of an existing 115-kV electric transmission line between Connecticut Light and Power Company’s Plumtree Substation in Bethel, through the towns of Redding, Weston, and Wilton, and to the Norwalk Substation in Norwalk, Connecticut.

Date: July 28, 2005

Location: Norwalk Substation Expansion

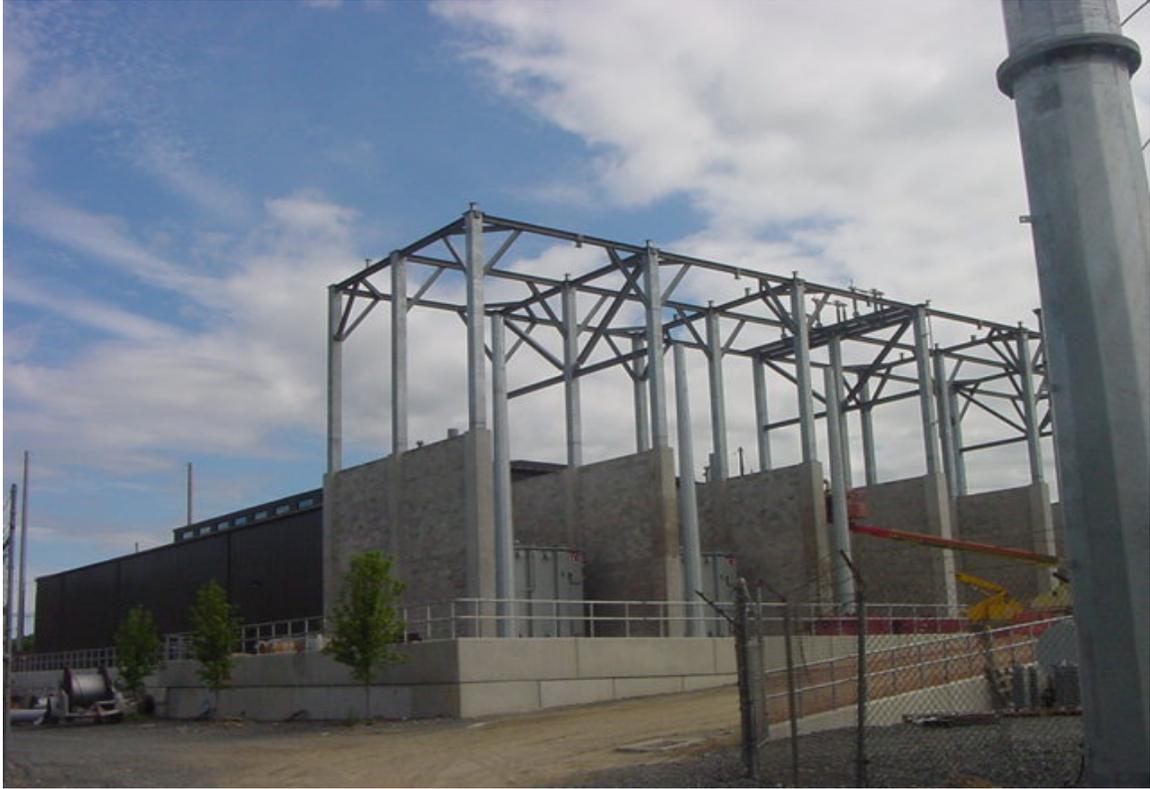
Norwalk Substation: Steel construction is ongoing in front of the GIS building and two transformers were delivered to this area during the inspection. (7/28/05)

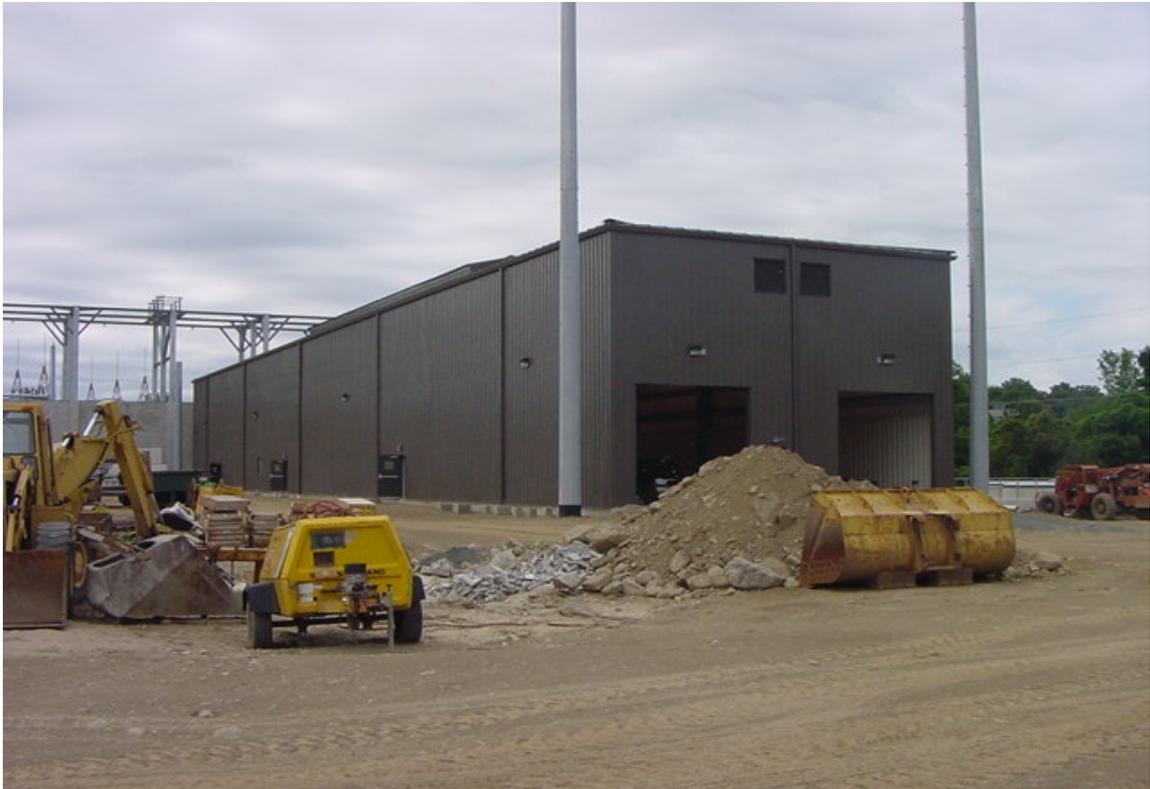
View of the rear of the GIS building where work is ongoing inside. (7/28/05)

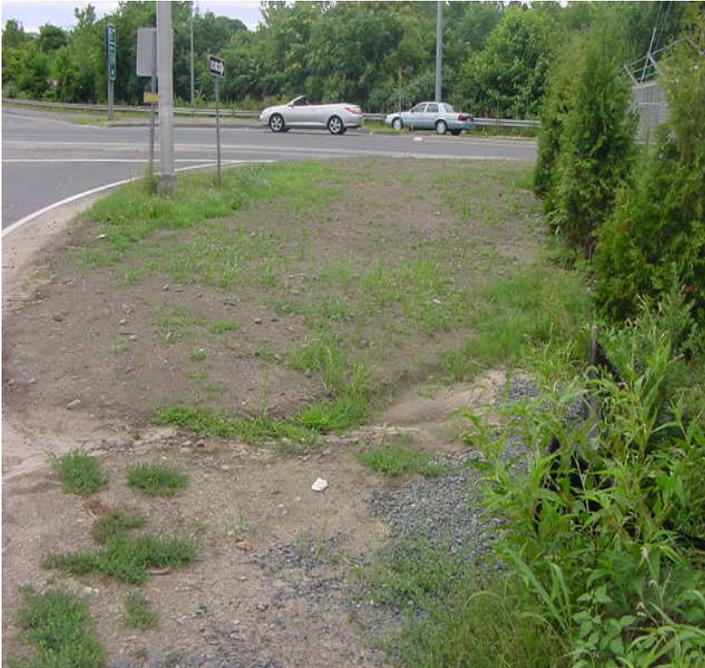
Grass growth is noted in the topsoil along the sidewalk installation (left photo). At the inlet located at the Route 7 off-ramp, the stone has had some washouts but vegetation is growing in here to aid in filtration (right photo). (7/28/05)

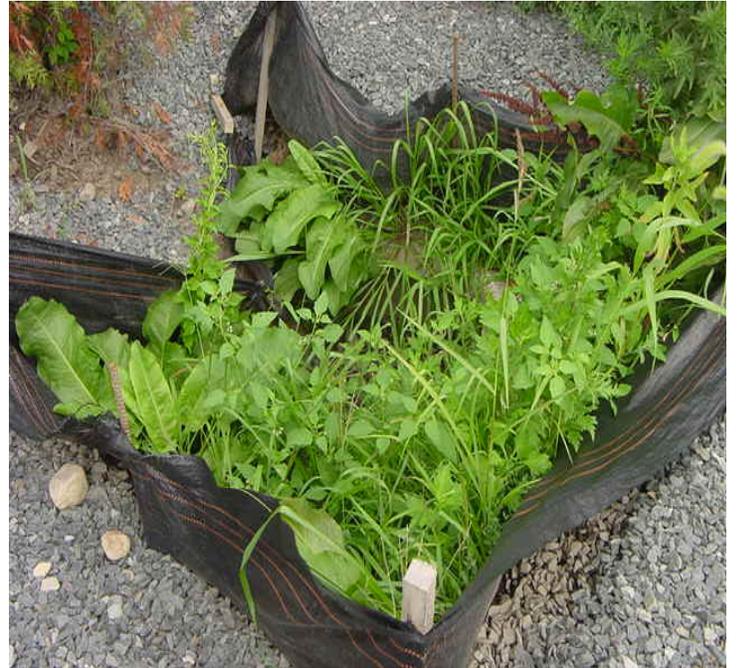
Areas of Inspection	Observation	Recommended Action
Access Roads and Adjacent Roadways	<ul style="list-style-type: none"> - Some washouts have occurred in the stone placed around the inlet near the Route 7 ramp and it has pushed the silt fence over but vegetation is growing within the inlet to help filter sediment. 7/28/05 - Additional grass growth was observed in the soil adjacent to the sidewalk. Final stabilization or vegetative cover will be monitored. 7/14-7/28/05 	<ul style="list-style-type: none"> -The area should continue to be monitored. The roots of the planting have started to become exposed again- it may not be in a good location. 7/6-7/28/05 Sediment is being filtered well by the stone and new growth. 7/28/05 - The soil adjacent to the sidewalk installation is experiencing increased grass growth. Continue to monitor. 7/14-7/28/05
Foundation construction	<ul style="list-style-type: none"> -Cable is being pulled within the yard. 7/28/05 - Most excavations are completed around the GIS building and small structure foundations are being installed around here. 7/22-7/28/05 -Steel work is ongoing at the GIS building and two large transformers were being brought into the yard. 7/28/05 -Structures are being removed from the active, live yard in order to create a new access drive. 7/6-7/28/05 Minor excavation was observed here. 	<ul style="list-style-type: none"> - None at this time. 7/28/05 - All excavation and backfill work is well within the yard and areas are contained, no issues at this time. 7/28/05

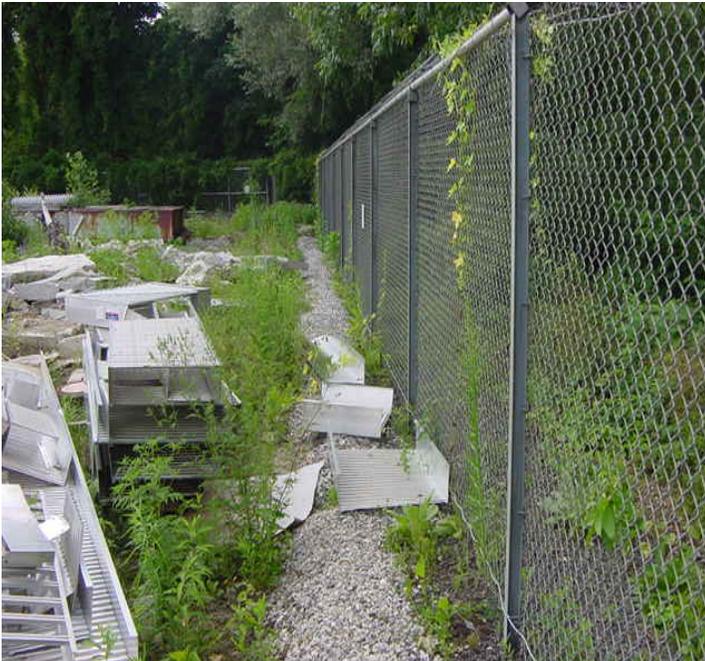
Plumtree Substation: The perimeter berm is still well in place (left photo). Work is ongoing within the control house (right photo). (7/28/05)
