Docket No. 217 – Development and Management Plan Inspection

Northeast Utilities Service Company Certificate of Environmental Compatibility and Public Need for the construction of a 345-kV electric transmission line and reconstruction of an existing 115-kV electric transmission line between Connecticut Light and Power Company’s Plumtree Substation in Bethel, through the towns of Redding, Weston, and Wilton, and to the Norwalk Substation in Norwalk, Connecticut.

Date: August 19, 2004

Location: Norwalk Substation Expansion

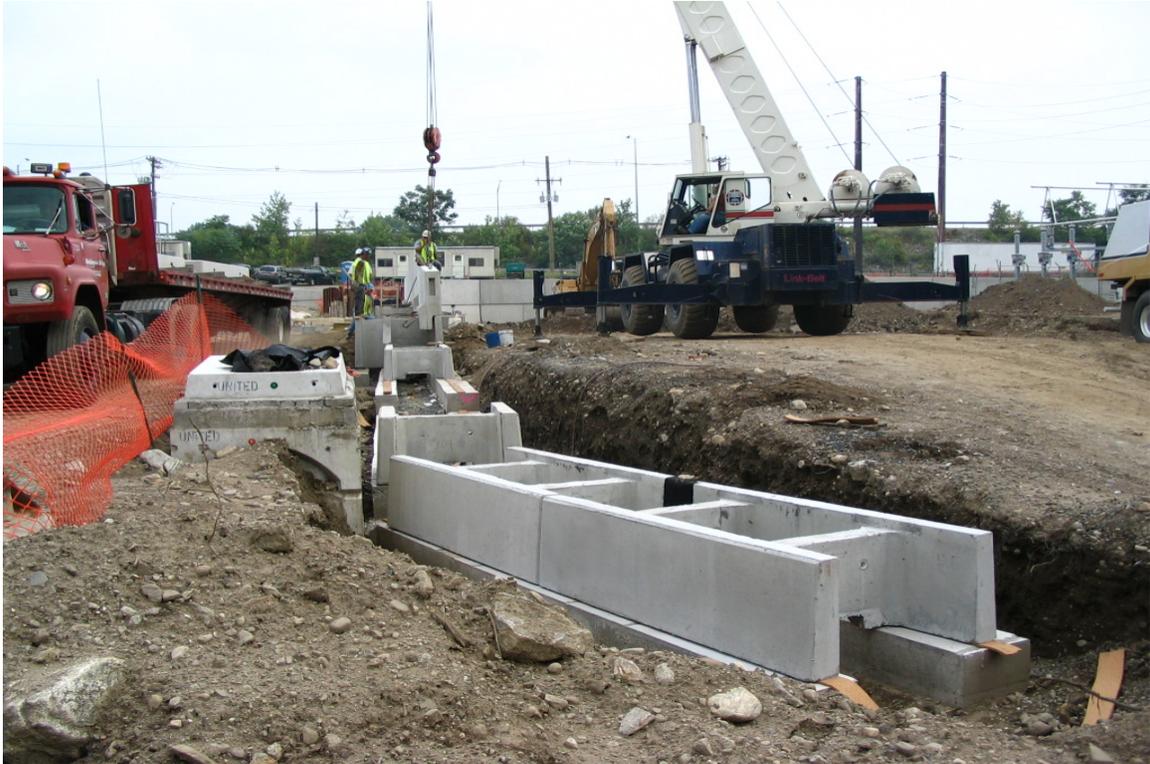
View of the progress on retaining wall #3. All excavations are contained at this time. 8/19/04

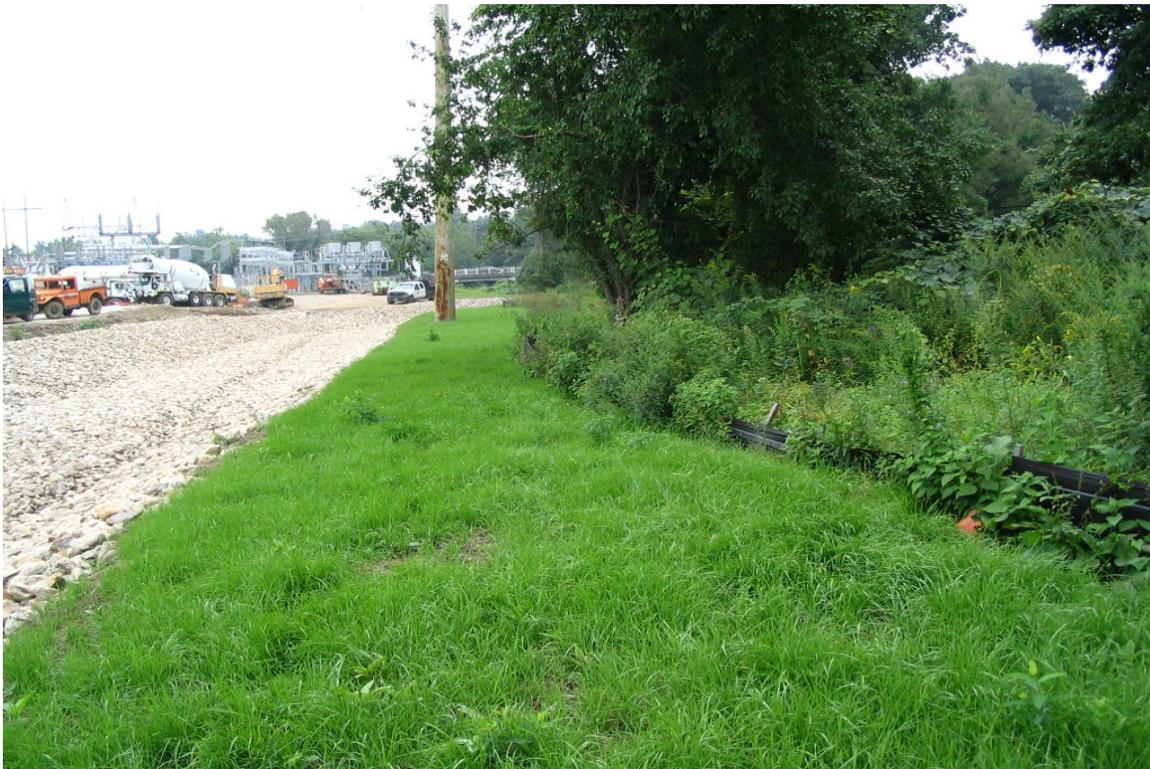
View of the grassed area between the overflow channel and the river. This area has revegetated very well and silt fence could be removed from this portion. Other adjacent portions must remain in place as they have not fully stabilized with cover. 8/19/04

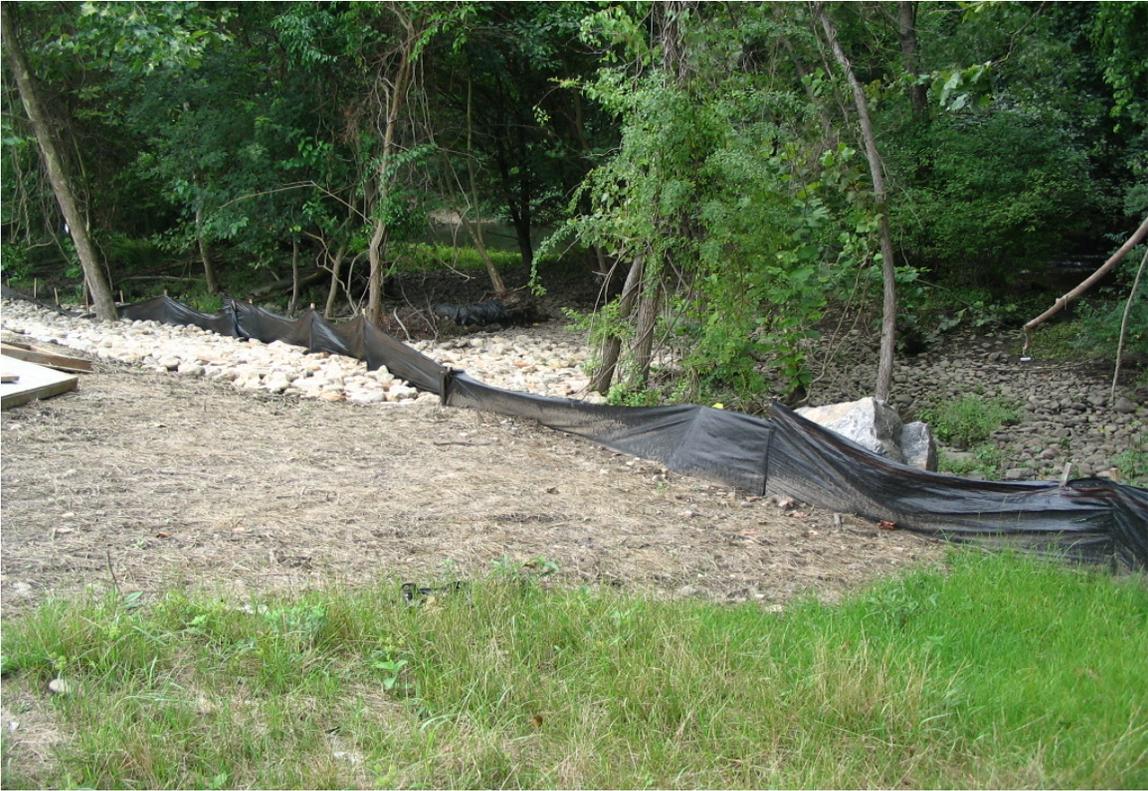
Areas of Inspection	Observation	Recommended Action
Erosion and Sediment Controls (includes inspection within 24 hours of a storm event)	<ul style="list-style-type: none"> - A section of silt fence located across the overflow channel has come down due to high river levels during the rain. 8/19/04 - The remainder of the fence is still in good shape. 8/19/04 	<ul style="list-style-type: none"> - This portion of fence, directly within the channel can be removed completely as it will only impede overflow into the channel. 8/19/04 - Continue to be proactive in silt fence repair and maintenance.
Erosion and Sediment Controls cont'd	<ul style="list-style-type: none"> - Concrete washouts were noted in other contained, low fill areas on site but attempts should be made to keep them more towards the center of site. 8/19/04 	<ul style="list-style-type: none"> - The main objective is to keep all washout water from resource areas and storm drains.

Inland Wetland and Watercourse encroachment and mitigation	<ul style="list-style-type: none"> - The silt fence is still well in place along the river with the exception of the portion across the channel. 8/19/04 - The areas along the channel 	<ul style="list-style-type: none"> - Continue to monitor silt fence and repair as necessary, especially in portions closest to the river. The downed fence, directly across the channel can be removed at this

The silt fence had fallen down within the main portion of the overflow channel (far background of photo) and this section can be removed completely. This area to the immediate north of the channel must be monitored, and silt fence left in place, as little vegetative cover has established. 8/19/04

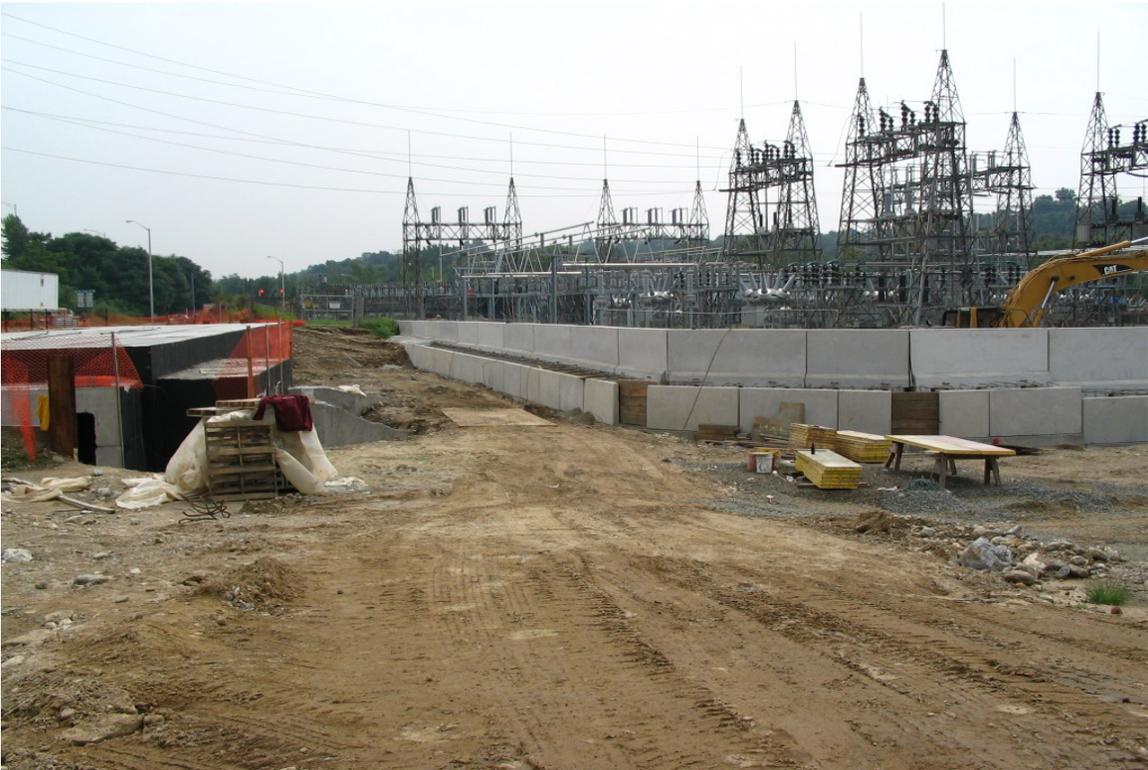
View of progress at retaining wall #3 and the control building. 8/19/04

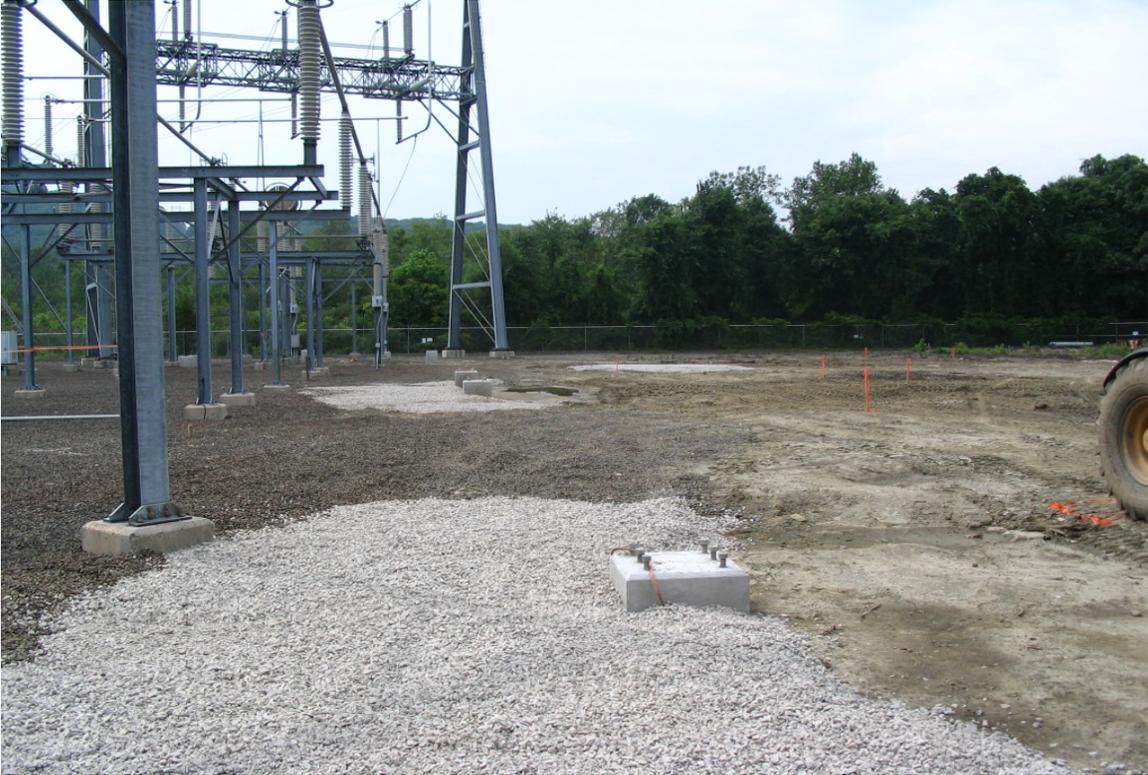
Most of the previous excavations for footings have been completed and backfilled. A few new smaller excavations are still open. 8/19/04

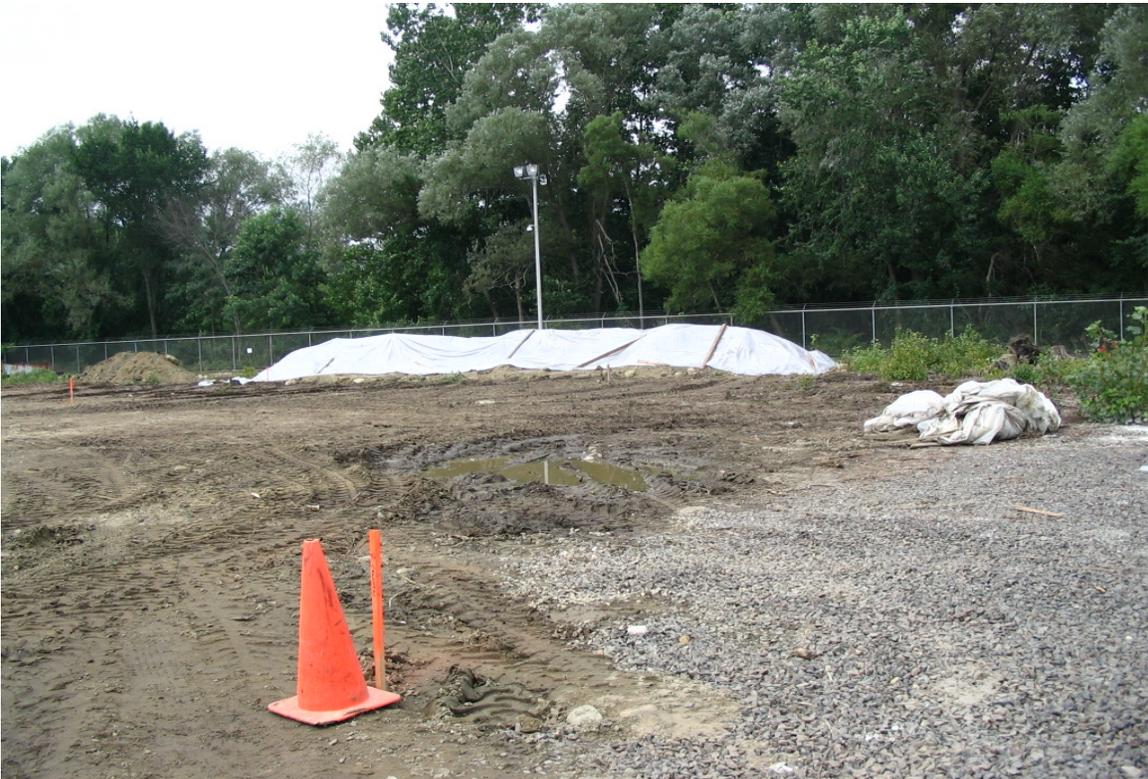
A new excavation and remaining soil stockpile are closer to the perimeter of the yard but there is no evidence of soil migration or sedimentation from the pile. The protective plastic is well in place. 8/19/04
