**Docket No. 217 – Development and Management Plan Inspection**

**Norwalk Substation**

**Date:** August 24, 2006

### Plumtree Substation

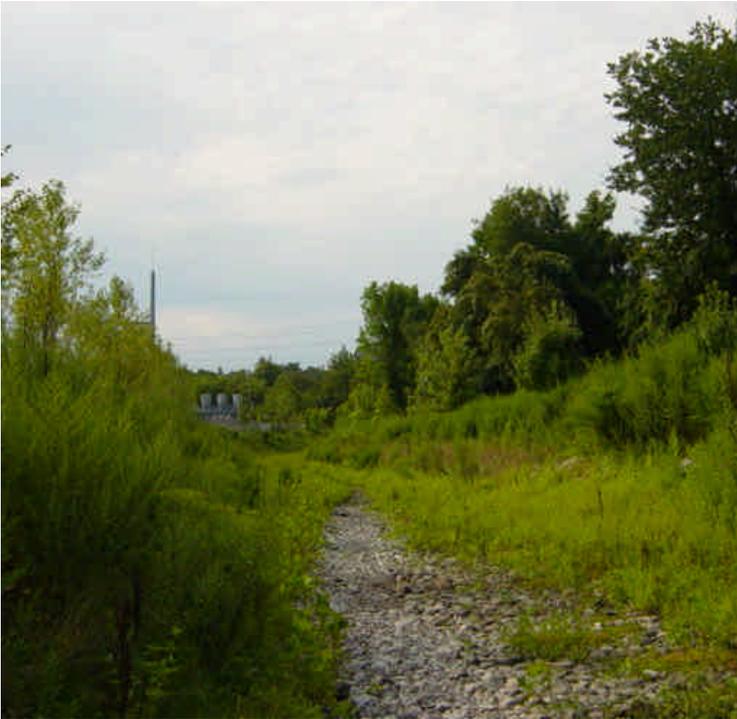
Areas of Inspection	Observation	Recommended Action	Corrected Action
Inland Wetland and Watercourse encroachment and mitigation	- Vegetation continues to grow well along the original overflow channel as well as in the landscaped area near the GIS building. 8/24/06.	- None at this time. The overflow channel was dry and well vegetated at the time of inspection. 8/24/06.	-N/A
Vegetative clearing limits (including trees to save or danger trees noted)	-The riverbank to the north of site in the ROW could use some vegetative cover. 5/17-8/24/06	- None at this time. Continue to monitor and consider adding seed if feasible. This is likely overhead jurisdiction. 5/17-8/24/06	-N/A
Dewatering	-Construction dewatering should no longer be occurring on site. 8/24/06.	-None at this time. 8/24/06.	-N/A.
Blasting	- Not applicable	- None at this time.	-N/A
Spills and Material Storage	- Wire pulling equipment was not on site at the time of inspection. 8/24/06.	In general: - Continue to keep all vehicles maintained well (i.e. no apparent fluid leaks) if they will be used or stored on site. - Report spills to the office immediately, even if they are being controlled.	-N/A

**(Norwalk Substation):** Photo on the left shows the overflow channel, well vegetated and dry at the time of inspection. Photo on the right shows a view looking towards the GIS building and adjacent vegetated area. 8/24/06

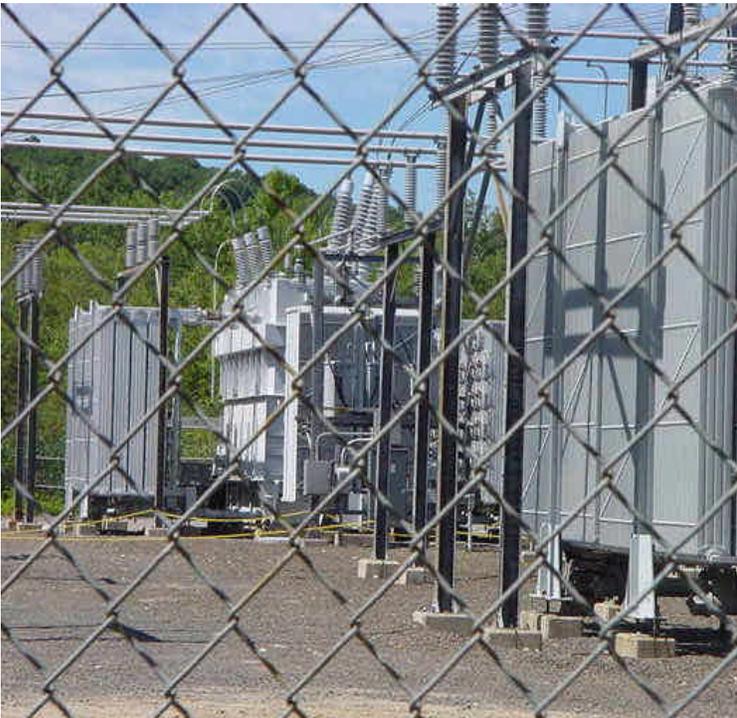
**(Plumtree Substation):** Photo on the left shows the work on the new equipment progressing in the northwestern side of the site. Photo on the right shows another view of the yard. 8/24/06
