**Docket No. 217 – Development and Management Plan Inspection**

Northeast Utilities Service Company Certificate of Environmental Compatibility and Public Need for the construction of a 345-kV electric transmission line and reconstruction of an existing 115-kV electric transmission line between Connecticut Light and Power Company's Plumtree Substation in Bethel, through the towns of Redding, Weston, and Wilton, and to the Norwalk Substation in Norwalk, Connecticut.

**Date:** August 25, 2005

**Location:** Norwalk Substation Expansion

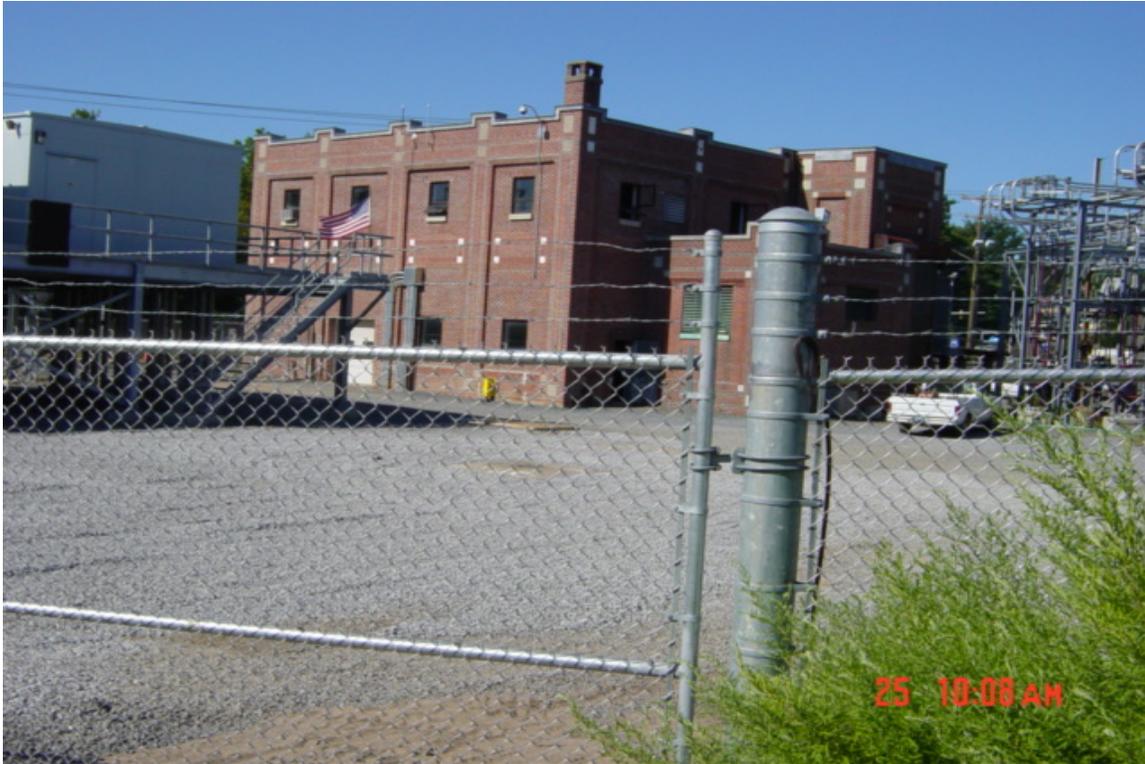
Norwalk Substation: The area where concrete was removed in the live yard has been restored. (8/25/05)

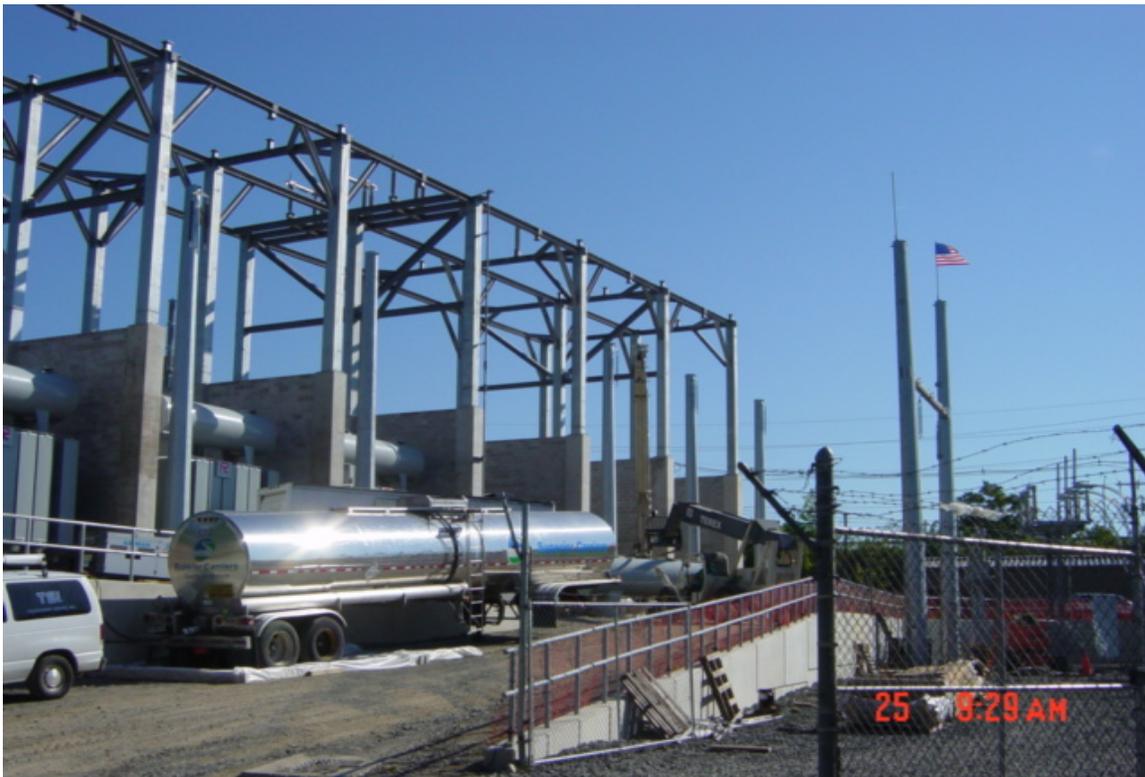
Areas of Inspection	Observation	Recommended Action
Spills and Material Storage continued	<p>material storage. The spots will be picked up and the equipment examined. 8/25/05</p> <p>-A truck has been on site this week to fill the transformers with oil. The transformer equipment did have some minor leaks but it was all contained and they are being repaired. The filling operations themselves did not have any issues. 8/25/05</p> <p>- Piles of debris were noted outside of the perimeter fence and adjacent to the Rt. 7 ramp. The siting council noticed these on their visit and requested that it be cleaned up 8/25/05</p>	<p>- The contractors should remain vigilant about securing and handling fuel and all other material containers due to the sensitivity of the area.</p> <p>- Report spills to the office immediately, even if they are being controlled.</p> <p>- Take care not to get carried away and to be vigilant when refueling.</p> <p>- All fuels and agents not in use should be covered and stored in the sheds and trailers before leaving for the day.</p>

View of the operation to fill the transformers with oil. The truck was placed with appropriate controls during the work. (8/25/05)

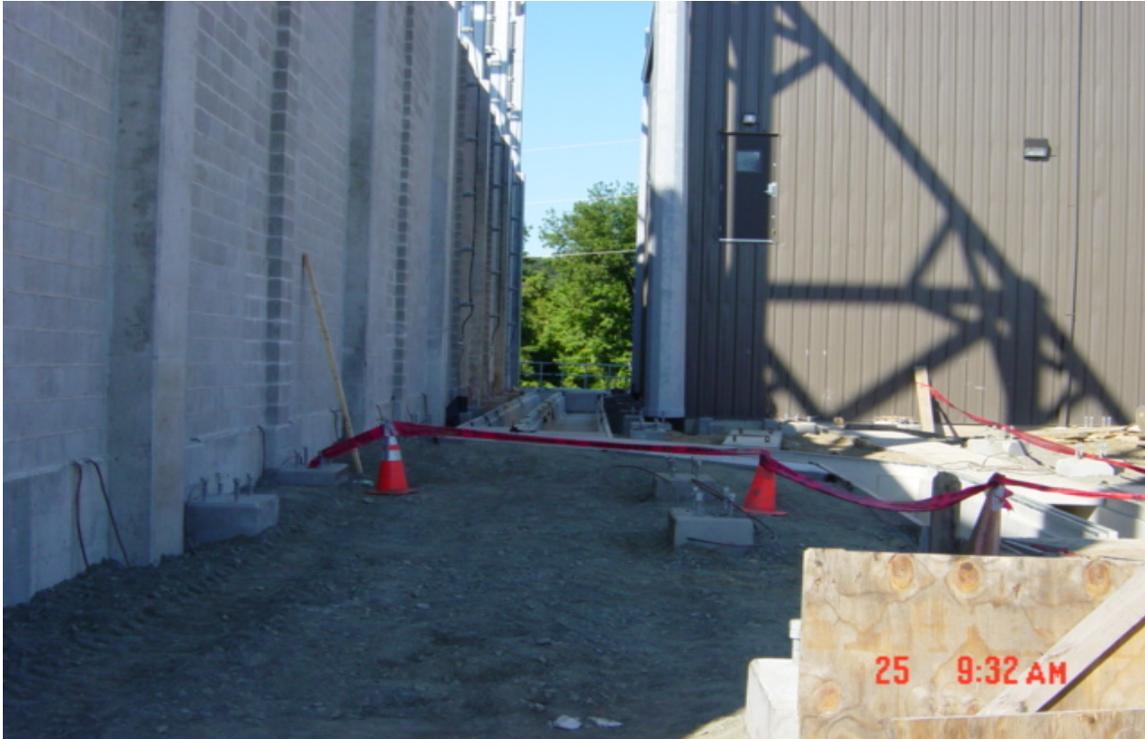
Work on the concrete cable boxes/trays was ongoing near the GIS building. (8/25/05)

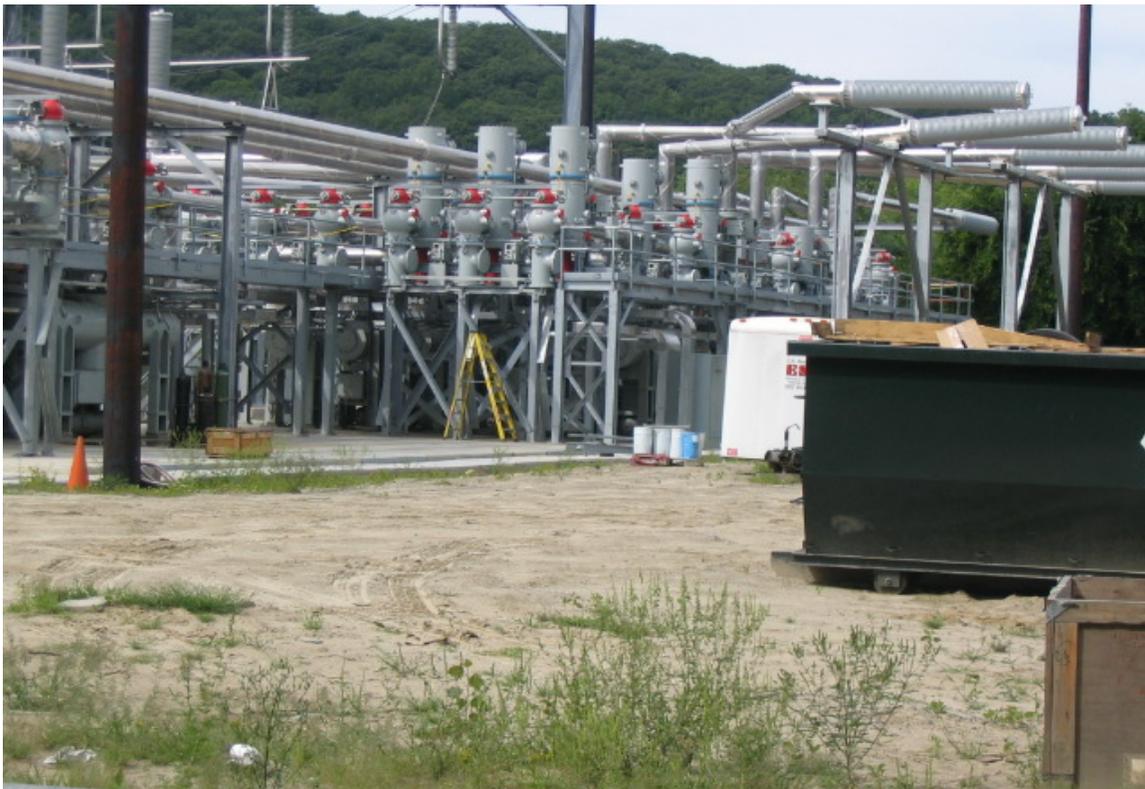
Plumtree Substation: General view of the site. No soil disturbing activities have been occurring. (8/25/05)
