**Docket No. 217 – Development and Management Plan Inspection**

Northeast Utilities Service Company Certificate of Environmental Compatibility and Public Need for the construction of a 345-kV electric transmission line and reconstruction of an existing 115-kV electric transmission line between Connecticut Light and Power Company’s Plumtree Substation in Bethel, through the towns of Redding, Weston, and Wilton, and to the Norwalk Substation in Norwalk, Connecticut.

**Date:** August 26, 2004

**Location:** Norwalk Substation Expansion

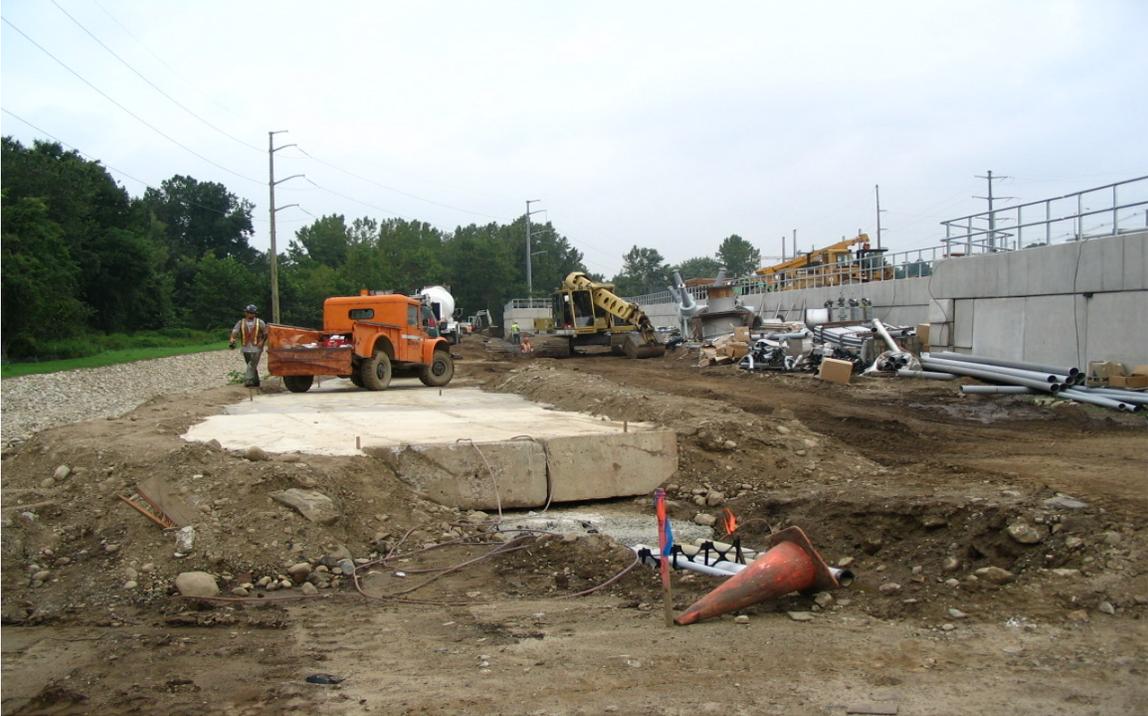
View of the concrete cover of the conduit bank from 8/19/04. As of 8/26/04, a new conduit section was being completed

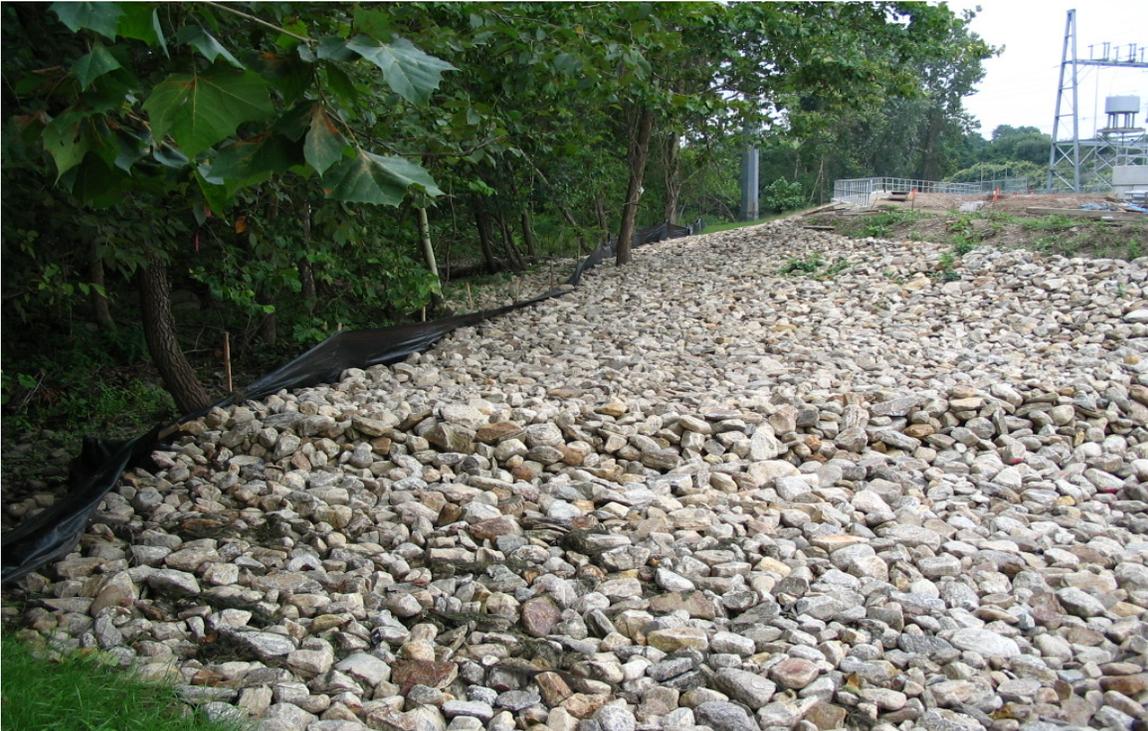
Areas of Inspection	Observation	Recommended Action
Erosion and Sediment Controls (includes inspection within 24 hours of a storm event)	<ul style="list-style-type: none"> <li>- A section of silt fence located across the overflow channel had come down due to high river levels during the rain last week. 8/19-8/26/04</li> <li>- The remainder of the fence is still in good shape. 8/26/04</li> </ul>	<ul style="list-style-type: none"> <li>- This portion of fence, directly within the channel can be removed completely as it will only impede overflow into the channel. 8/26/04</li> <li>- Continue to be proactive in silt fence repair and maintenance.</li> </ul>
Erosion and Sediment Controls cont'd	<ul style="list-style-type: none"> <li>- Concrete washouts continue towards the center of site in the low fill area. 8/26/04</li> </ul>	<ul style="list-style-type: none"> <li>- The main objective is to keep all washout water from resource areas and storm drains.</li> </ul>

The silt fence had fallen down within the main portion of the overflow channel (background of photo) as of 8/19/04 and this section can be removed completely.

<ul style="list-style-type: none"> <li>- Coconut fiber logs have been delivered to the site and will be installed into the base of the overflow channel in the near future. 8/26/04</li> </ul>	<ul style="list-style-type: none"> <li>- The biologs will be staked into the base of the channel and seeded. 8/26/04</li> </ul>
Inland Wetland and Watercourse encroachment and mitigation	<ul style="list-style-type: none"> <li>- The silt fence is still well in place along the river. Most areas have sufficient vegetative cover but a few areas remain sparse. 8/26/04</li> </ul>	<ul style="list-style-type: none"> <li>- Continue to monitor silt fence and repair as necessary, especially in portions closest to the river. The downed fence, directly across the channel can be removed at this time 8/19-8/26/04</li> </ul>
