**Docket No. 217 – Development and Management Plan Inspection**

Northeast Utilities Service Company Certificate of Environmental Compatibility and Public Need for the construction of a 345-kV electric transmission line and reconstruction of an existing 115-kV electric transmission line between Connecticut Light and Power Company's Plumtree Substation in Bethel, through the towns of Redding, Weston, and Wilton, and to the Norwalk Substation in Norwalk, Connecticut.

**Norwalk Substation**

**Date:** August 30, 2006

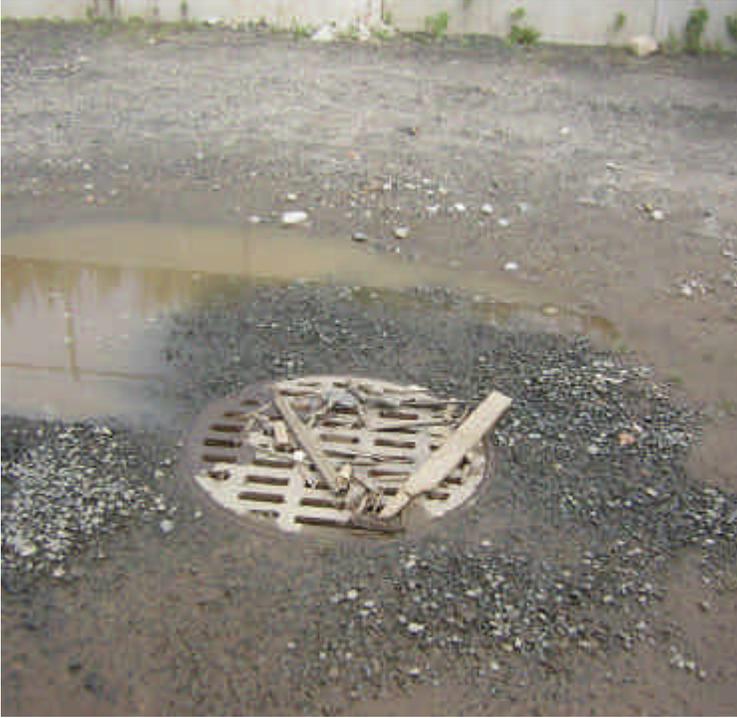
**(Norwalk Substation):** Photo on the left shows the inlet within the substation yard. Some additional stone may be necessary to keep turbid run-off from entering the Norwalk River. Photo on the right shows the 345kV turning structure base with riprap in place. Remove any left over wire debris from the area. 8/30/06
