**Docket No. 217 – Development and Management Plan Inspection**

Northeast Utilities Service Company Certificate of Environmental Compatibility and Public Need for the construction of a 345-kV electric transmission line and reconstruction of an existing 115-kV electric transmission line between Connecticut Light and Power Company's Plumtree Substation in Bethel, through the towns of Redding, Weston, and Wilton, and to the Norwalk Substation in Norwalk, Connecticut.

**Norwalk Substation**

**Date:** September 20, 2006

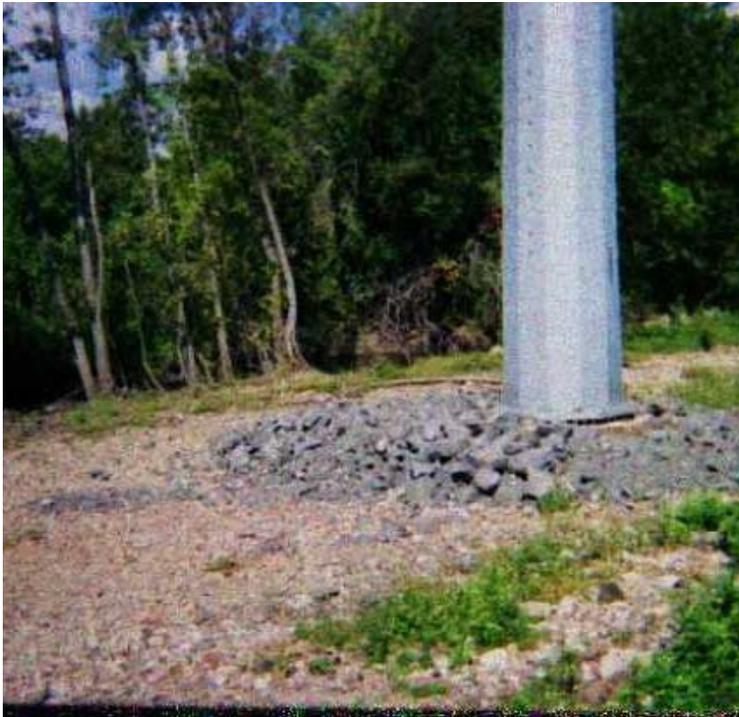
| Areas of Inspection | Observation | Recommended Action | Corrected Action |
|--|---|--|---|
| Inland Wetland and Watercourse encroachment and mitigation | - The original overflow channel is fully vegetated. 9/20/06.<br><br>- Repaired stone fill at the turning structure appears to be piled noticeably higher than adjacent | - None at this time. 9/20/06.<br><br>- Ensure that appropriate grades are met. 9/20/06 | -N/A<br><br>- Needs evaluation |

| Areas of Inspection | Observation | Recommended Action | Corrected Action |
|--|---|--|---|
| | grades. 9/13-9/20/06 | | |

(Norwalk Substation): Photo on the left shows the repaired stone area at the 345kV turning structure Photo on the right shows a view of the yard. Electrical work was noted. 9/20/06

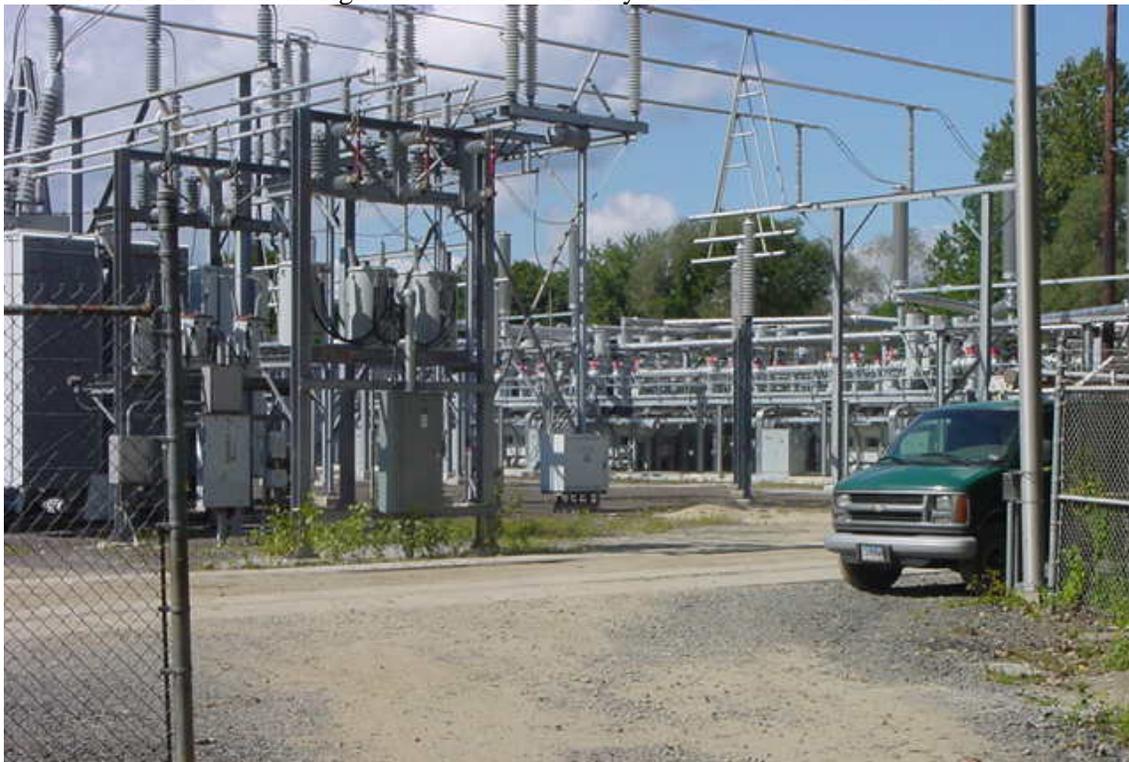
(Plumtree Substation): Photo on the left shows a current view of the yard with some electrical and equipment work still occurring here. 9/20/06
