Docket No. 217 – Development and Management Plan Inspection

Northeast Utilities Service Company Certificate of Environmental Compatibility and Public Need for the construction of a 345-kV electric transmission line and reconstruction of an existing 115-kV electric transmission line between Connecticut Light and Power Company’s Plumtree Substation in Bethel, through the towns of Redding, Weston, and Wilton, and to the Norwalk Substation in Norwalk, Connecticut.

Date: September 30, 2004

Location: Norwalk Substation Expansion

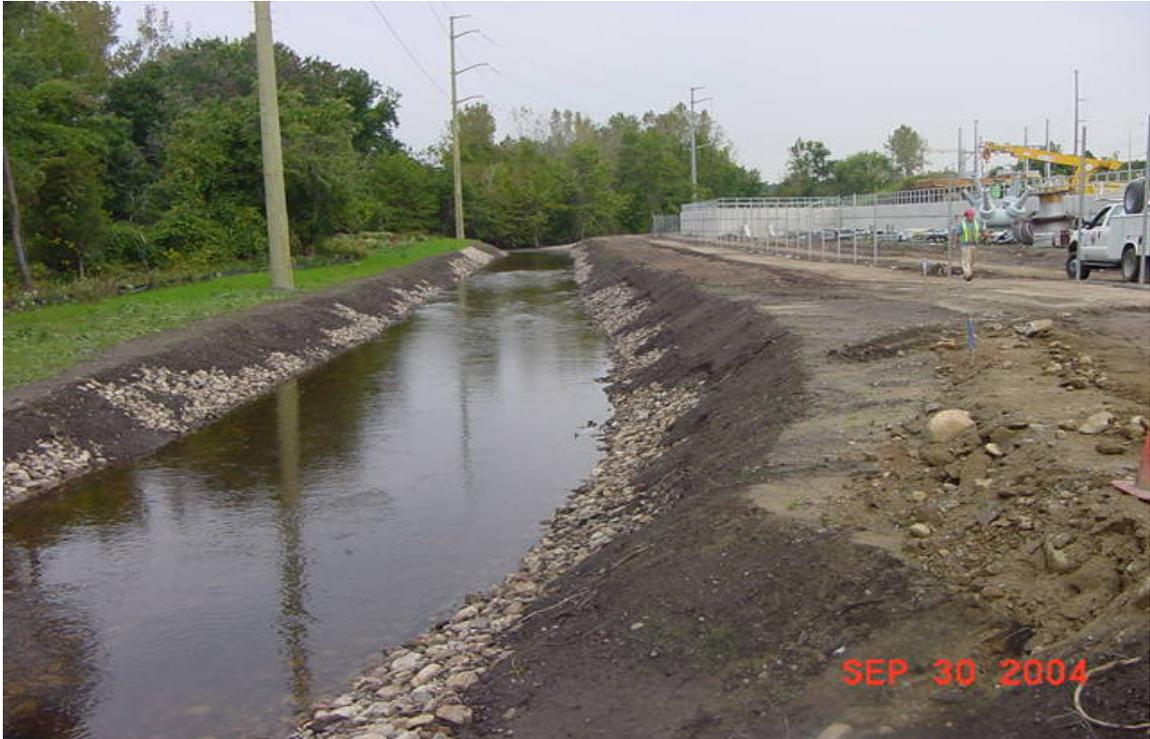
Following last week's repairs on the soil erosion within the overflow channel, another large storm event caused similar damage and washouts. 9/30/04

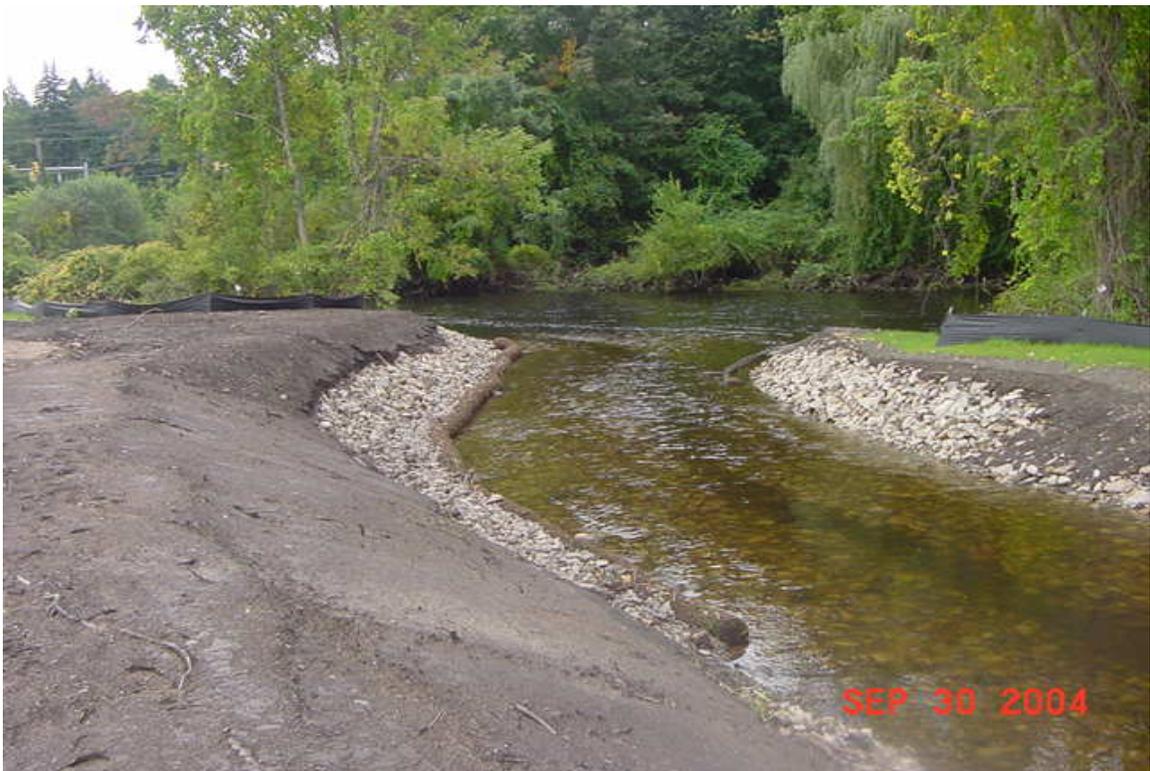
View of the southern portion of the channel where some erosion had occurred in the recently repaired areas. Further repairs are on hold while discussions on how to best stabilize the area are ongoing. 9/30/04

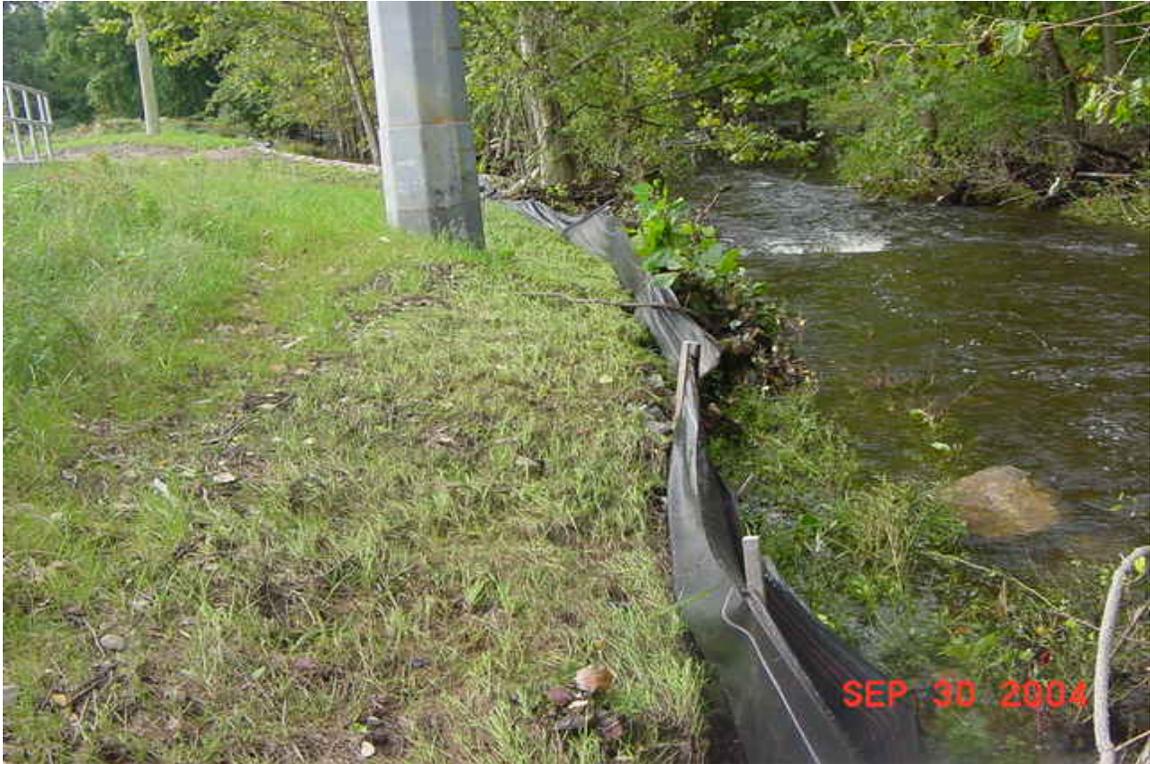
View of the area near retaining wall #5 which again had flows over the silt fence but remains stabilized with vegetative cover. 9/30/04

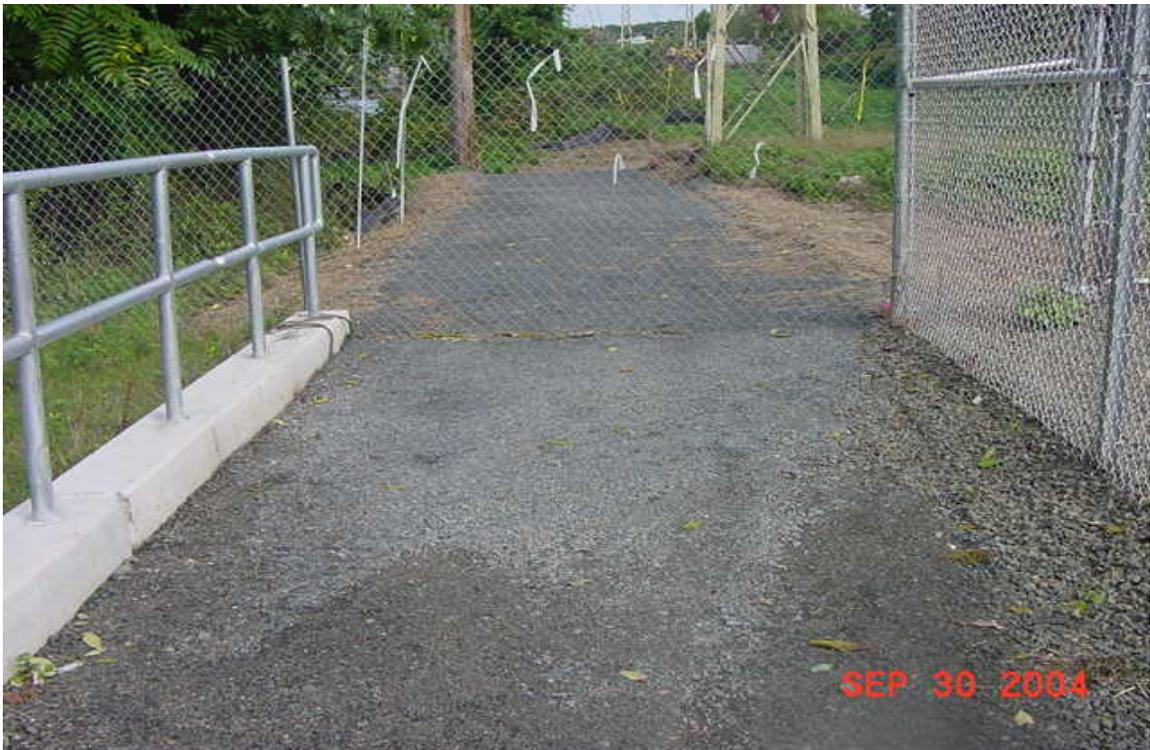
Areas of Inspection	Observation	Recommended Action
Erosion and Sediment Controls continued	- The erosion at the northernmost portion of the bike pike has been repaired and the path was extended further north. 9/30/04	- Paving is now proposed in the coming week and this should reduce the chance of future erosion. 9/30/04

The bike path erosion has been repaired and the path was extended further north. The path will likely be paved during the following week. 9/30/04

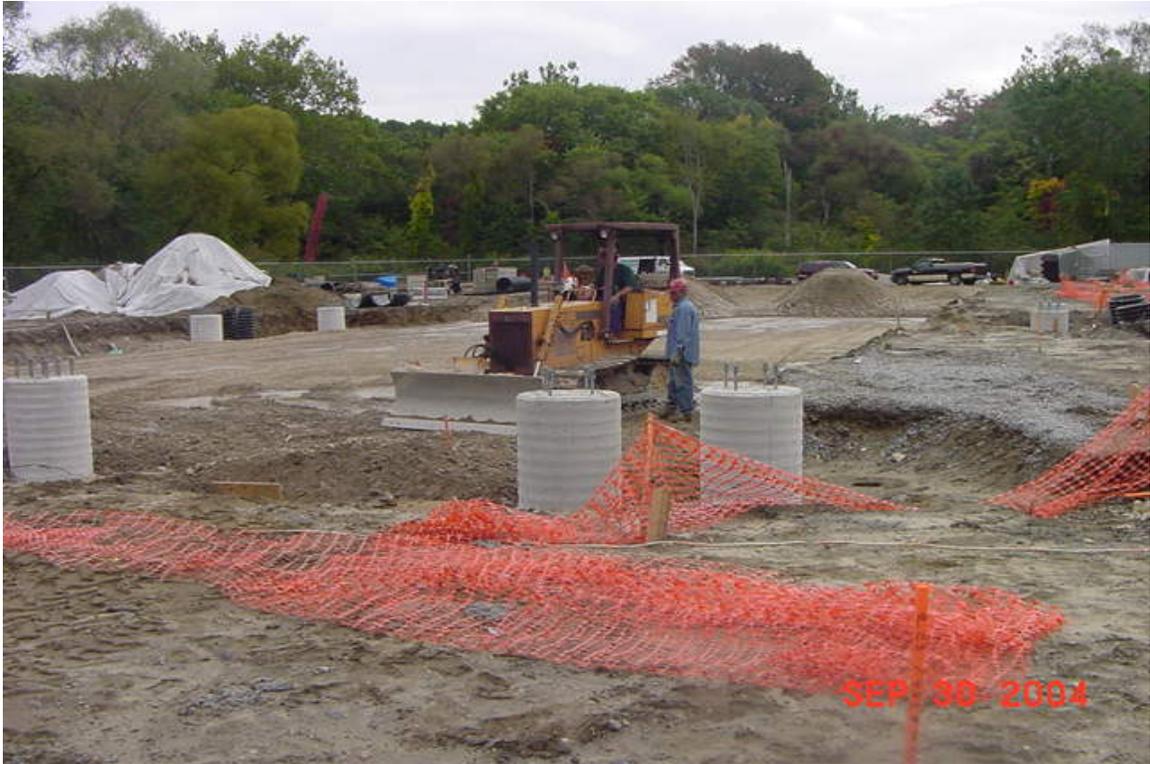
Plumtree Substation: View of the continuing excavation, grading and work on the GIS concrete pad.. 9/30/04

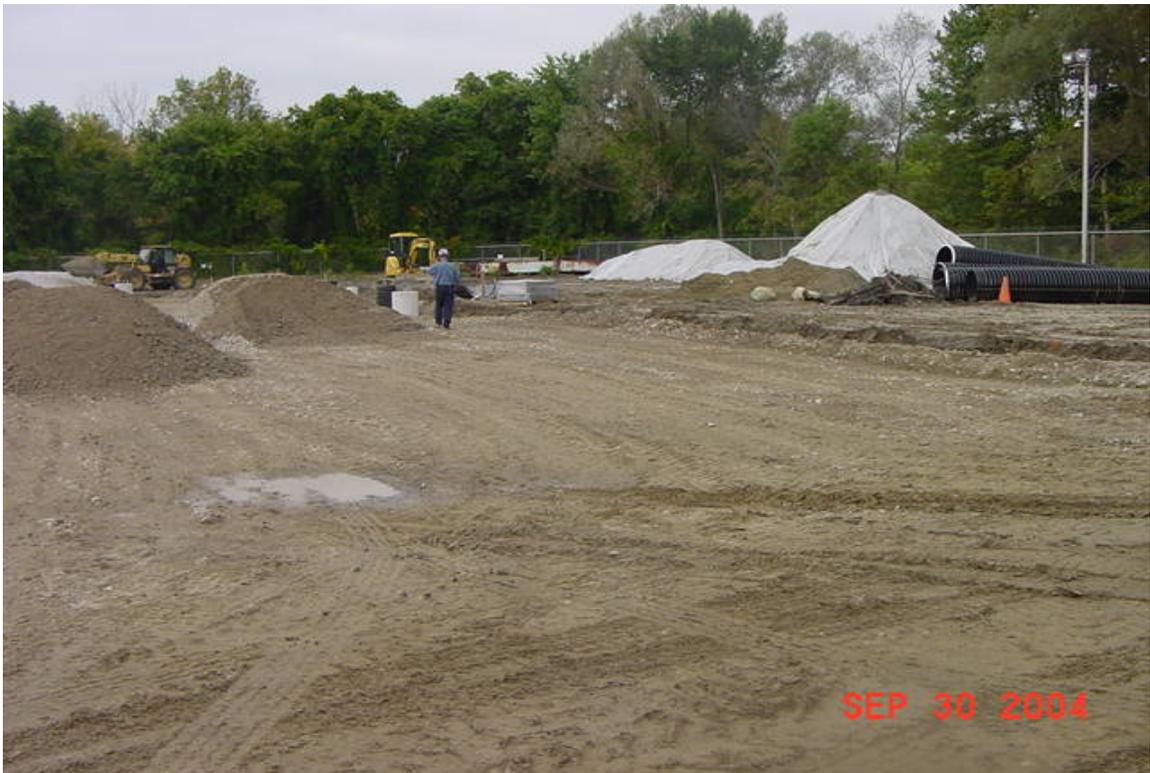
Areas of Inspection	Observation	Recommended Action
Erosion and Sediment Controls (includes inspection within 24 hours of a storm event)	- The stone perimeter berm is well in place and contains the yard. It prevented any turbid water from leaving the site during the second storm as well. 9/30/04	- The berm is working well at this time. Continue to monitor for any trouble spots. 9/30/04

Overall view of the site with stockpiles covered in plastic. Rainfall and any sediment continues to be kept on site within the perimeter berm, even following the second large storm in two weeks. 9/30/04
