Docket No. 217 – Development and Management Plan Inspection

Northeast Utilities Service Company Certificate of Environmental Compatibility and Public Need for the construction of a 345-kV electric transmission line and reconstruction of an existing 115-kV electric transmission line between Connecticut Light and Power Company’s Plumtree Substation in Bethel, through the towns of Redding, Weston, and Wilton, and to the Norwalk Substation in Norwalk, Connecticut.

Date: October 13, 2005

Location: Norwalk Substation Expansion

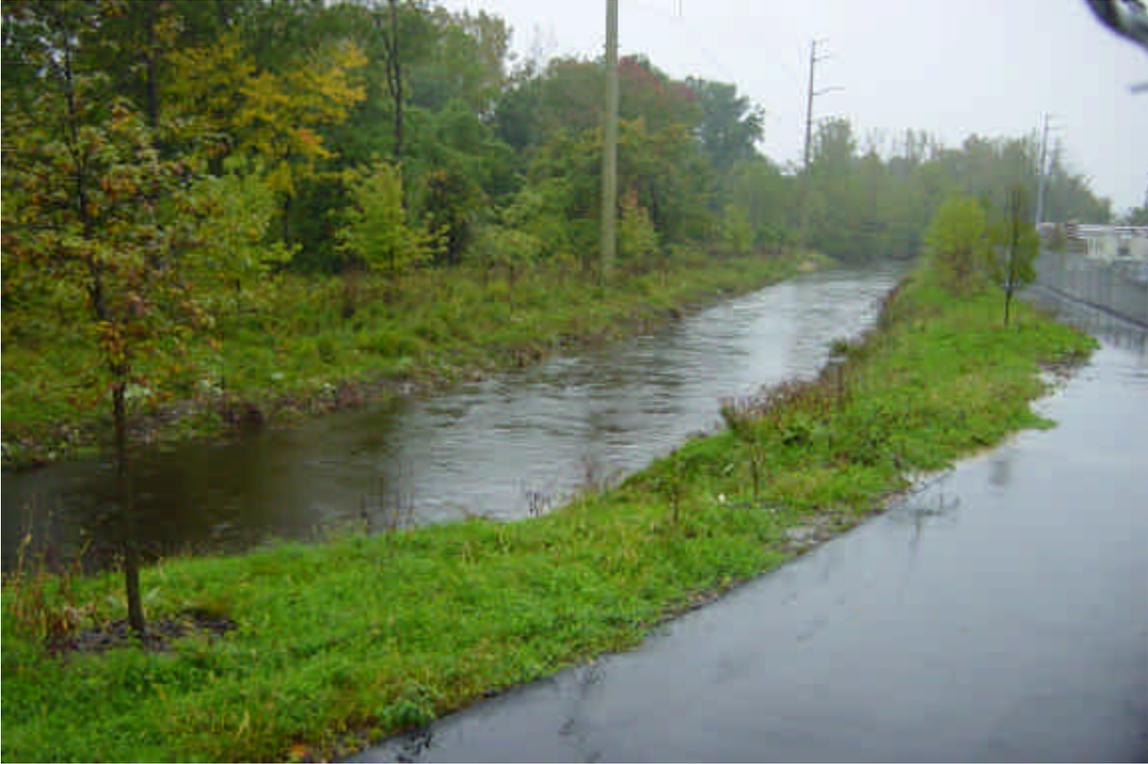
Areas of Inspection	Observation	Recommended Action
<p>Erosion and Sediment Controls</p> <p>(includes inspection within 24 hours of a storm event)</p>	<p>-The overflow channel was filled almost to capacity due to the high volume of the river. 10/13/05.</p> <p>- Sedimentation from the access road off the Rt. 7 ramp was noted in the vegetated perimeter swale but it did not leave the site. 9/21/05-10/13/05</p> <p>- Large amounts of stormwater from the Rt. 7 ramp as well as portions of the perimeter of the site continue to flow to the inlet but the vegetation and stone aid filtration. 8/19-10/13/05</p> <p>-The river has flooded over the erosion controls and work area associated with the installation of the turning structure. The partial cofferdam installed here was not able to handle the unexpected amount of flooding. 10/13/05</p>	<p>-Make any repairs necessary to the vegetation and topsoil in the channel after the water has receded. 10/13/05</p> <p>- Sedimentation and gravel remain contained within the swale. The access road will be paved eventually which will remove the problem. Continue to monitor area until final stabilization. 9/21/05-10/13/05</p> <p>- Continue to monitor the area and the silt fence could be removed as the stone is now in place. 10/13/05</p> <p>- The silt fence will likely need to be repaired once the waters have receded. 10/13/05</p>

Norwalk Substation: The overflow channel is flowing at capacity due to the heavy rains and river flooding. (10/13/05)

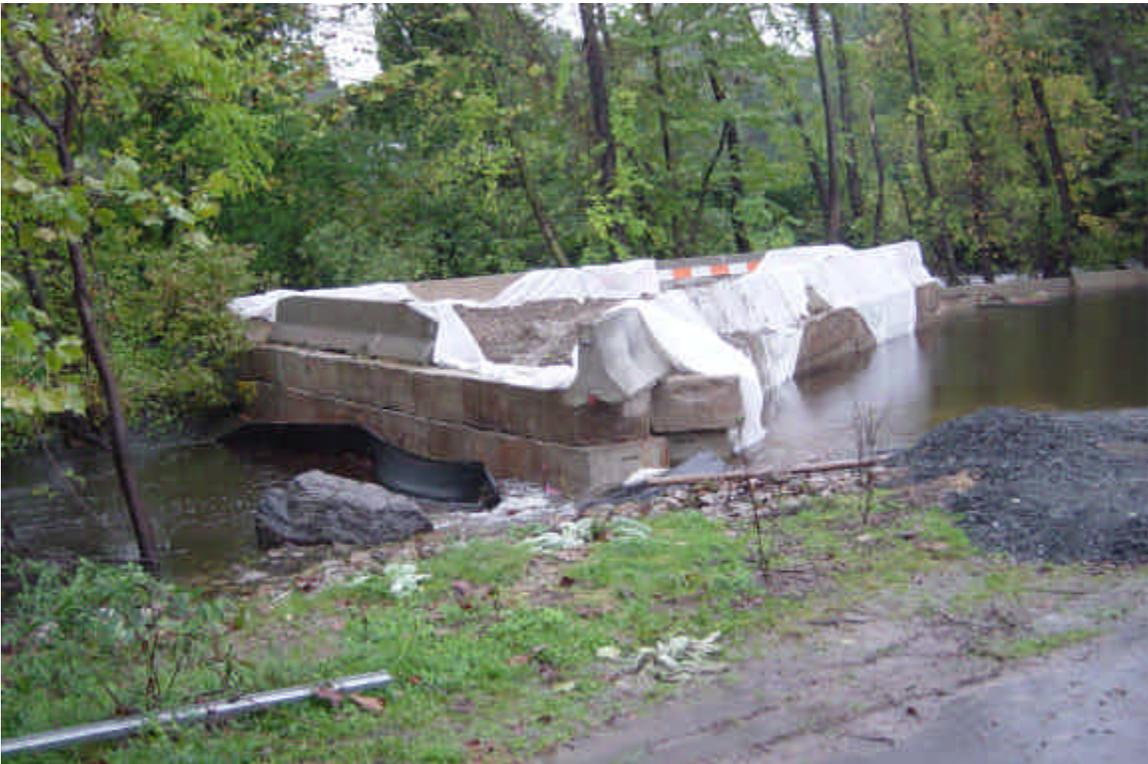
<p>Inland Wetland and Watercourse encroachment and mitigation</p>	<p>-The Norwalk River was in a state of flooding following the rain. The overflow channel was flowing near capacity and the river had flooded over the 345kV turning structure work area. 10/13/05</p> <p>- Sheet piling had been installed at the channel entrance as a temporary, partial dam for the work. 10/5-10/13/05</p>	<p>- The area will have to be repaired following the flood. At completion of the work, the remaining temporary fill will be removed and the site restored to its original condition. 10/13/05</p>
<p>State species of concern, threatened and endangered species</p>	<p>- No species of concern are located in this area of construction.</p>	<p>- N/A</p>
<p>Vegetative clearing limits (including trees to save or danger trees noted)</p>	<p>-Some clearing near the overflow channel and island was necessary to access the work site for the tower. 9/29/05-10/13/05</p>	<p>- Clearing was limited to what is necessary and it will continue to be monitored. 9/29/05-10/13/05</p>

Areas of Inspection	Observation	Recommended Action
Dewatering	-The caisson was installed but has since been flooded. A certain amount of dewatering will be necessary when the floodwater recedes. 10/13/05	-None at this time, If the slurry pit is still necessary, keep it well contained. 10/13/05
Blasting	- No blasting is occurring on site at this time and it is not anticipated to be necessary.	- None at this time.
Spills and Material Storage	- No drips or leaks were noted on the site at the time of inspection. 10/13/05.	<p>In general:</p> <ul style="list-style-type: none"> - Continue to keep all vehicles maintained well (i.e. no apparent fluid leaks) if they will be used or stored on site. - The contractors should remain vigilant about securing and handling fuel and all other material containers due to the sensitivity of the area. - Report spills to the office immediately, even if they are being controlled. - Take care not to get carried away and to be vigilant when refueling. - All fuels and agents not in use should be covered and stored in the sheds and trailers before leaving for the day.

View of the 345kV turning structure caisson installation work area which has been flooded and overwhelmed by the river. (10/13/05)

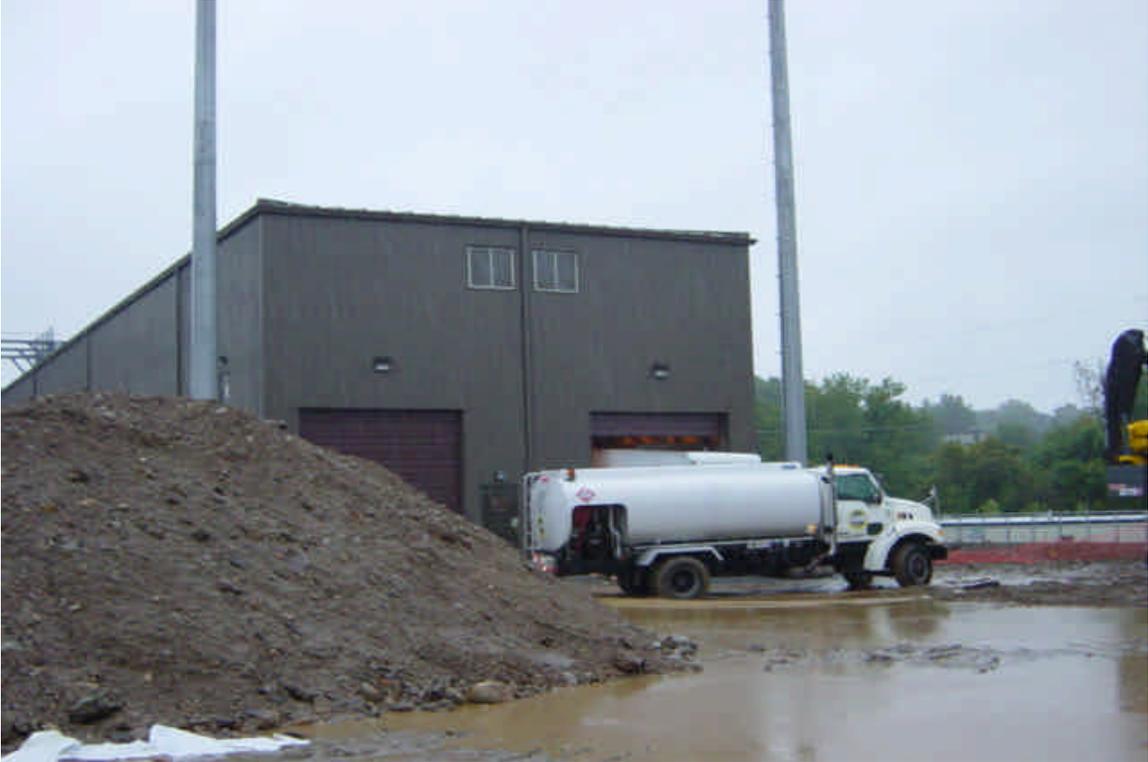
Additional Observations	-Trenching for the Gas Insulated Transmission Line (GITL) was occurring on the western side of the GIS building. 10/5/05	-This excavation and backfill work is well within the yard and areas are contained. 10/5/05

View of the excavation and stockpile area near the GIS building which is well contained within the site. (10/13/05)

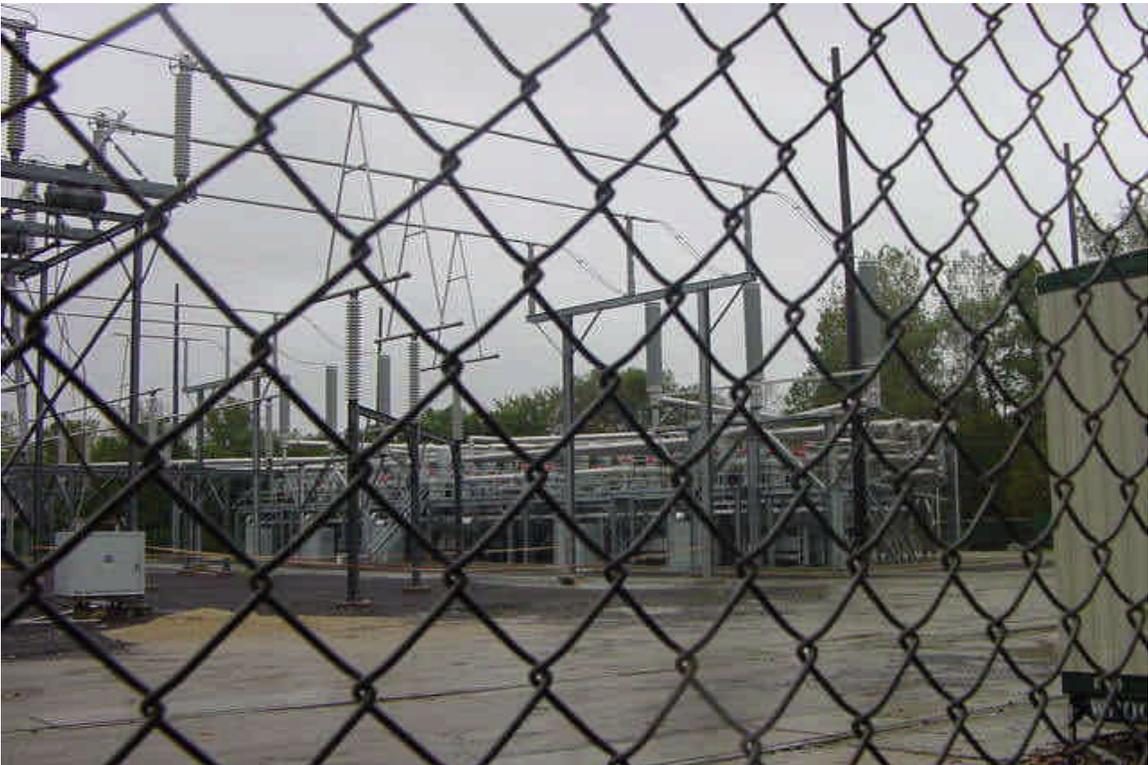
Plumtree Substation: It seems the work on structures to the pad have been completed for the most part. (10/13/05)
