Docket No. 217 – Development and Management Plan Inspection

Date: October 19, 2005

Location: Norwalk Substation Expansion

Location: Plumtree Substation Expansion, Bethel

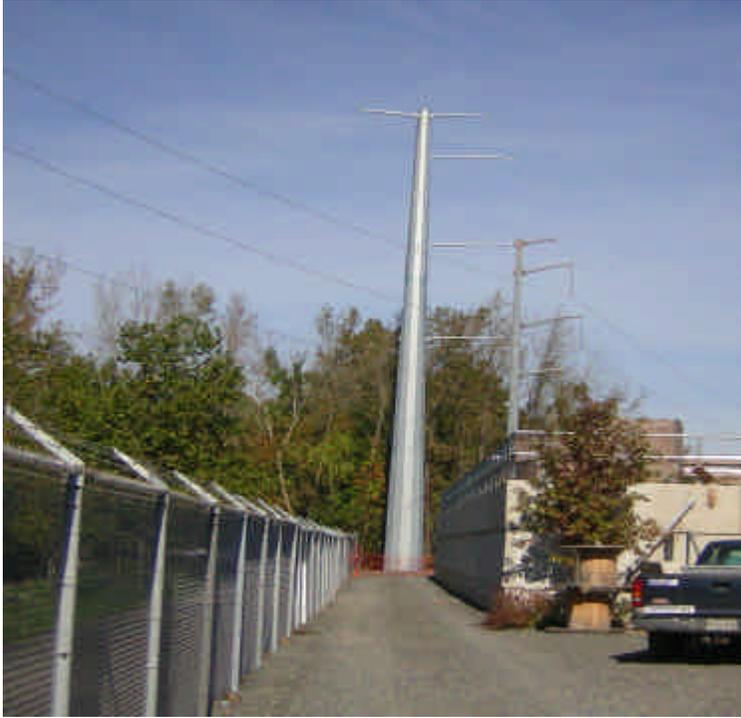
Norwalk Substation: Photo on the left shows a view of the 345kV turning structure. Photo on the right shows a view of the stockpile area near the GIS building. All stockpiles are well contained within the site. (10/19/05)

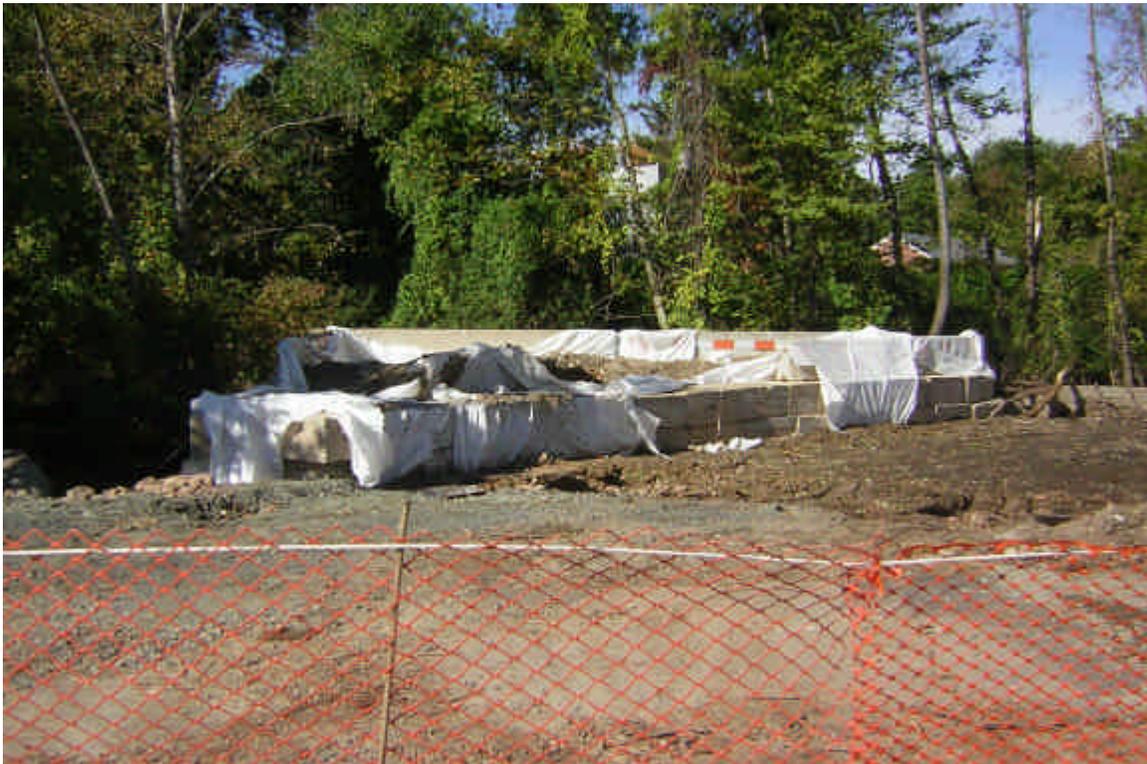
Inland Wetland and Watercourse encroachment and mitigation	<ul style="list-style-type: none"> -The Norwalk River has receded since last week's flooding and the overflow channel and the 345kV work area have dried out. Some of the temporary fill was washed away but was not noticeable in the river. 10/19/05 - Sheet piling remains intact at the channel entrance as a temporary, partial dam for the work. 10/5-10/19/05 	<ul style="list-style-type: none"> - All flood damages should be repaired within the work area and surrounding channel. At completion of the work, any remaining temporary fill will be removed and the site restored to its original condition. 10/19/05
State species of concern, threatened and endangered species	<ul style="list-style-type: none"> - No species of concern are located in this area of construction. 	<ul style="list-style-type: none"> - N/A
Vegetative clearing limits (including trees to save or danger trees noted)	<ul style="list-style-type: none"> -Some clearing near the overflow channel and island was necessary to access the work site for the tower. 9/29/05-10/19/05 	<ul style="list-style-type: none"> - Clearing was limited to what is necessary and it will continue to be monitored. 9/29/05-10/19/05

View of the 345kV turning structure work area damaged during flooding. A portion of the temporary fill appears to have washed out, but the slurry pit remains intact. (10/19/05).

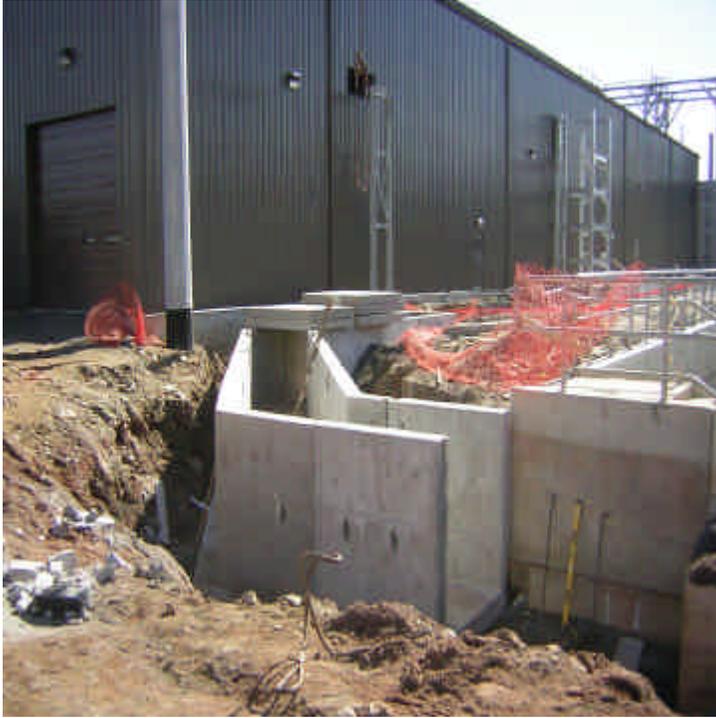
Photo on the left shows trenching near the GIS building continues. Photo on the right shows view of the northern portion of the yard. This area was electrified at the time of inspection. (10/19/05).

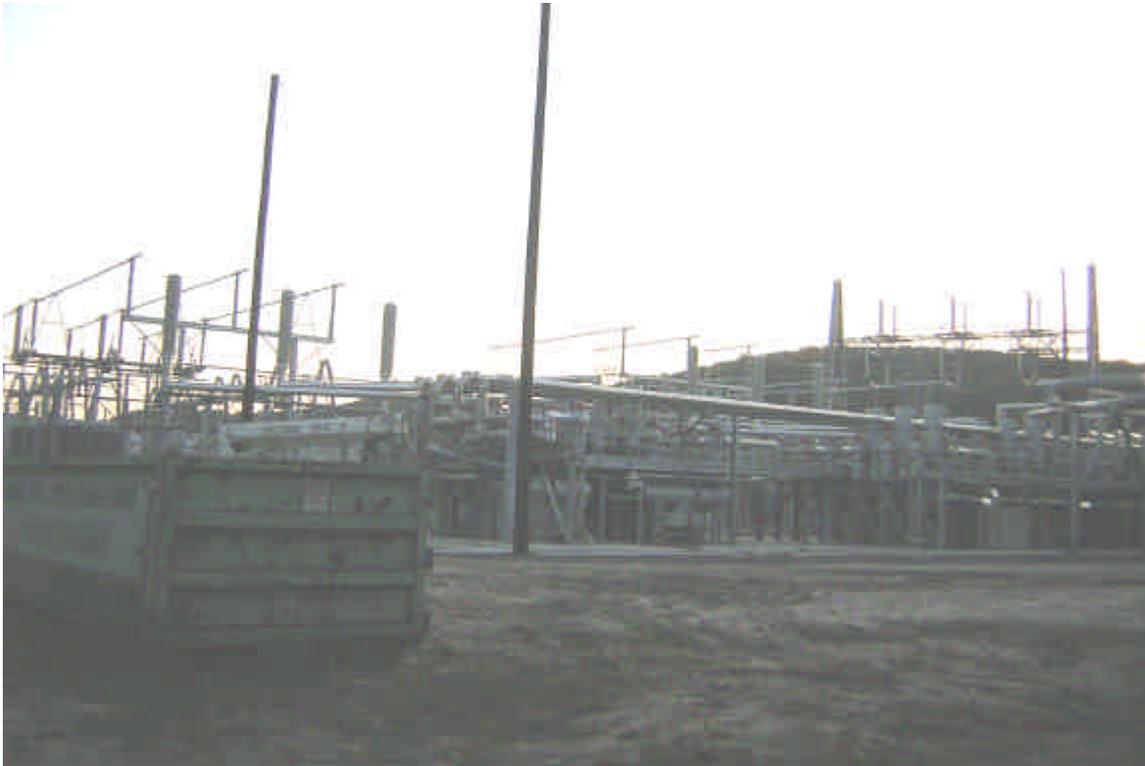
Plumtree Substation: It seems work on the structures to the pad have been completed. (10/19/05).
