Docket No. 217 – Development and Management Plan Inspection

Northeast Utilities Service Company Certificate of Environmental Compatibility and Public Need for the construction of a 345-kV electric transmission line and reconstruction of an existing 115-kV electric transmission line between Connecticut Light and Power Company’s Plumtree Substation in Bethel, through the towns of Redding, Weston, and Wilton, and to the Norwalk Substation in Norwalk, Connecticut.

Date: October 29, 2004

Location: Norwalk Substation Expansion

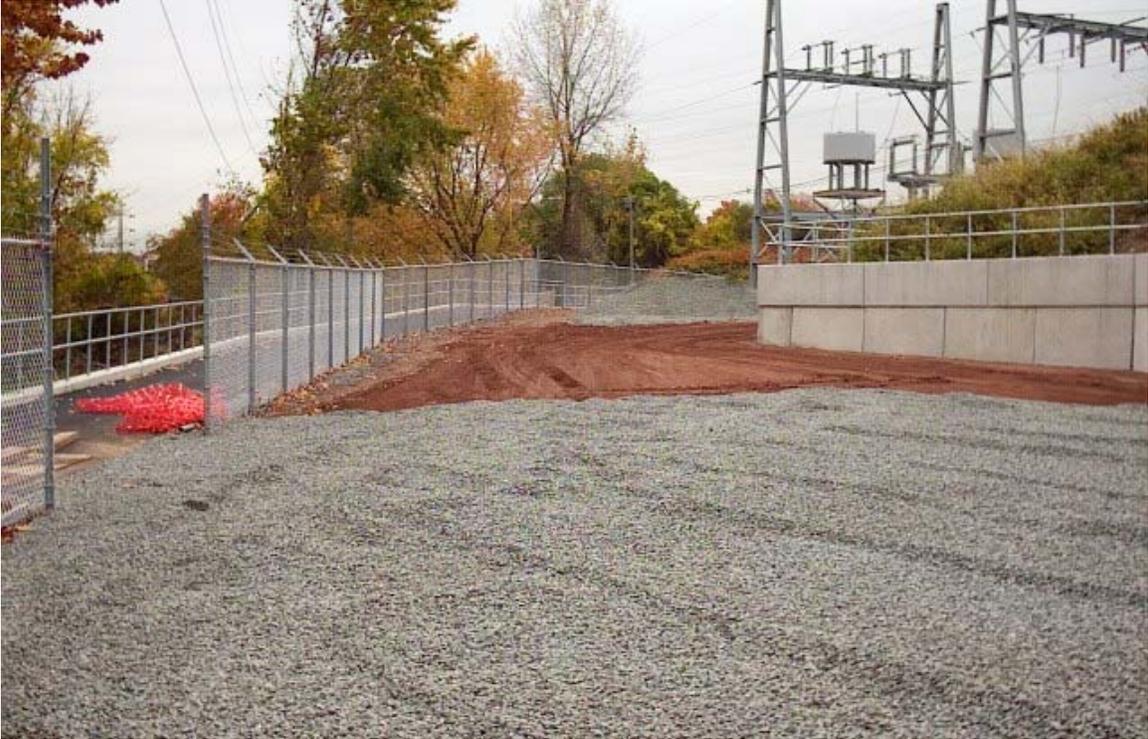
Crushed stone has been placed within the yard behind wall #2. 10/29/04

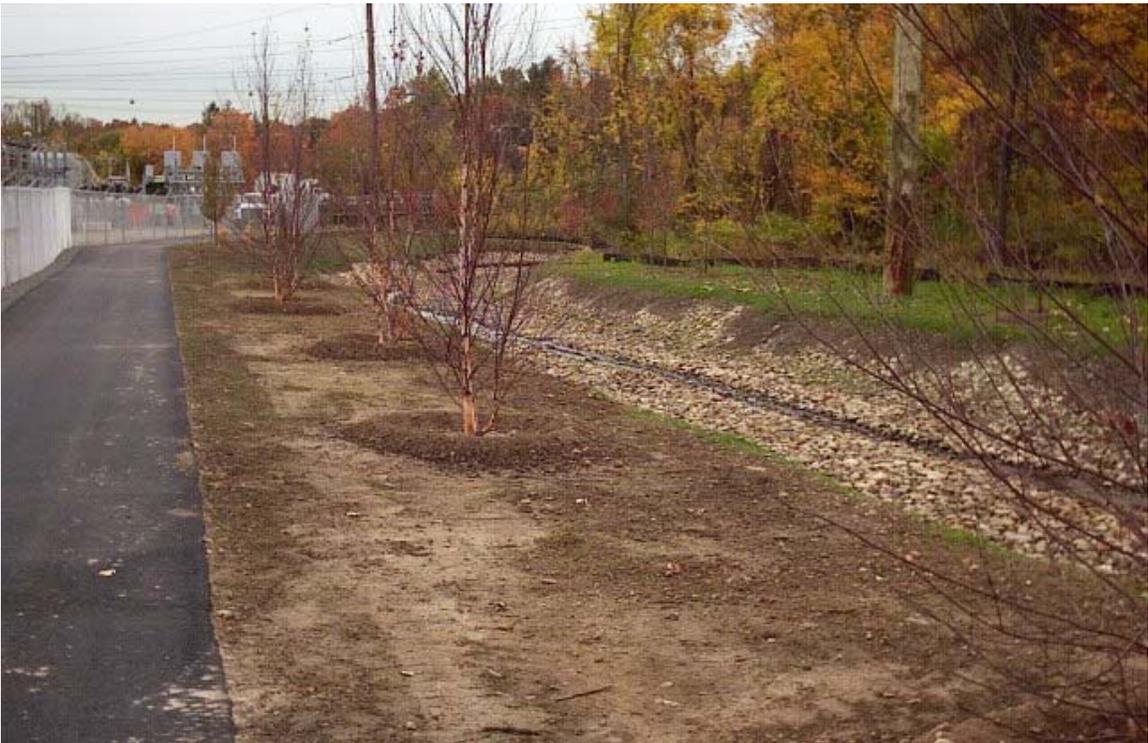
View of the overflow channel with the recent plantings and vegetative growth. Straw mulch should be placed here as an additional measure. 10/29/04

Inland Wetland and Watercourse encroachment and mitigation	- Most areas have sufficient vegetative cover but a few areas remain sparse. Some additional growth had occurred but the areas adjacent to and within the channel especially need stabilizing cover. 10/21-10/29/04	- Continue to monitor silt fence and repair as necessary, especially in the portions closest to the river. Fence could be removed from areas with sufficient cover. 10/29/04
State species of concern, threatened and endangered species	- No species of concern are located in this area of construction.	- N/A
Vegetative clearing limits (including trees to save or danger trees noted)	-The River birch (<i>Betula nigra</i>) plantings have been visibly browsed by deer. 10/29/04 - Straw mulch should be placed along any bare areas to help provide cover. 10/29/04	- Focus should be on trying to get sparsely vegetated areas to get sufficient growth before the winter. Placement of straw mulch may help to promote growth. 10/21-10/29/04

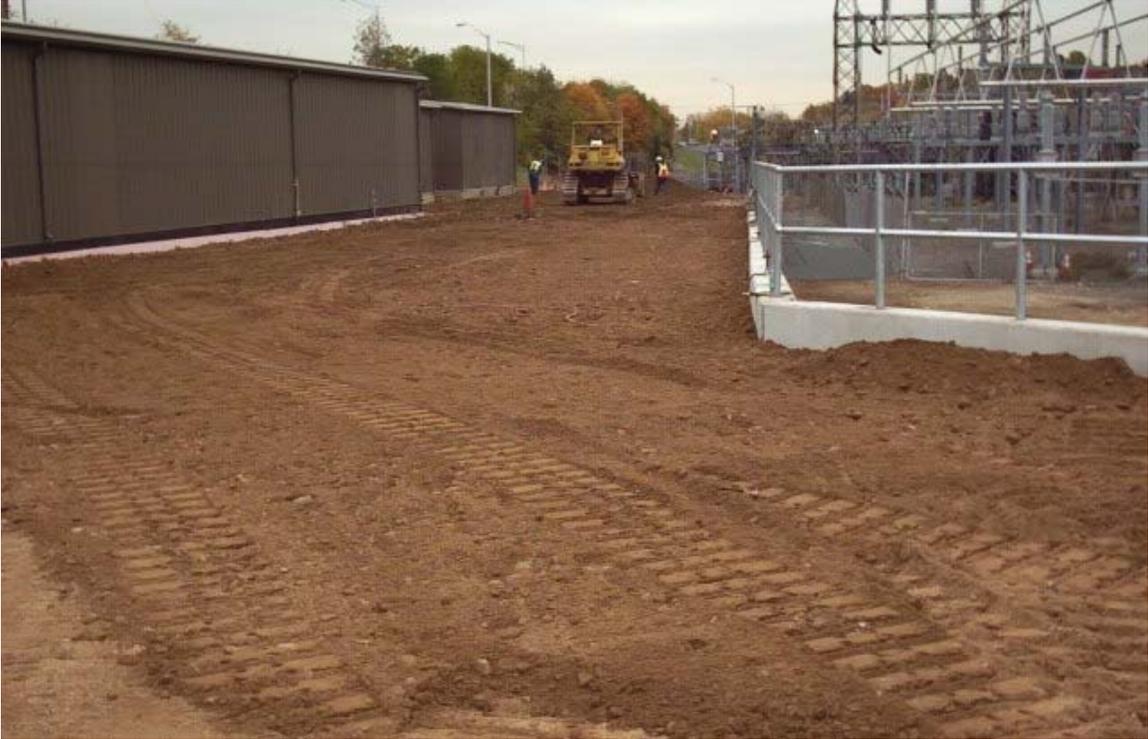
View of the area behind the control building which was recently filled and brought to subgrade. 10/29/04

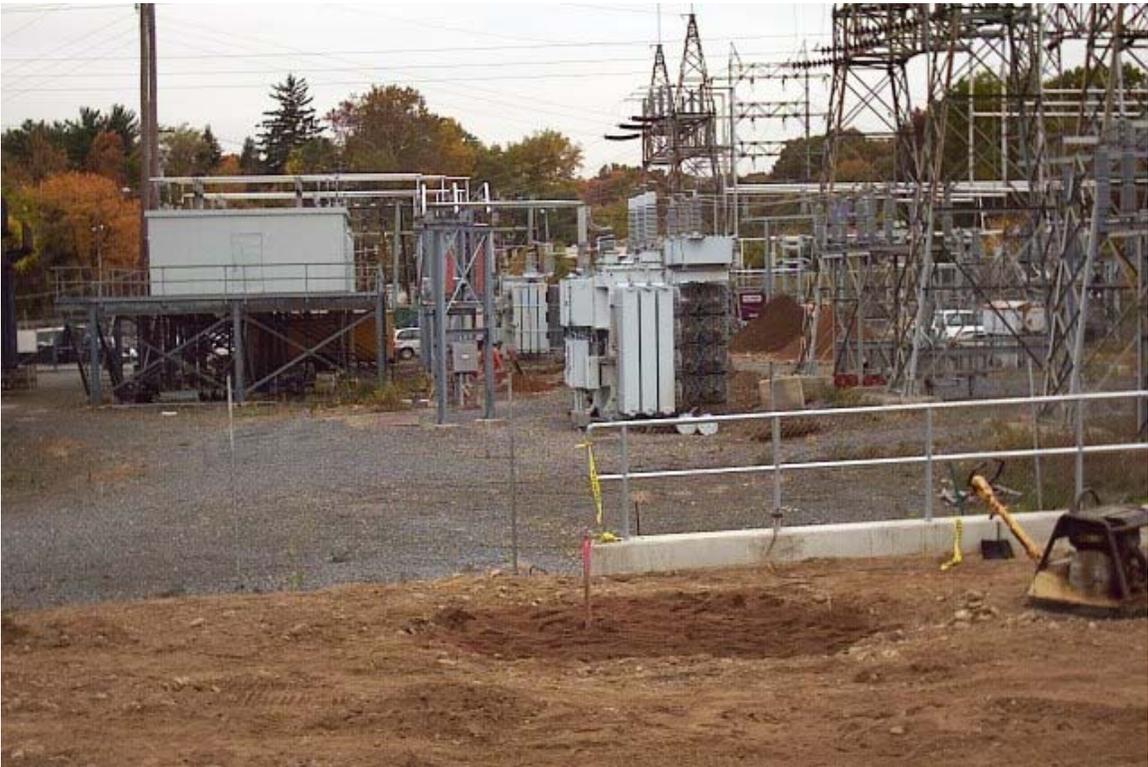
A small excavation for a service conduit is taking place within the internal charged yard. 10/29/04

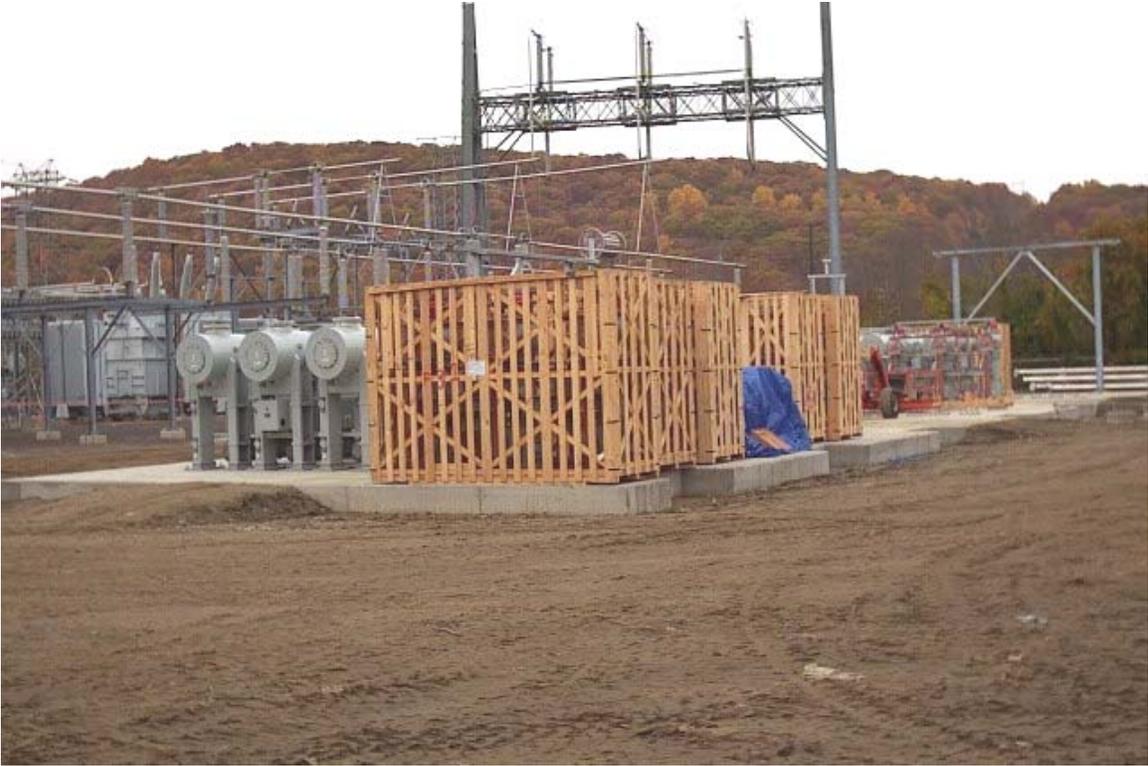
Plumtree Substation: View of the concrete pad for the GIS building with recently constructed equipment. 10/29/04

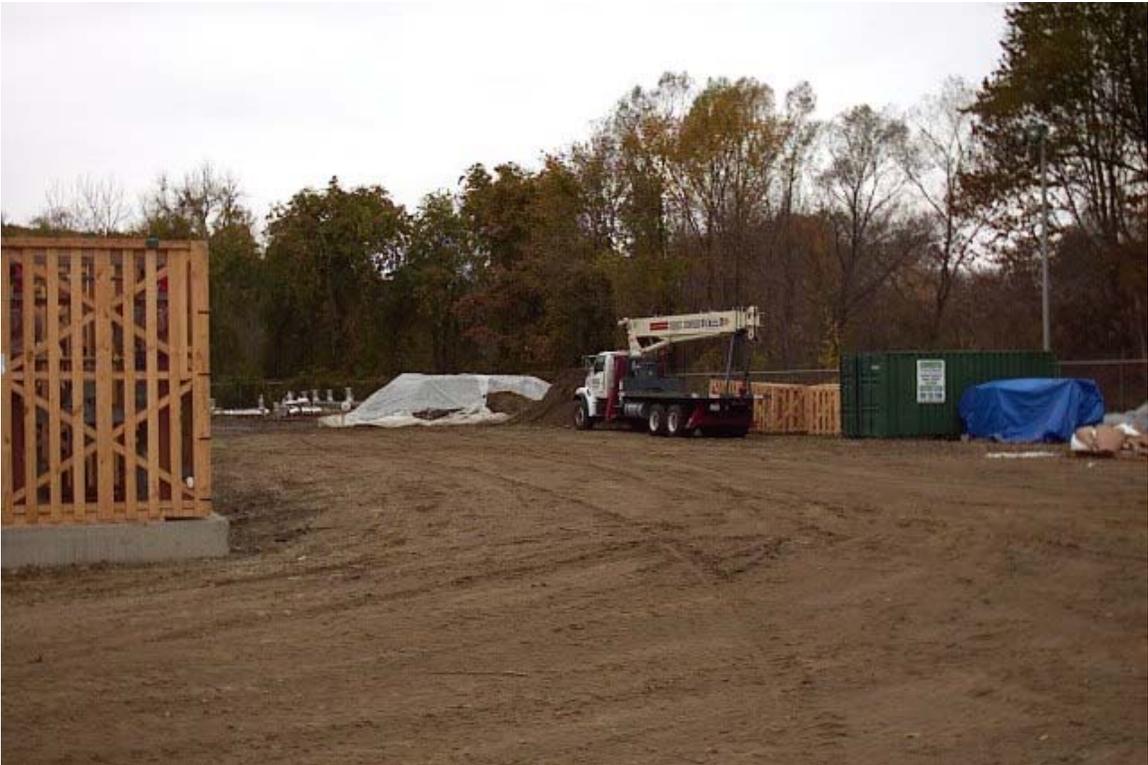
General view of the substation yard. 10/29/04
