**Docket No. 217 – Development and Management Plan Inspection**

Northeast Utilities Service Company Certificate of Environmental Compatibility and Public Need for the construction of a 345-kV electric transmission line and reconstruction of an existing 115-kV electric transmission line between Connecticut Light and Power Company's Plumtree Substation in Bethel, through the towns of Redding, Weston, and Wilton, and to the Norwalk Substation in Norwalk, Connecticut.

**Date:** November 2, 2005

**Location:** Norwalk Substation Expansion

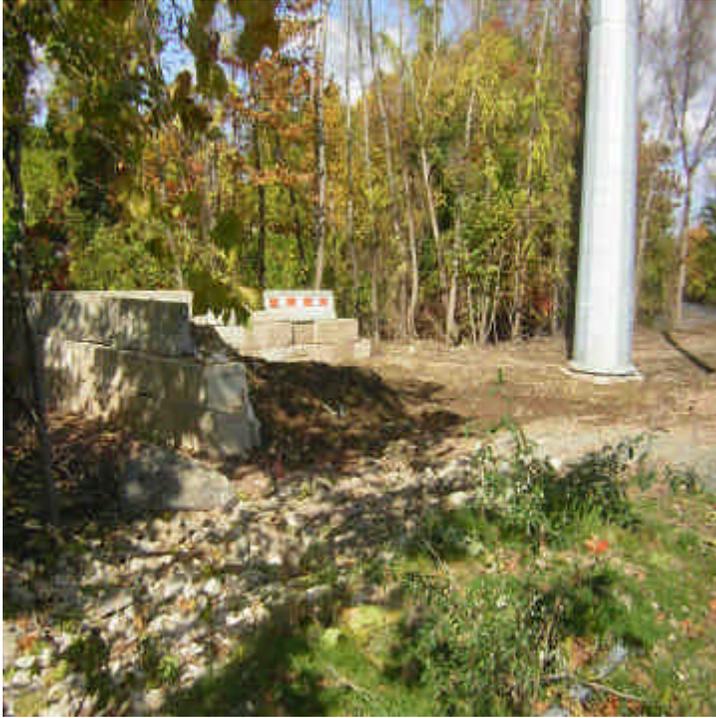
**Norwalk Substation: Photo on the left is a view of the turning structure work area. Jersey barriers, sheet piling, and erosion controls have been removed. Photo on the right shows contractors in the process of removing the slurry pit. 11/2/05**

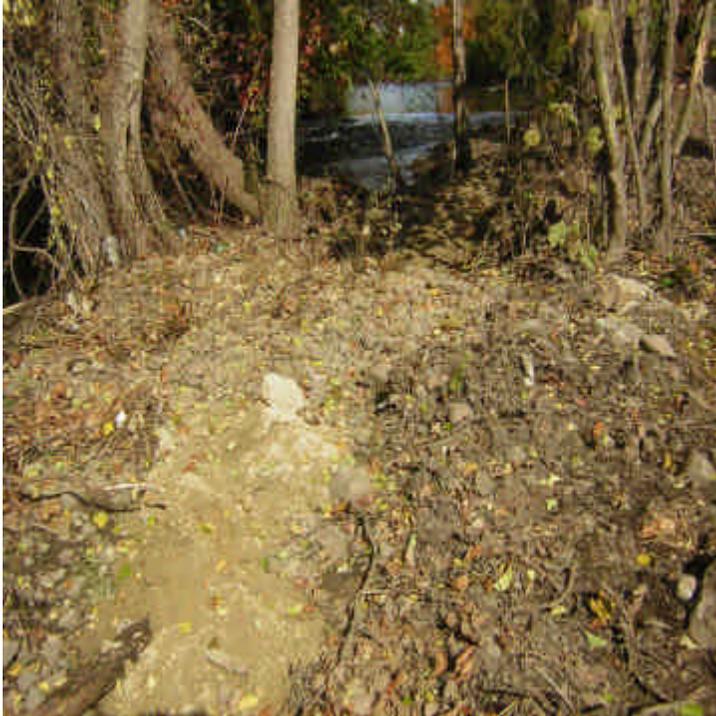
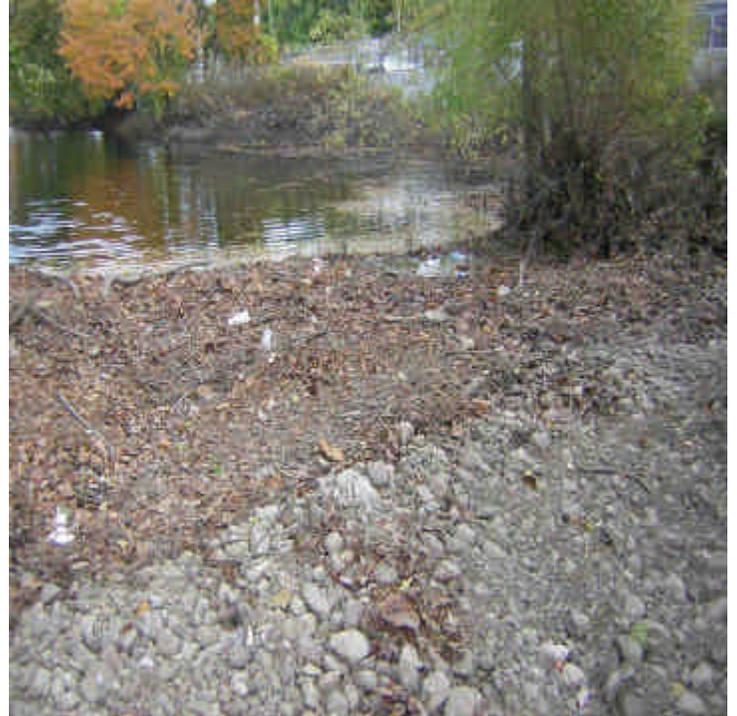
<p>Inland Wetland and Watercourse encroachment and mitigation</p>	<ul style="list-style-type: none"> <li>-The 345kV work area is in the process of being restored. Sediment was noticed at the edge of the overflow channel and the river. 11/02/05.</li> <li>- Sheet piling, used as a temporary, partial dam for the work, was removed at the channel entrance. 11/02/05.</li> </ul>	<ul style="list-style-type: none"> <li>- The remaining temporary fill and concrete blocks will be removed and the site restored to its original condition. As part of the work, all loose soil that accumulated in the channel will be removed. 11/02/05.</li> </ul>

**Silt fence had been removed from the area somewhat prematurely but now that work is done, excess sediment will be scraped up from the channel to return it to original conditions. 11/02/05**

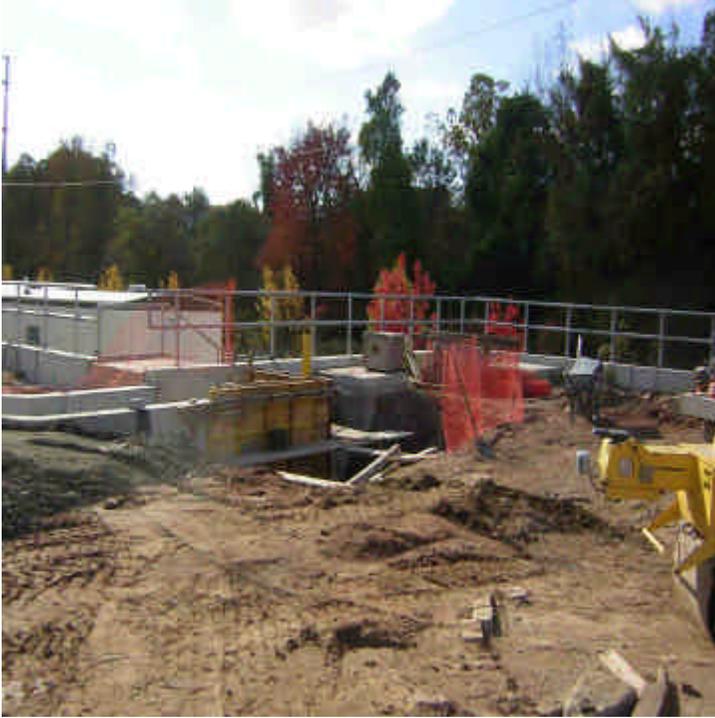
Photo on the left shows excavation work in the yard near the GIS building which remains contained. Photo on the right shows the repaired sidewalk along New Canaan Ave. 11/02/05

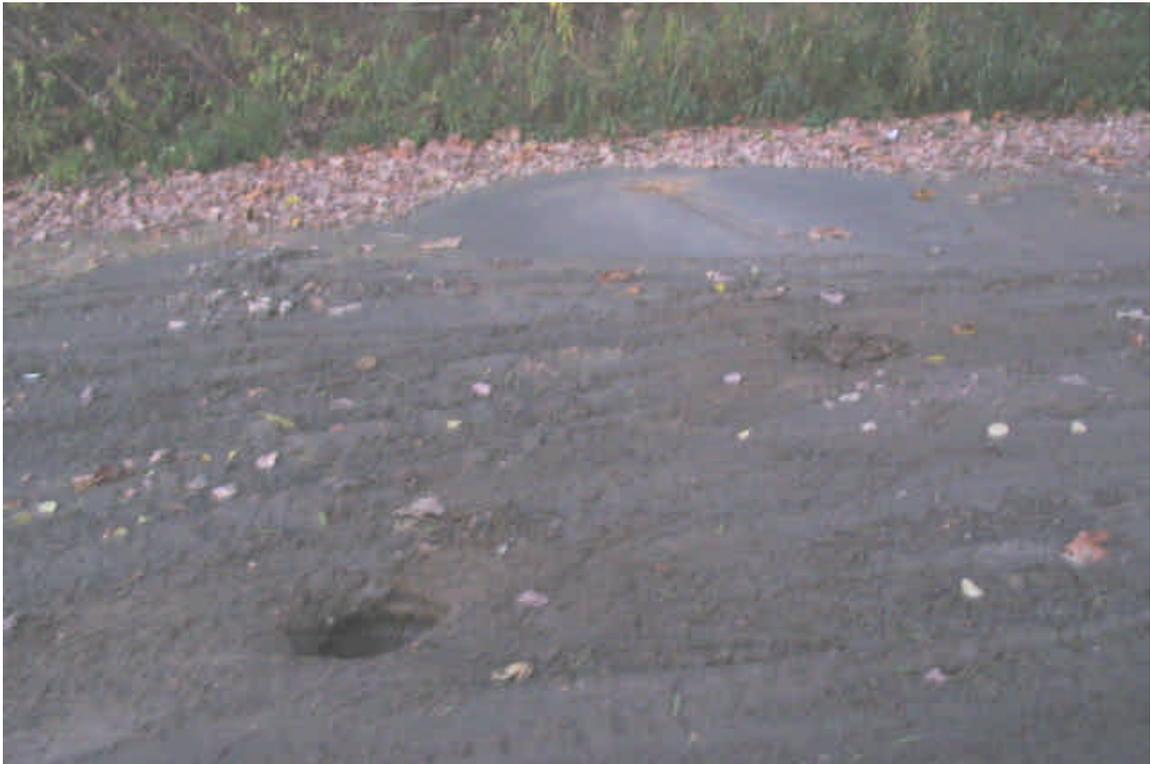
Areas of Inspection	Observation	Recommended Action
Access Roads	- No new access roads have been constructed at this time but the driveway to the substation had some soil test borings completed for future trenching here. 11/02/05	- Take care not to let accumulated soil from the borings enter the wetland swales adjacent to the driveway. 11/2/05
Foundation construction	-The remaining work is mostly electrical and within the control house. 11/02/05. -No further civil or earth disturbing work was noted on site at this time but apparently a construction trailer was returned to the yard. 11/02/05	- The areas are all contained at this time.11/02/05  - Open excavations were not observed at this time. 11/02/05.
Erosion and Sediment Controls (includes inspection within 24 hours of a storm event)	- Although no silt fence is in place, the perimeter stone berm continues to work well to control the yard even with the significant rain. 11/02/05.	-All stockpiles are well-contained and the berm is working effectively at this time. 11/02/05

Plumtree Substation: View of what appears to be soil testing bores performed in the driveway of the substation for future trenching in this area. Take care not to allow sediment to get into the adjacent wetland swales. 11/02/05
