Docket No. 217 – Development and Management Plan Inspection

Date: December 2, 2004

Location: Norwalk Substation Expansion

Location: Plumtree Substation Expansion , Bethel

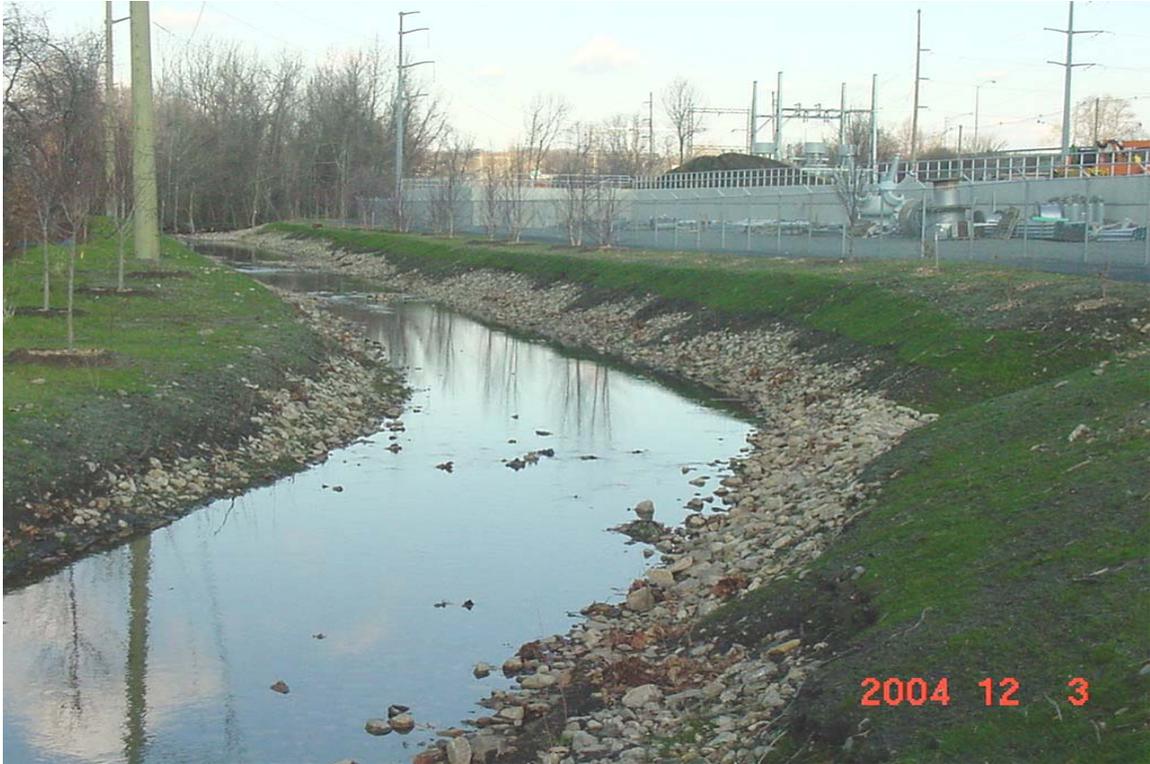
Areas of Inspection	Observation	Recommended Action
Erosion and Sediment Controls continued	-The overflow channel held a significant flow of floodwaters following the rain event and was working very well as a bypass. The water was free of sediment and the hydroseed appeared to have helped prevent further erosion in this area. 12/02/04.	- The hydroseed appears to have helped provide stabilization to the slopes of the overflow channel and reduce erosion. The channel is also working very well directing floodwaters. 12/02/04

View of the overflow channel with a significant flow of water following the recent rain event. The hydroseed appears to have helped stabilize the area to some degree. 12/02/04

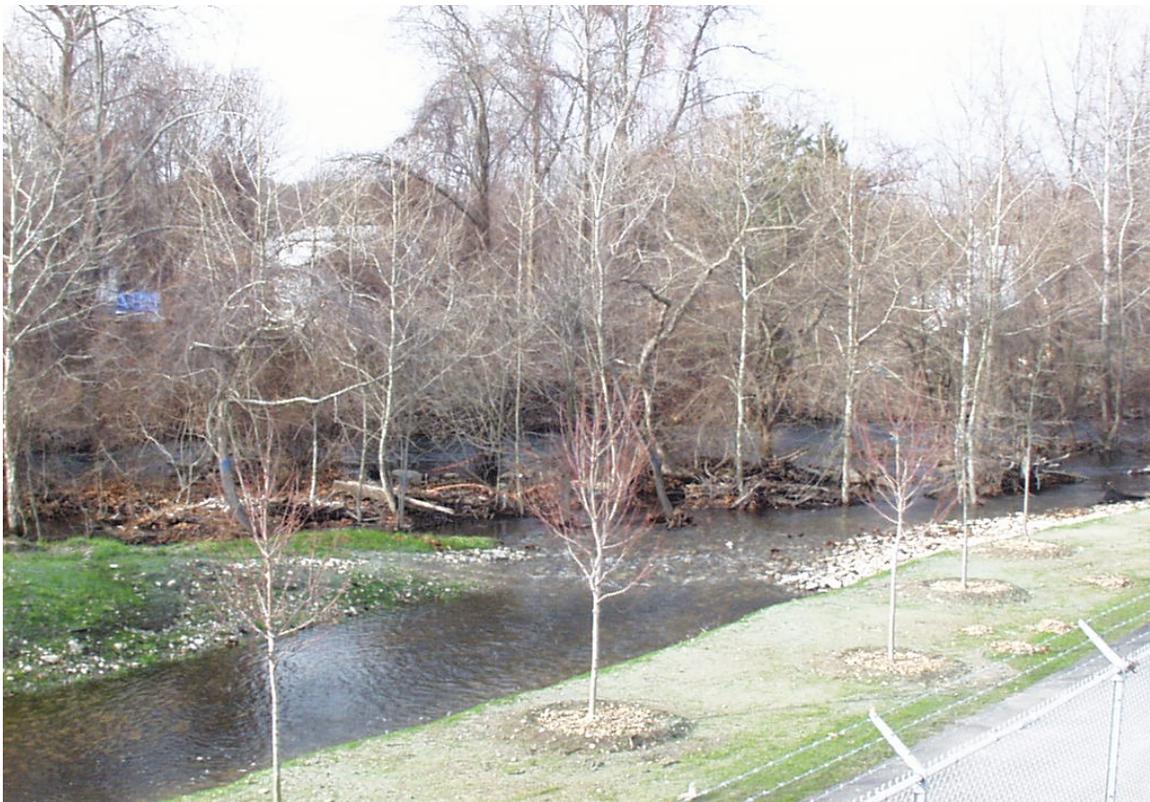
Floodwaters were flowing well through the channel. The water was free of sediment and the channel was working as expected. 12/02/04

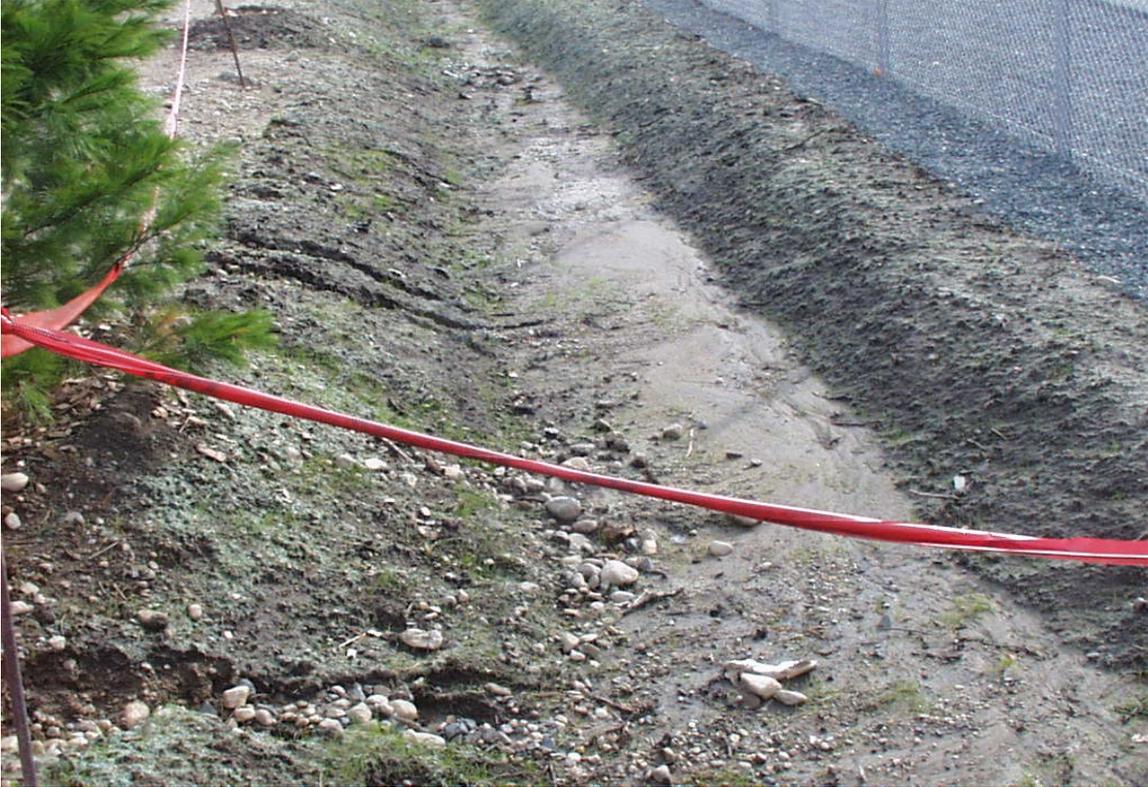
- Some erosive gullies were noted in the slopes of the ditch along the perimeter fence and Rt 7 ramp. The sediment had traveled down-gradient within the ditch and ended up within the substation yard in the crushed stone. 12/02/04	- The sediment did not travel off site or affect any storm water system but the area will be built up into a better swale for directing run off. 12/02/04
Inland Wetland and Watercourse encroachment and mitigation	- The adjacent wetland areas were in flooded conditions as a result of the rain events. The overflow channel was working very well however. 12/02/04	-Silt fence will be removed from areas with sufficient cover. Continue to monitor areas 12/02/04
State species of concern, threatened and endangered species	- No species of concern are located in this area of construction.	- N/A
Vegetative clearing limits (including trees to save or danger trees noted)	-Some plantings along the channel were flagged for damage to see how they survive the winter. Evergreen /conifer plantings are in place at the yard's perimeter. 11/18-12/02/04	- The plantings will be evaluated for any permanent damage in the spring and hydroseed was placed as ground cover here. 12/02/04

View of the ditch along the Route 7 ramp and perimeter fence. Some erosive gullies had formed as a result of the rains and sediment traveled into the ditch. 12/02/04

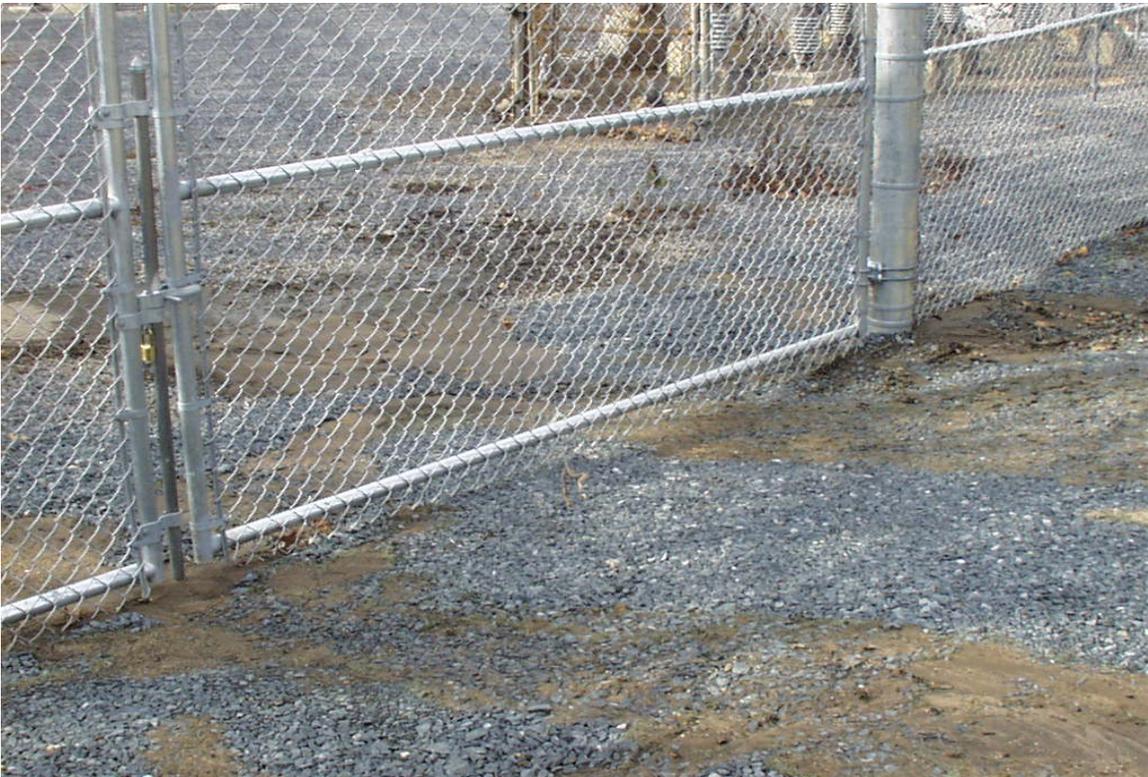
The sediment from the ditch did not leave the site and is not affecting any storm water system. It was actually deposited in the crushed stone at the gate to the substation yard. 12/02/04

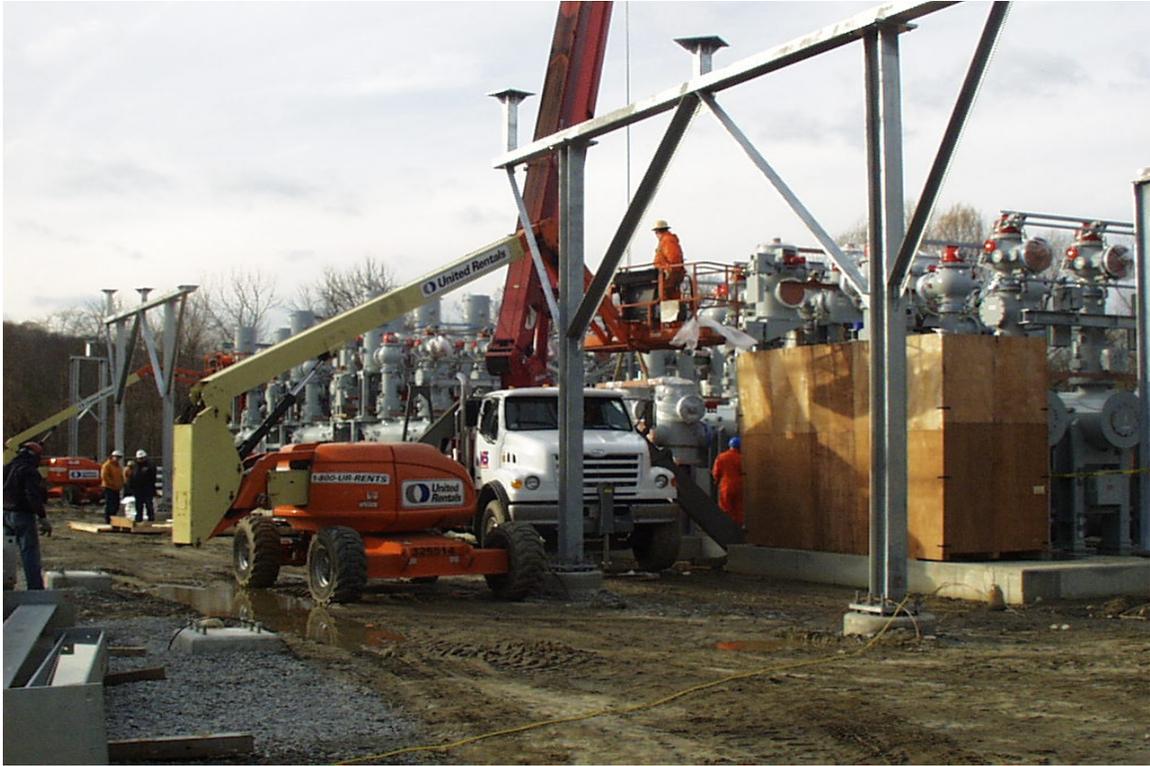
Plumtree Substation: Work continues on the installation of equipment on the concrete slab as well as a few minor excavations. 12/02/04

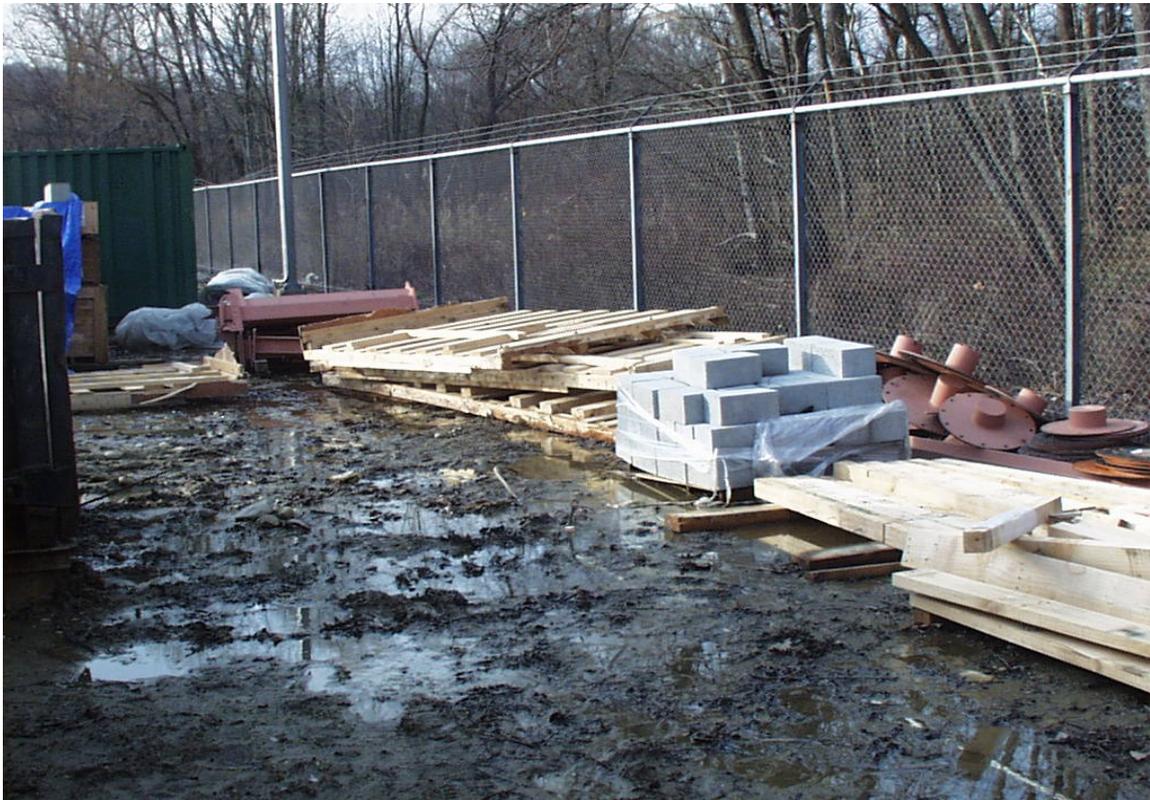
Dewatering	- Some minor dewatering has resumed as a result of the minor excavation near the pad and the rains. The end of the discharge hose is fairly close to the perimeter fence and conditions are muddy here. The berm continues to prevent any overflow but this area should be monitored because of the proximity. 12/02/04	- None at this time.
Blasting	- No blasting is occurring on site at this time.	- None at this time.
Spills	- There were no spills reported during the week or noted on site during the inspection. There are few pieces of machinery on site at	- The contractors should remain vigilant about securing and handling fuel containers. - Keep all vehicles maintained

Some minor dewatering has become necessary as a result of the recent rains and the excavations. This caused some muddy conditions near the perimeter fence which will be monitored. 12/02/04
