**Docket No. 217 – Development and Management Plan Inspection**

Northeast Utilities Service Company Certificate of Environmental Compatibility and Public Need for the construction of a 345-kV electric transmission line and reconstruction of an existing 115-kV electric transmission line between Connecticut Light and Power Company's Plumtree Substation in Bethel, through the towns of Redding, Weston, and Wilton, and to the Norwalk Substation in Norwalk, Connecticut.

**Date:**            December 30, 2003  
\_\_\_\_\_

**Location:**      Norwalk Substation Expansion  
\_\_\_\_\_

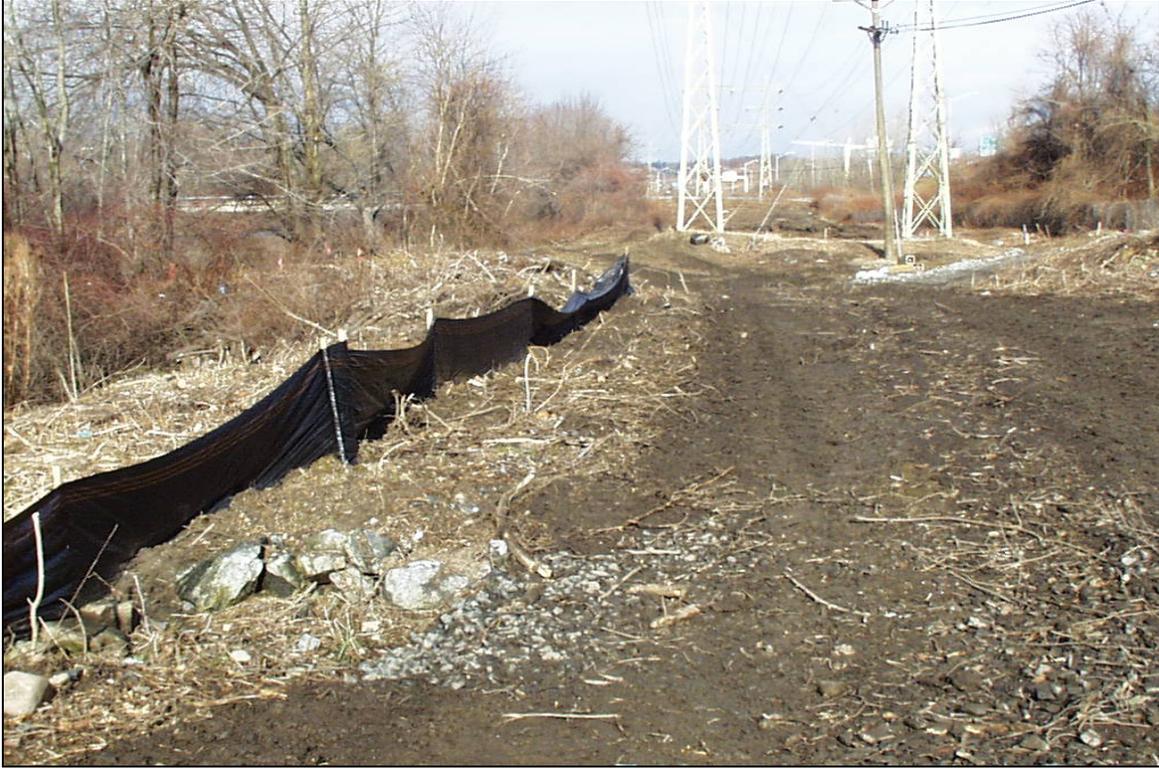
- The gravel tracking pad near the swale continues to accumulate sediment. The silt fence previously mentioned was installed along the access road adjacent to this crossing and the ruts were smoothed out. 12/30/03	- Continue to monitor and install clean rock when necessary. The silt fence was installed properly and adds an additional barrier. 12/30/03

VIEW NEAR THE GRAVEL ACCESS PAD AND DRAINAGE SWALE. THE SILT FENCE HAS BEEN INSTALLED AS REQUESTED AND THE AREA GRADED SMOOTH. 12/30/03

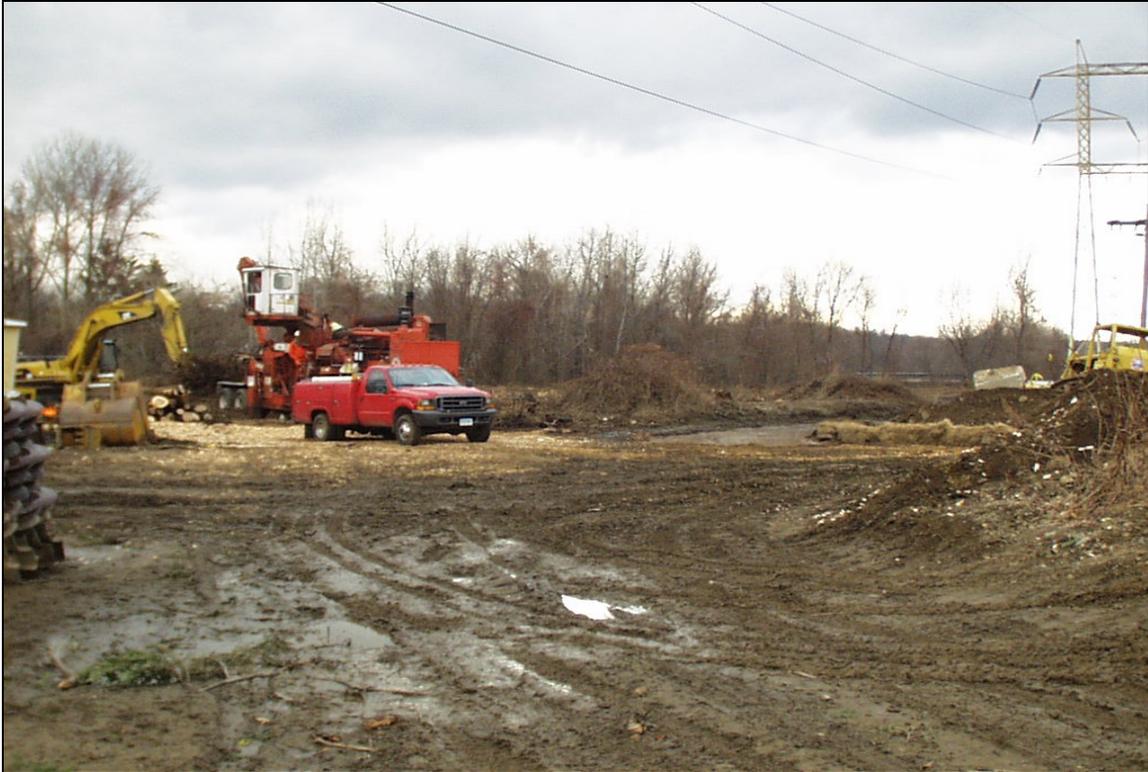
Areas of Inspection	Observation	Recommended Action
Access Roads	<p>- The Route 7 ramp access road is in active use. No issues with erosion were noted at this time, however it continues to accumulate mud from the equipment tracking. Work will begin to firm up the road in the next week. 12/30/03</p> <p>- The access road to the existing ROW has been smoothed/graded. Although the ground is still soft and muddy, it is much less rutted than in previous weeks. Silt fence has been installed between the road and river bank as requested. 12/30/03</p>	<p>- None at this time. Work on the road next week will help firm up this area. 12/30/03</p> <p>-If the ground doesn't freeze sufficiently by the time equipment needs to access this area again, prepare to use timber mats for stabilization if rutting becomes a problem again. 12/30/03</p>
Foundation construction	<p>- Chain link fence installation continues along the edge of the yard in order to create access for vehicles. The energized yard has been cordoned off. 12/30/03</p> <p>- Some excavation is planned for next week in the existing ROW to begin installing the</p>	<p>- None at this time. 12/30/03</p> <p>- None at this time 12/30/03</p>

OVERALL VIEW OF THE ACCESS ROAD AND CONSTRUCTION AREA. THIS AREA WILL BE FIRMED UP WHEN THE ACCESS ROAD IS CONSTRUCTED NEXT WEEK. 12/30/03

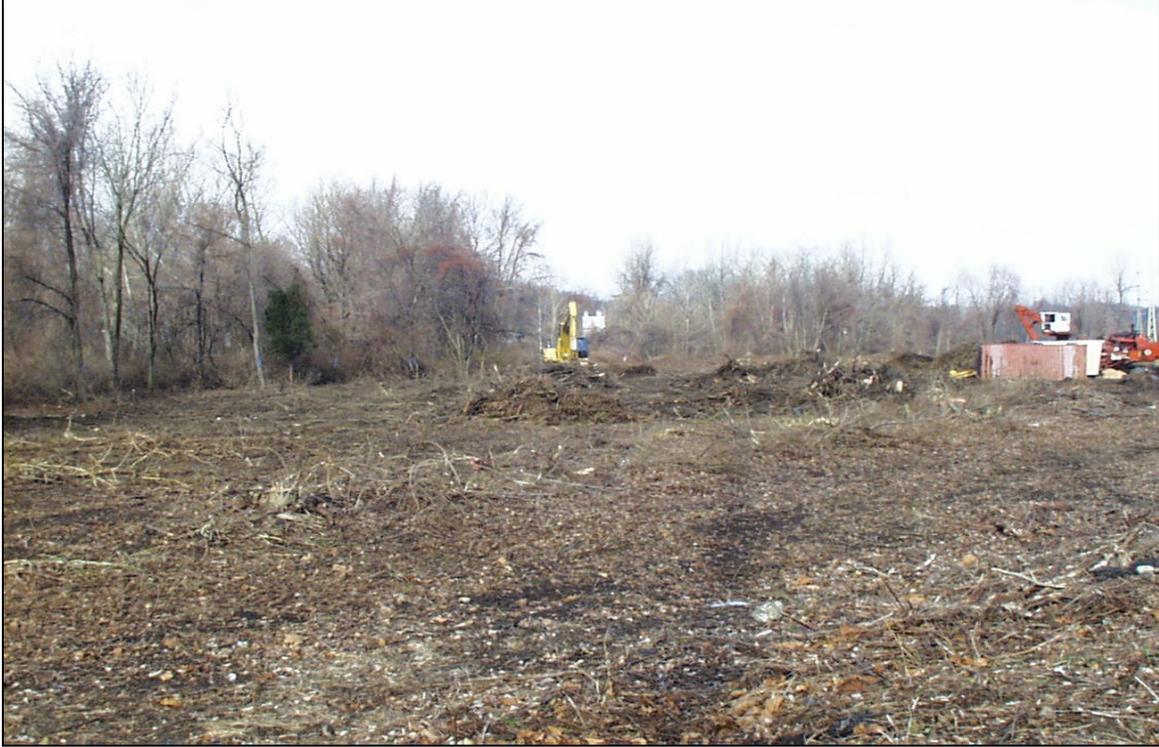
Areas of Inspection	Observation	Recommended Action
Inland Wetland and Watercourse encroachment and mitigation	<ul style="list-style-type: none"> <li>- The stream encroachment permit was obtained and clearing has commenced along the river and within the buffer zone. Silt fence will be installed tomorrow (12/31). 12/30/03</li> <li>- Locations within the stream encroachment area are being identified for monitoring well placement. 12/30/03</li> </ul>	<ul style="list-style-type: none"> <li>- As stated previously, install silt fence between all disturbed areas and resource areas as soon as possible. 12/30/03</li> <li>- None at this time 12/30/03</li> </ul>
State species of concern, threatened and endangered species	<ul style="list-style-type: none"> <li>- No species of concern are located in this area of construction 12/30/03</li> </ul>	<ul style="list-style-type: none"> <li>- N/A</li> </ul>
Vegetative clearing limits (including trees to save or danger trees noted)	<ul style="list-style-type: none"> <li>-The clearing at the yard was completed in under two days, following obtaining the stream encroachment permit. Minor root systems are still in place which helps keep soil stable. 12/30/03</li> <li>- Major stumps are being removed at this time and chipping is occurring. 12/30/03</li> <li>- Trees and stumps immediately on the riverbank are being preserved whenever possible. 12/30/03</li> </ul>	<ul style="list-style-type: none"> <li>- Keep root systems in place for as long as possible to anchor the soil, and try to disturb only the areas necessary at any one time. 12/30/03</li> <li>- The areas near the river still appear stable. There is no erosion on the banks or sedimentation to the water. 12/30/03</li> <li>- The more vegetation left in place, the more stable the bank will be. 12/30/03</li> </ul>

VIEW OF CLEARING IN THE STREAM ENCROACHMENT AREA FOLLOWING  
OBTAINING THE PERMIT. TREES ARE BEING LEFT STANDING ON THE RIVER  
BANK WHENEVER POSSIBLE. 12/30/03

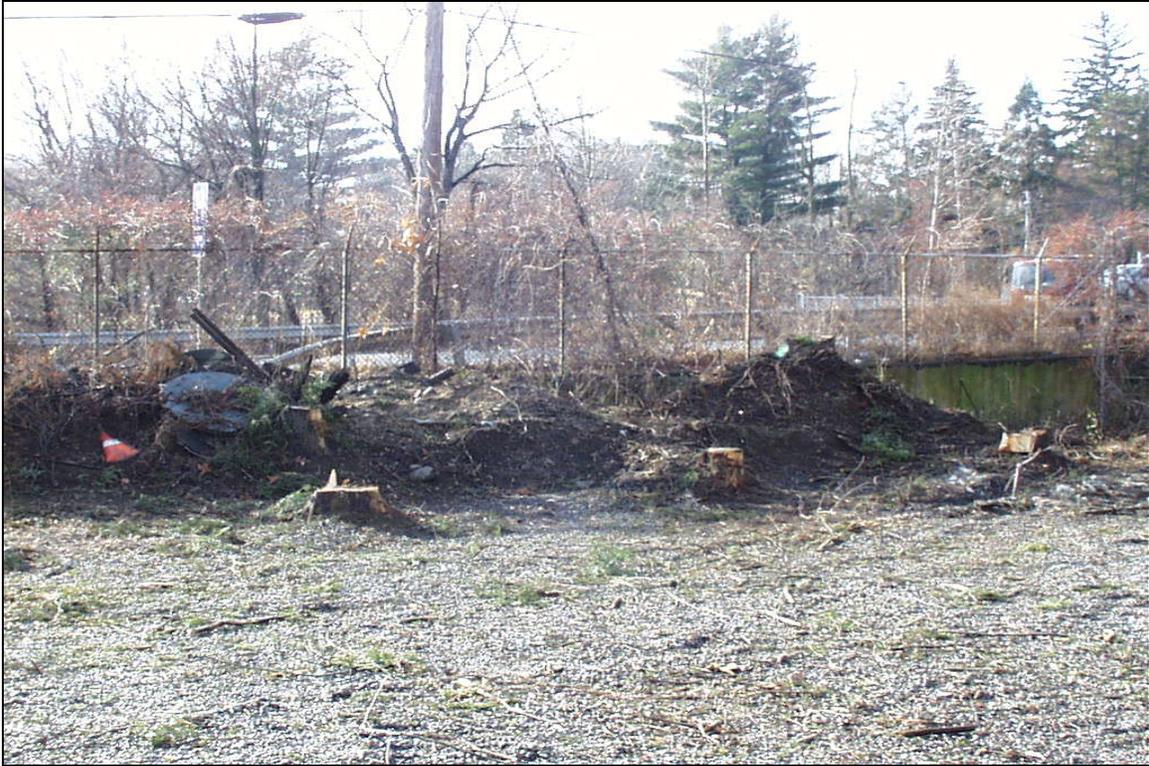
VIEW OF CLEARING OF TREES NEAR NEW CANAAN AVENUE AND  
ADJACENT TO THE RIVER. 12/30/03

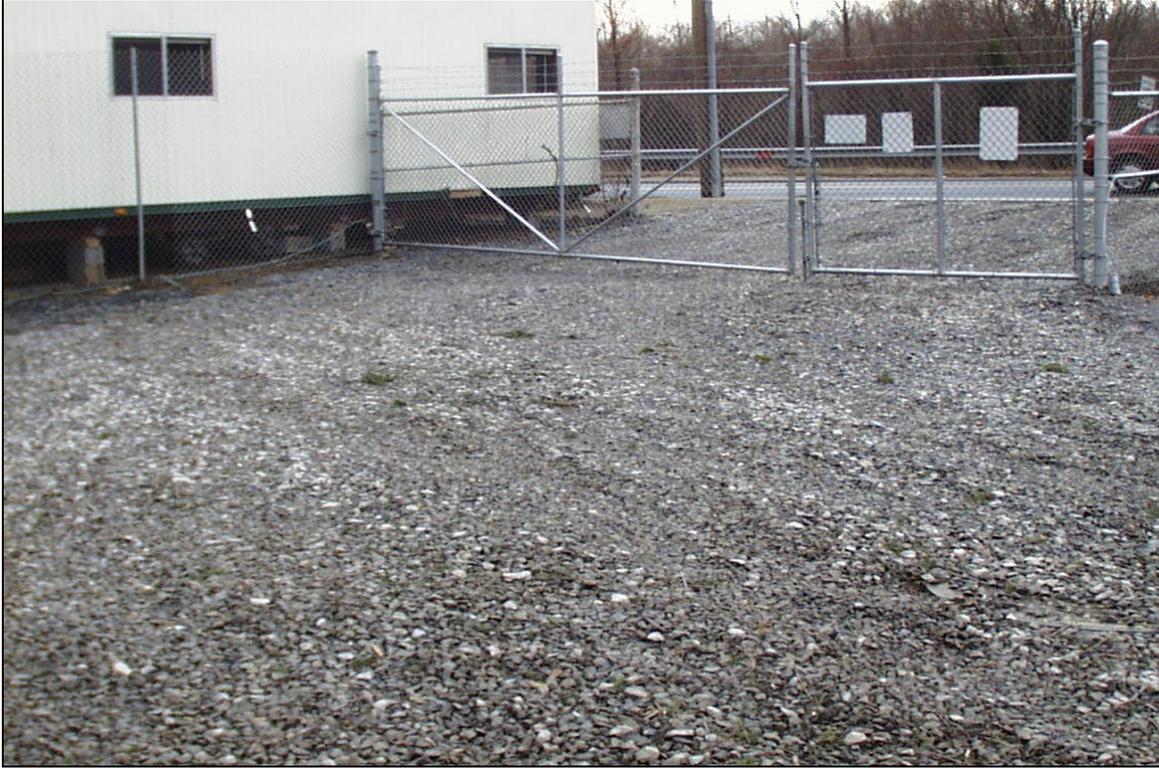
- The gravel construction pad was installed at the fence at New Canaan Ave in order to reduce off site tracking. The rock used was the maximum allowed, 1½" diameter. 12/30/03	- Monitor gravel and replace with clean rock as necessary. It is not yet in use. 12/30/03

VIEW OF NEWLY INSTALLED GRAVEL CONSTRUCTION PAD AT NEW  
CANAAN AVENUE GATE. 12/30/03
