Docket No. 217 – Development and Management Plan Inspection

Date: December 14, 2005

Inspector: Lee Curtis

Location: Norwalk Substation Expansion

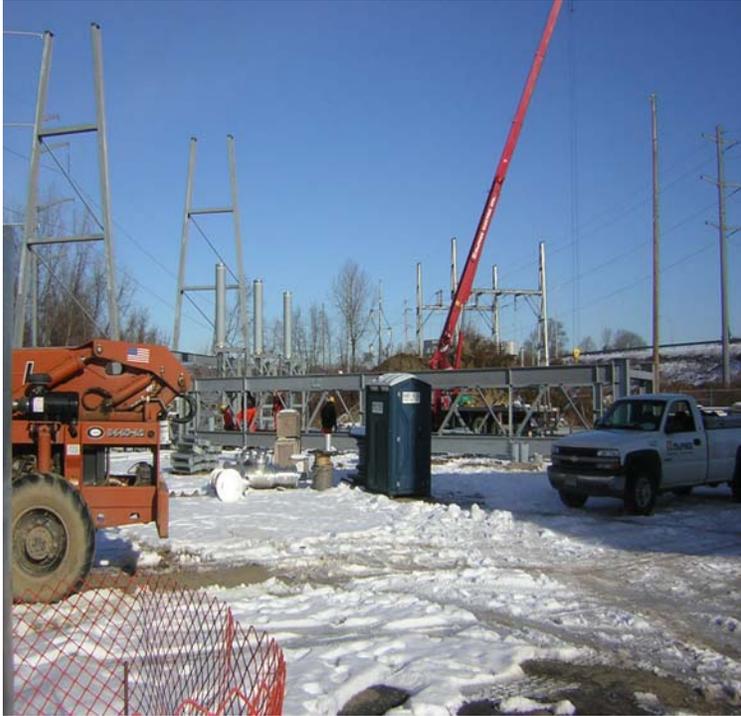
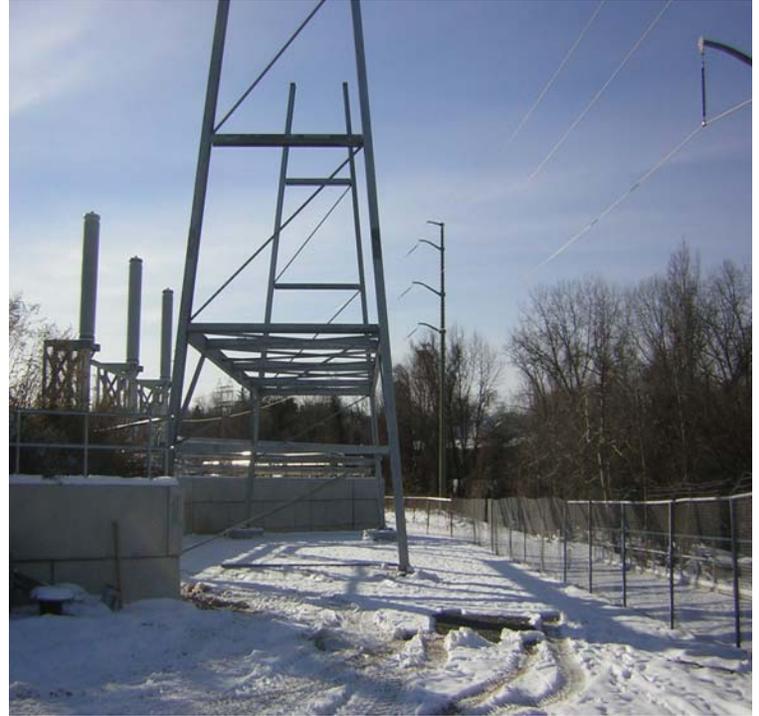
Norwalk Substation: Both photos show views of the structures being installed adjacent to the bike path and retaining wall to the northwest of the GIS building. 12/14/05.

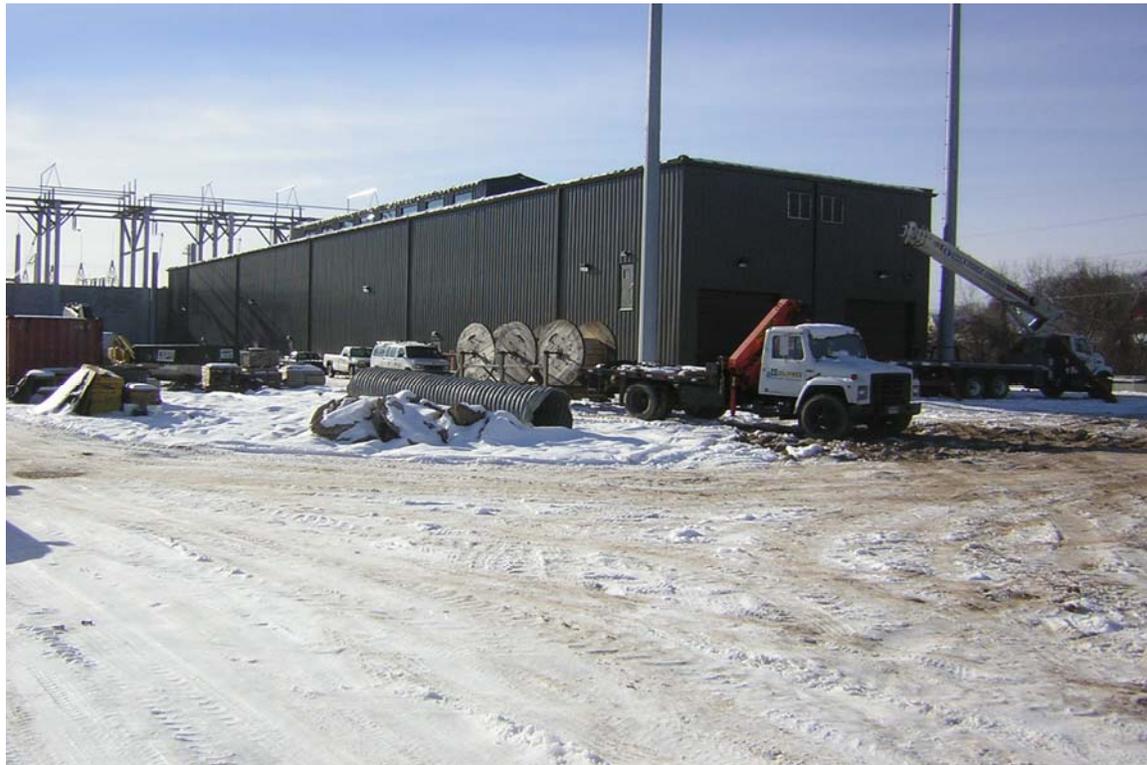
Overview of the yard adjacent to the GIS building where stockpiles have been removed. This area remains unpaved. 12/14/05.

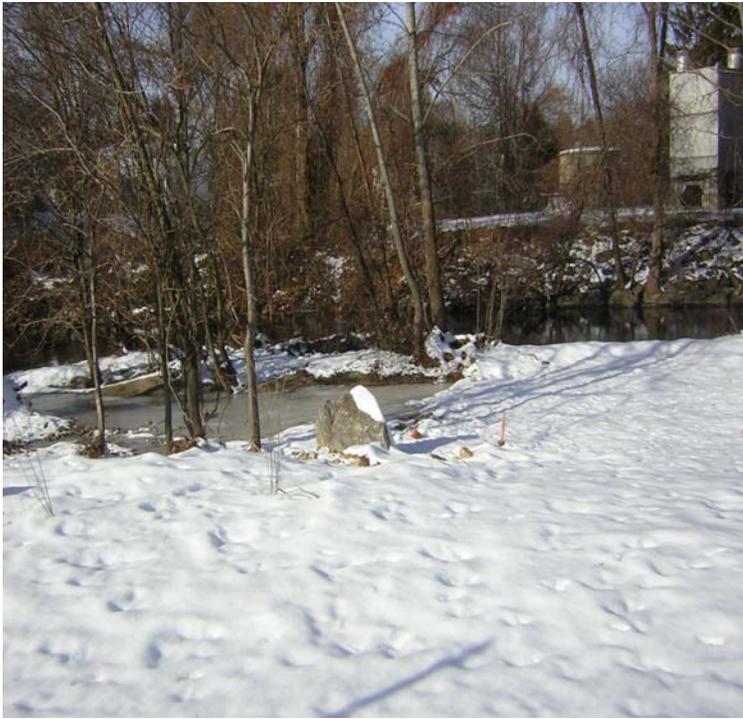
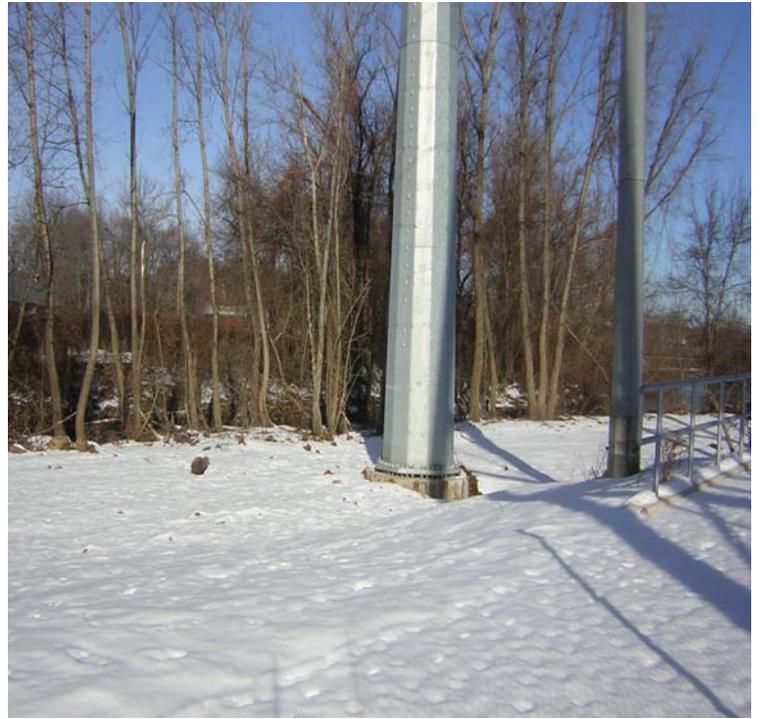
Inland Wetland and Watercourse encroachment and mitigation	-Water has been flowing clear in both the natural and constructed overflow channel, but additional small sediment/sand piles were noted here when the water receded. 12/8-12/14/05.	- Try to determine whether the loose sediment noted is project related. This may be natural deposition by the river. Snow cover is now an issue. 12/14/05.
State species of concern, threatened and endangered species	- No species of concern are located in this area of construction.	- N/A
Vegetative clearing limits (including trees to save or danger trees noted)	-No additional clearing is needed at this time. 12/14/05	- Clearing was limited to what is necessary and it will continue to be monitored. 12/14/05
Dewatering	-Dewatering was not observed during this inspection. 12/14/05.	-None at this time. 12/14/05.
Blasting	- No blasting is occurring on site at this time and it is not anticipated to be necessary.	- None at this time.

Views of the constructed and natural overflow channel areas. Photo on the left shows the 345kV turning structure area with snow cover. 12/14/05.

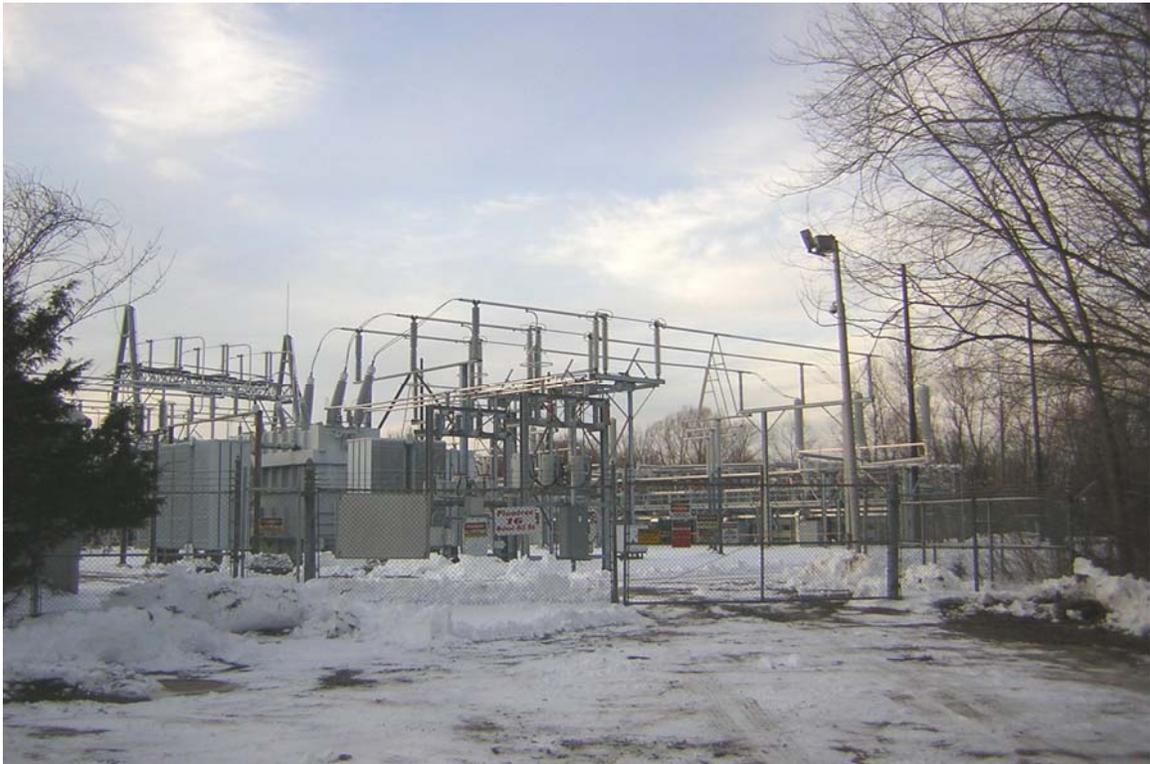
Plumtree Substation: Most substation related work here is complete. 12/14/05.
