Docket No. 217 – Development and Management Plan Inspection

Northeast Utilities Service Company Certificate of Environmental Compatibility and Public Need for the construction of a 345-kV electric transmission line and reconstruction of an existing 115-kV electric transmission line between Connecticut Light and Power Company's Plumtree Substation in Bethel, through the towns of Redding, Weston, and Wilton, and to the Norwalk Substation in Norwalk, Connecticut.

Date: January 4, 2006

Location: Transition Stations: Hoyts Hill, Archers Lane, Norwalk Junction

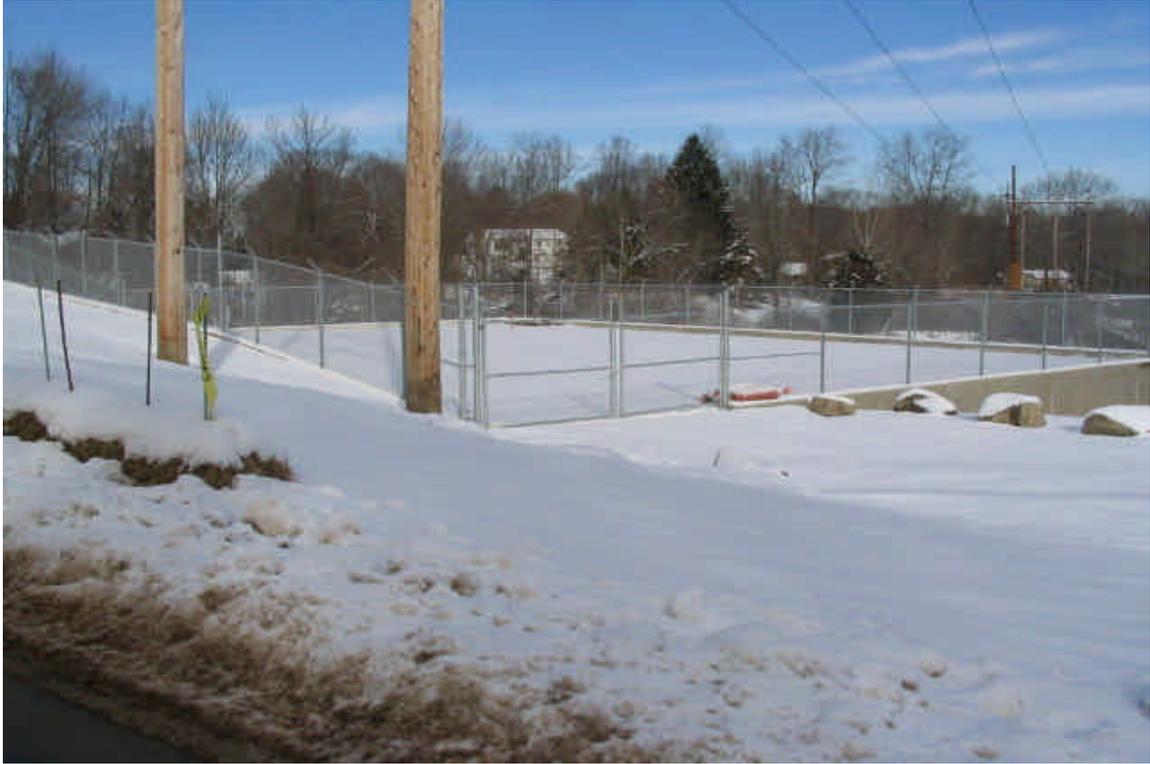
Hoyts Hill Transition Station: Overall view of the yard with snow cover. 1/4/06

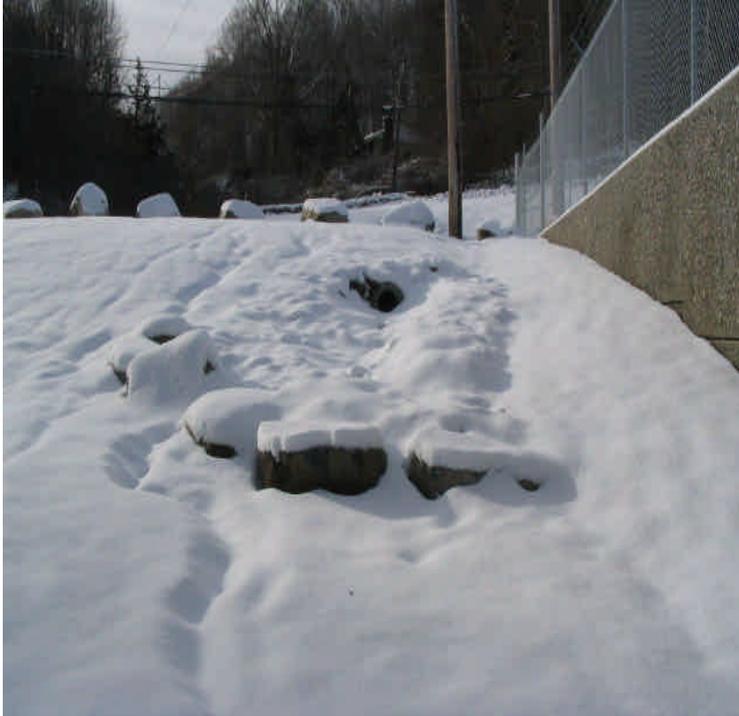
Photo on the left shows the gullies still present under the snow cover at the yard. Photo on the right shows the silt fence still in place along the wetland edge. 1/4/06.

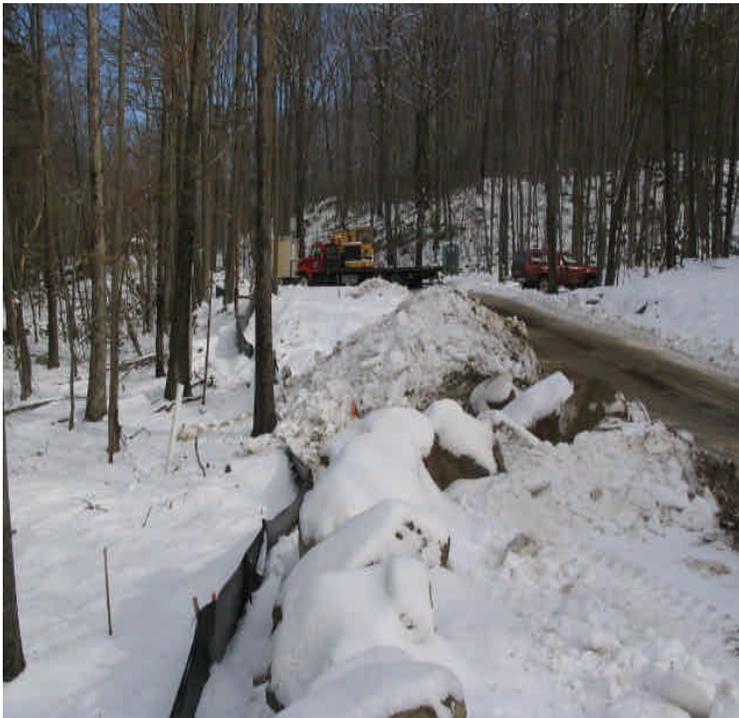
Archers Lane: Photo on the left shows some snow piled over the silt fence along the access roads. Wetlands are not immediately adjacent, but attempt to prevent this in general. Photo on the right shows a view along the boulder slope of the access road. 1/4/06.

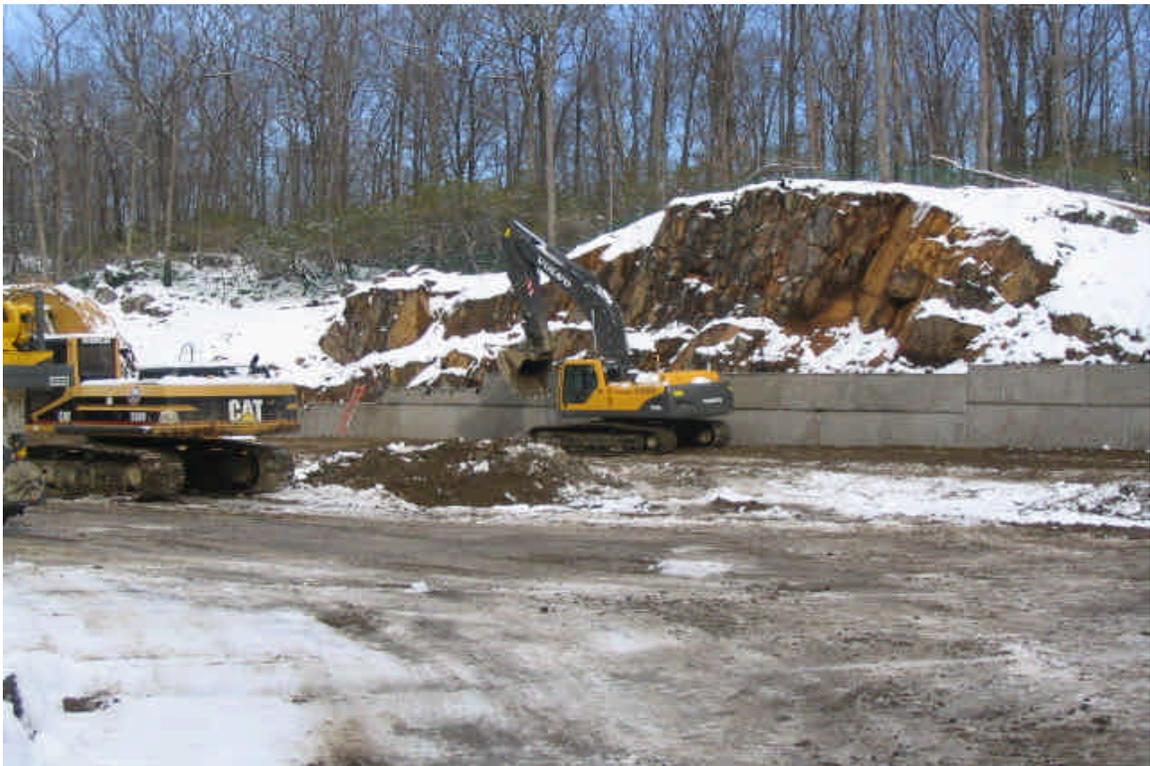
Photo shows the continuing progress being made on the retaining walls. 1/4/06.

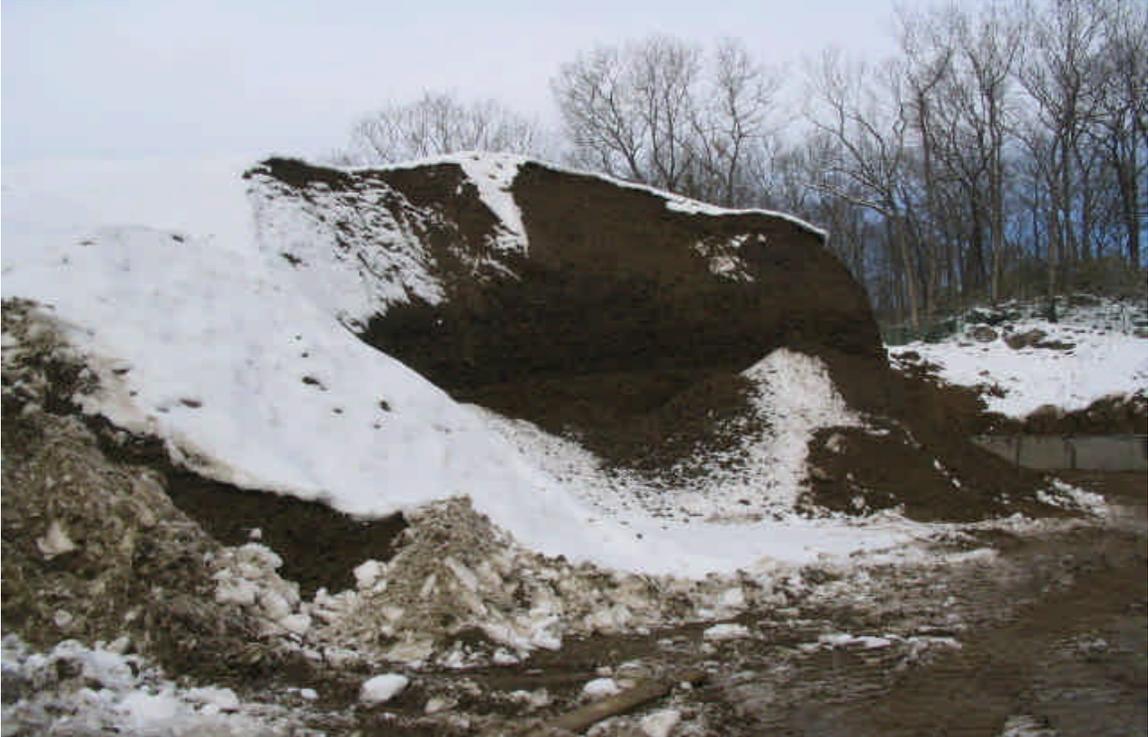
Photo shows the large soil stockpile at Archers Lane. The soil remains well contained to the site. 1/4/06

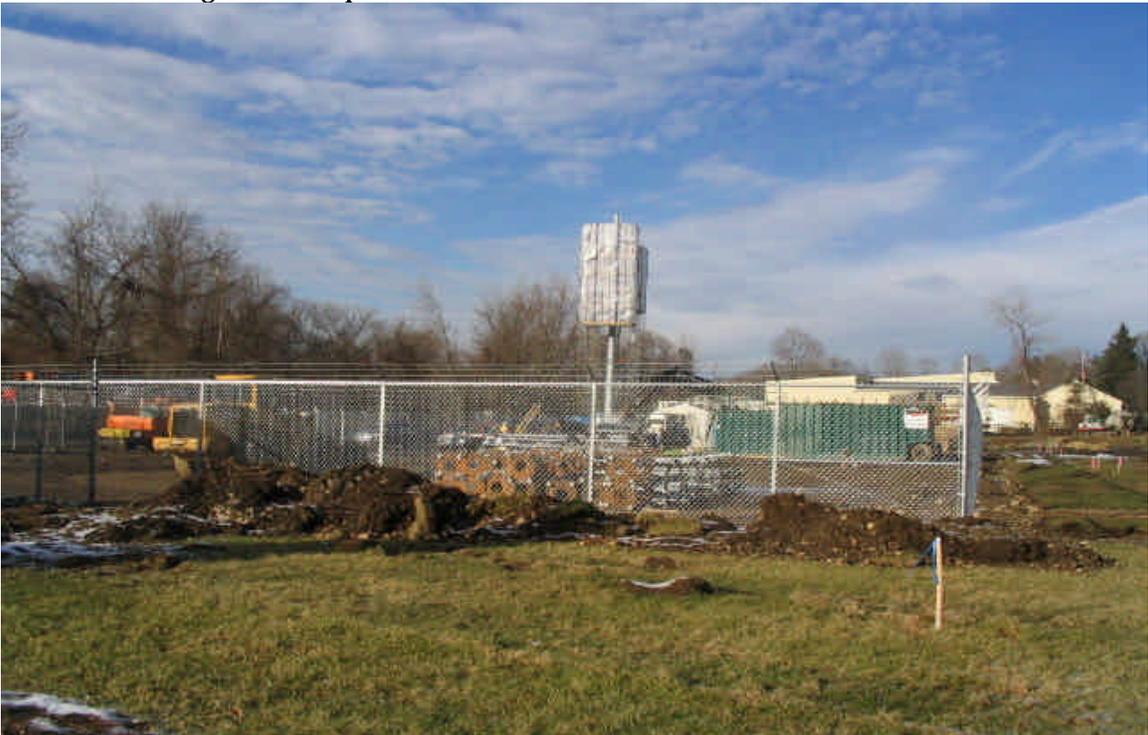
Norwalk Junction: Overall view of the yard. Various contractors are working on site at this time. 345kV contractors are installing vaults resulting in the use of frac tanks for dewatering. 115kV contractors are working on the structure with scaffolding and shrouding in place. 1/4/06

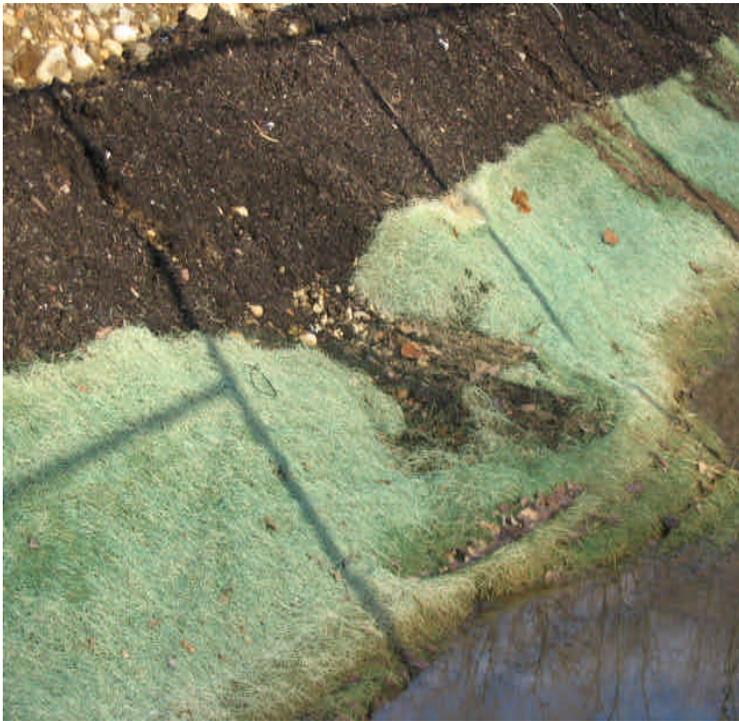
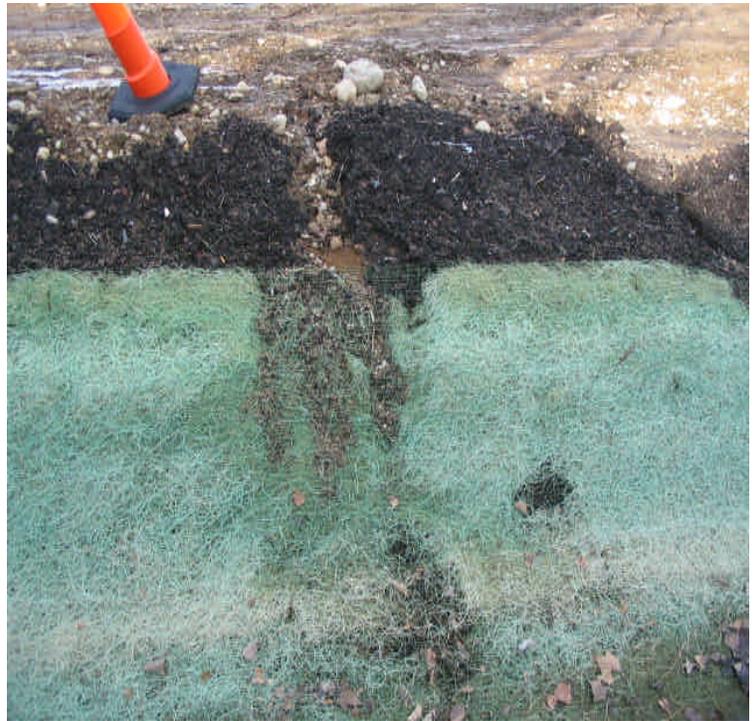
Both photos show close-ups of some of the erosive gullies still noted along the drainage swale. Soil has slumped from the top of slope over the erosion control matting. The mat will likely need to be extended to stabilize the top of slope as well.
1/4/06

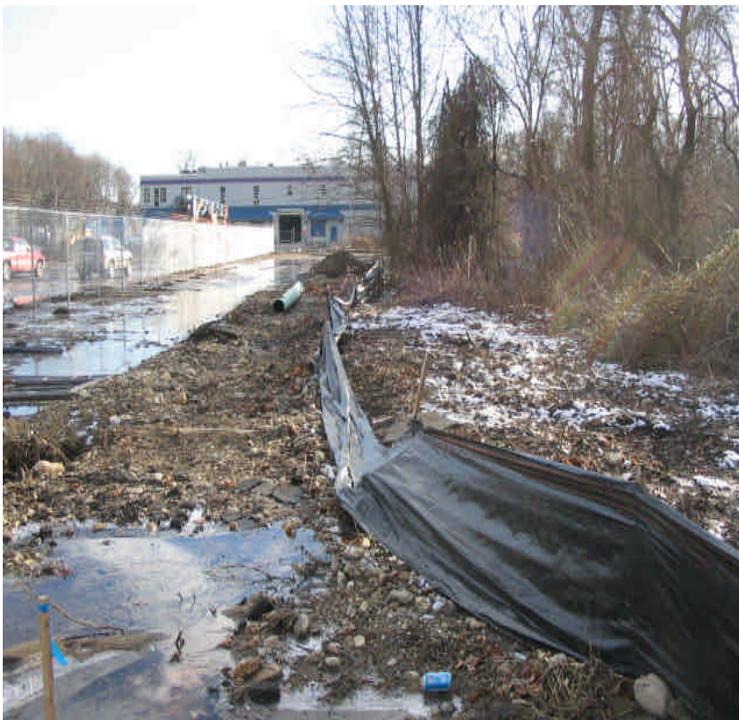
Photo on the left shows the perimeter silt fence which still needs some attention and toeing-in. Photo on the right shows turbid water pooling just beyond the fence. This is partially a result of the dewatering from the 345kV contractors and may be compounded from the sedimentation in the drainage swale. Contractors should work together to remove their contributing factors. 1/4/06
