Docket No. 217 – Development and Management Plan Inspection

Northeast Utilities Service Company Certificate of Environmental Compatibility and Public Need for the construction of a 345-kV electric transmission line and reconstruction of an existing 115-kV electric transmission line between Connecticut Light and Power Company's Plumtree Substation in Bethel, through the towns of Redding, Weston, and Wilton, and to the Norwalk Substation in Norwalk, Connecticut.

Date: January 19, 2006

Location: Transition Stations: Hoyts Hill, Archers Lane, Norwalk Junction

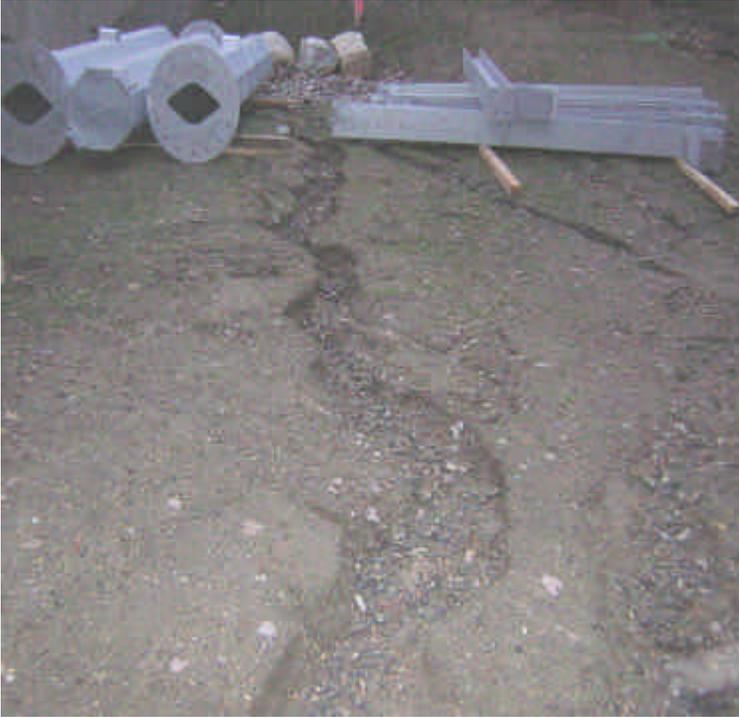
Hoyts Hill Transition Station: Photo on the left shows the erosive gullies visible now that the snow has melted. Photo on the right shows where run-off has led to some increasing sedimentation beyond the silt fence and in the wetlands. 1/19/06

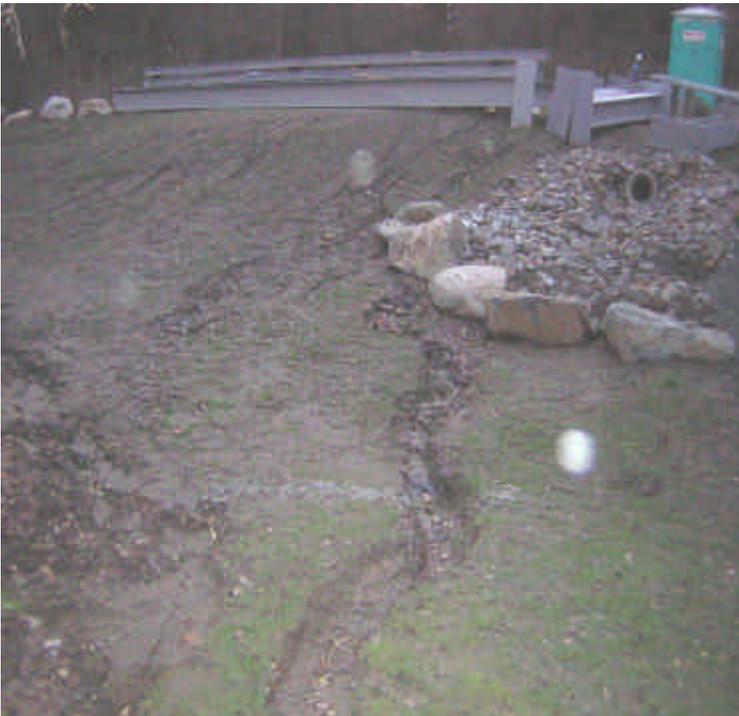
Photo on the left shows the smaller rills and larger erosive gully down the slope which are visible once again. Photo on the right shows some of the ruts and run-off noted along the access point from Hoyts Hill. Structures and materials have recently been delivered to the station yard for installation. 1/19/06.

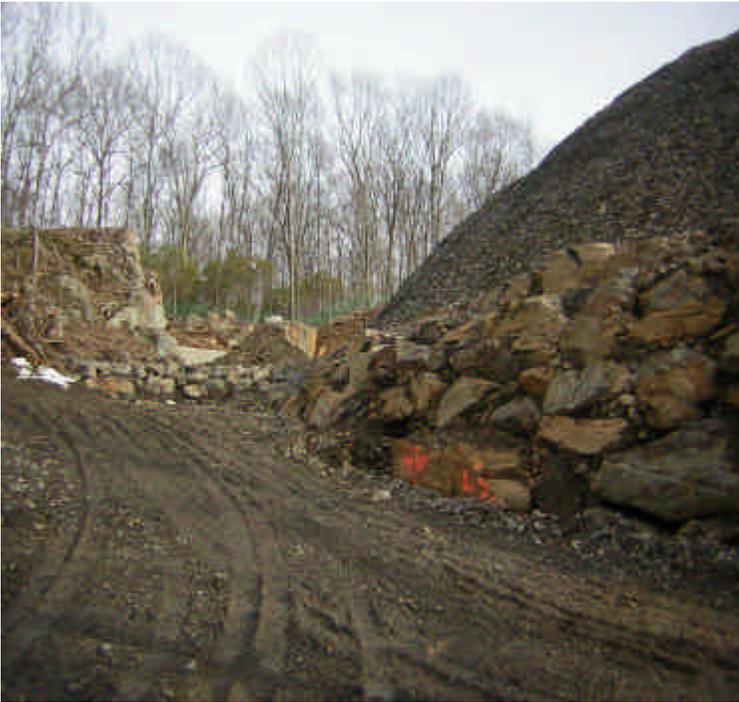
Photo on the left shows the sediment pile and boulder wall in place on site. Photo on the right shows a recently discovered pipe which drains under the access road to the ROW. This was located near the base of the stockpile area on the other side of the access drive and resulted in turbid water to the wetland. 1/19/06.

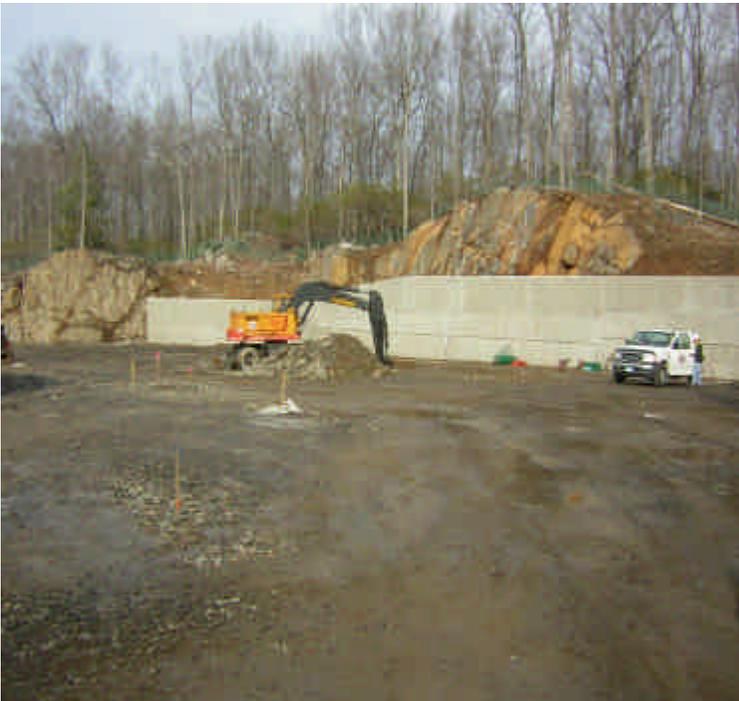
Photo on the left shows the continuing progress on the retaining walls and earthwork. Photo on the right shows one of the low wetland crossings within the ROW with significant flooding. It needs to be determined whether the work on the transition station has resulted in these water issues. 1/19/06

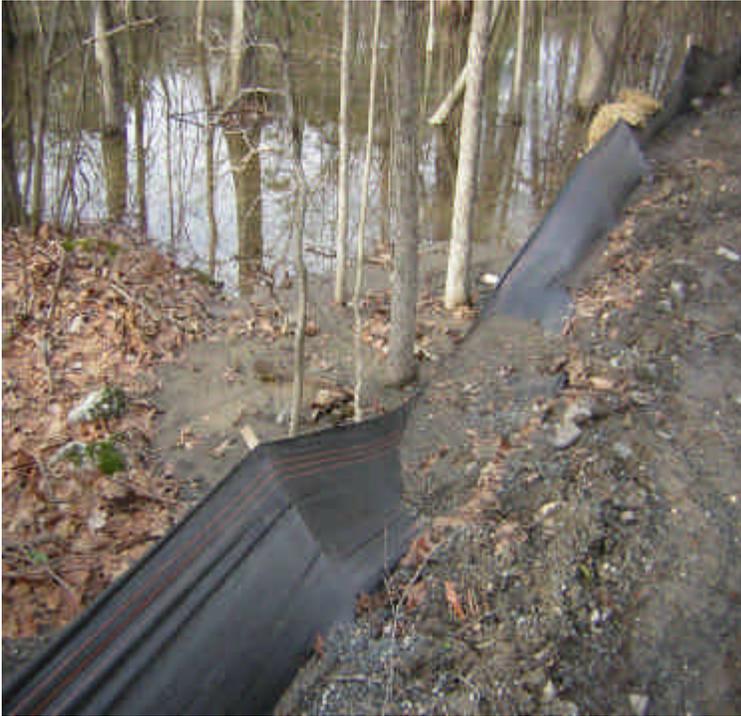
Photo on the left shows one of the spots where sediment from the site and access road has washed over the silt fence adjacent to the wetland. Photo on the right where turbid water associated with the pipe is entering the wetland. Standing water in the wetlands is also turbid with a layer of sediment on the leaves. 1/19/06

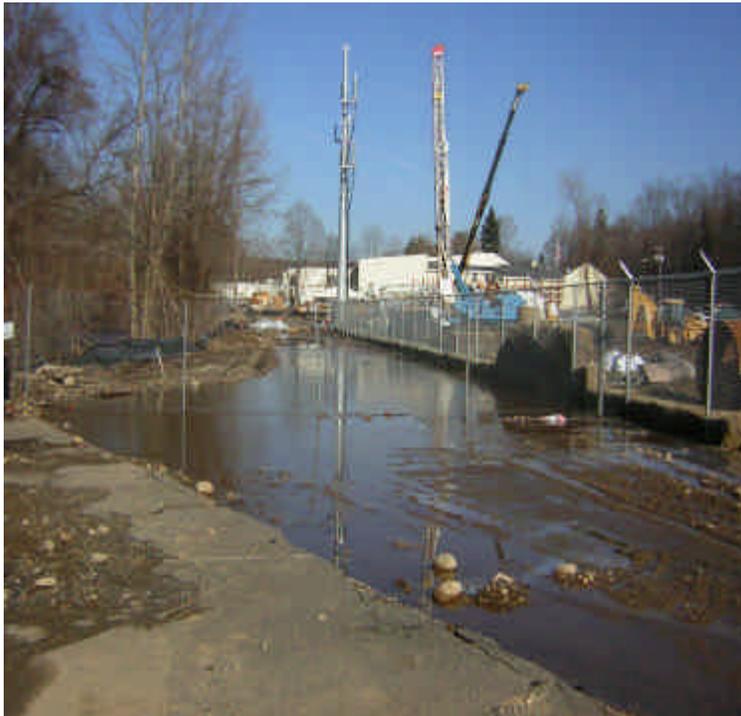
Norwalk Junction: Photo on the left looks toward the site with some ponding occurring along the perimeter fence. A line of haybales has been installed along the fence to keep sediment within the site. Photo on the right shows a close-up of the haybale line with the silt fence in place adjacent to the river. 1/19/06

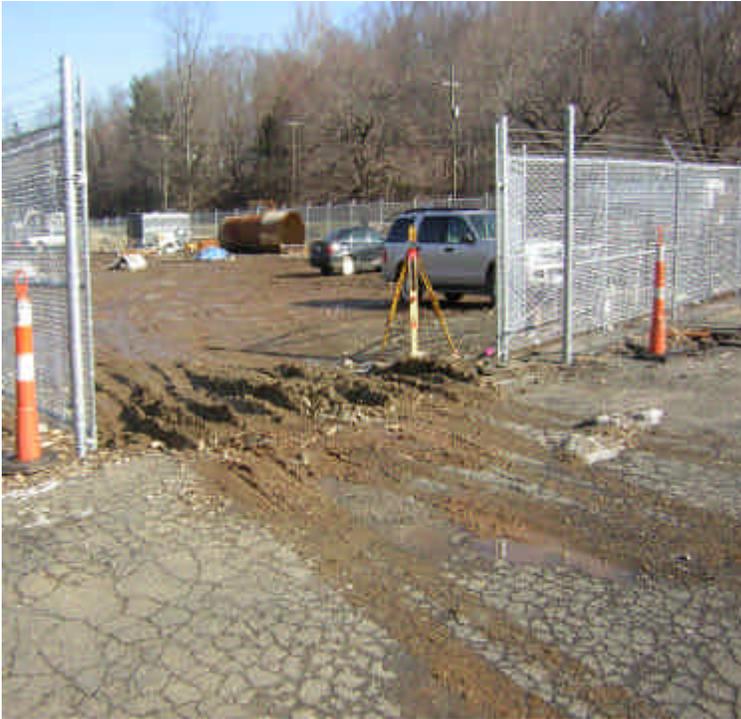
Photo on the left shows where a truck leaving the site created some ruts and resulted in sediment tracking. This entrance is almost never used but sweep up sediment as feasible. Photo on the right is a view of the drainage swale which still needs some attention along this portion. Rills/washouts need repair and trash has collected at the culvert. Turbid water is also present from adjacent site run-off. 1/19/06

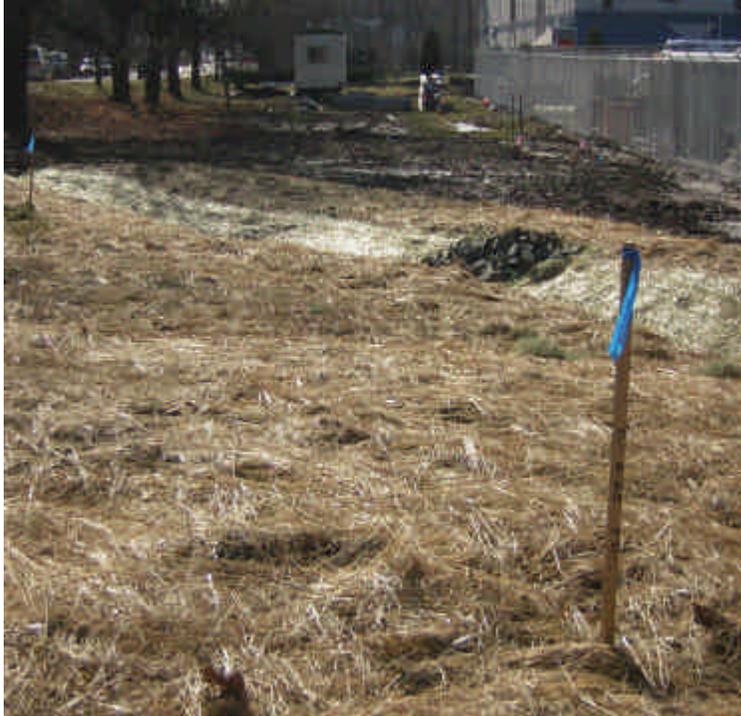
Photo on the left shows the upper portion of the swale which has been well restored. Adjacent areas need similar restoration where feasible to reduce turbid run-off from the site. The photo on the right shows the wetland where the swale outlets, resulting in turbid, standing water. Reducing the extent of disturbance on site will help. 1/19/06
