**Docket No. 217 – Development and Management Plan Inspection**

Northeast Utilities Service Company Certificate of Environmental Compatibility and Public Need for the construction of a 345-kV electric transmission line and reconstruction of an existing 115-kV electric transmission line between Connecticut Light and Power Company’s Plumtree Substation in Bethel, through the towns of Redding, Weston, and Wilton, and to the Norwalk Substation in Norwalk, Connecticut.

**Date:** January 26, 2006

**Location:** Transition Stations: Hoyts Hill, Archers Lane, Norwalk Junction

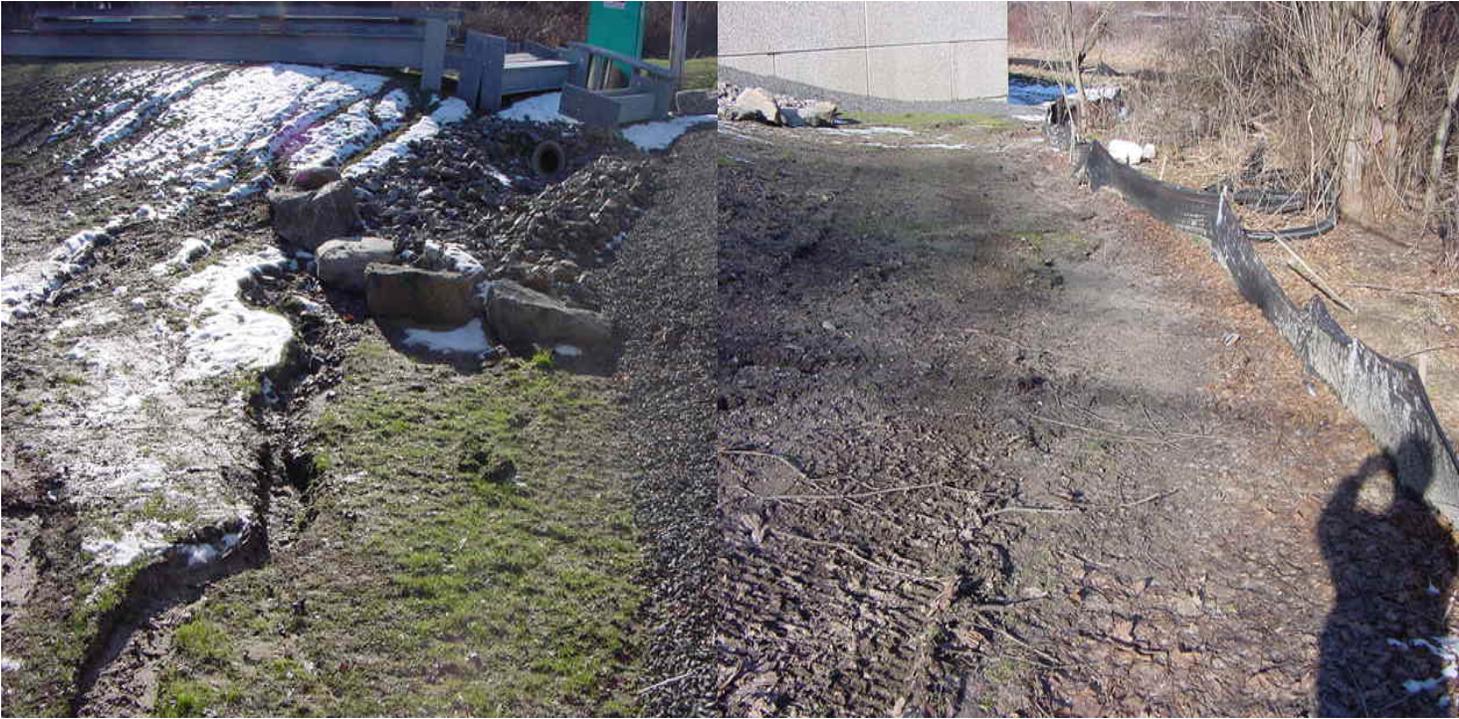
Areas of Inspection	Observation	Recommended Action
<p>Foundation construction continued</p>	<p>- Additional work may be necessary on the outlet/dissipater pads as erosive gullies and sedimentation continue to worsen. 12/01-1/26/06.</p> <p>-At <b>Archers Lane</b>, the large stone pile was removed and the pad is graded and awaiting structure installation. 1/26/06</p> <p>- A stone drain swale is in place along the ledge which infiltrates to a pipe in the stone at the edge of the pad. 1/26/06</p> <p>-At <b>Norwalk Junction</b>, drilling and foundation installation was ongoing. Some soil was also being removed from site. 1/26/06</p>	<p>-The stone may need to be extended based on the noted erosion issues. See erosion control section. 12/01-1/26/06.</p> <p>-None at this time. 1/26/06</p> <p>- Controls should be installed in the swale if dewatering is occurring. 1/26/06</p> <p>- See erosion control section for more information. 1/26/06.</p>

Hoyts Hill Transition Station: Photo on the left shows a view of the continuing gully along the slope adjacent to the pad. Photo on the right shows some less severe erosion along the edge of the silt fence. 1/26/06

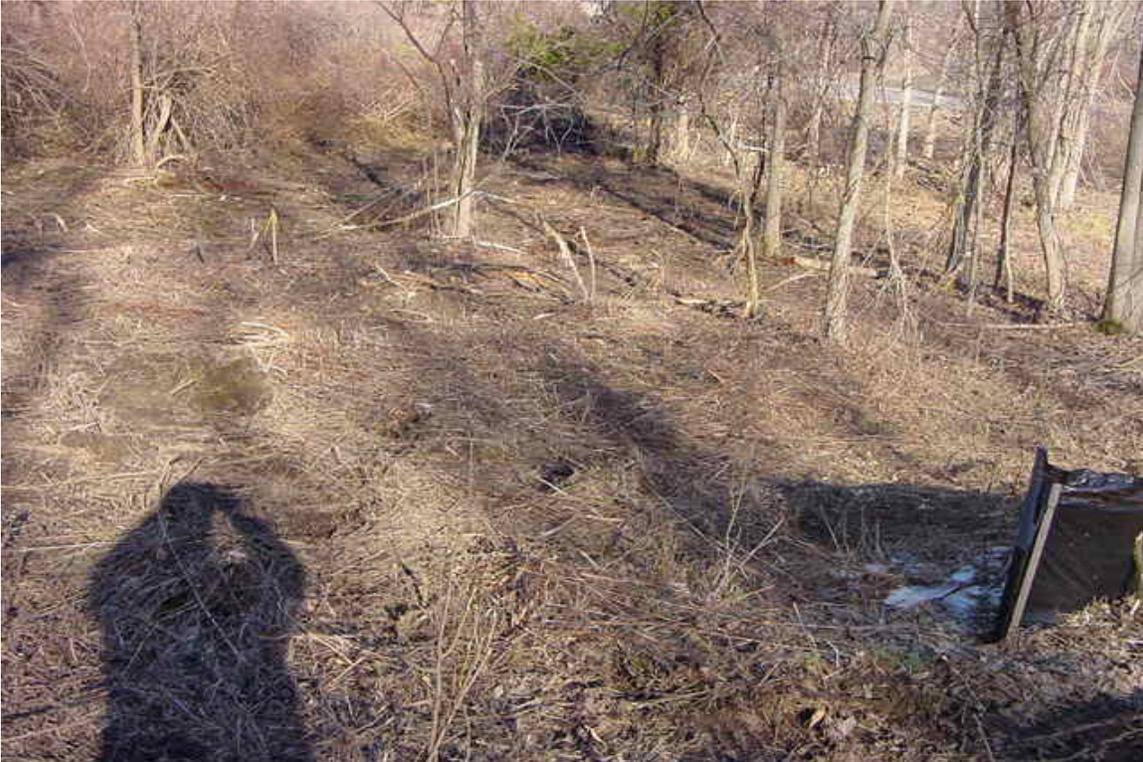
View of the clearing which has started to take place within the woods adjacent to the station. A majority of the clearing will occur in wetlands. Silt fence will have to be installed prior to soil disturbance. 1/26/06.

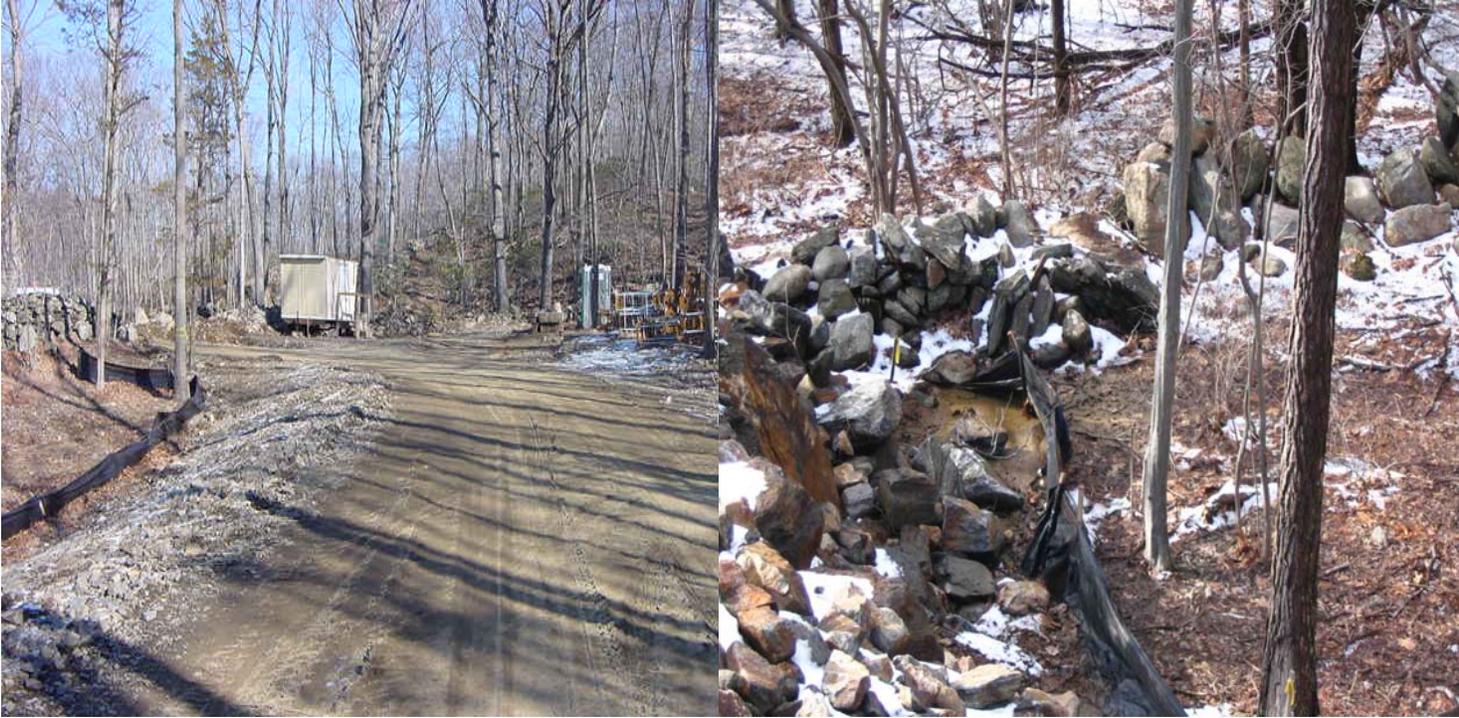
Photo on the left shows a view of the access drive and a trailer placed on site for the next portion of construction. Photo on the right shows where run-off from the site collects at the base of the steep slope on the access drive. Turbid water was contained at this time 1/24 and 1/26/06.

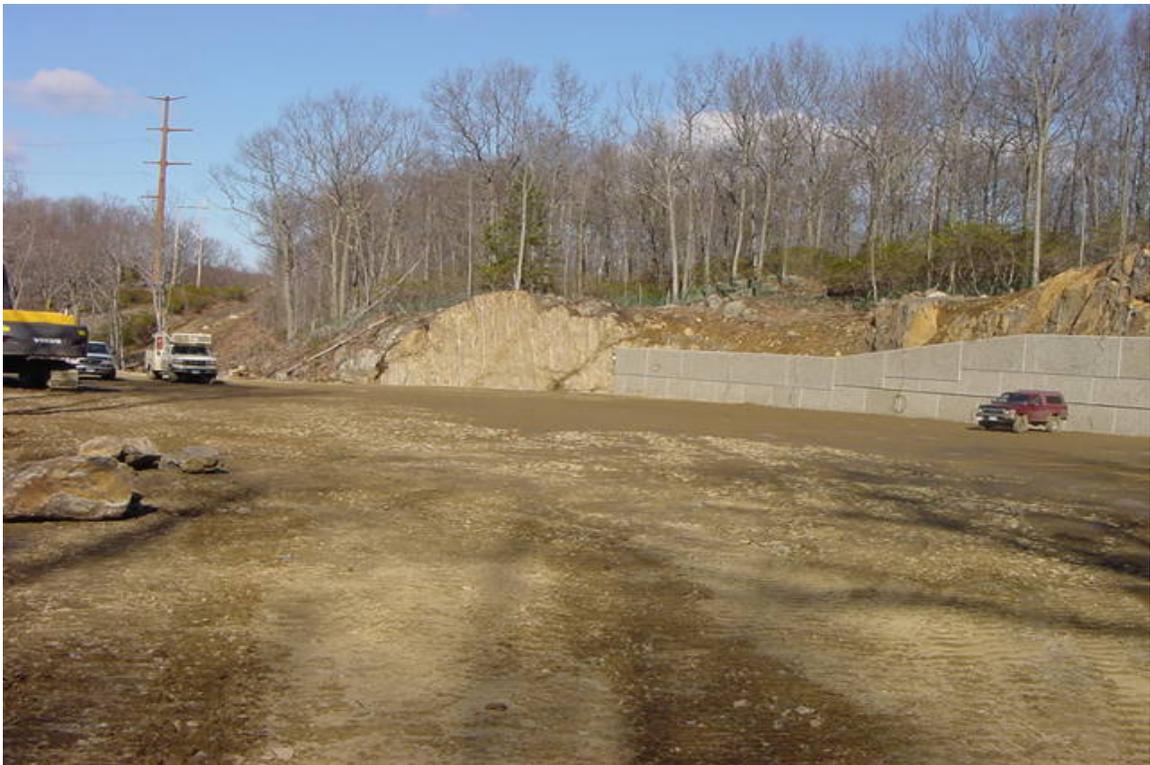
Overall view of the site. The large pile of stone/soil has been removed from the site and the pad is ready for foundation construction. 1/26/06.

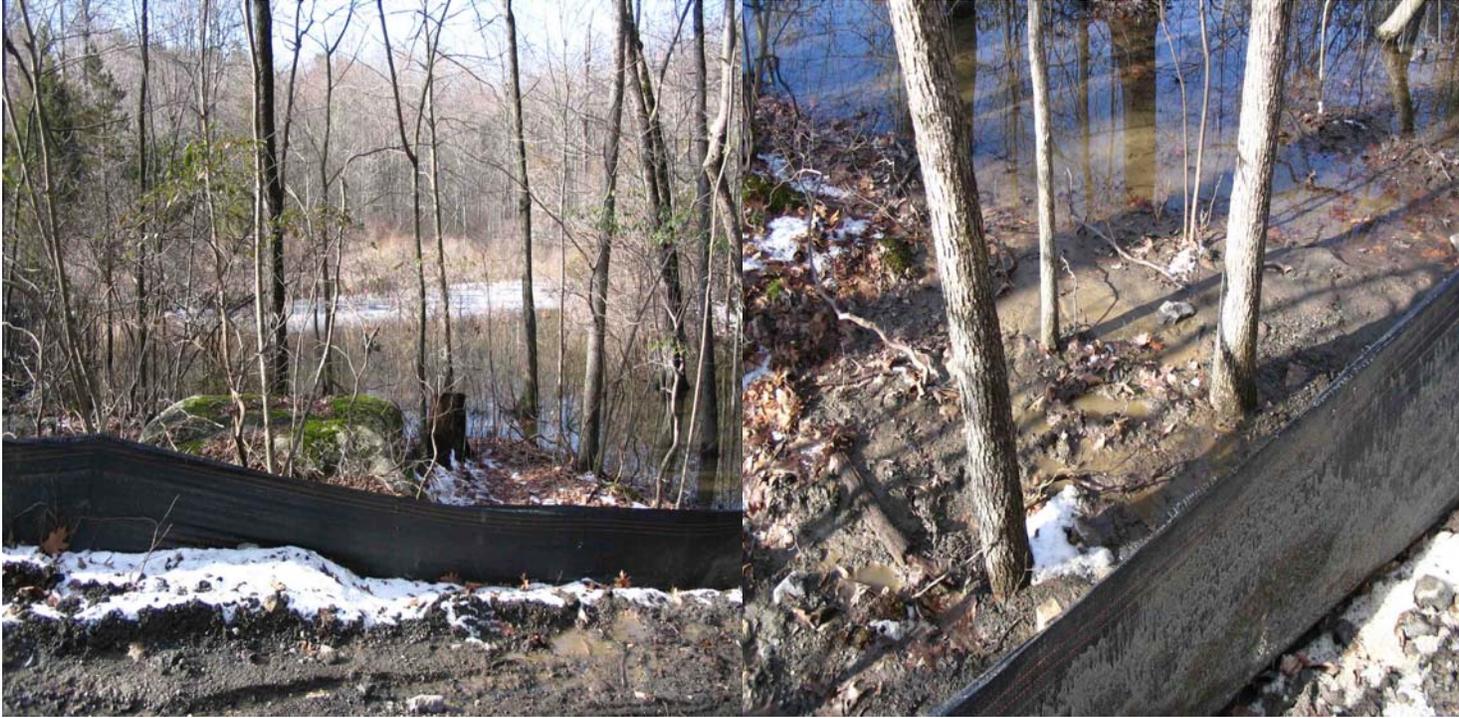
<b>Areas of Inspection</b>	<b>Observation</b>	<b>Recommended Action</b>
	from the transition station across the access road had overwhelmed the silt fence last week but it was well repaired. 1/26/06.	the access road but sediment had accumulated in and adjacent to the wetland and will need to be removed. 1/26/06.

Photo on the left shows where a previous washout to the silt fence along the access road to the ROW has been repaired. Photo on the right shows where sediment has accumulated within the wetland as a result of run-off from the site. 1/26/06.

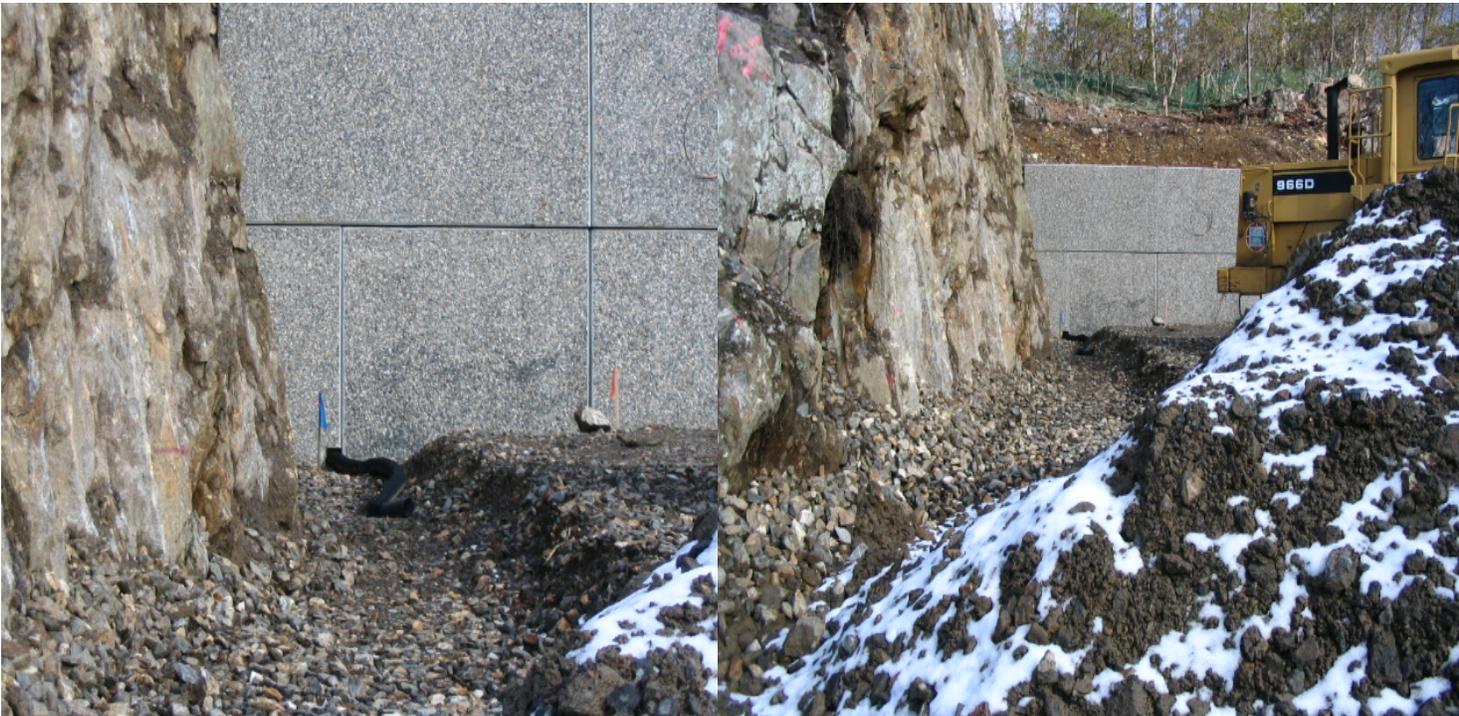
Photo on the left shows the stone swale constructed along the edge of the pad. This area drains the site to infiltrate in the stone. Photo on the right shows a wider view of the area. The water infiltrates to a drainage pipe. 1/26/06

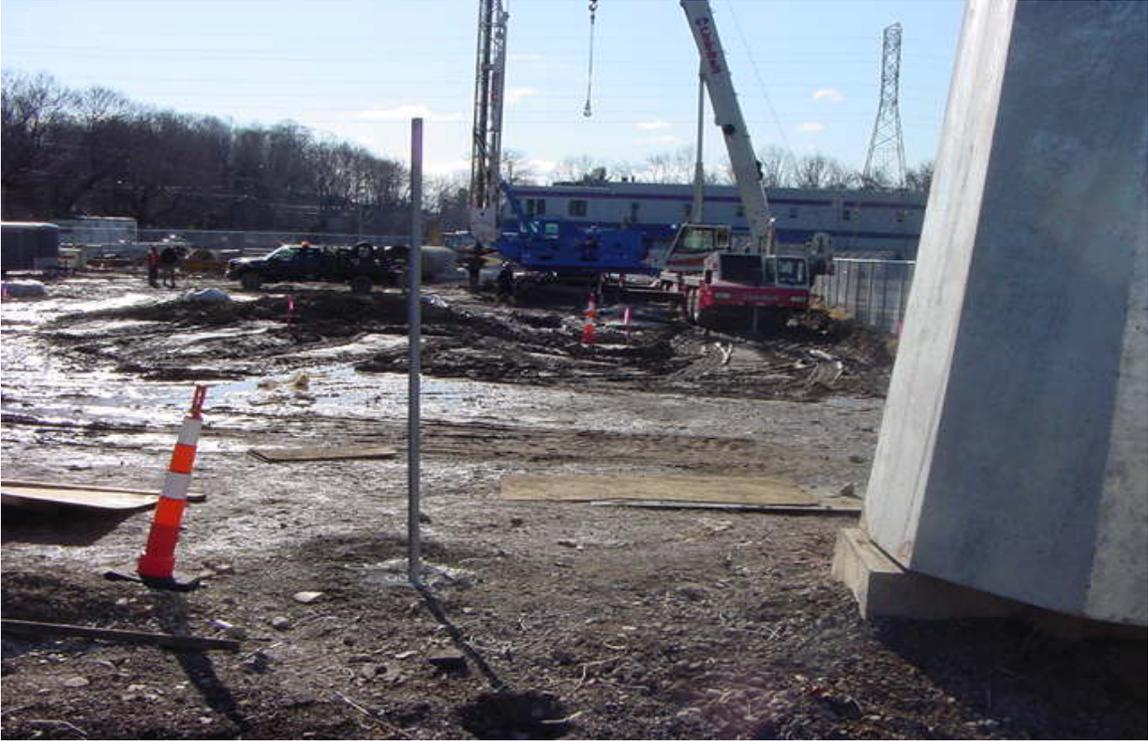
Norwalk Junction: Photo shows an overview of the site with construction of structure foundations ongoing. 1/26/06

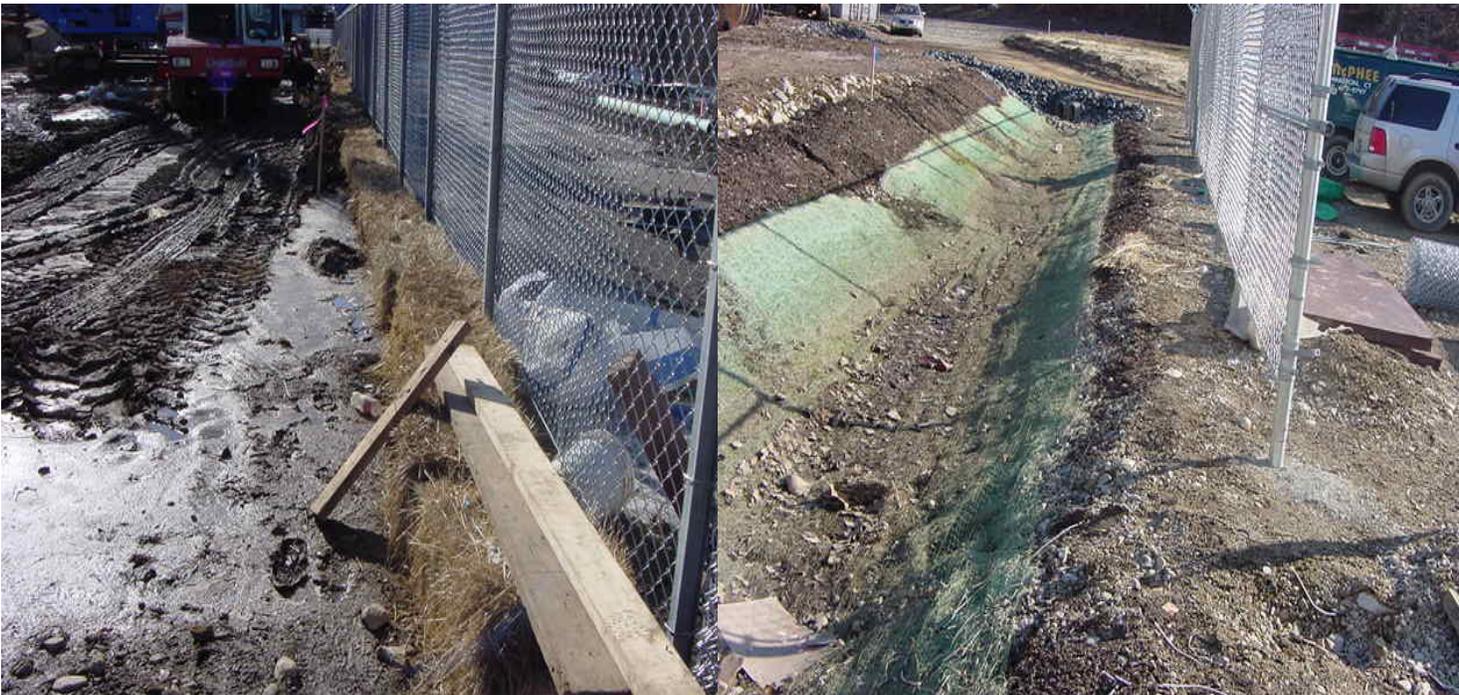
Photo on the left shows a row of haybales installed along the perimeter fence. It appears this is a good control, keeping sediment on site. Photo on the right shows the swale which is still exhibiting washouts and loose sediment. Trash will be removed shortly. 1/26/06
