Docket No. 217 – Development and Management Plan Inspection

Northeast Utilities Service Company Certificate of Environmental Compatibility and Public Need for the construction of a 345-kV electric transmission line and reconstruction of an existing 115-kV electric transmission line between Connecticut Light and Power Company’s Plumtree Substation in Bethel, through the towns of Redding, Weston, and Wilton, and to the Norwalk Substation in Norwalk, Connecticut.

Date: February 2, 2006

Location: Transition Stations: Hoyts Hill, Archers Lane, Norwalk Junction

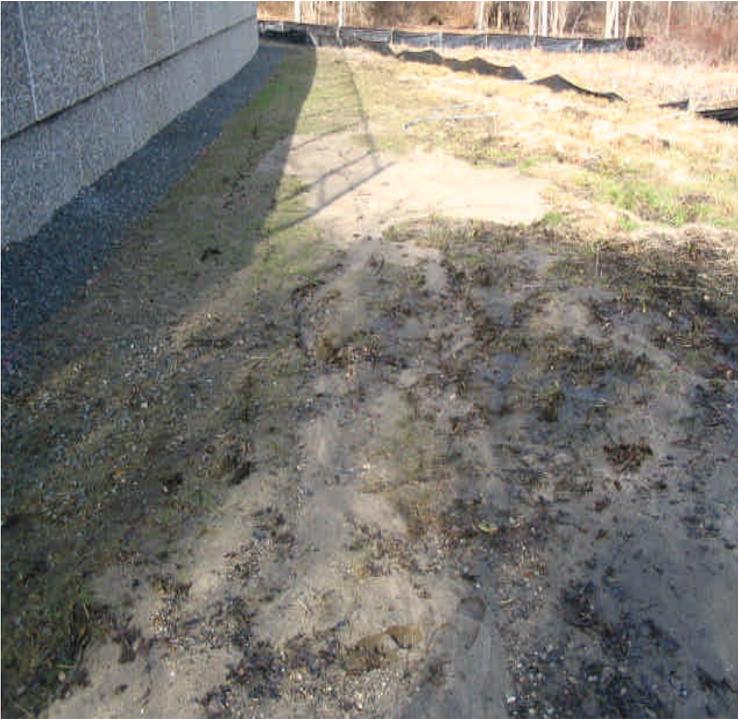
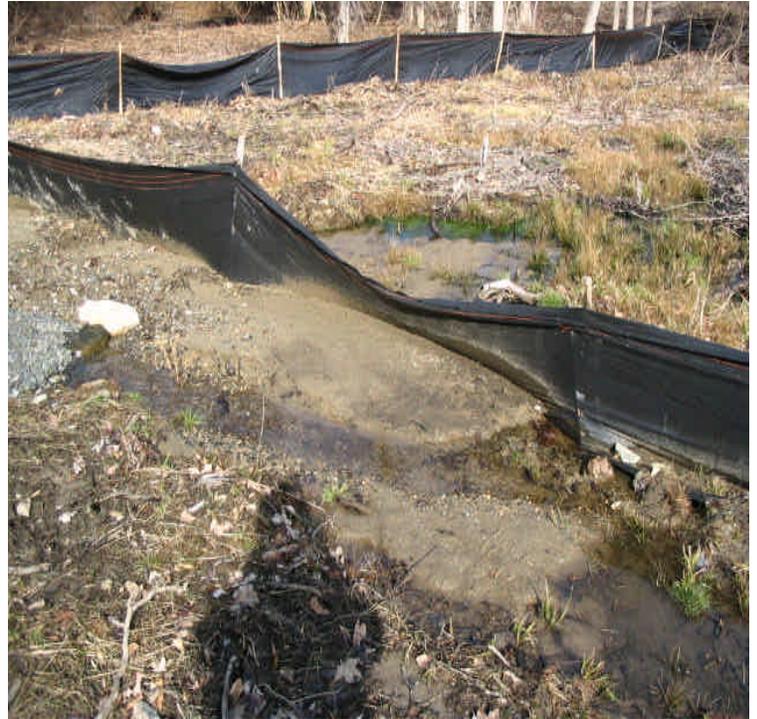
Hoyts Hill Transition Station: Photo on the left shows the sedimentation that has occurred along the southern side of the station pad. Photo on the right shows where sediment has accumulated beyond the silt fence as a result of the northern gully. 2/2/06

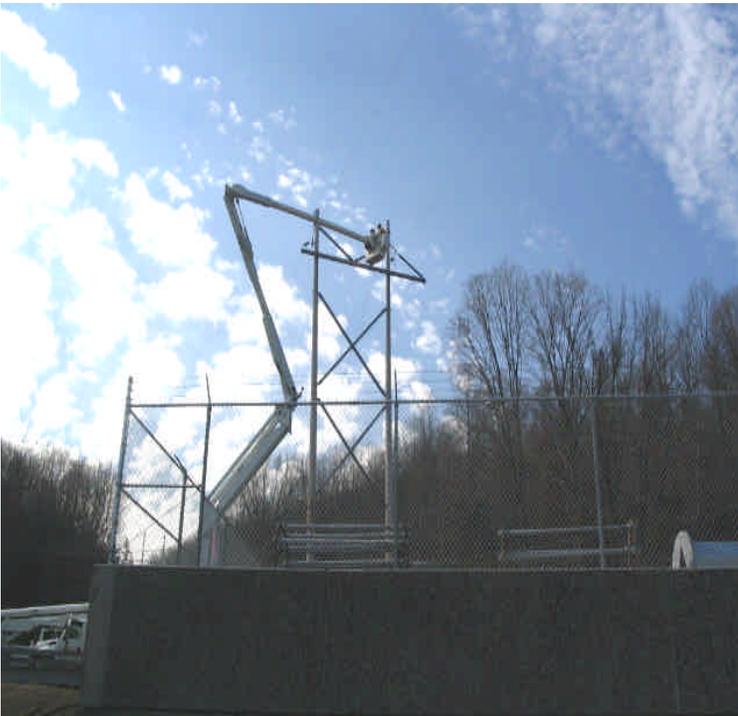
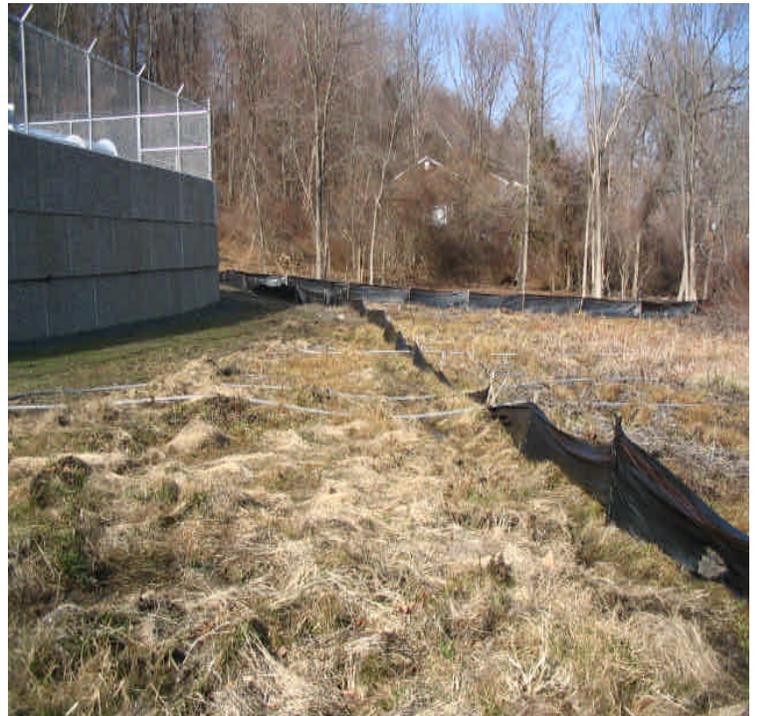
Photo on the left shows some work on the structure adjacent to the station pad. Photo on the right is a view looking towards the wetland. Wires were being taken down and removed at the time. 2/2/06.

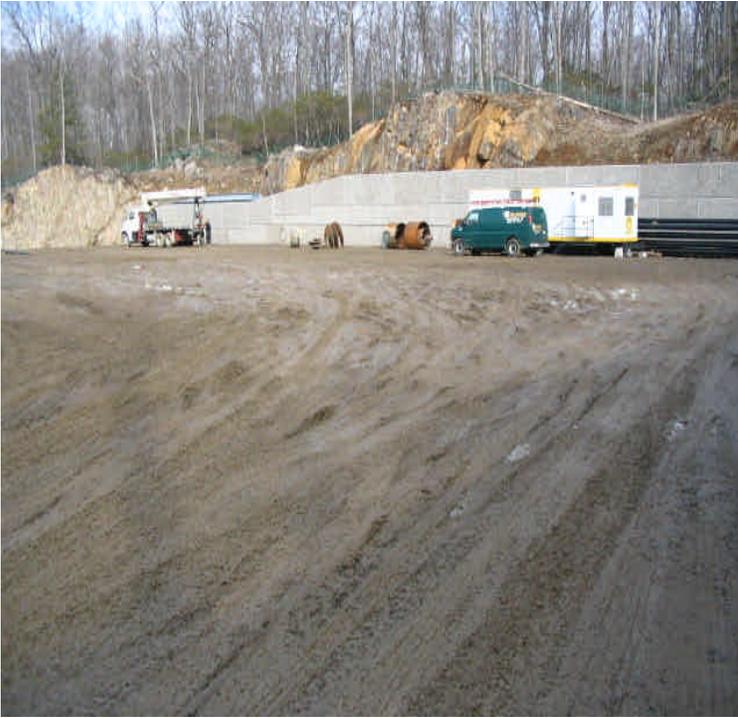
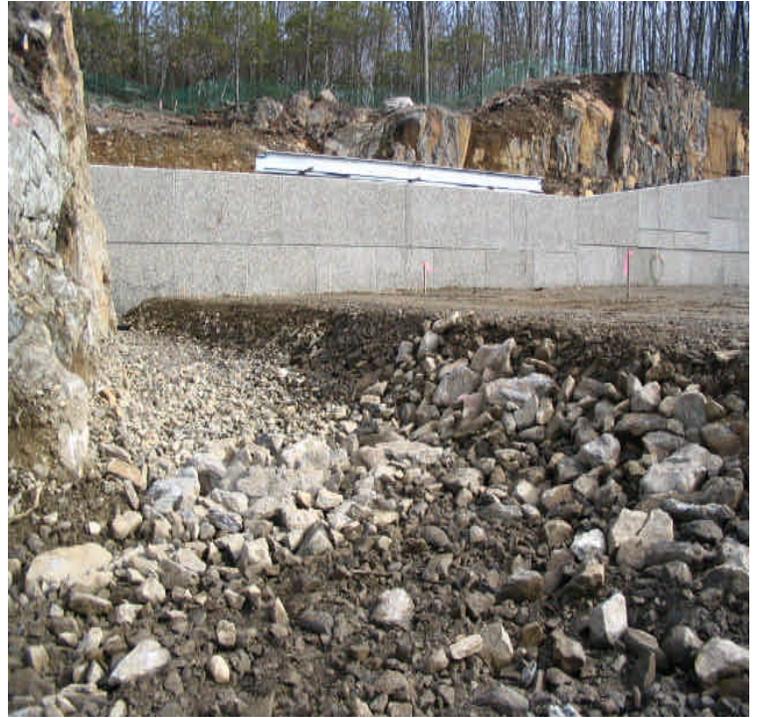
Archers Lane: Photo on the left shows a view of the station pad. Excavation will begin soon for foundation construction. Photo on the right shows a view of the edge of the pad with grading complete and the stone swale in place 2/2/06.

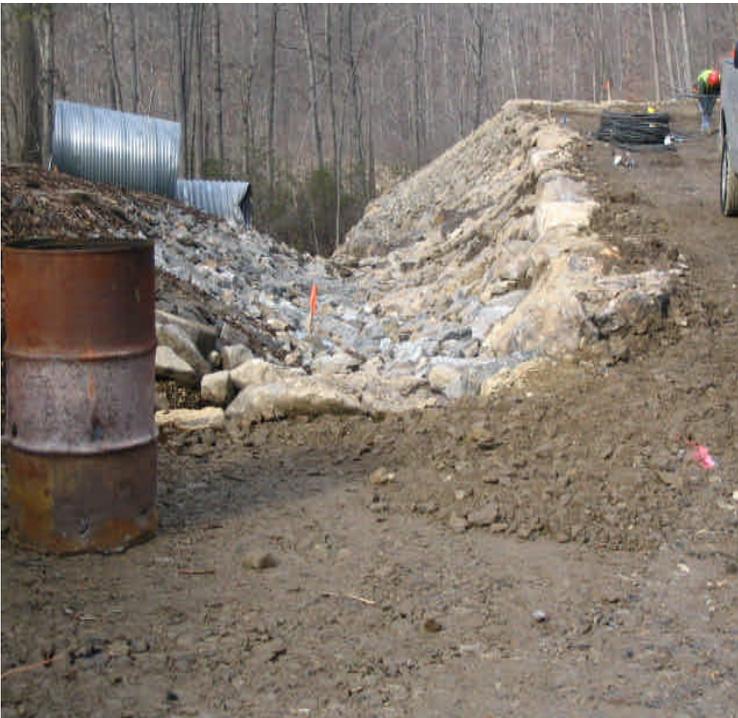
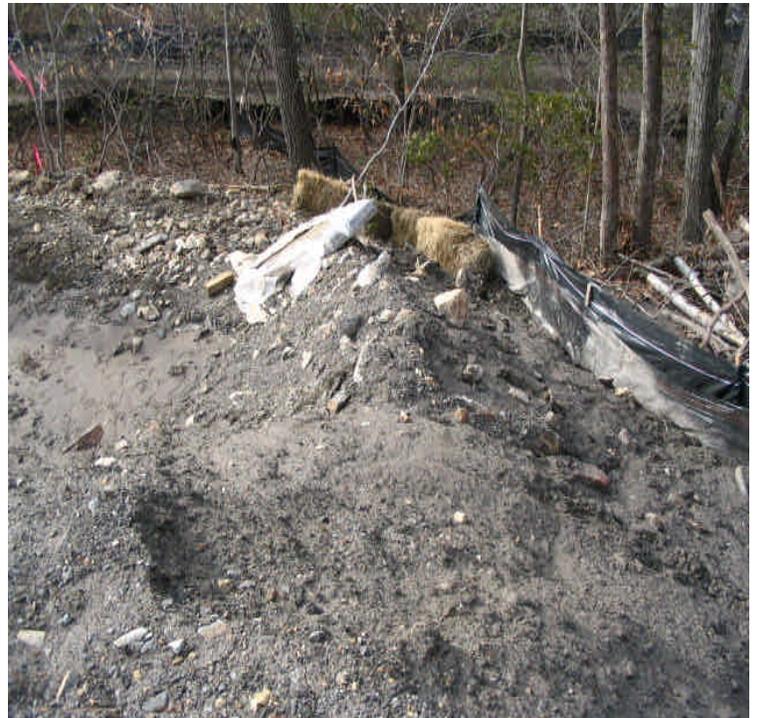
Photo on the left looks along the edge of the pad at the engineered slope. Photo on the right shows where erosion controls were installed as recommended at the stockpile resulting from the structure foundation adjacent to the pad. 2/2/06.

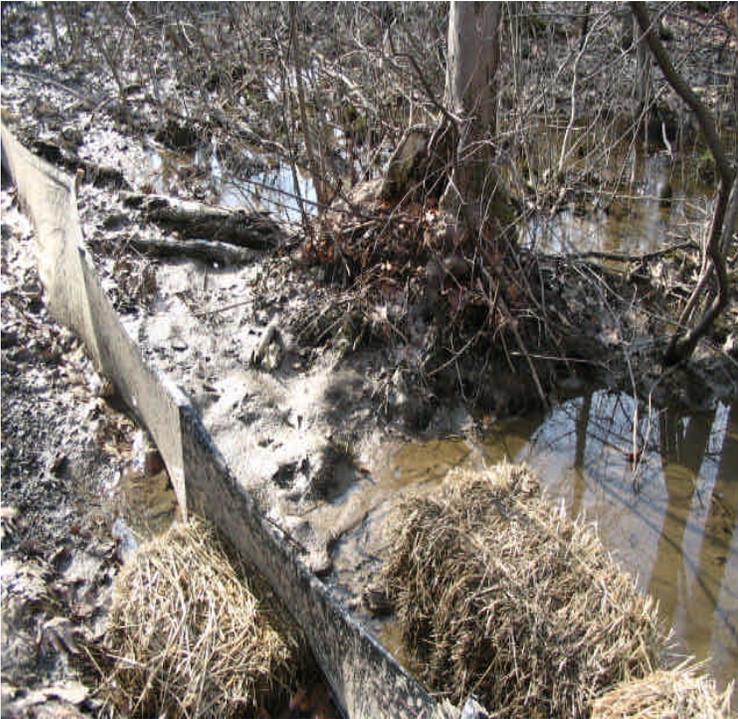
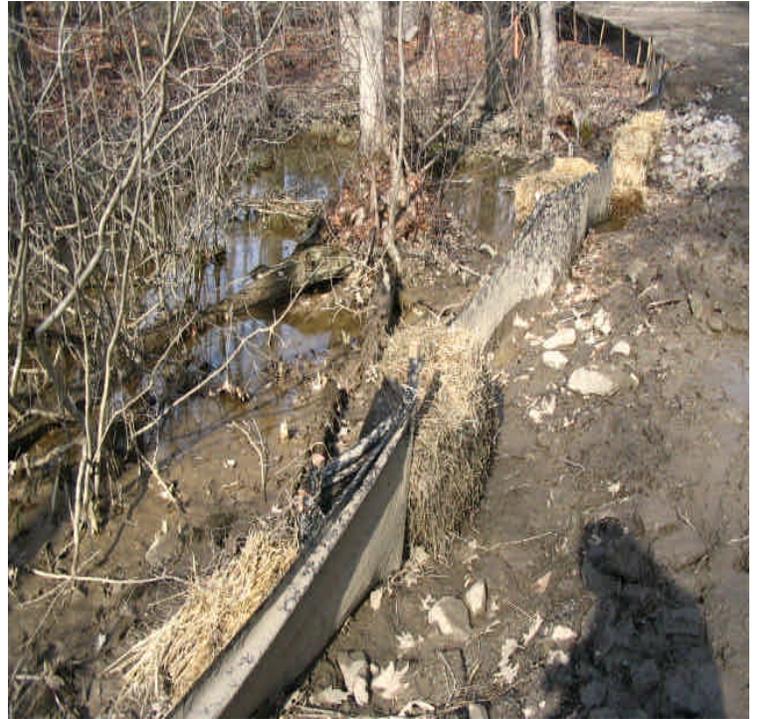
Both photos show the status at the first wetland crossing, adjacent to the station where sediment has accumulated as a result of run-off. In areas where sediment is inches thick and easily reached, it should be removed carefully from the wetland by hand. 2/2/06.

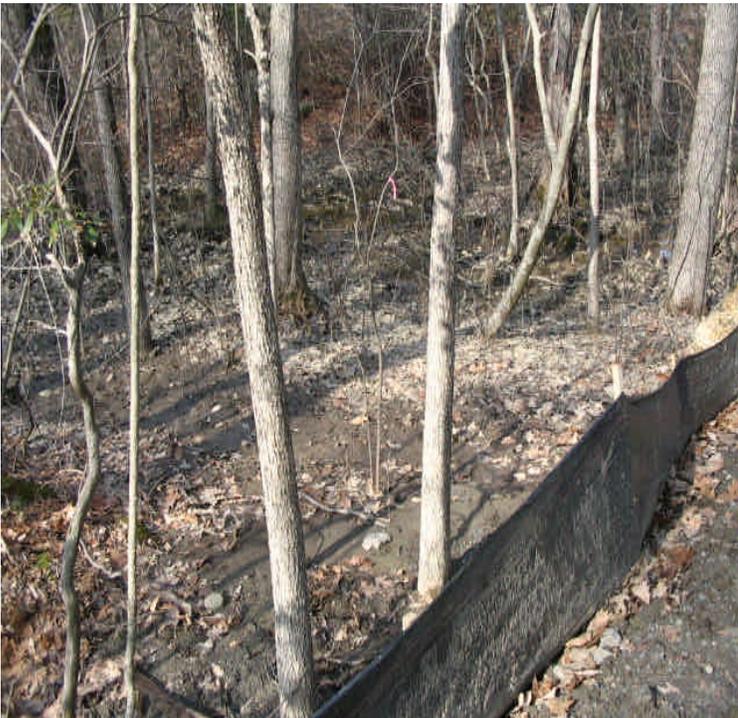
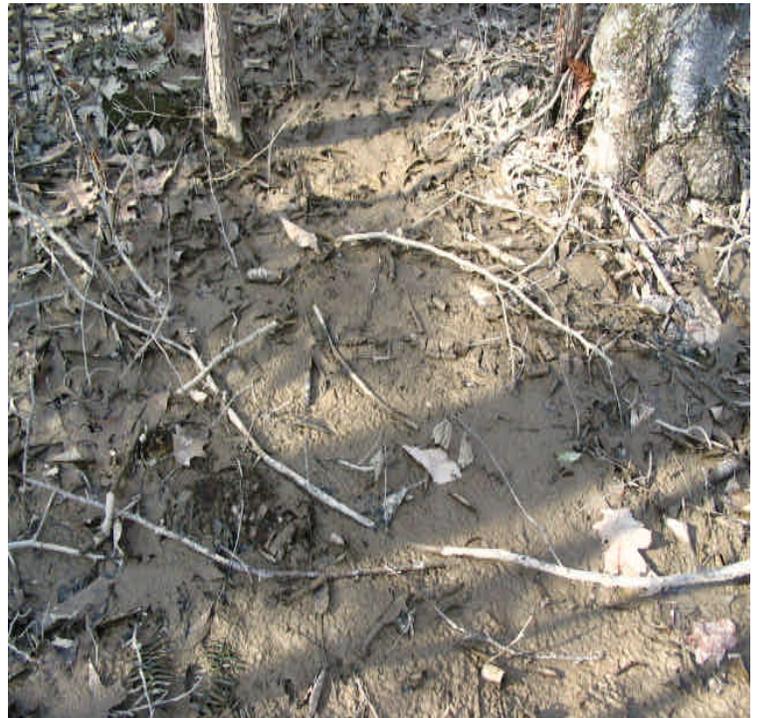
Photo on the left shows where deposits of sediment can be more easily seen now that the water in this area has dried up. Photo on the right shows sediment accumulation in the 2nd wetland crossing, just past the station. This was resulting from the drainage pipe from the site. 2/2/06

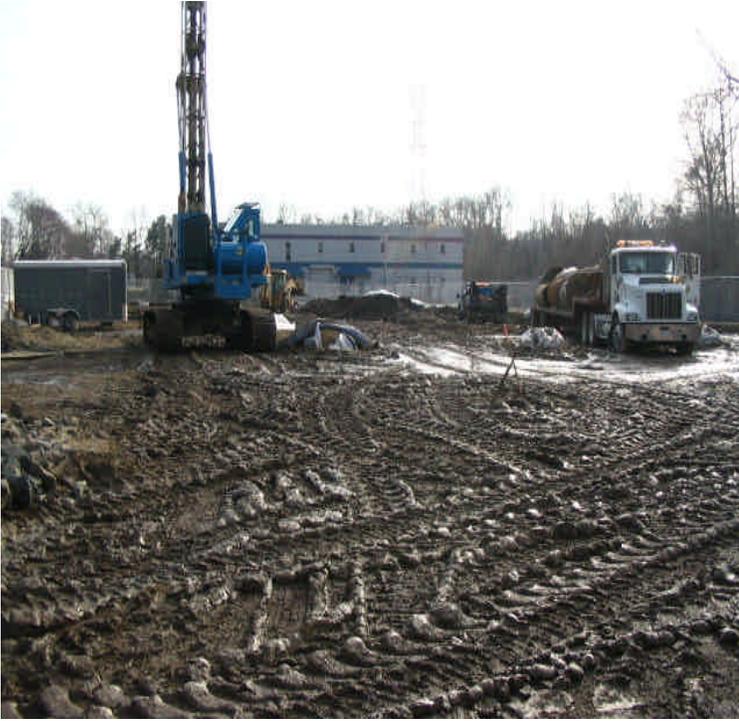
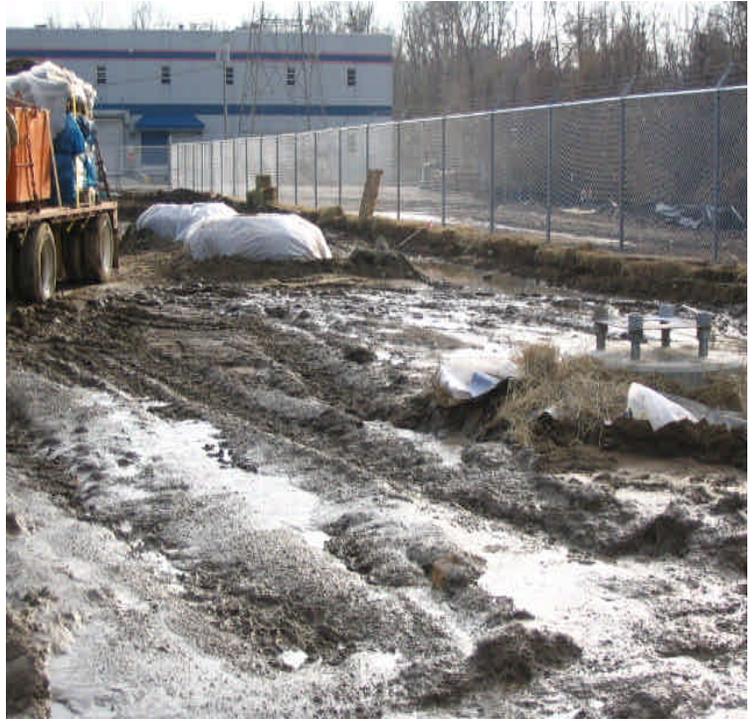
Norwalk Junction: Photo on the left shows an overview of the site. The stockpile in the background is to be removed from the site but the soil is too wet at this time. Photo on the right shows several foundations in place, covered in plastic. 2/2/06

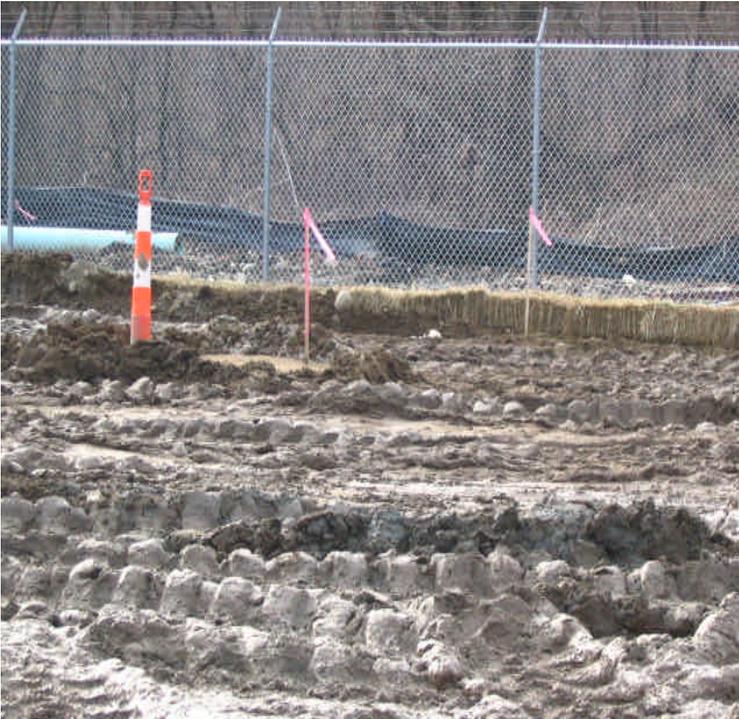
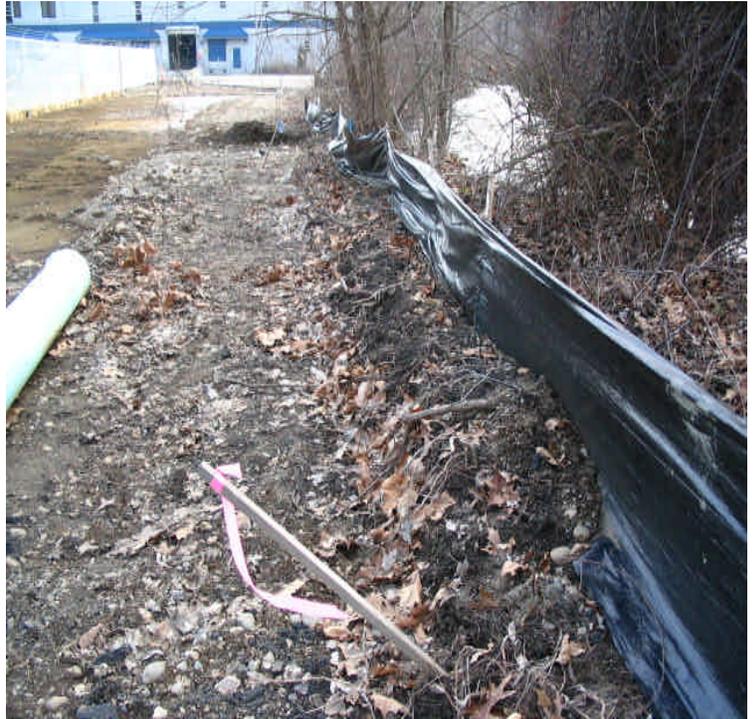
Photo on the left shows the haybale line, still working well to keep sediment on site. Photo on the right shows the silt fence adjacent to the river. Some areas are still not toed in but the haybales appear to keep site sediment from reaching this point. 2/2/06

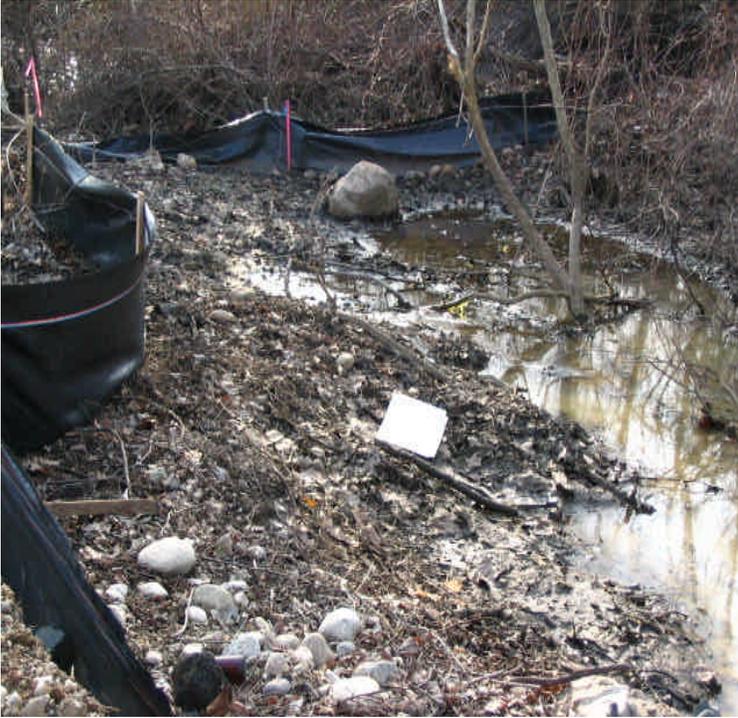
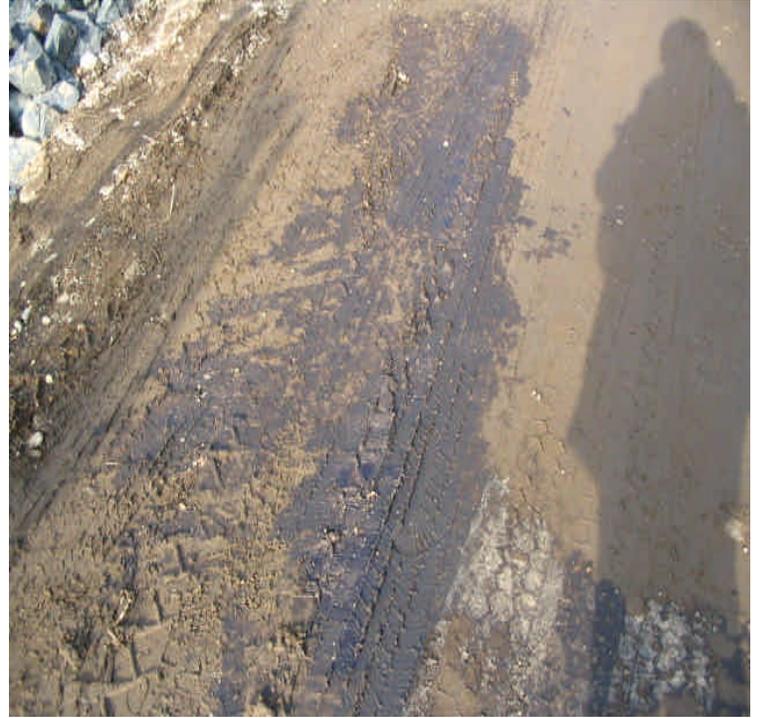
Photo on the left shows the pooled wetland area adjacent to the river and at the end of the swale on site. Water remains turbid indicating a need to stabilize surfaces around the swale. Photo on the right shows a spill of a resinous material which was being shoveled up and disposed of. 2/2/06

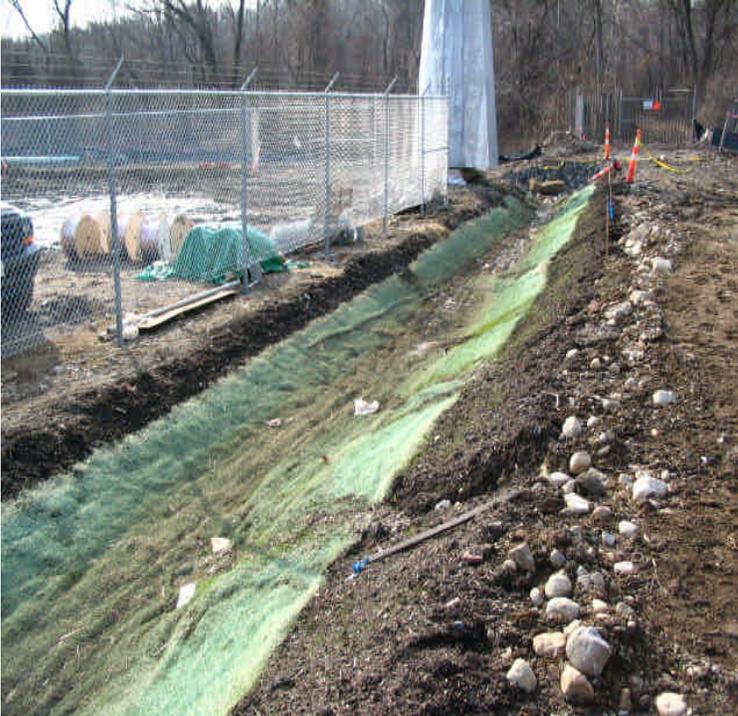
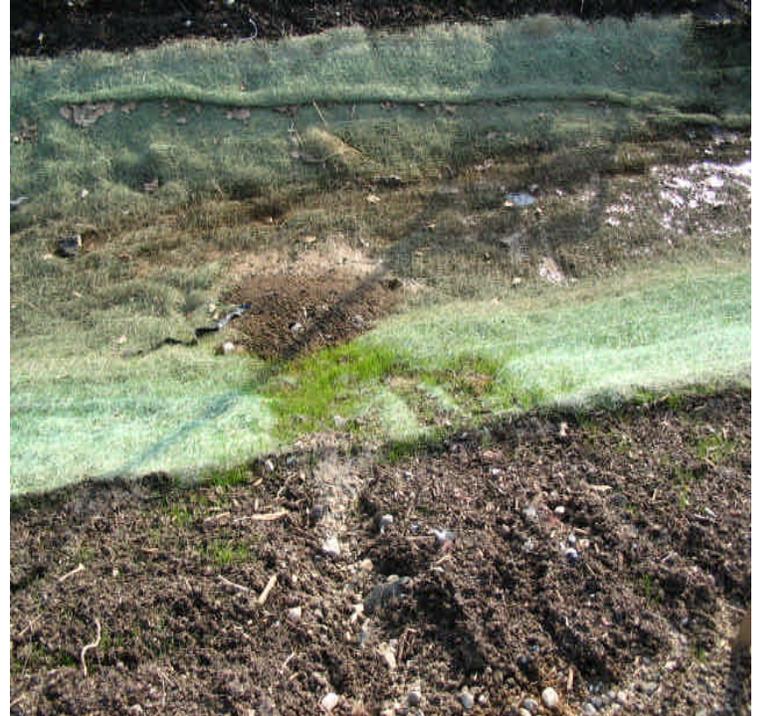
Photo on the left shows an overview of the swale with washouts remaining along the slopes. Surrounding surfaces should be stabilized where possible. Photo on the right shows new grass growth occurring at the swale as a result of the warmer weather. 2/2/06
