Docket No. 217 – Development and Management Plan Inspection

Northeast Utilities Service Company Certificate of Environmental Compatibility and Public Need for the construction of a 345-kV electric transmission line and reconstruction of an existing 115-kV electric transmission line between Connecticut Light and Power Company’s Plumtree Substation in Bethel, through the towns of Redding, Weston, and Wilton, and to the Norwalk Substation in Norwalk, Connecticut.

Date: February 16, 2006

Location: Transition Stations: Hoyts Hill, Archers Lane, Norwalk Junction

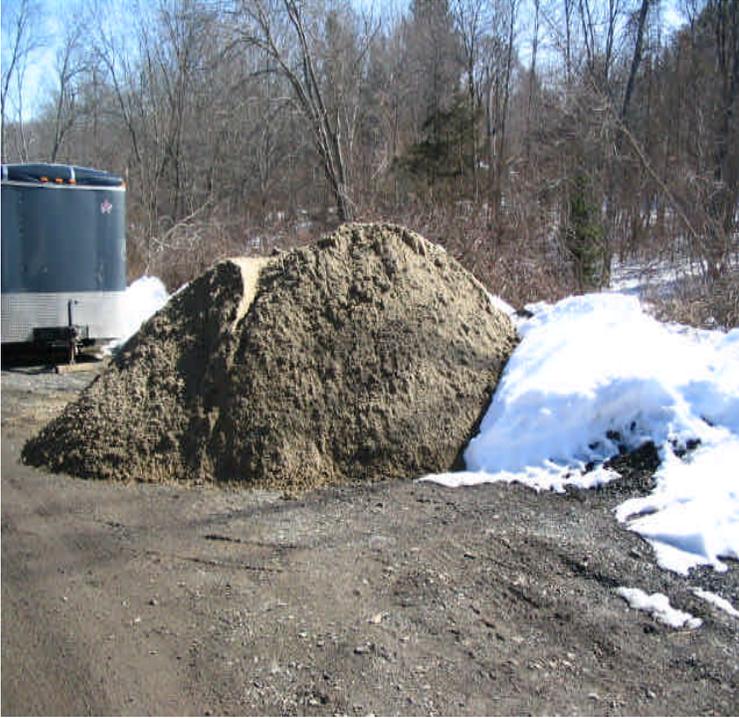
Hoyts Hill Transition Station: Photo on the left shows a stockpile of sand for mixing concrete placed across Rt. 58 from the station. Silt fence should be installed at the base to prevent sedimentation. Photo on the right shows where sediment continues to accumulate beyond the silt fence. Haybales should be installed here and the fence should be fixed, especially as dewatering is scheduled. 2/16/06

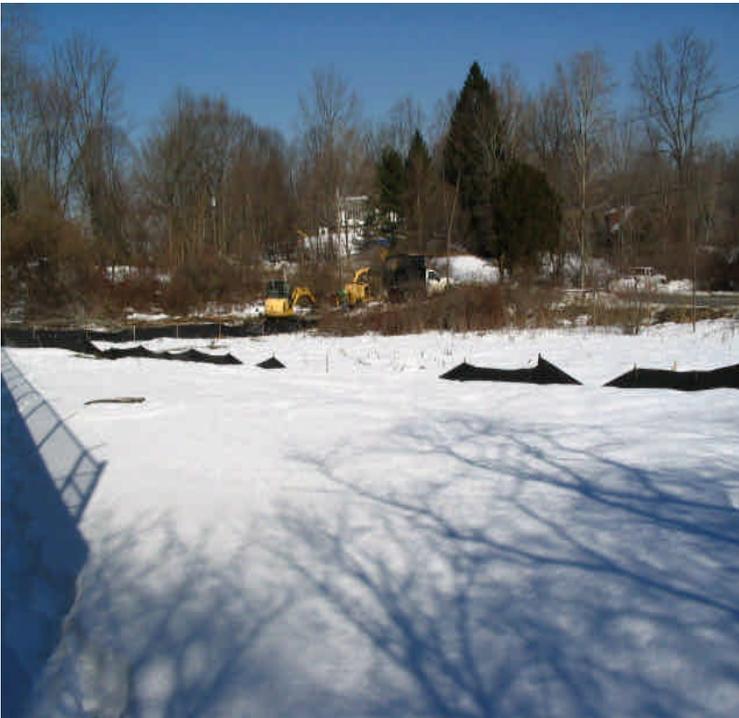
Photo on the left shows the perimeter silt fence where snow has pulled it down in some areas. The controls should be repaired. Photo on the right is a view of controls placed at the catch basin for future dewatering. 2/16/06.

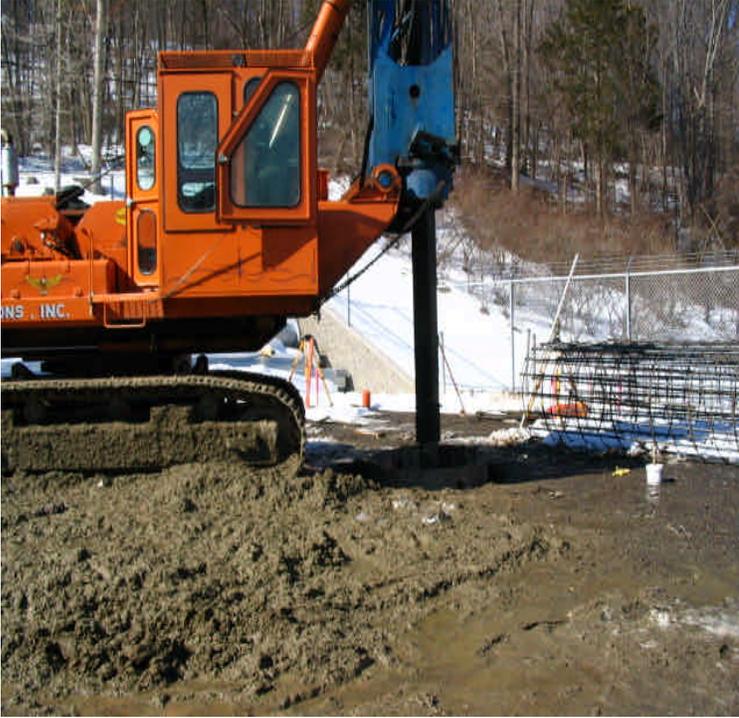
Photo on the left shows a view of the drilling/excavation for installing structures on the pad. Photo on the right shows a resulting stockpile which will eventually be removed appropriately from site. 2/16/06.

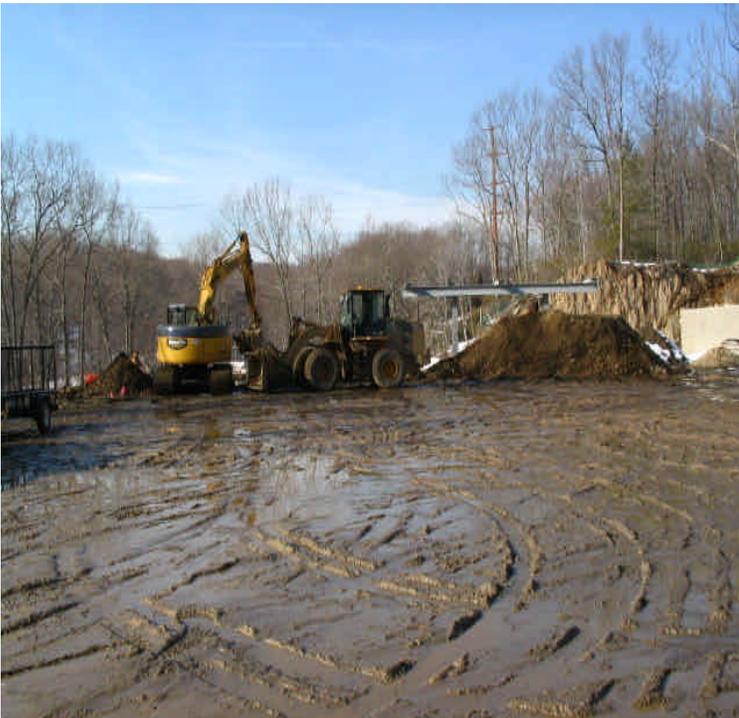
Archers Lane: Photo on the left looks towards the excavation as part of the 345kV work to install a vault in the station yard. Photo on the right shows the retaining walls, construction trailer and some of the structure work which has occurred. 2/16/06.

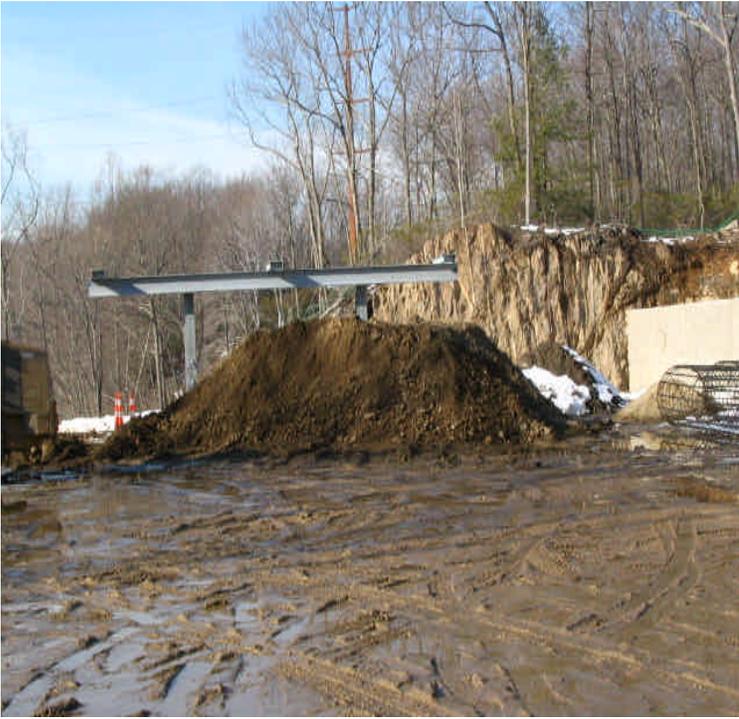
Photo on the left shows the stockpile resulting from the 345kV vault work with some of the installed structure work behind it.. Photo on the right shows where sediment continues to accumulate in the wetland adjacent to the access road. Sediment will need to be removed when and where feasible. 2/16/06.

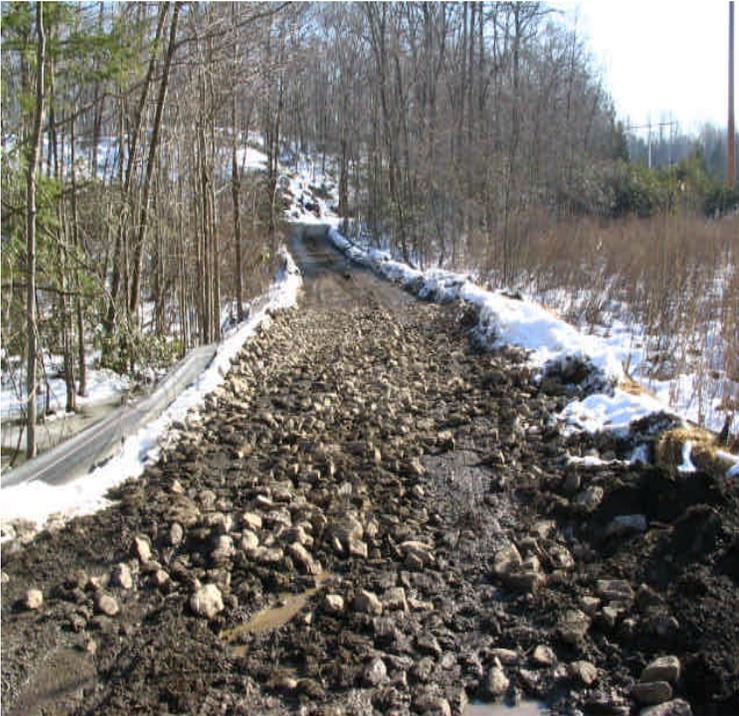
Photo on the left shows the access road within the ROW when snow plowing has created some sedimentation issues to the wetland. Water levels have increased following the snow but have not returned to the problem causing amounts previously seen. Photo on the right shows the increasing water levels in the 1st wetland along the ROW access road where sediment will need to be removed. 2/16/06

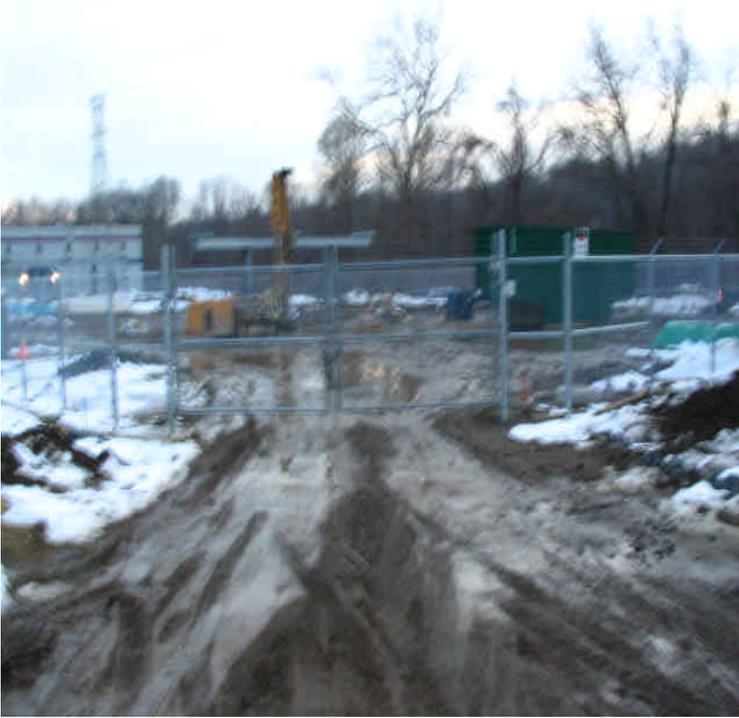
Norwalk Junction: Photo on the left shows an overview of the yard with some of the steel structure work underway. Photo on the right shows a view of sediment and snow plowed into the swale. This should be removed prior to snowmelt to avoid additional sediment inputs to the swale. 2/16/06

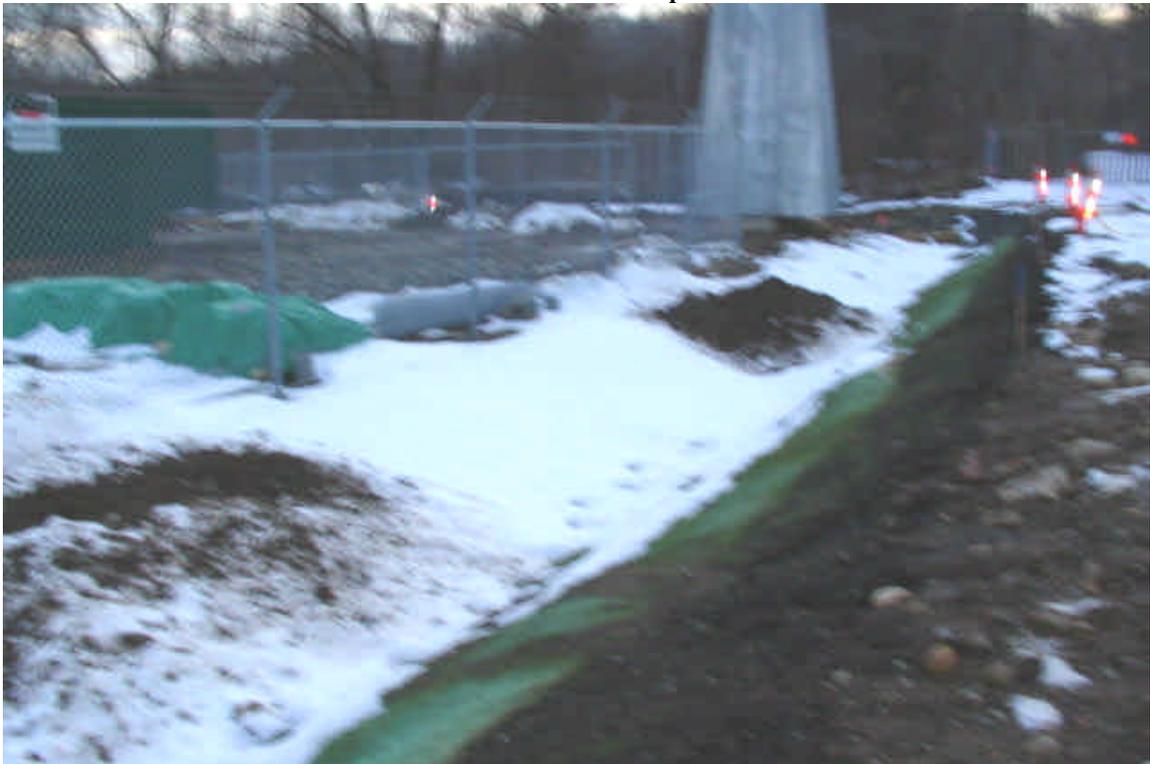
Photo shows an overview of the swale with several sediment/snow piles along the slope. This should be pulled back and care taken to keep sediment from stormwater run-off pathways the next time plowing is necessary. 2/16/06

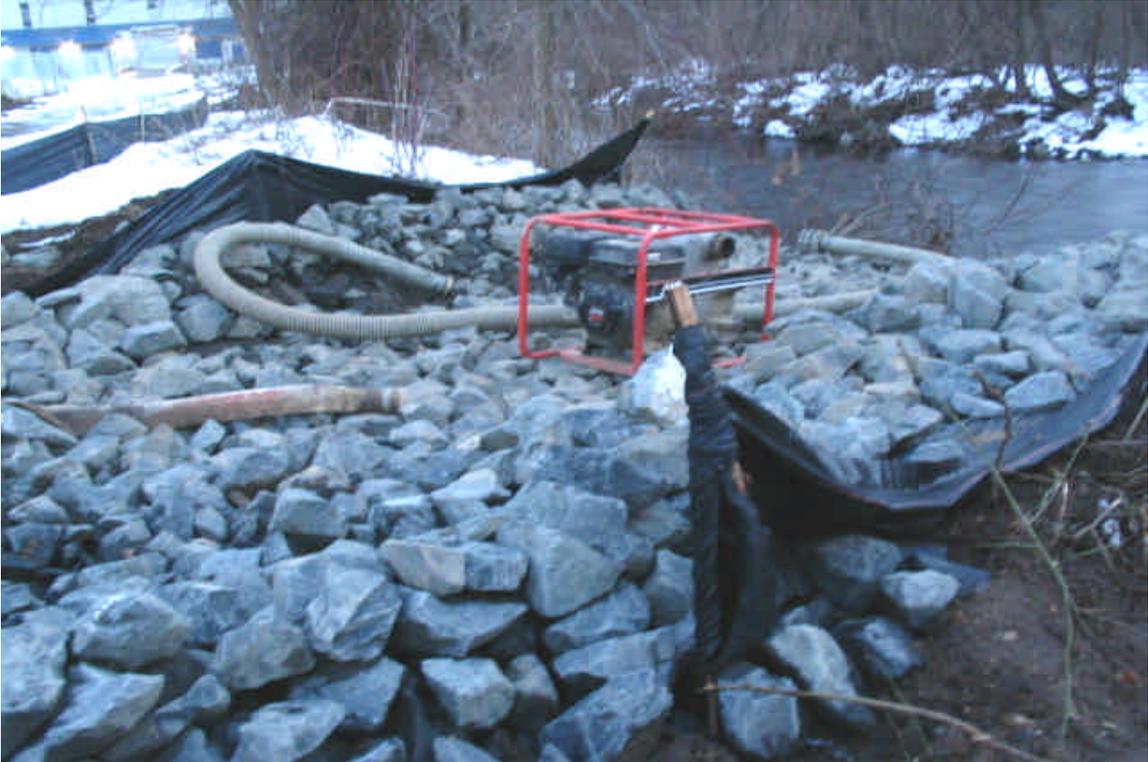
Photo shows the riprap swale built to the Norwalk River for dewatering well points within the station yard. Water is being directed to a frac tank where it can settle before it is pumped to the swale. Take care to let water run the length of the swale for further filtration and provide secondary containment for the pump. 2/16/06

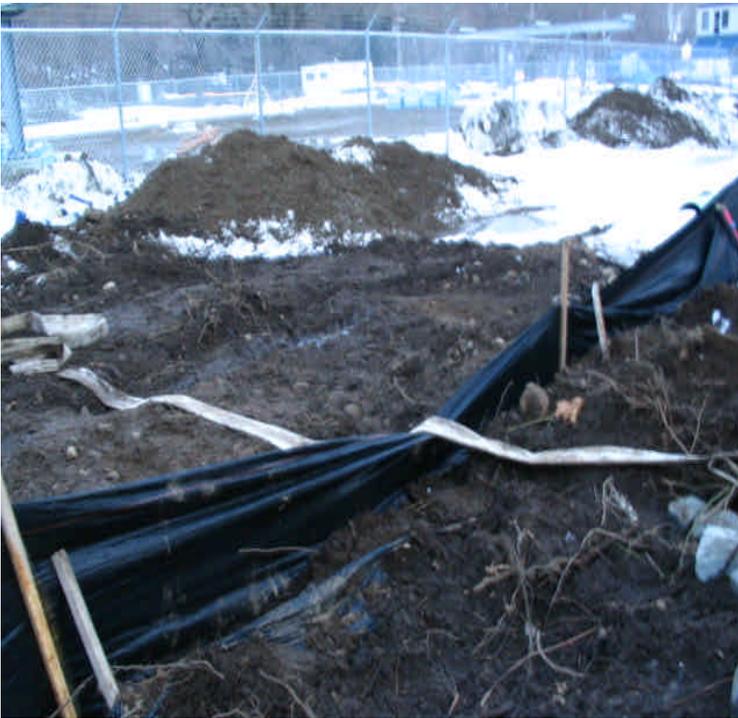
Photo on the left shows the perimeter of Norwalk Junction. Since snow/sediment piles have been placed in the vicinity, make sure the silt fence is toed in. Consider using haybales or stakes to support the dewatering hose and keep it from pulling down the fence. Photo on the right shows the pooled area at the end of the swale. 2/16/06
