Docket No. 217 – Development and Management Plan Inspection

Northeast Utilities Service Company Certificate of Environmental Compatibility and Public Need for the construction of a 345-kV electric transmission line and reconstruction of an existing 115-kV electric transmission line between Connecticut Light and Power Company's Plumtree Substation in Bethel, through the towns of Redding, Weston, and Wilton, and to the Norwalk Substation in Norwalk, Connecticut.

Date: February 22 and 23, 2006

Location: Transition Stations: Hoyts Hill, Archers Lane, Norwalk Junction

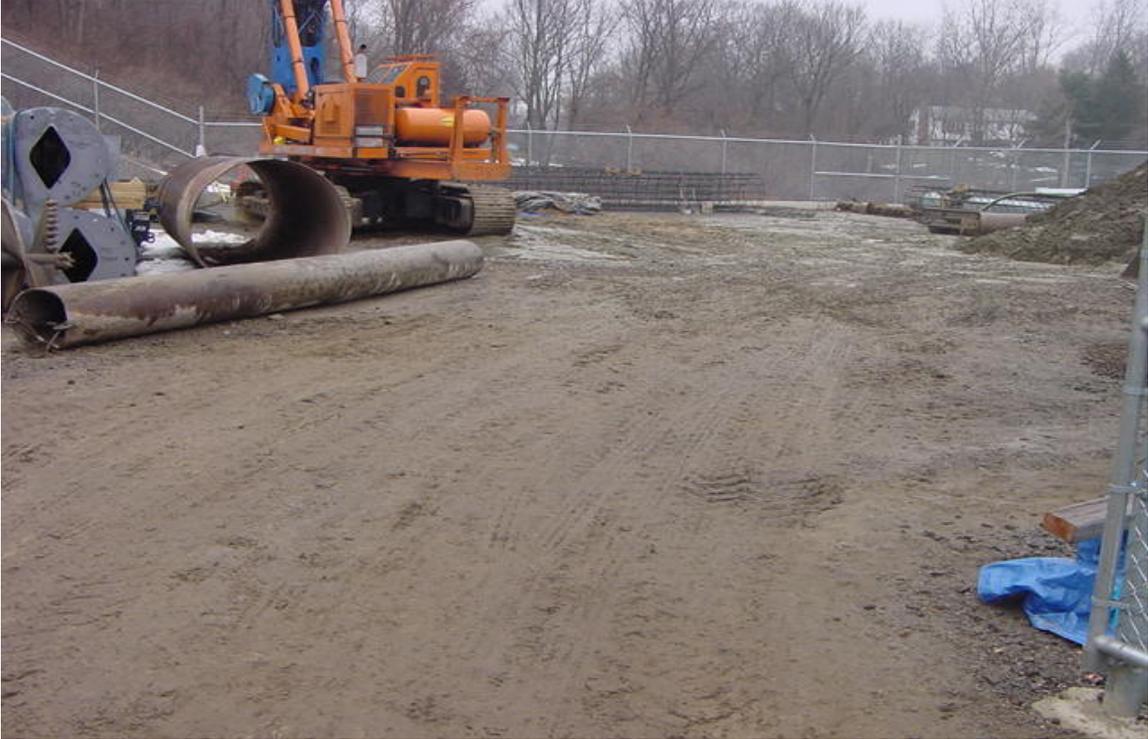
Hoyts Hill Transition Station: Photo shows an overview of the station pad where a caisson is being drilled. 2/22/06

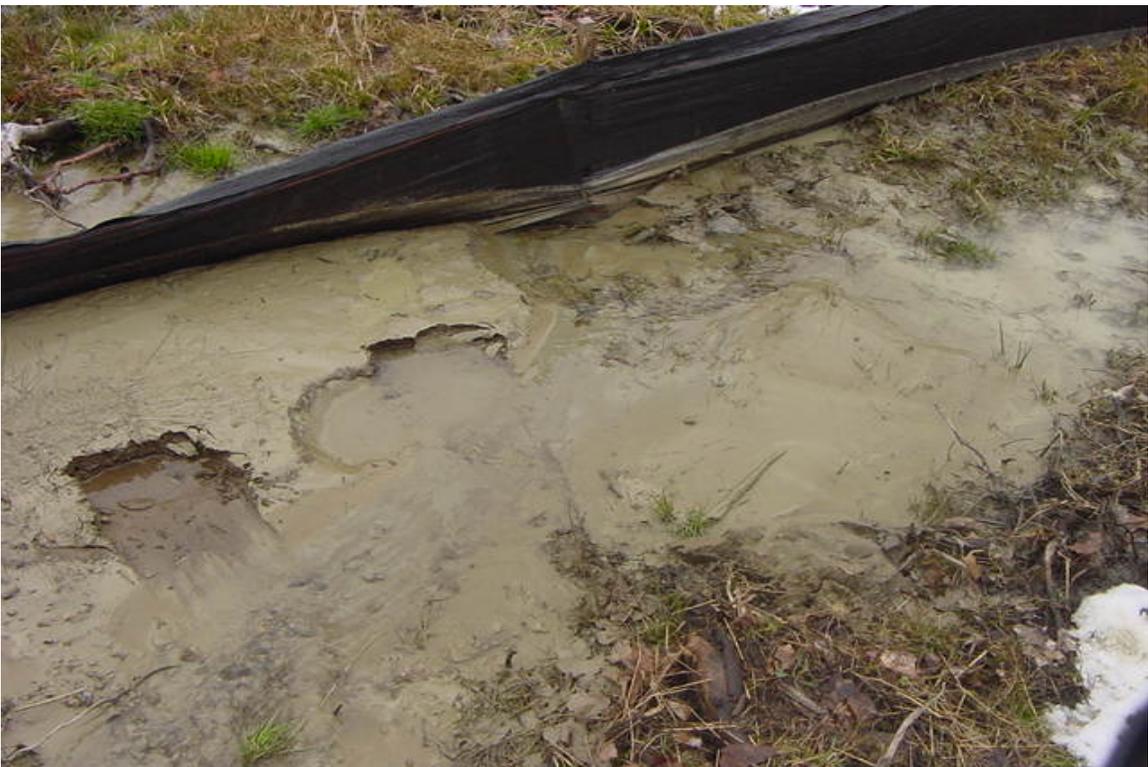
View shows the spot in the silt fence where sediment from the gullies had previously been washing under the silt fence. This increased sediment is from the dewatering operation. Contractors were asked to have toed this area in and install haybales prior to the dewatering. This should be done ASAP and sediment needs to be pulled back 2/22/06.

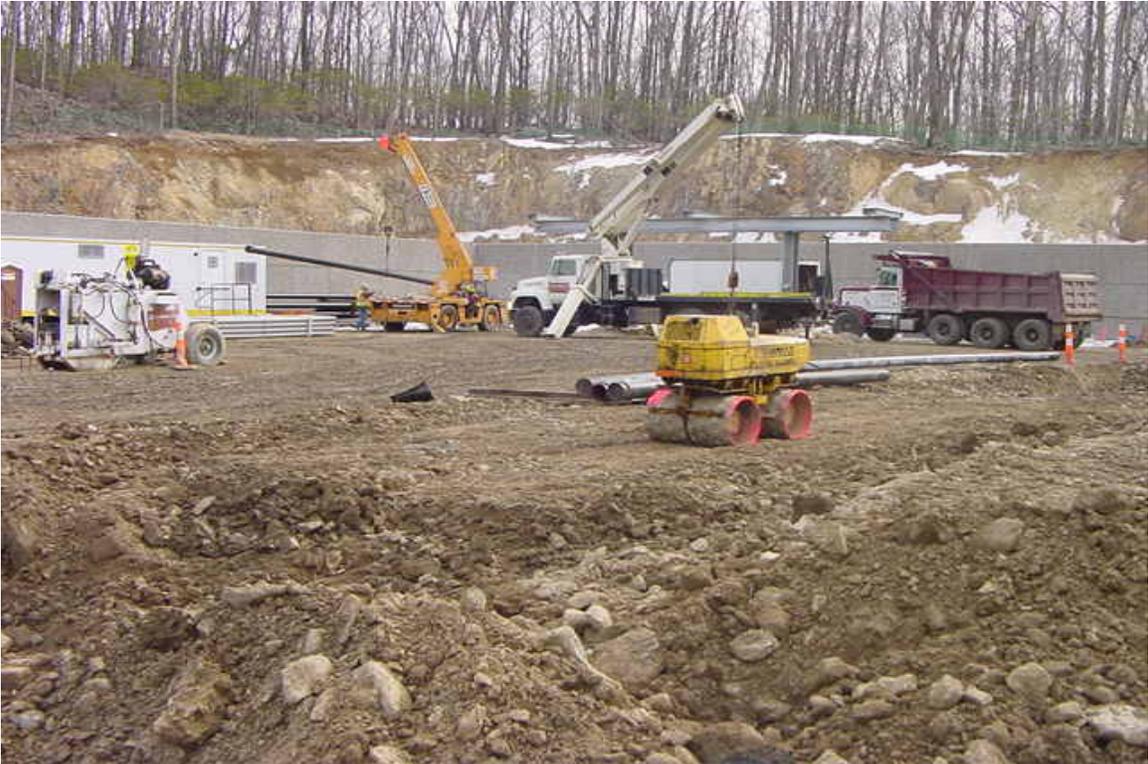
Archers Lane: Photo shows an overview of the station pad following installation of the 345kV vault. 2/22/06.

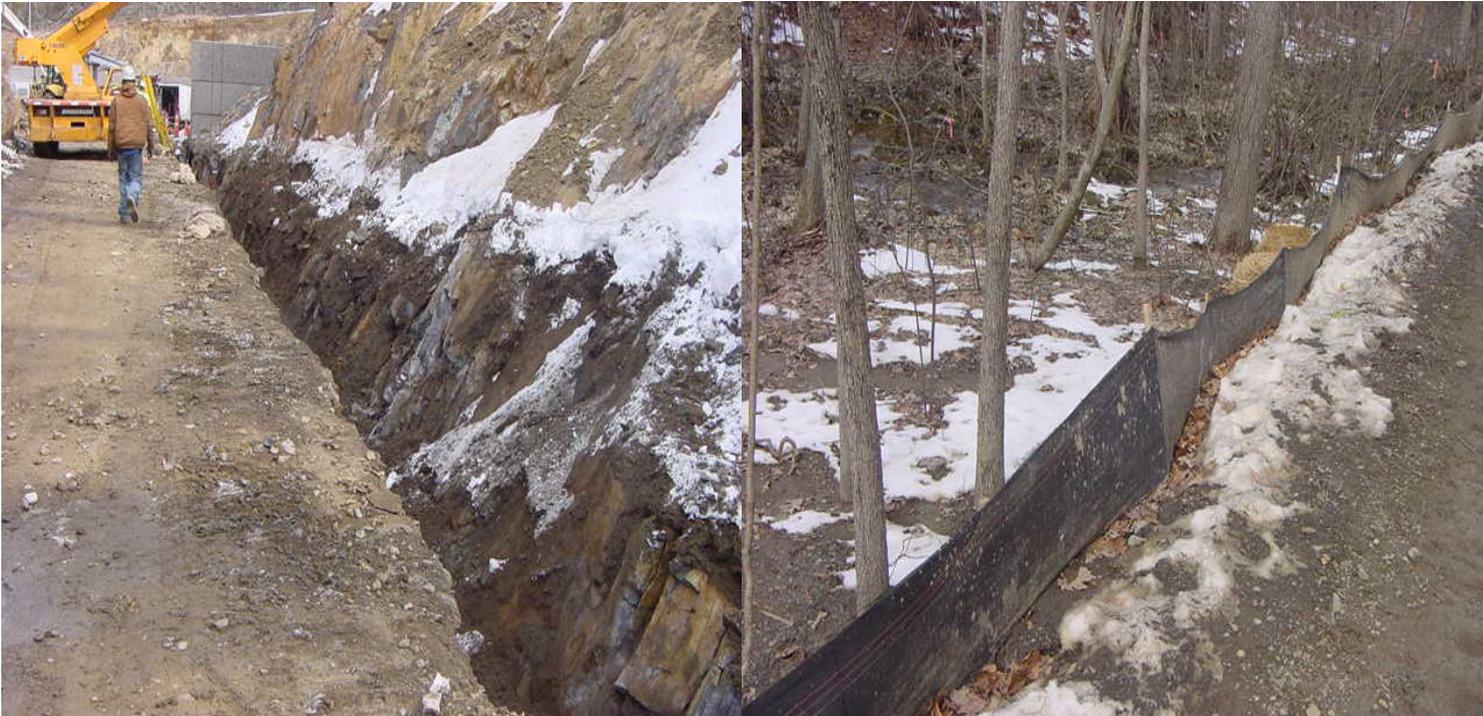
Photo on the left is a view of the trenching being performed along the access road into the pad as part of the 345kV work. Photo on the right shows the 1st wetland crossing adjacent to the access road towards the ROW. Previous sedimentation will need to be removed from here when feasible. 2/22/06.

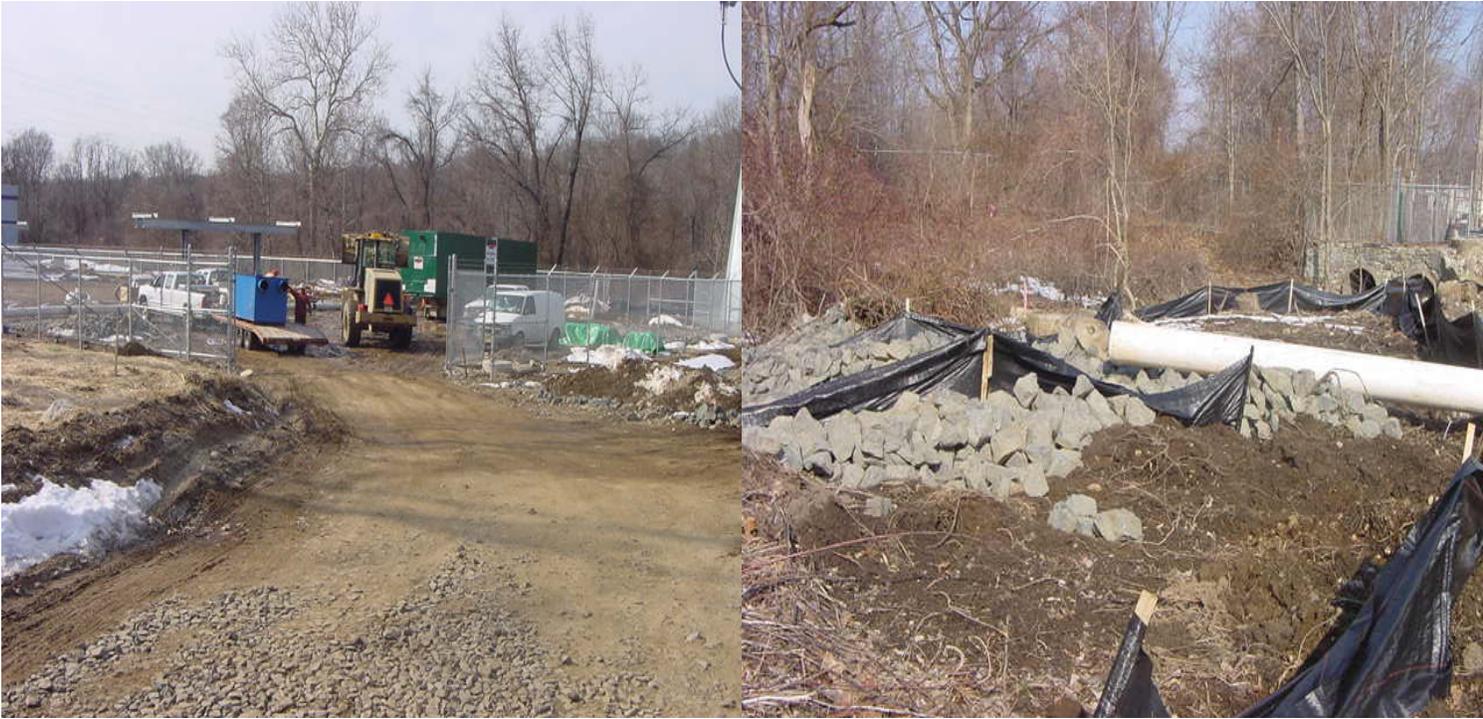
Norwalk Junction: Photo on the left shows an overview of the station pad from the access drive. Photo on the right shows where the outlet pipe from the well points on site dewaterers to the riprap swale at the river. 2/22/06.

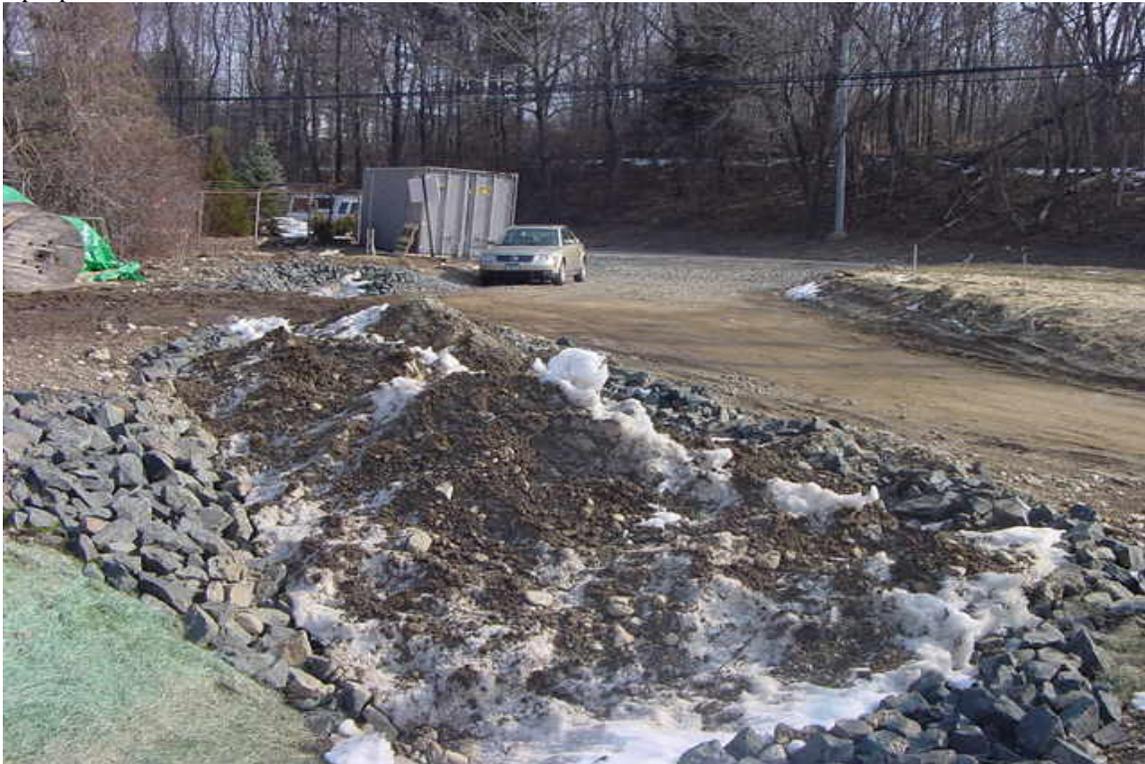
Photo shows the sediment covered snow piles which remain in the swales since last week's storm. The snow piles still need to be pulled back to remove the potential for increased sedimentation to swale. The snow is also blocking the flow from the culverts. 2/22/06
