**Docket No. 217 – Development and Management Plan Inspection**

Northeast Utilities Service Company Certificate of Environmental Compatibility and Public Need for the construction of a 345-kV electric transmission line and reconstruction of an existing 115-kV electric transmission line between Connecticut Light and Power Company's Plumtree Substation in Bethel, through the towns of Redding, Weston, and Wilton, and to the Norwalk Substation in Norwalk, Connecticut.

**Date:** March 23-24, 2006

**Location:** Transition Stations: Hoyts Hill, Archers Lane, Norwalk Junction

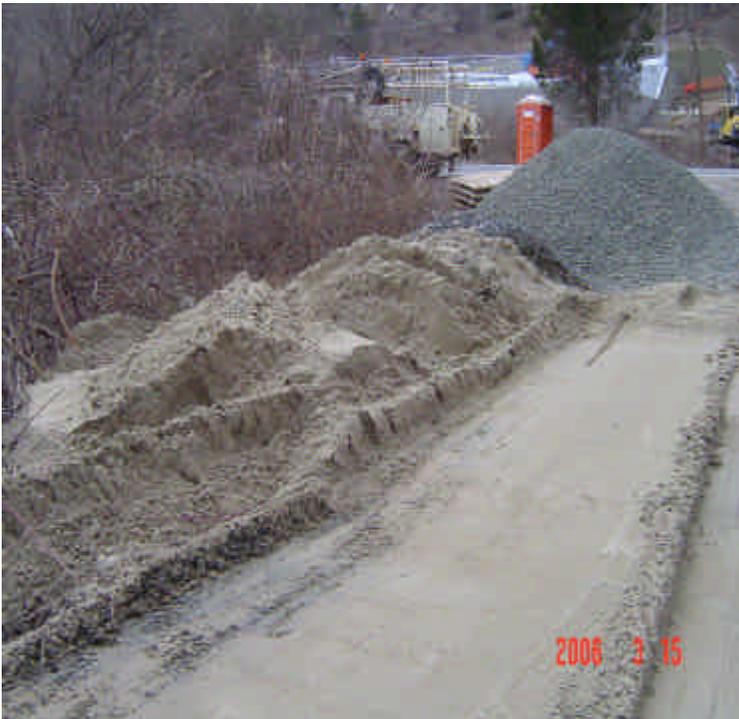
**Hoyts Hill Transition Station: Photo on the left shows a stockpile remaining across Rt 58 on the driveway. It should either be removed or controls installed. Photo on the right shows the area where silt/sediment leftover from transition station dewatering needs to continue to be removed. 3/24/06**

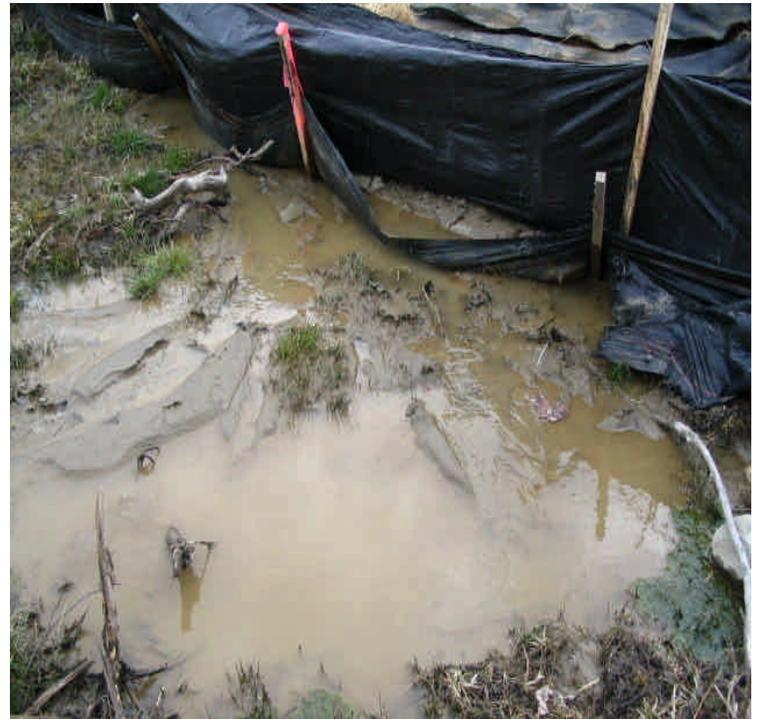
Areas of Inspection	Observation	Recommended Action	Corrected Actions
	<p>- Accumulated sediment remains at the fence and in the wetland as a result of previous dewatering from the station pad. 3/9-3/23/06</p>	<p>- Transition station contractors will need to continue to remove sediment as this is also exacerbating the current XLPE dewatering situation. 3/9-3/23/06.</p>	<p>-Some efforts had been made to remove the sediment. Continue to do so. 3/9-3/23/06</p>
<p>Erosion and Sediment Controls continued</p>	<p>- It appears the erosive gullies on the northern slope of the station were filled in and repaired. 3/23/06.                      -The southern gully and less severe erosion along the face of the southern silt fence still needs attention. 1/26-3/23/06.                       - A sand pile for mixing concrete was being stored in the driveway across from Rt. 58. 2/16-3/23/06.</p>	<p>-Continue to monitor the northern slope as it does not appear the outlet pad was changed. 3/2-3/23/06.                      -Plan to repair/stabilize the southern slope as well. 3/23/06                       - Either install silt fence at the stockpile due to its proximity to wetlands or remove it all together. 2/16-3/23/06</p>	<p>- The northern gully was filled-in / regraded..</p>

<p>Inland Wetland and Watercourse encroachment and mitigation</p>	<ul style="list-style-type: none"> <li>- <b>Hoyts Hill:</b> Not all of the previously accumulated silt was removed from the wetland yet. 3/9-3/23/06.</li> <li>- This was exacerbating the turbidity noted as part of the XLPE dewatering.</li> </ul>	<ul style="list-style-type: none"> <li>-Contractors had removed some but need to return to complete the job. 3/23/06.</li> <li>- See 34kV XLPE report for more details. 3/23/06</li> </ul>	<p>- Efforts need to continue. 3/23/06</p>

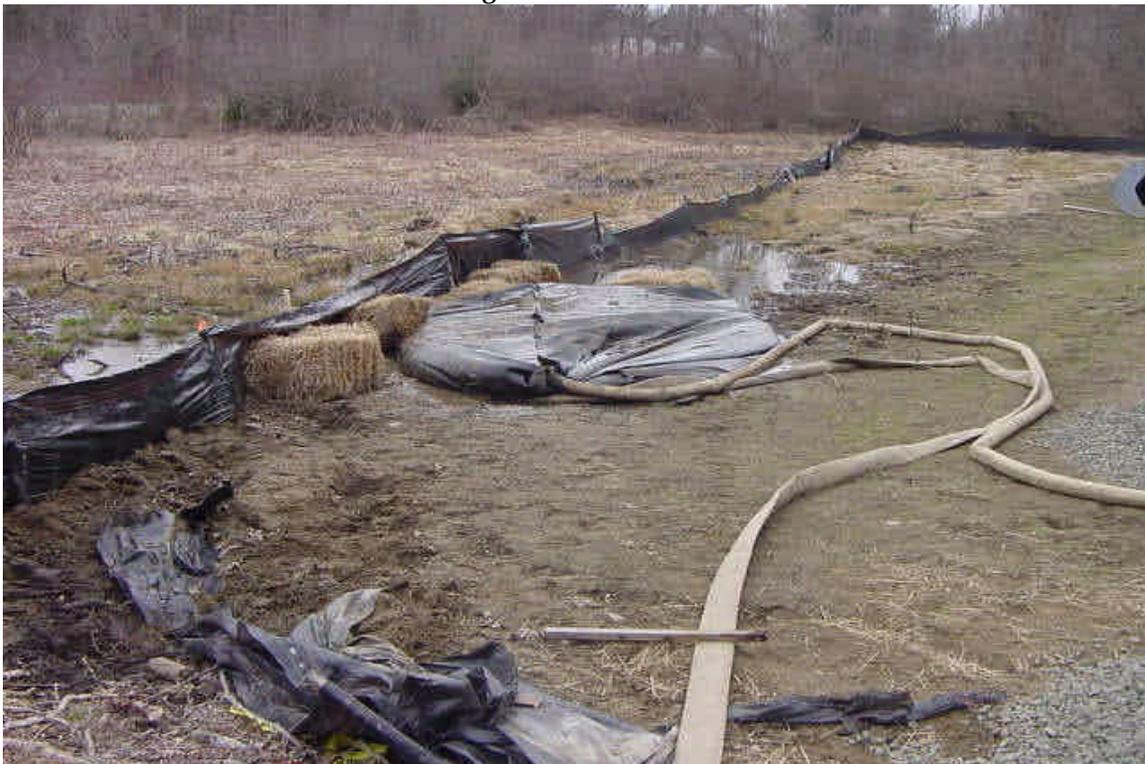
Erosion and Sediment Controls	<p>-<b>Hoyts Hill</b>: The perimeter silt fence along the wetlands at the rear of the station is still toed in but wear and tear is visible. 3/23/06 Although XLPE crews attempted to patch the fence, turbid water from their operation is still getting through. 3/23/06.</p>	<p>-The fence should be maintained as necessary. 345kV XLPE crews are only responsible for the portions of controls they are utilizing. 3/23/06</p>	<p>- A silt fence patch was attempted but still needs more attention.</p>

**Photo shows an overview of the perimeter fence and the controls installed for 345kV XLPE dewatering on site. 3/24/06.**

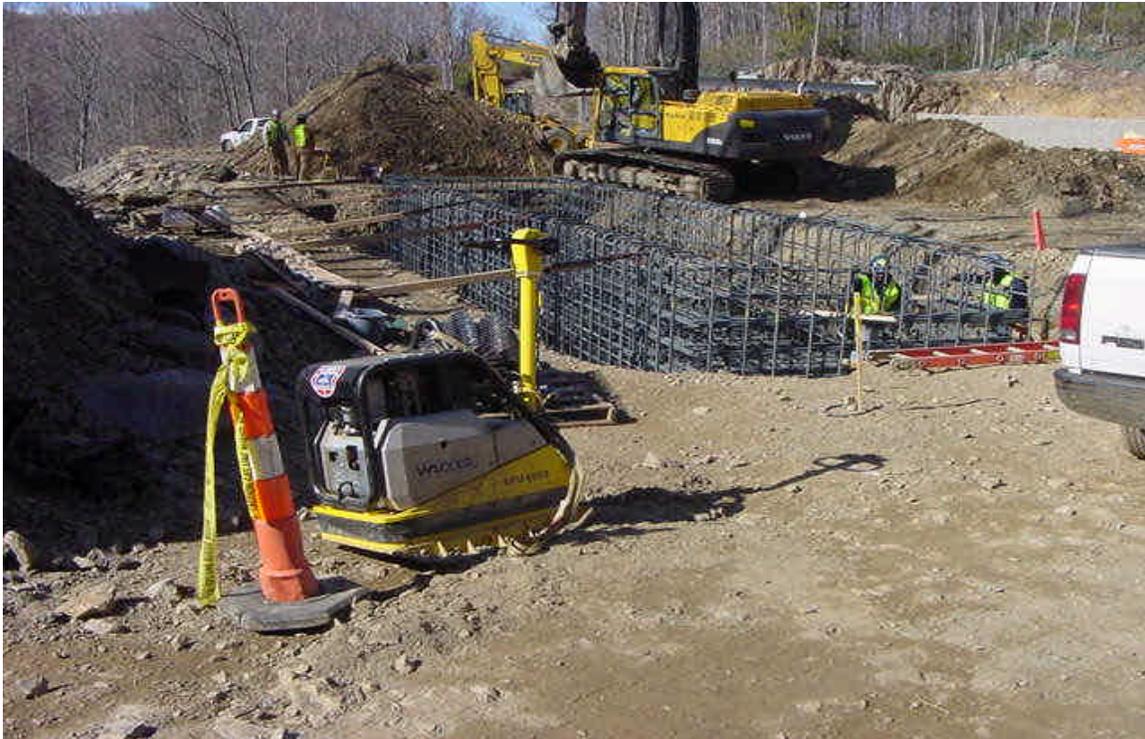
Archers Lane Transition Station: Photo shows an overview of the work continuing within the station pad. 3/23/06.

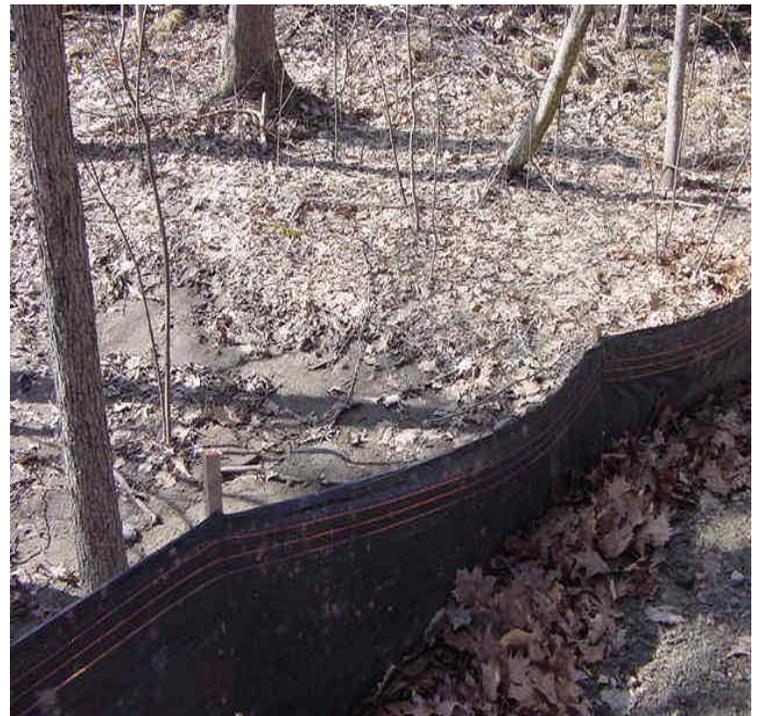
Areas of Inspection	Observation	Recommended Action	Corrected Actions
	<p>- <b>Archers Lane:</b>            Sedimentation in the 1<sup>st</sup> wetland crossing to varying degrees from a fine layer over the leaf litter to several inches of accumulation. 1/26-3/23/06.</p> <p>- Water levels have remained low for the most part. 3/23/06</p> <p>-Some materials were placed on the silt fence along the access drive. 3/23/06</p> <p>- <b>Norwalk Junction:</b>            Haybales remain along the perimeter fence on site as an additional control, but sections have been removed due to the placement of hoses. 3/8-3/23/06. Equipment movement is also damaging haybales.</p>	<p>- Any easily accessible deposits of sediment will need to be removed. Fine layers of silt can remain. 1/26-3/15/06.</p> <p>-Sediment should be removed prior to the growing season. 3/23/06</p> <p>-None at this time.</p> <p>- This may be 345kV crews responsibility to remove and restore fence. 3/23/06</p> <p>- The haybales appear to be working well for the most part, keeping mud and soil from the site from reaching the silt fence. 2/16-3/23/06</p> <p>Repair sections where needed. 3/23/06</p>

Photo on the left shows another view of the station pad. Photo on the right shows where accumulated sediment remains on the wetland side of the silt fence on the access drive to the ROW. Sediment will still need to be removed from a few areas here. 3/23/06

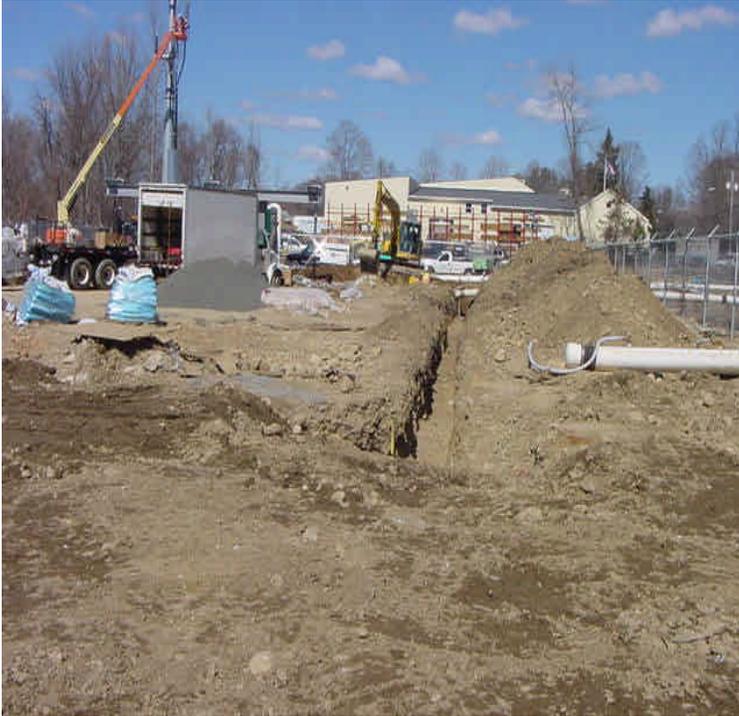
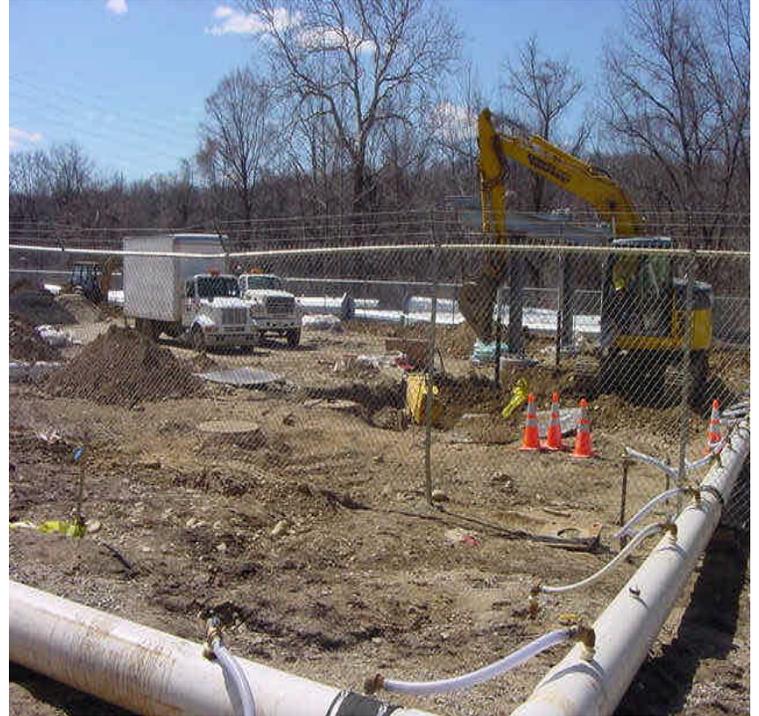
**Norwalk Junction: Both photos show an overall view of the station yard where excavation continues. All stockpiles and disturbed soil remains fairly well contained to the site. 3/23/06**

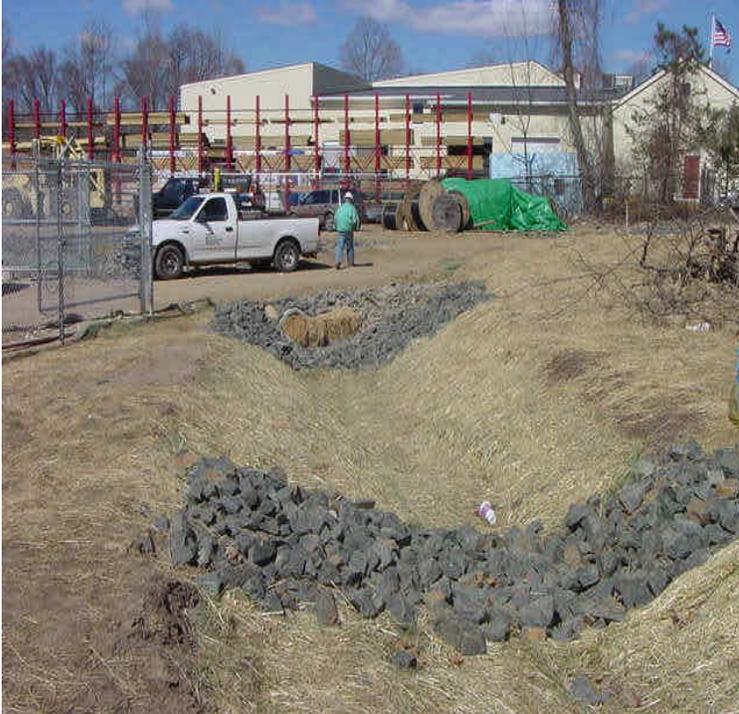
**Photo on the left shows a view of the upper swale which remains well restored. Photo on the right shows water from the well points leaving the outlet pipe to the swale where it will enter the Norwalk River. The water is crystal clear at this time. 3/23/06.**
