Docket No. 217 – Development and Management Plan Inspection

Northeast Utilities Service Company Certificate of Environmental Compatibility and Public Need for the construction of a 345-kV electric transmission line and reconstruction of an existing 115-kV electric transmission line between Connecticut Light and Power Company's Plumtree Substation in Bethel, through the towns of Redding, Weston, and Wilton, and to the Norwalk Substation in Norwalk, Connecticut.

Date: April 12, 2006

Location: Transition Stations: Hoyts Hill, Archers Lane, Norwalk Junction

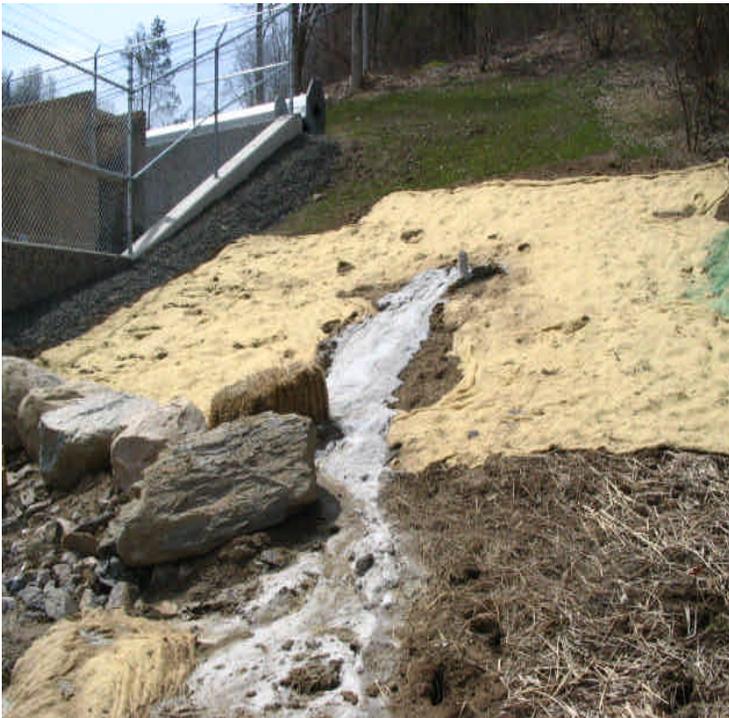
Hoyts Hill Transition Station: Photo on the left shows the erosion control mats installed on the northern slope with an area of grout. Photo on the right shows a view of the dewatering and perimeter controls well in place. These areas are considered jurisdictional to 345kV XLPE work. 4/12/06

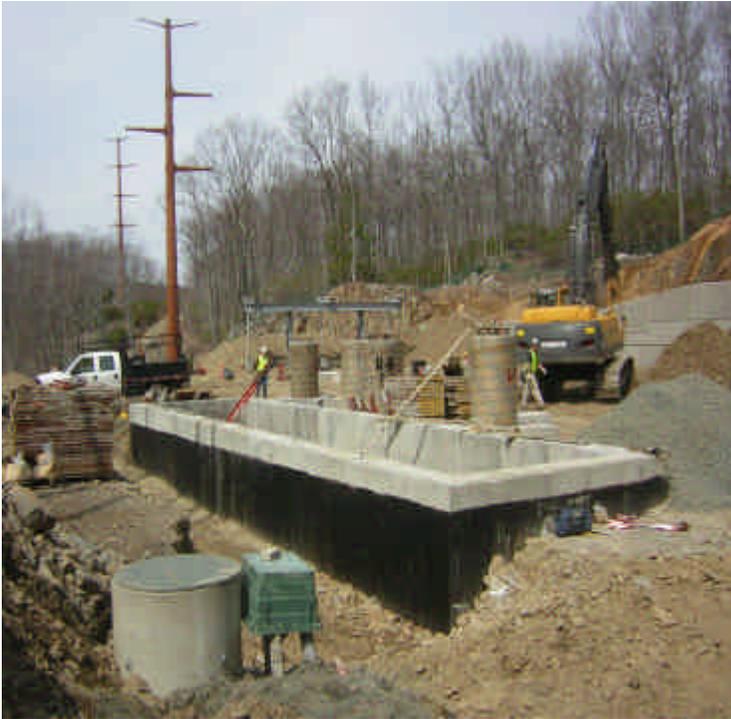
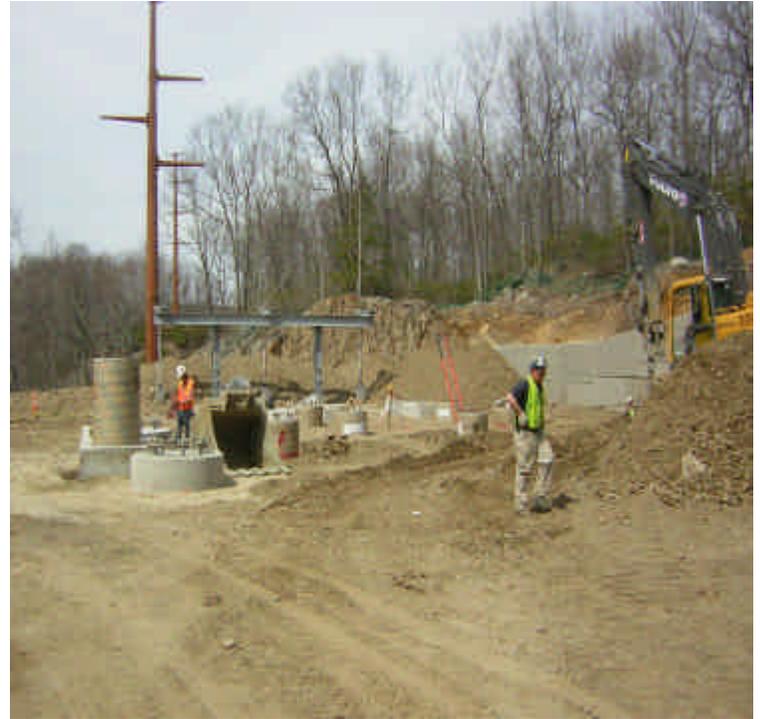
Archers Lane: Both photos show views of the foundation work continuing at the station pad. 4/12/06.

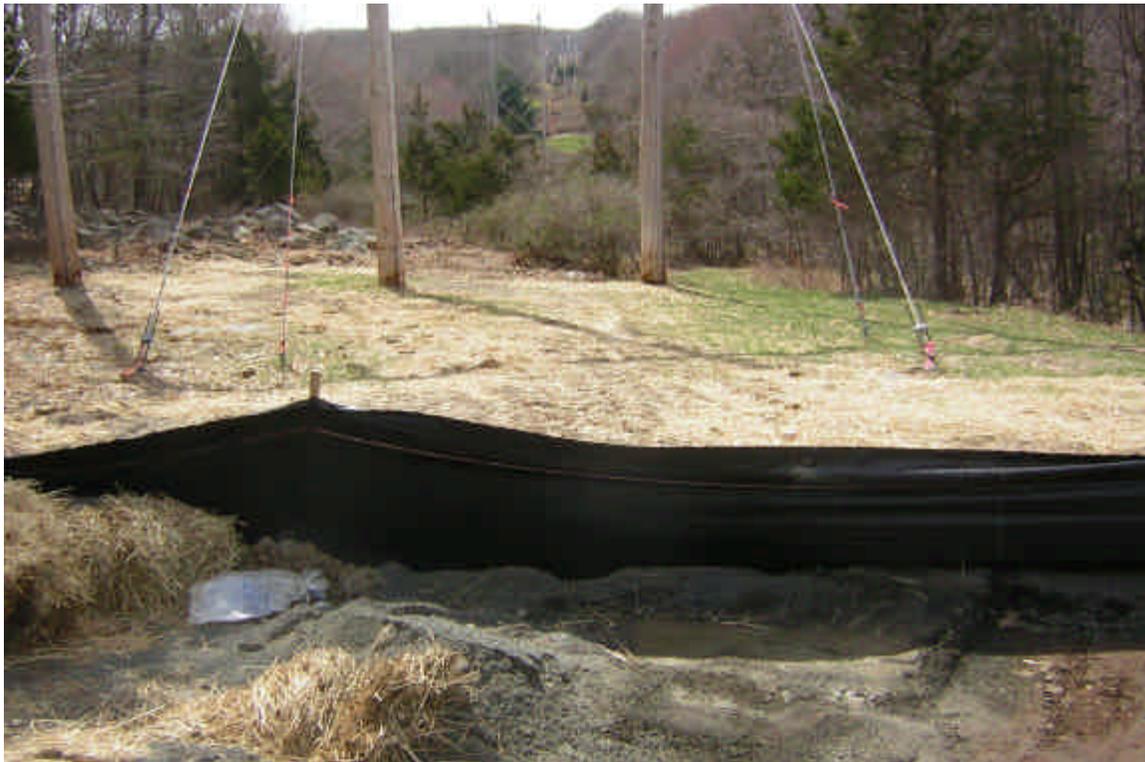
Photo shows the restored area located at the top of slope, adjacent to the access road into the transition station. Hay mulch has been applied and the area is beginning to re-vegetate. Silt fence remains intact. 4/12/06.

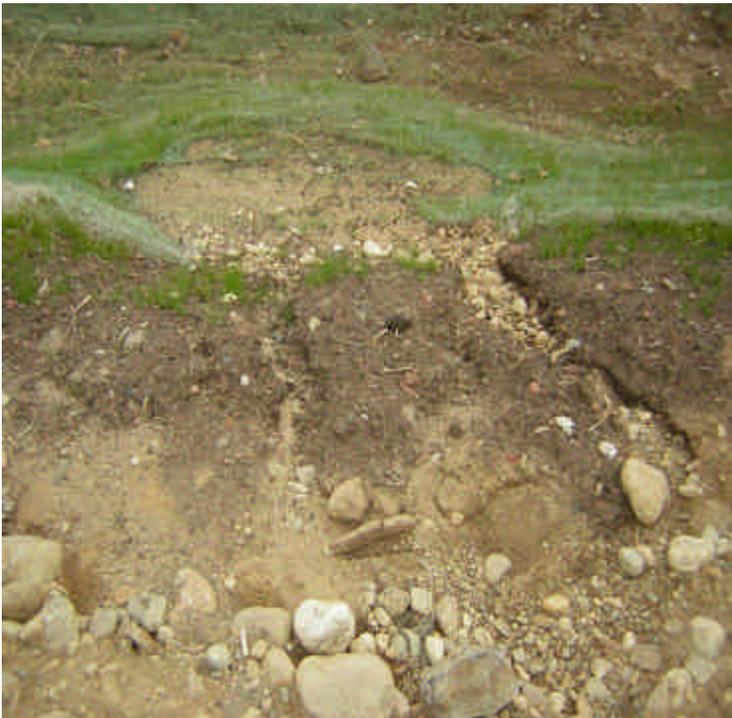
Areas of Inspection	Observation	Recommended Action	Corrected Actions
<p>Erosion and Sediment Controls continued</p>	<p>- Soil has slumped/washed out in several spots in the lower drainage swale due to site run-off, resulting in further sedimentation to the swale. 12/30-4/12/06. Haybales remained in the inlets. 2/2-4/12/06.</p> <p>-A large soil stockpile was placed directly adjacent to the lower swale and was not protected with erosion controls. Contractors were made aware of the problem and were going take immediate action. 4/12/06.</p> <p>-The riprap swale to the Norwalk River had been removed and dewatering activities had ceased. The outlet area appears to have been restored 4/12/06.</p>	<p>- The erosion control matting on the swale likely needs to be extended up and over the top of slope to prevent further erosion until the growing season. 12/30-4/12/06.</p> <p>-Install erosion controls around the stockpile at the perimeter fence, adjacent to the swale. 4/12/06.</p> <p>- Monitor this area for re-vegetation and erosion. Maintain erosion controls until stabilized. 4/12/06.</p>	<p>-The riprap swale had been removed and the outlet area restored. 4/12/06.</p>

Norwalk Junction: Photo on the left shows the erosive gullies on the slopes of the lower swale. Photo on the right shows a view of the large stockpile placed adjacent to the swale. Erosion controls need to be installed here. 4/12/06.

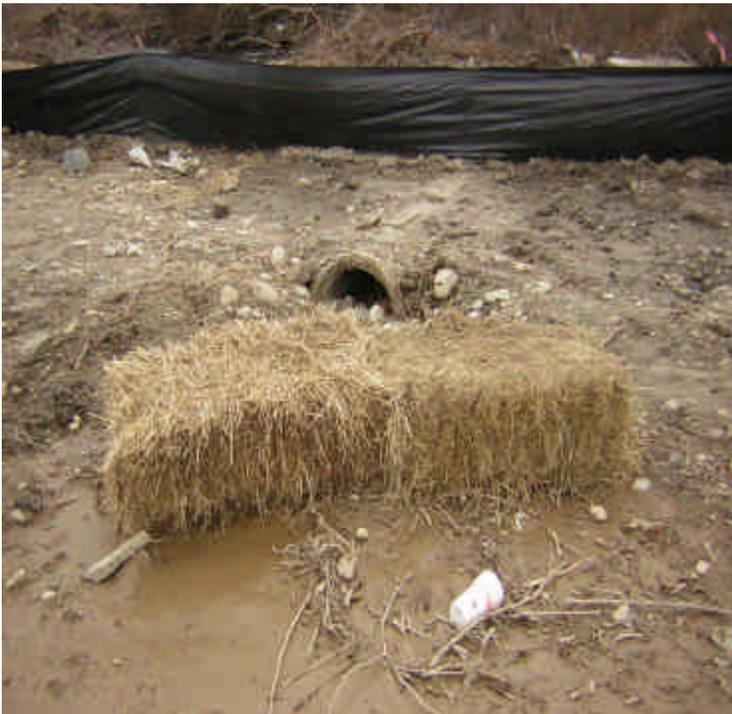
Areas of Inspection	Observation	Recommended Action	Corrected Actions
	<p>-The old culvert near the silt fence and the river was observed. It still shows evidence of occasional flow, including sediment from the disturbed soil at the site. 3/15-4/12/06.</p> <p>-Haybales were placed near the inlet but sediment remains in and around the culvert. 4/12/06.</p> <p>-The wetland area outside the silt fence adjacent to the river shows some accumulated sediment 3/8-4/12/06.</p> <p>- Silt fence should be maintained in this location. 4/12/06.</p> <p>- Sediment from previously plowed snow piles remained directly in and along the swale. This introduces more potential for turbidity. 2/16-4/12/06.</p>	<p>- The culvert needs to have haybales installed closer to the inlet if it is going to remain in place. Otherwise it should be removed/or the connection cut, completely 4/12/06.</p> <p>- This area receives direct runoff from the site through the swale making water quality important. The adjacent site is disturbed resulting in this turbidity. 1/19-4/12/06.</p> <p>- Snow has melted but sediment could be removed from the swale. 3/8-4/12/06.</p>	<p>-Haybales were installed at the culvert as an attempt to decrease sedimentation. Haybales should be placed closer to the inlet.</p>

Photo on the left shows the haybales that were placed in front of the old culvert as requested. Sediment remains in and around the culvert. Photo on the right shows a section of the perimeter haybales that are in need of repair. 4/12/06.
