**Docket No. 217 – Development and Management Plan Inspection**

Northeast Utilities Service Company Certificate of Environmental Compatibility and Public Need for the construction of a 345-kV electric transmission line and reconstruction of an existing 115-kV electric transmission line between Connecticut Light and Power Company's Plumtree Substation in Bethel, through the towns of Redding, Weston, and Wilton, and to the Norwalk Substation in Norwalk, Connecticut.

**Date:** May 4, 2006

**Location:** Transition Stations: Hoyts Hill, Archers Lane, Norwalk Junction

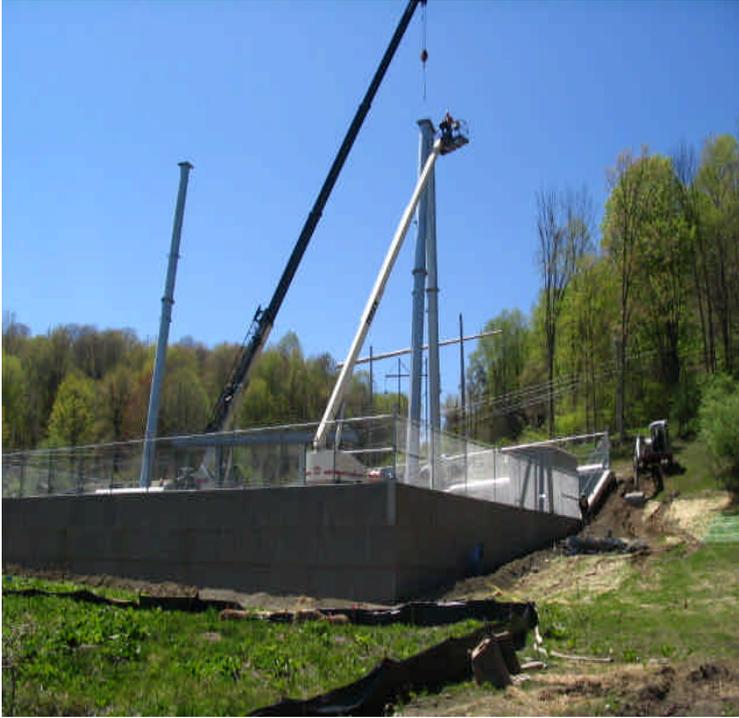
**Hoyts Hill Transition Station: Photo on the left shows the transition station pad where active work had returned to set structures. Photo on the right shows where grounding work disturbed the EC blanket on the slope. Contractors will restore the mat when work is complete. 5/4/06**

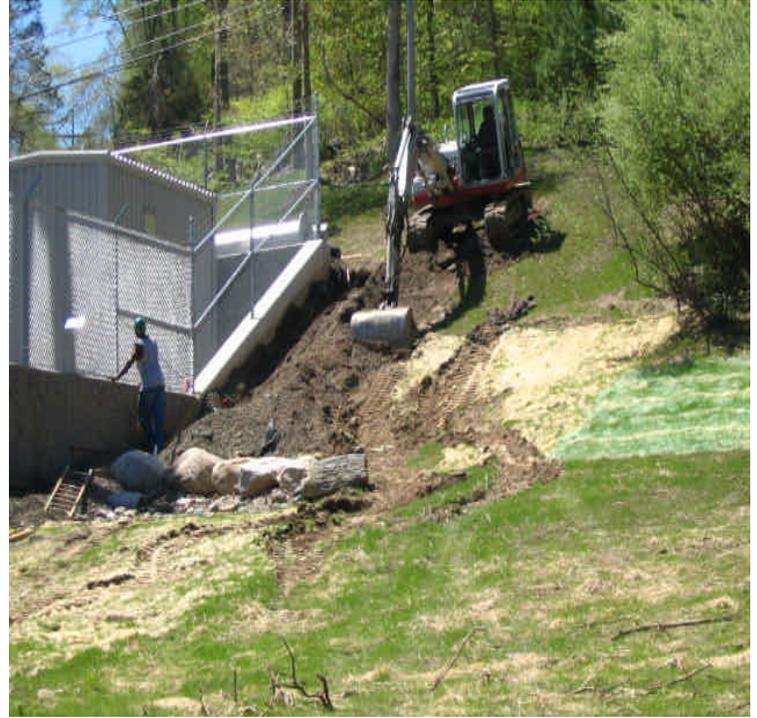
Areas of Inspection	Observation	Recommended Action	Corrected Actions
Erosion and Sediment Controls	<p><b>-Hoyts Hill:</b> The perimeter silt fence along the wetlands at the rear of the station remains in good shape. 4/6-5/4/06.</p> <p>- The EC blankets along the northern slope were disturbed in one location due to the grounding work. 5/4/06.</p> <p>-The southern gully and less severe erosion along the face of the southern silt fence still needs attention. 1/26-5/4/06.</p> <p>- <b>Archers Lane:</b> Sediment removal efforts are still needed at the 1<sup>st</sup> wetland as accumulation increased with recent rains. 4/26-5/4/06.</p>	<p>-Monitor and maintain the fence as necessary. 4/6-5/4/06</p> <p>- The EC mats will be repaired when work is complete. The resulting stockpiles are contained. 5/4/06</p> <p>-Plan to repair/stabilize the southern slope as well and potentially extend the outlet. 1/26-5/4/06.</p> <p>-Any easily accessible deposits of sediment need to be removed. Fine layers of silt can remain. Controls also need to be cleaned up. 4/6-5/4/06</p>	<p>- N/A</p> <p>- Needs attention- Contractors will repair the mats.</p> <p>- Still needs attention</p> <p>- Still needs attention</p>

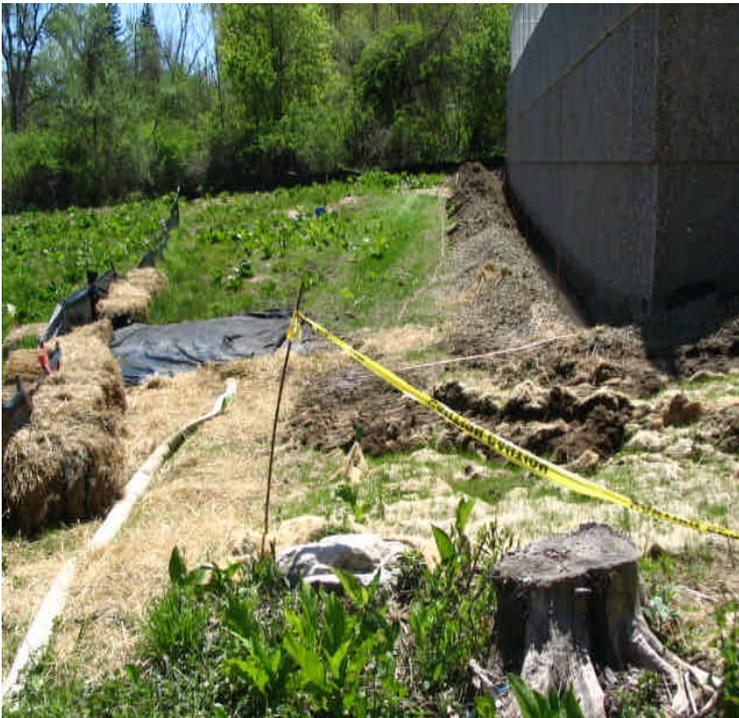
Areas of Inspection	Observation	Recommended Action	Corrected Actions
Foundation construction	<p>- At <b>Hoyts Hill</b>: A small area of 345kV XLPE excavation remains at the base of the slope. 5/4/06.</p> <p>- Contractors were excavating along the retaining wall for installing grounding grids. 5/4/06</p> <p>- Active work was occurring on the pad as structures were being installed. A small building was also in place. 5/4/06</p> <p>-At <b>Archers Lane</b>, foundation work continues within the station pad. 3/29-5/4/06</p> <p>-At <b>Norwalk Junction</b>: Work continues on the structures in the station pad including several large excavations. 3/15-5/4/06.</p>	<p>-Work will return eventually to continue the trench into Rt.58 5/4/06.</p> <p>- Small stockpiles resulted but were well contained. See erosion control section. 5/4/06</p> <p>- None at this time. The area is contained. 5/4/06</p> <p>-None at this time. The area is contained. 5/4/06</p> <p>- None at this time, the area is well contained. See erosion control section for more information. 5/4/06.</p>	<p>-N/A</p> <p>- N/A.</p> <p>-N/A</p> <p>-N/A</p> <p>- N/A</p>

**Photo on the left shows the grounding work along the retaining wall. Erosion controls along the wetland are still in good shape. Photo on the right shows the southern slope where restoration of the erosive gullies is still necessary. 5/4/06.**

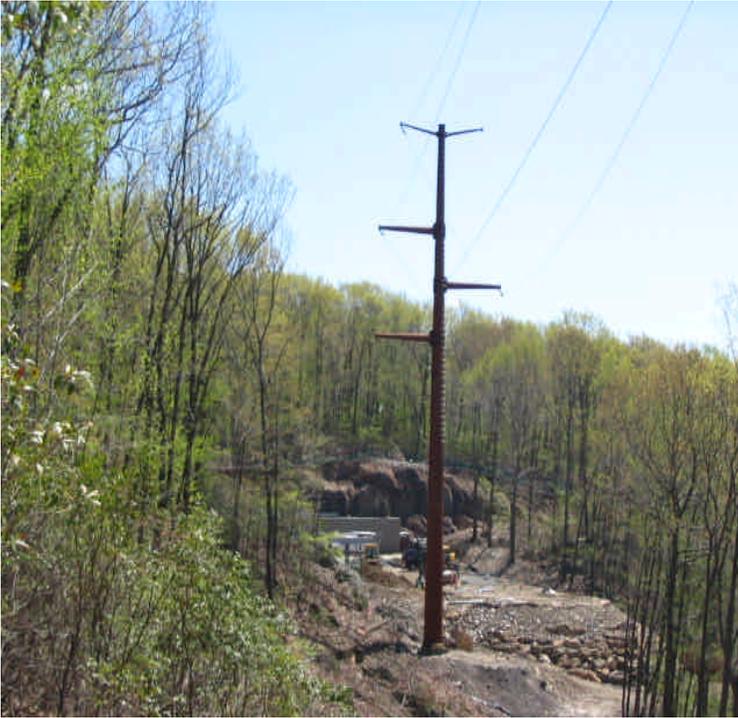
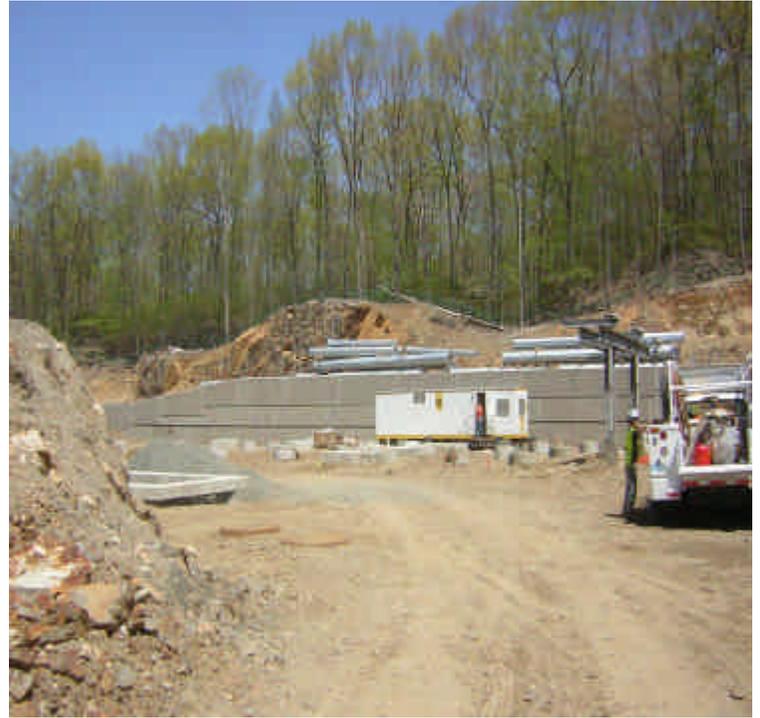
Archers Lane: Photo on the left shows a view of the station from the ROW with the adjacent structure in place. Photo on the right shows an overall view of the station pad. 5/4/06.

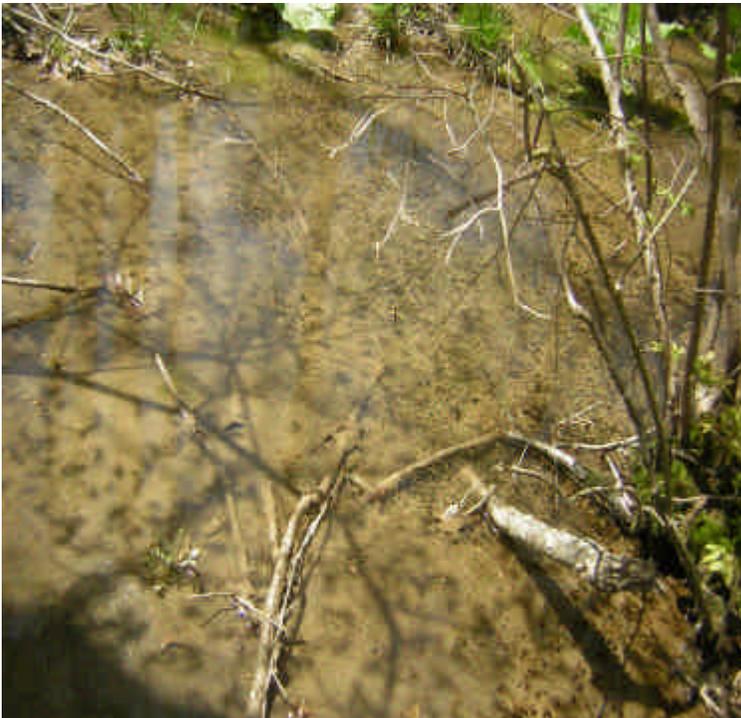
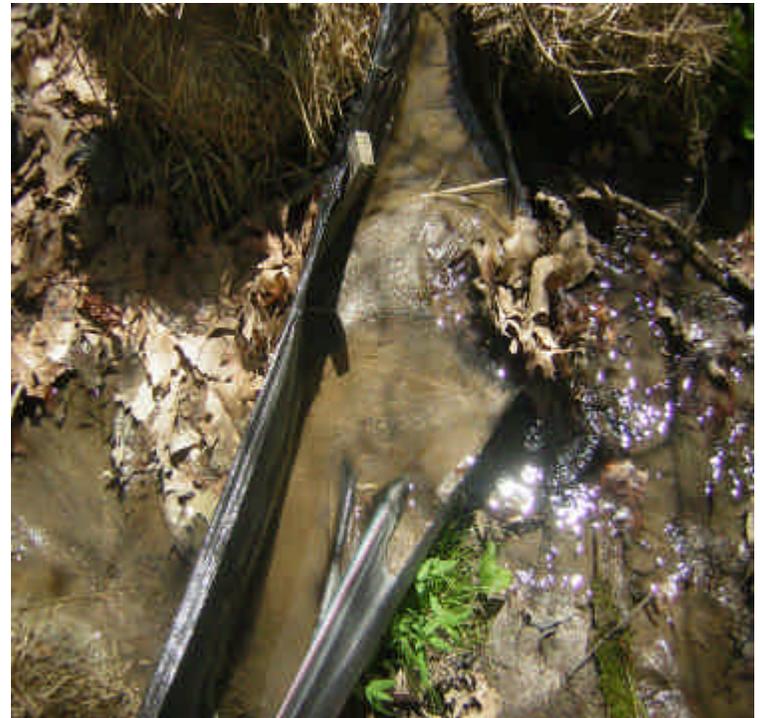
- <b>Archers Lane:</b> Water levels at the wetland crossings on the access road to the ROW remain below problem levels. 5/4/06.	-Crossings and controls are in good shape with the exception of attention needed near the 1 <sup>st</sup> wetland. See other sections 5/4/06.	-Needs attention
	-Slopes remain disturbed along the access road where 345kV trenching occurred. 4/26-5/4/06	-The area should be restored if vault access and work here is complete. 5/4/06	- Needs attention

Both photos show the 1<sup>st</sup> wetland crossing near the station where sediment has continued to acculate. Sediment should be removed carefully by hand where obvious deposits have built up and controls should be cleaned out and improved as seen in the photo on the right. 5/4/06.

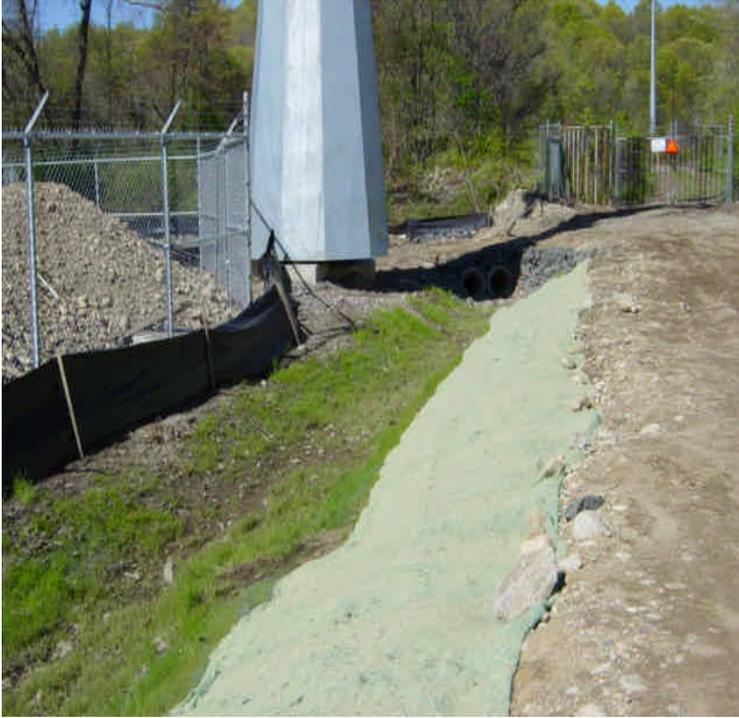
- <b>Norwalk Junction:</b> Sediment tracking did not appear to be an issue at this time. The swale has been repaired. 2/16-5/4/06.	-Continue to monitor Rt. 7 at the main access pad. 5/4/06. - See erosion control section for more details on the swale repair 5/4/06.	-N/A

**Norwalk Junction:** Photo on the left shows the recently restored slope of the swale. EC matting was extended as recommended. Photo on the right shows where haybales had been disturbed by the flooding but the outer perimeter fence has been repaired. 5/4/06.

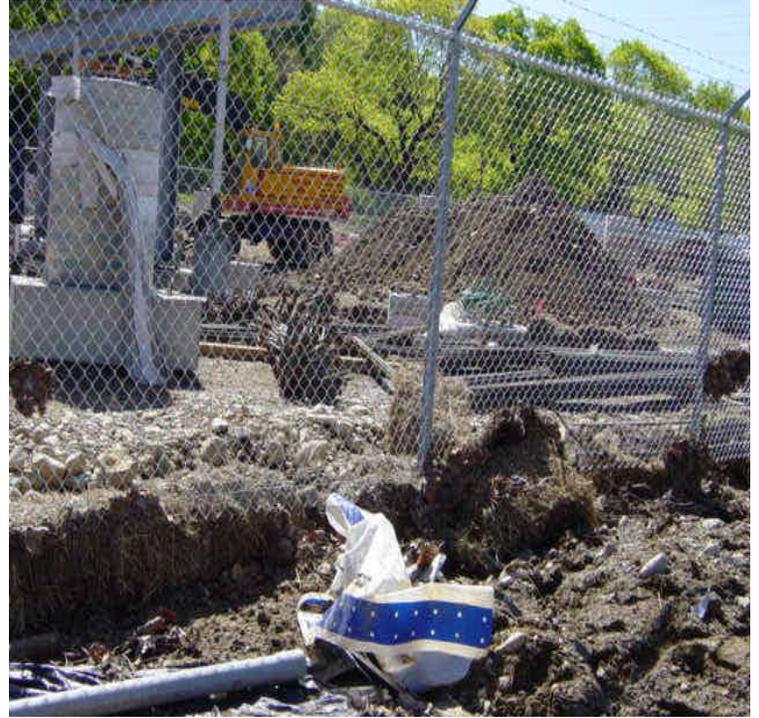
Areas of Inspection	Observation	Recommended Action	Corrected Actions
	<p>- <b>Norwalk Junction:</b> The recent Norwalk River flood scattered the haybales along the perimeter fence 4/26-5/4/06.</p> <p>- The perimeter silt fence was completely restored following the flooding. 5/4/06.</p>	<p>- The haybales should be repaired as an additional control but are not as essential as having the silt fence in place 4/26-5/4/06.</p> <p>- None at this time. Continue to monitor. 5/4/06.</p>	<p>-Needs attention if feasible</p> <p>- Silt fence was restored</p>
	<p>-The old culvert near the silt fence and the river was observed. It was partially buried. 5/4/06.</p> <p>-The wetland area outside the silt fence adjacent to the river contained pooled turbid water. 4/26-5/4/06.</p> <p>- The washouts along the slope of the swale were repaired by extending the erosion control mat. 5/4/06.</p> <p>-Dewatering outfalls appeared to be clear at the time. 5/4/06</p>	<p>- The culvert connection should be cut completely if feasible or continue to bury it. 5/4/06.</p> <p>- This area receives direct runoff from the site through the swale making water quality important. 1/19-5/4/06</p> <p>-None at this time. Continue to monitor. 5/4/06.</p> <p>-None at this time. Continue to monitor. 5/4/06.</p>	<p>- The culvert was partially buried. Still needs attention</p> <p>- N/A</p> <p>- EC mat was extended and the washouts repaired.</p> <p>- Controls were filtering water well.</p>

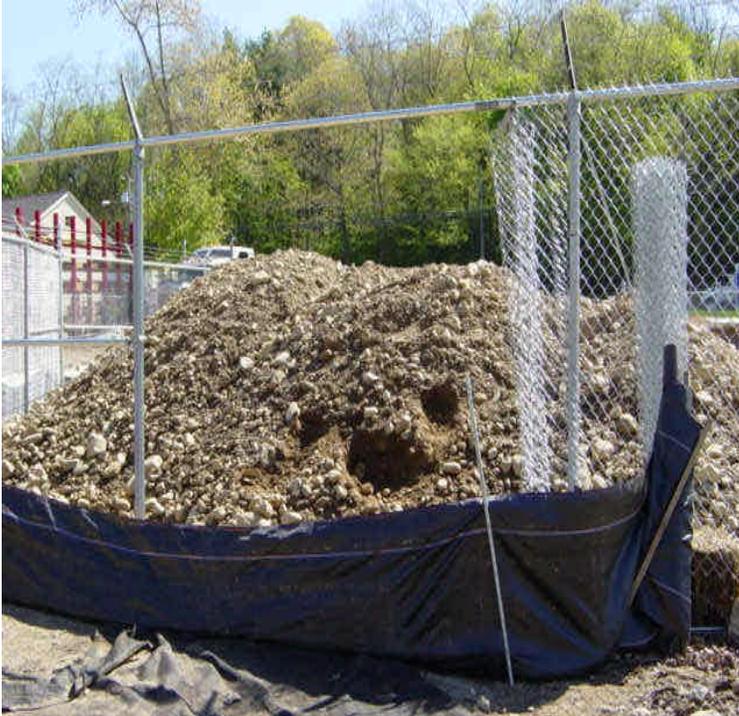
<p>- Additional silt fence was also noted at the base of a stockpile internal to the site. 5/4/06</p>	<p>- None at this time. 5/4/06</p>	<p>- Silt fence was installed proactively</p>
<p>Inland Wetland and Watercourse</p> <p>encroachment and mitigation</p>	<p>- <b>Hoyts Hill:</b> The wetland remains well protected at this time. 4/6-5/4/06.</p> <p>-<b>Archers Lane:</b> Watch run-off velocity down the completed slopes and walls. Efforts need to continue removing deposited sediment from the 1<sup>st</sup> wetland crossing. 2/16-5/4/06.</p> <p>- <b>Norwalk Junction:</b> The outlet of the drainage</p>	<p>-Continue to monitor this area until slopes have stabilized completely . 5/4/06.</p> <p>- Continue to remove the sediment from the wetland where there are significant buildups. Several inches of sediment were noted. 2/16-5/4/06.</p> <p>-See Erosion Control</p>	<p>- N/A.</p> <p>- Still needs attention</p> <p>-N/A at this time</p>

Photo on the left shows where additional silt fence was installed the base of a stockpile internal to the site. The outer silt fence is also in place. Photo on the right shows grass growth beginning at the swale and adjacent area near Rt. 7. 5/4/06.
