Docket No. 217 – Development and Management Plan Inspection

Northeast Utilities Service Company Certificate of Environmental Compatibility and Public Need for the construction of a 345-kV electric transmission line and reconstruction of an existing 115-kV electric transmission line between Connecticut Light and Power Company's Plumtree Substation in Bethel, through the towns of Redding, Weston, and Wilton, and to the Norwalk Substation in Norwalk, Connecticut.

Date: May 17, 2006

Location: Transition Stations: Hoyts Hill, Archers Lane, Norwalk Junction

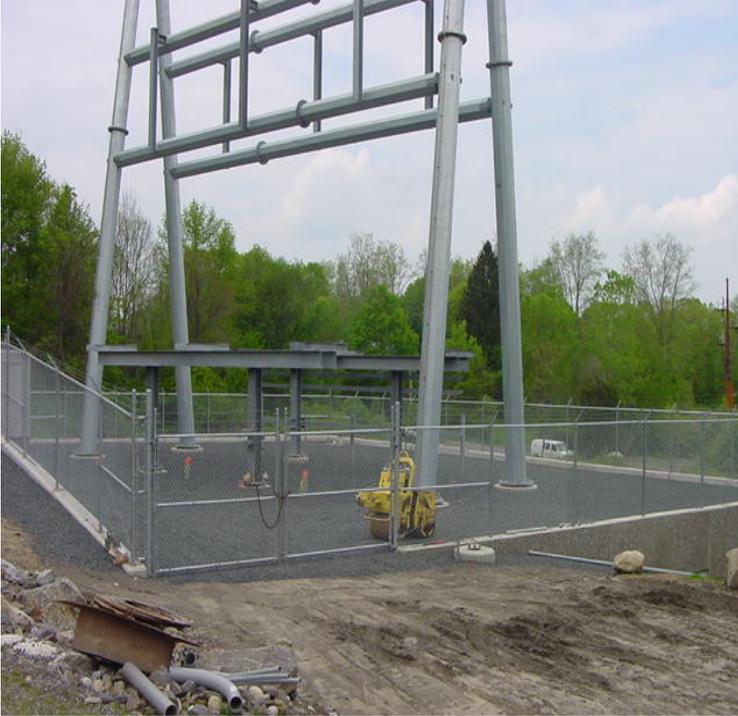
Hoyts Hill Transition Station: Photo on the left shows a view of the station pad with structures installed and no active work. The pad surface appeared to be finished as well. Photo on the right shows the open end of the 345kV XLPE work and the well-restored northern slope. 5/17/06

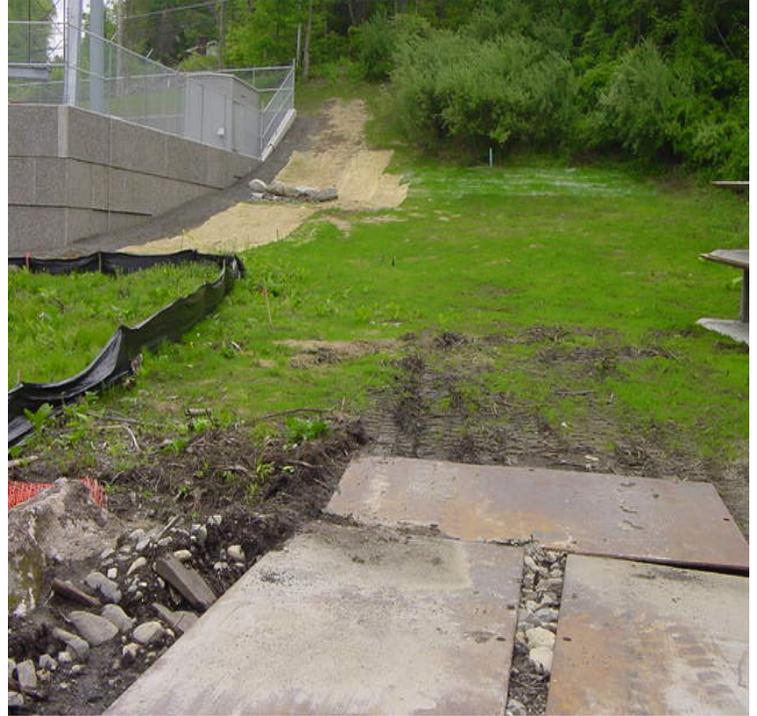
Foundation construction	<p>- At Hoyts Hill: A small area of 345kV XLPE excavation remains at the base of the slope.</p>	<p>-Work will return eventually to continue the trench into Rt.58 5/17/06.</p>	<p>-N/A</p>

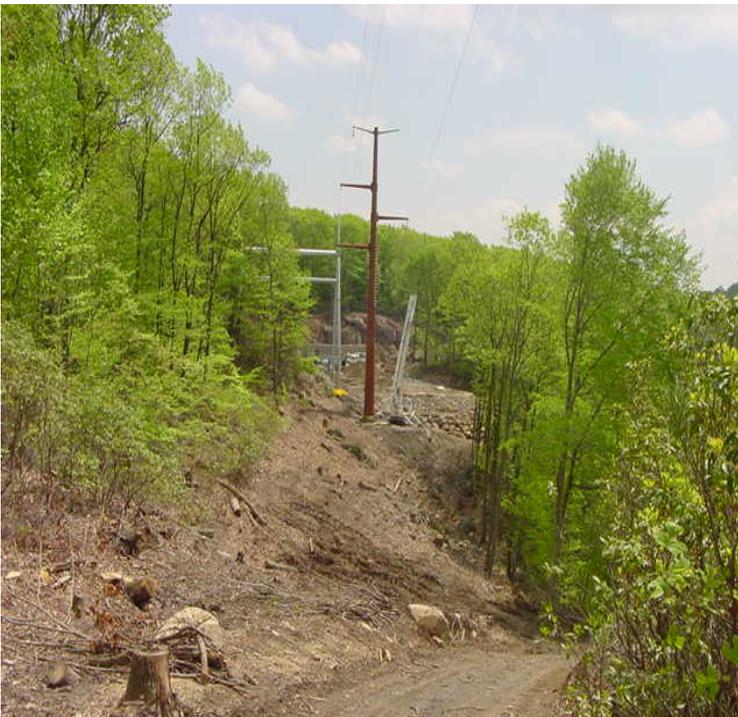
Archers Lane: Photo on the left shows a view of the ongoing work of the transition station from the ROW. Photo on the right shows a spot along the access drive leading to the ROW which could use some repair due to the wash out of sediment. 5/17/06.

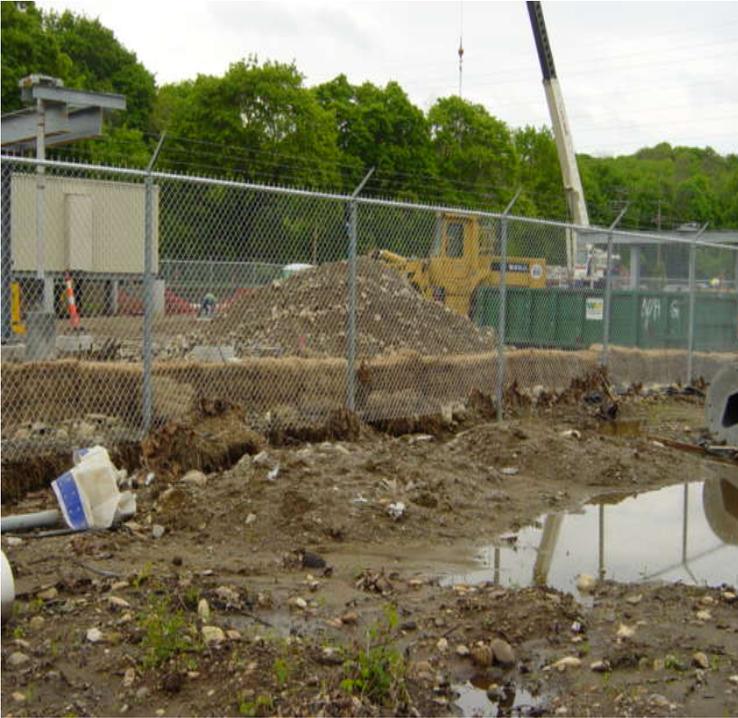
- Norwalk Junction: Haybales were restored as an additional control along the perimeter chain link fence. Perimeter silt fence remains in good shape along the river. 5/17/06.	- None at this time. Continue to monitor controls. 5/17/06.	-Haybales were replaced along the site.

Norwalk Junction: Photo on the left shows the haybales installed along the fence as an additional control to the silt fence along the river. Photo on the right shows where turbid water is again collecting in the wetland area at the end of the swale, likely due to dewatering on site. It remains contained to this wetland basin. 5/17/06.

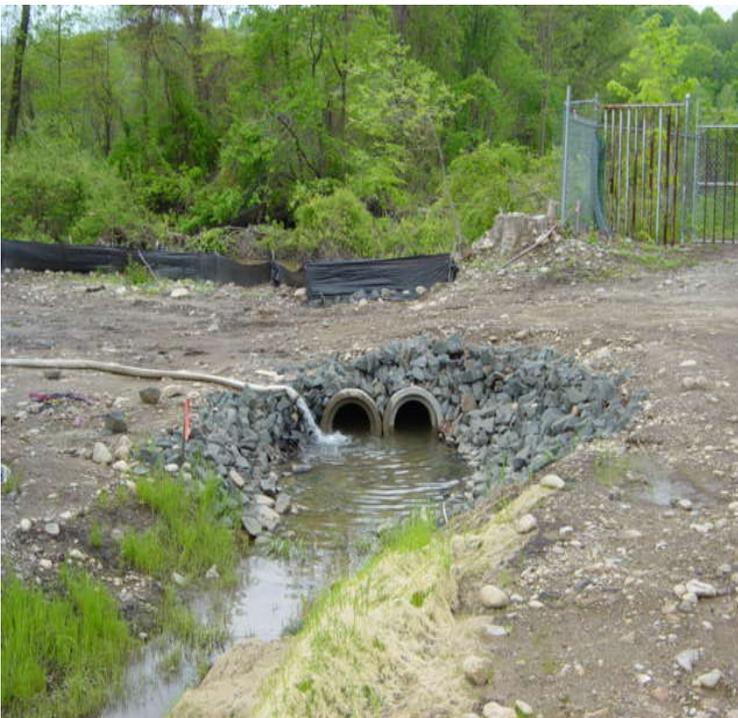
Photo on the left shows dewatering to the culvert to the wetland with no haybales or filtration controls in place.
Photo on the right shows the swale in good shape with the EC blanket in place. 5/17/06.
