Docket No. 217 – Development and Management Plan Inspection

Northeast Utilities Service Company Certificate of Environmental Compatibility and Public Need for the construction of a 345-kV electric transmission line and reconstruction of an existing 115-kV electric transmission line between Connecticut Light and Power Company's Plumtree Substation in Bethel, through the towns of Redding, Weston, and Wilton, and to the Norwalk Substation in Norwalk, Connecticut.

Date: June 7, 2006

Location: Transition Stations: Hoyts Hill, Archers Lane, Norwalk Junction

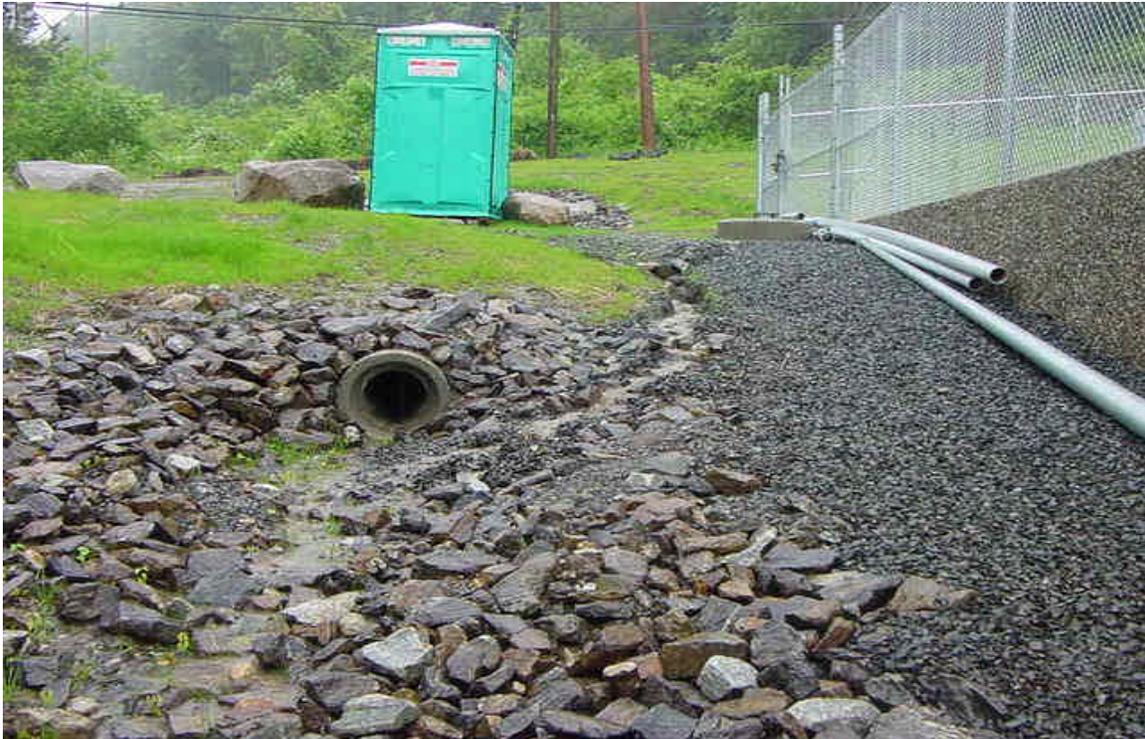
<p>Erosion and Sediment Controls</p>	<p>-Hoyts Hill: The perimeter silt fence along the wetlands at the rear of the station remains in good shape. 4/6-6/7/06.</p> <p>-The gullies in the southern slope are worsening and re-forming even with the recent repairs. 5/17-6/7/06.</p> <p>- Water running down the driveway area is not reaching the catch basin and is channeling down</p>	<p>-Monitor and maintain the fence as necessary. 4/6-6/7/06 Vegetation is growing very well in the adjacent wetland 6/7/06</p> <p>-The area will need to be repaired and possible placed with erosion control mats or the pad should be extended. 6/7/06.</p> <p>- Consider reshaping the area so water runs to the appropriate area. 6/7/06</p>	<p>- N/A</p> <p>- Needs attention</p> <p>-Needs attention</p>

Hoyts Hill Transition Station: Photo shows a gully forming to the right of the outlet. The washout continues below the outlet where repairs had been made recently. It should be considered whether the driveway area needs to be regraded so that water flows better to the catch basin. 6/7/06

Areas of Inspection	Observation	Recommended Action	Corrected Actions
Access Roads and Adjacent Roadways	- Hoyts Hill: Access is gained off Hoyts Hill Road. This area may need to be regraded in order to direct water to the catch basin. Run-off is channeling over the slope and re-forming the washouts and gullies. 6/7/06.	- Look at the design to determine if grades were not met and consider berming or grading the area so water is directed appropriately. 6/7/06.	-Needs attention.

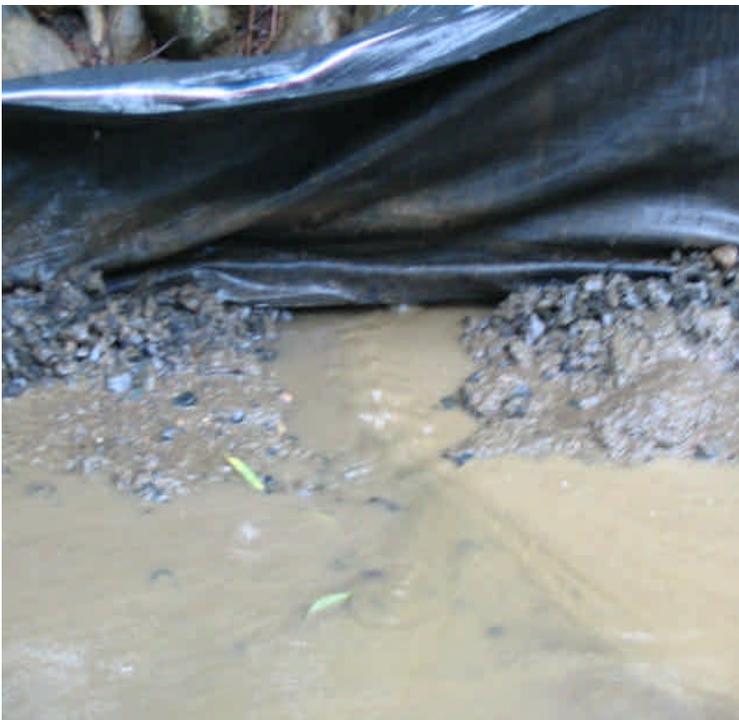
Archers Lane: Photo on the left shows where run-off has washed under the silt fence recently installed along the stone wall at the access drive. Haybales should be placed here and silt fence toed back in. Photo on the right shows where turbid water from the access drive is overtopping the silt fence. 6/7/06.

- Silt fence was installed near the stone wall along the access drive but the rains caused the area to wash under again and turbid water was flowing to the wetland. 6/7/06	-Repair the silt fence. Toe it back in and place haybales in this spot for filtration. 6/7/06	- Needs attention

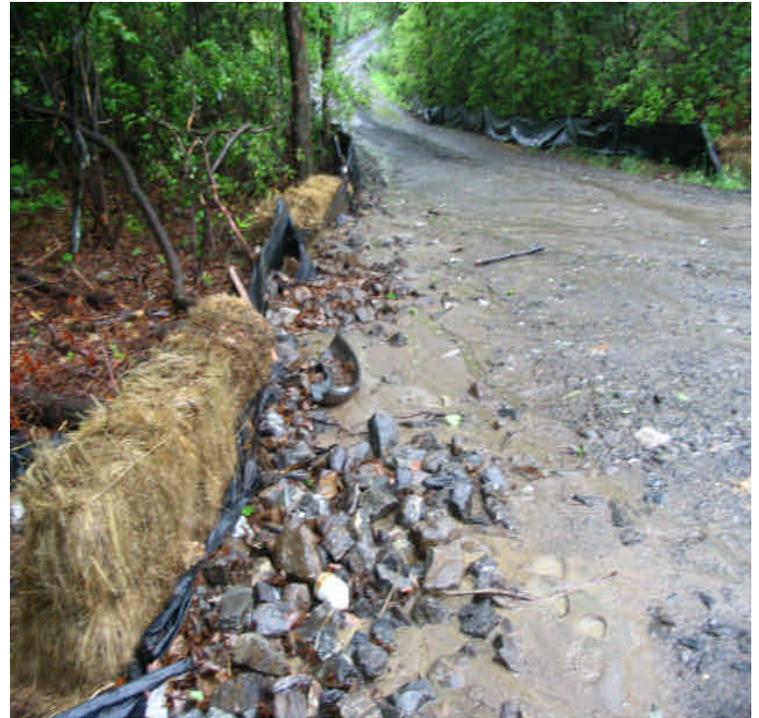
Archers Lane: Photo on the left shows the station pad and the ongoing work here. Photo on the right shows the access road towards the ROW. Fence was down but run-off was flowing along the erosion control line. 6/7/06.

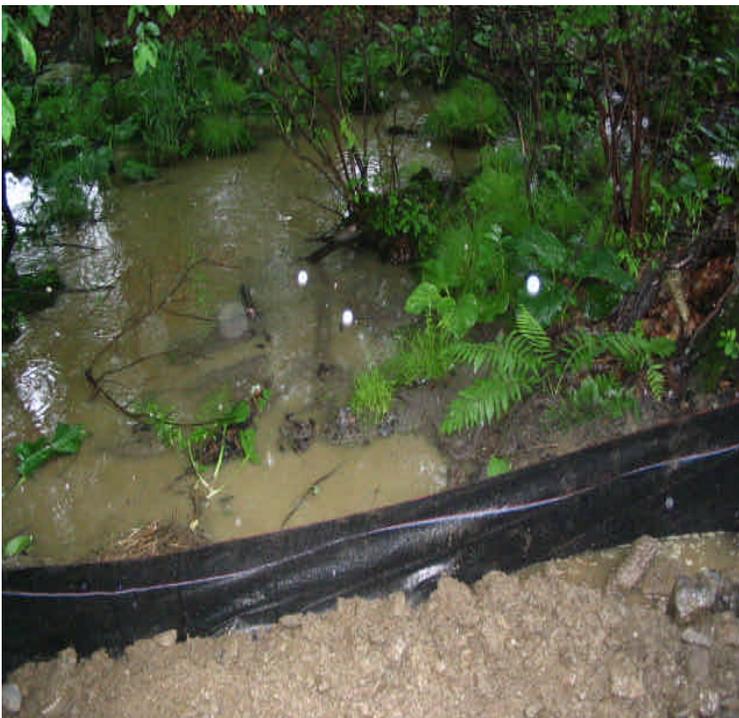
Photo on the left shows where turbid run-off had entered the 1st wetland crossing along the access road. Photo on the right shows where crews were working in this area in the rain to install new controls. Sediment will also be removed by hand from this area. 6/7/06.

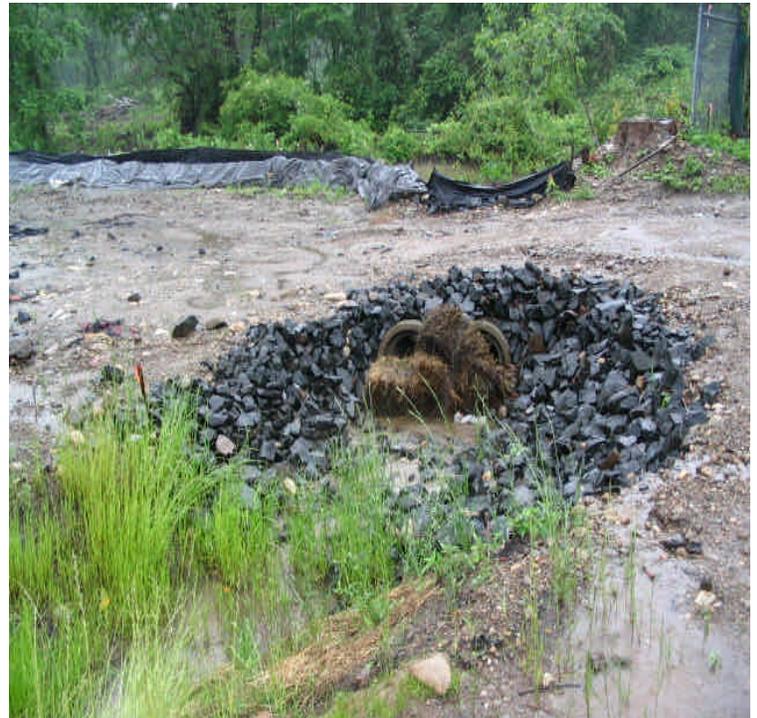
Norwalk Junction: Photo on the left shows the station with the ongoing work. Photo on the right shows the swale at the culvert where haybales are filtering out some of the turbidity. 6/7/06.

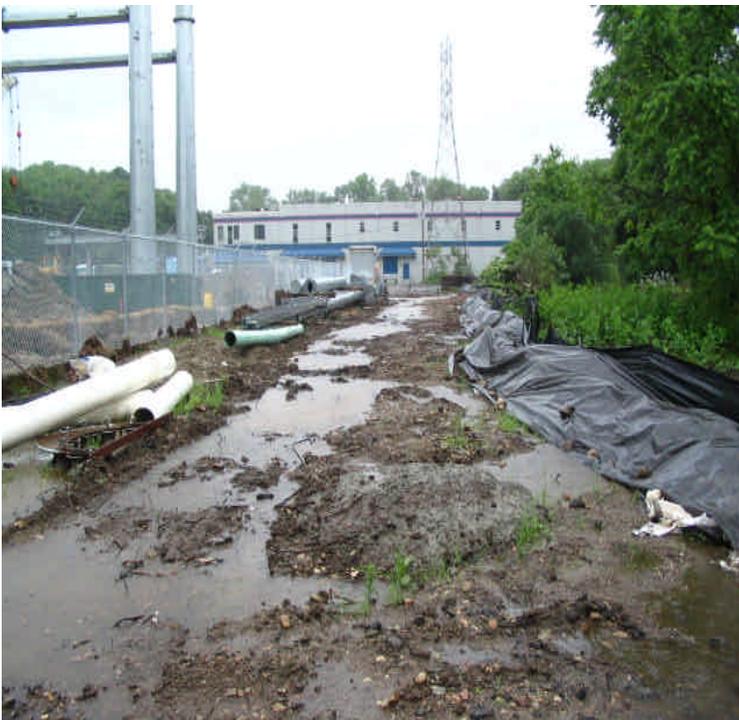
Norwalk Junction: Photo on the left shows the area along the perimeter fence, where run-off is well contained . Photo on the right shows the wetland area where the turbid water is leaving the swale but remains contained to this area. 6/7/06.
