Docket No. 217 – Development and Management Plan Inspection

Northeast Utilities Service Company Certificate of Environmental Compatibility and Public Need for the construction of a 345-kV electric transmission line and reconstruction of an existing 115-kV electric transmission line between Connecticut Light and Power Company's Plumtree Substation in Bethel, through the towns of Redding, Weston, and Wilton, and to the Norwalk Substation in Norwalk, Connecticut.

Date: June 14, 2006

Location: Transition Stations: Hoyts Hill, Archers Lane, Norwalk Junction

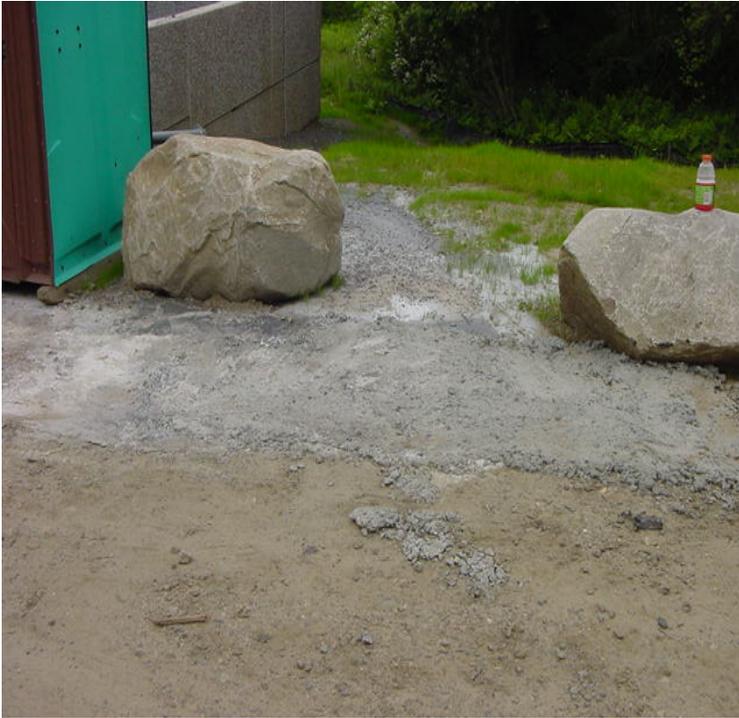
- A concrete washout was also noted at the top of slope. 6/14/06	-It is unclear which section of the project is responsible. 6/14/06	- Needs attention

Hoyts Hill Transition Station: Photo on the left shows where a concrete washout had occurred. Washout water ran down the slope in the outlet pad to the edge of the wetland. It is unclear which section of the project would be responsible for cleanup. Photo on the right shows work on the structures. 6/14/06

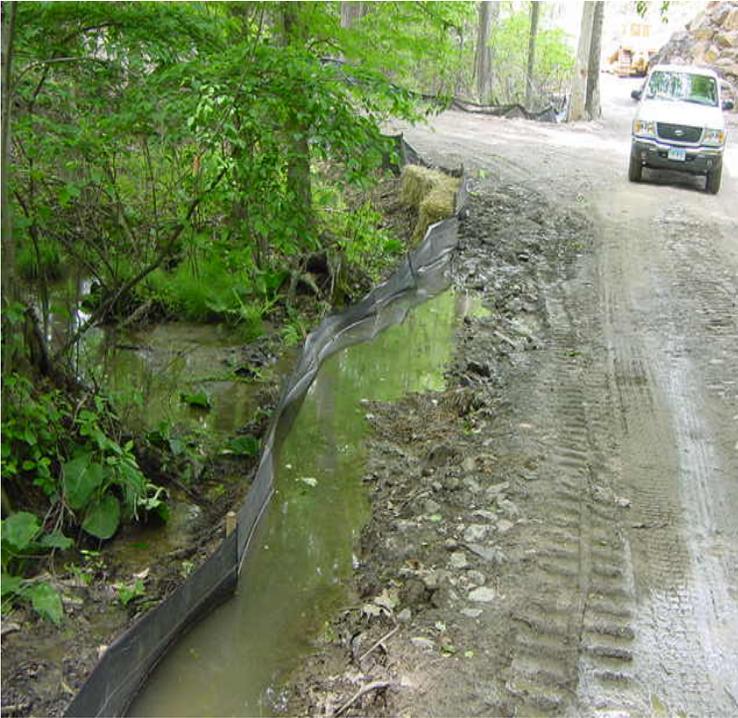
Archers Lane: Photo on the left shows the repaired silt fence at the wetland crossing. Turbid water is being held back and filtered but this fence will have to continue to be monitored. (Norwalk Junction): Photo on the right shows an overview of the yard here. 6/14/06.

- Crews repaired silt fence along the access road and it is holding back turbid run-off from the wetland. 6/14/06	- Continue to monitor and repair as soon as necessary. 6/14/06	-Silt fence was repaired
	-Slopes remain disturbed along the access road where 345kV trenching occurred. 4/26-6/14/06	-The area should be restored after vault access and work here is complete. 5/4-6/14/06	- Needs attention when work is complete

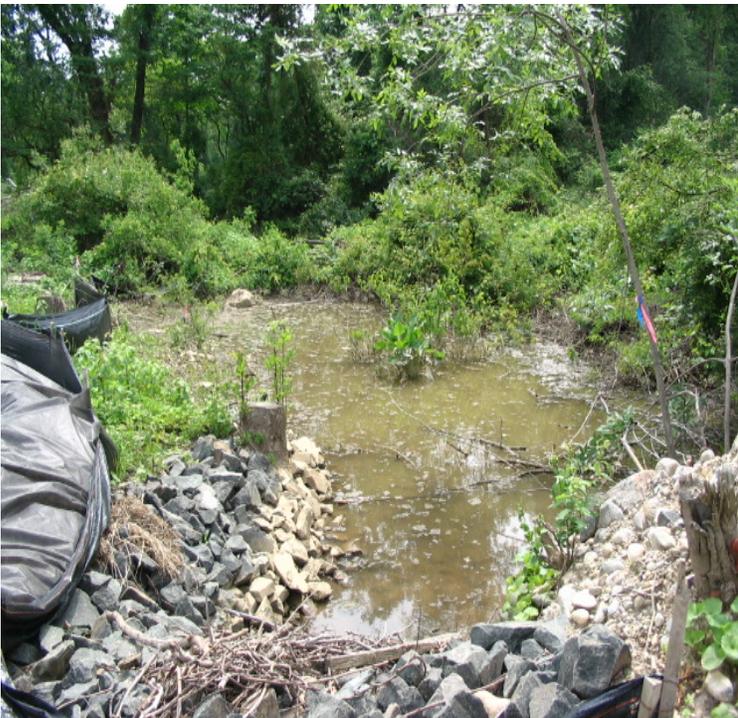
Photo on the left shows the wetland area at the end of the swale where turbid water has ponded again. Photo on the right shows a close up view of the outlet where sediment is accumulating. Sediment should be carefully removed by hand from this area. 6/14/06.
