**Docket No. 217 – Development and Management Plan Inspection**

Northeast Utilities Service Company Certificate of Environmental Compatibility and Public Need for the construction of a 345-kV electric transmission line and reconstruction of an existing 115-kV electric transmission line between Connecticut Light and Power Company's Plumtree Substation in Bethel, through the towns of Redding, Weston, and Wilton, and to the Norwalk Substation in Norwalk, Connecticut.

**Date:** July 5, 2006

**Location:** Transition Stations: Hoyts Hill, Archers Lane, Norwalk Junction

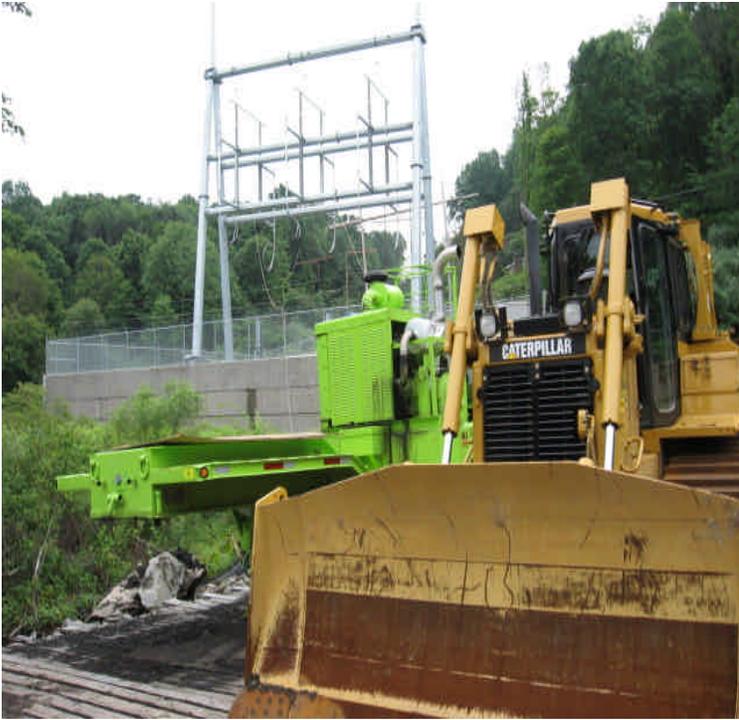
**Hoyts Hill Transition Station: Photo on the left shows equipment in place for pulling wire. Photo on the right shows where the old filter bag was removed from the wetland. The area should be revegetated if this does not occur naturally in the near future. 7/5/06**

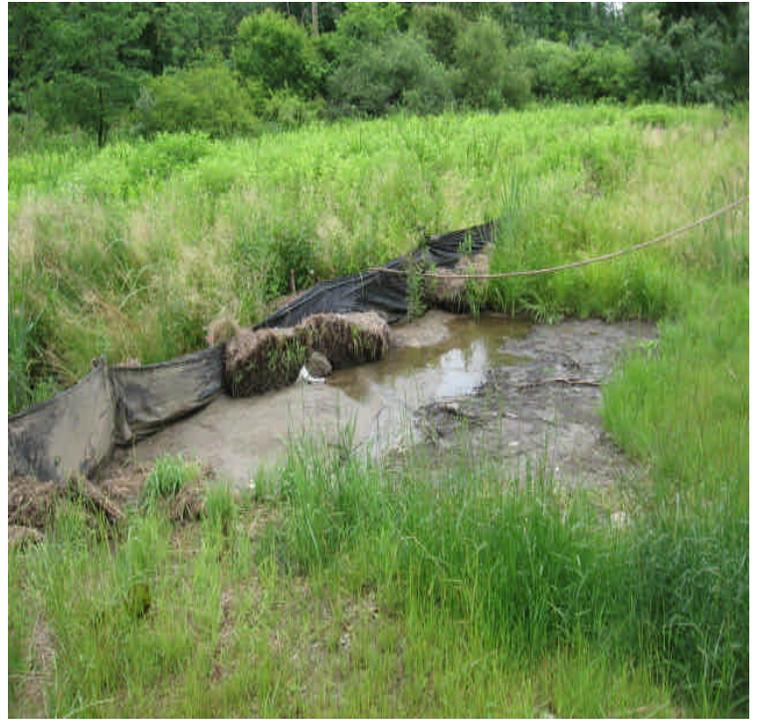
Areas of Inspection	Observation	Recommended Action	Corrected Actions
<p>Erosion and Sediment Controls continued</p>	<ul style="list-style-type: none"> <li>- The area where the filter bag was removed remains bare with some accumulated sand. 7/5/06</li> <li>-One gully in the southern slope remains along the stone pad. The rest of the repaired slope is revegetating well. 6/28-7/5/06.</li> <li>- The concrete washout at the top of slope was cleaned up on 6/28/06</li> <li>- <b>Archers Lane:</b> Silt fence along the access road at the 1<sup>st</sup> wetland had washed out at one obvious spot. Sediment has accumulated in the wetland. 7/5/06</li> <li>- The remaining fence was holding back significant amounts of pooled run-off 7/5/06</li> </ul>	<ul style="list-style-type: none"> <li>- Plan to revegetate if this does not occur naturally soon. 7/5/06</li> <li>-The gully will be repaired and the slope reshaped to promote sheet flow. 6/28-7/5/06.</li> <li>- None at this time. 7/5/06</li> <li>-Repair fence ASAP and reinforce with haybales or wire backing. Remove sediment by hand 7/5/06</li> <li>- Continue to monitor and reinforce when necessary. It appears some sediment has seeped through. 7/5/06</li> </ul>	<ul style="list-style-type: none"> <li>- Needs evaluation</li> <li>- Needs attention</li> <li>-The concrete was cleaned up</li> <li>- Needs attention</li> <li>-Needs monitoring</li> </ul>

<p>Inland Wetland and Watercourse encroachment and mitigation</p>	<p>- <b>Hoyts Hill:</b> The wetland remains well protected at this time. 4/6-7/5/06.</p> <p>- The area where the filter bag was should be restored. 7/5/06</p> <p>- Mats are in place for wire pulling access at the wetland off Rt 58. 6/28-7/5/06</p> <p>-<b>Archers Lane:</b> Watch run-off velocity down the completed slopes and</p>	<p>-Continue to monitor this area until slopes are stabilized completely. Vegetation is growing well 7/5/06.</p> <p>- Continue to monitor and do not access the wetland without mats. 6/28-7/5/06</p> <p>- Remove the sediment from the wetland where there are significant buildups. 6/20-7/5/06.</p>	<p>- N/A.</p> <p>-N/A</p> <p>- Needs attention</p>

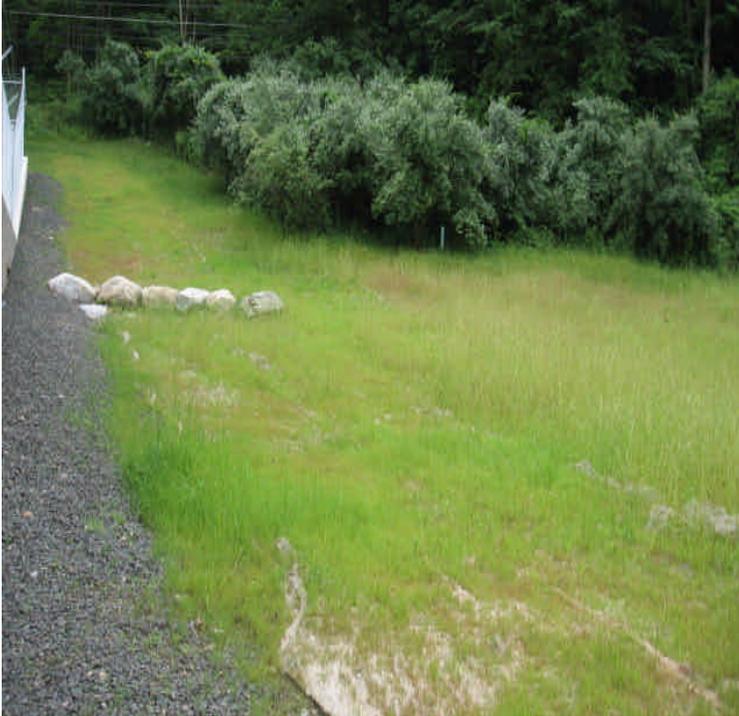
**Photo on the left shows the well restored northern slope. Photo on the right shows the southern slope which is also stabilizing. However, the one gully remains above and below the outlet pad. 7/5/06.**

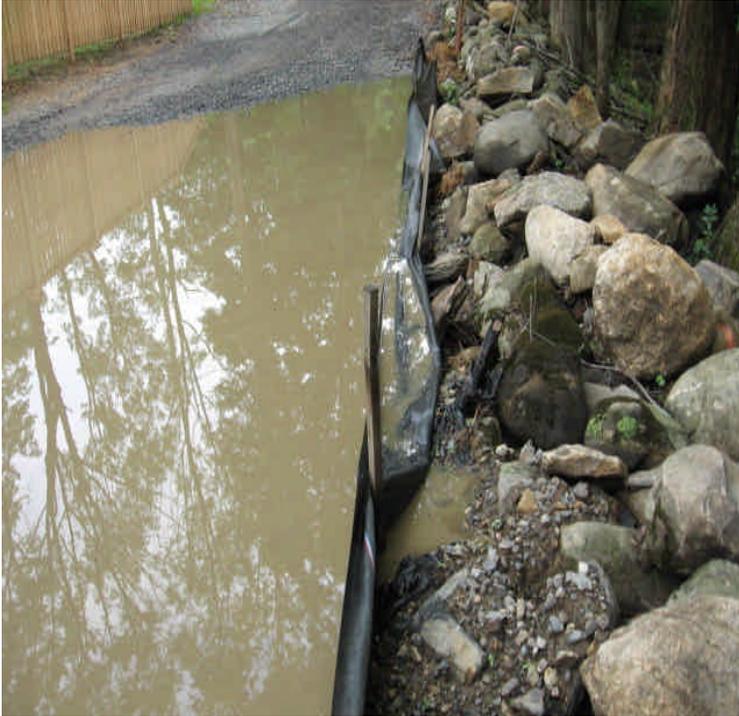
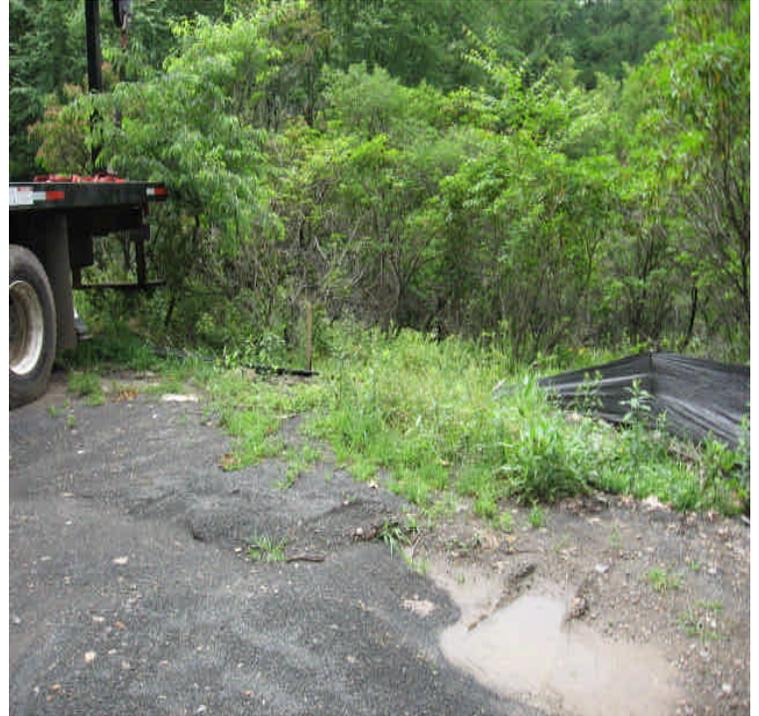
Archers Lane: Photo shows a view of the area along the station yard near the river with some areas of pooled water following the recent heavy rains. 6/29/06.

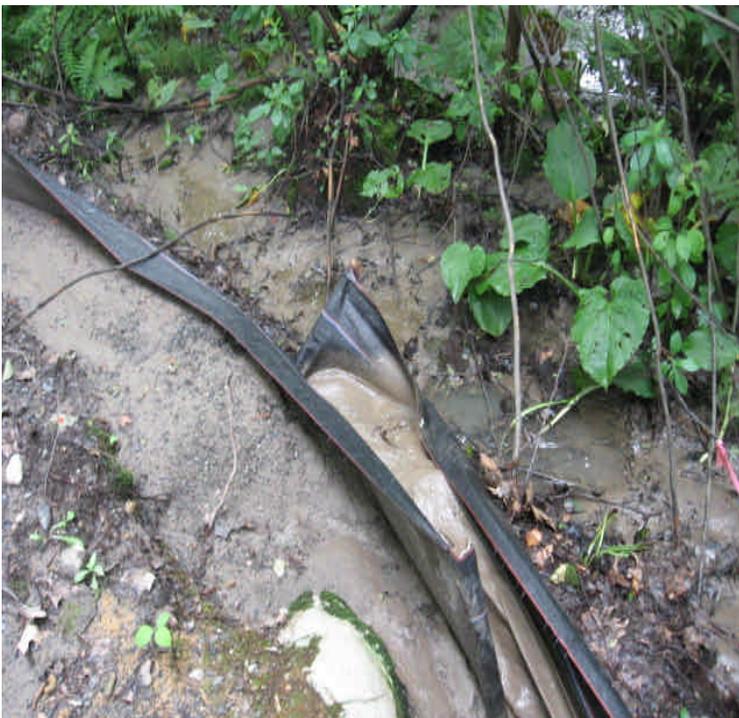
- The silt fence along the access road washed out in one obvious spot and sediment had reached the wetland. 7/5/06	- The fence should be repaired and reinforced-see erosion control section. 7/5/06	- Needs attention

Photo on the left shows where sediment from the access road washed over the silt fence along the 1<sup>st</sup> wetland crossing. The area should be reinforced with haybales or wire backing and the sediment removed by hand. Photo on the right shows the continuing work at the station yard. 7/5/06.

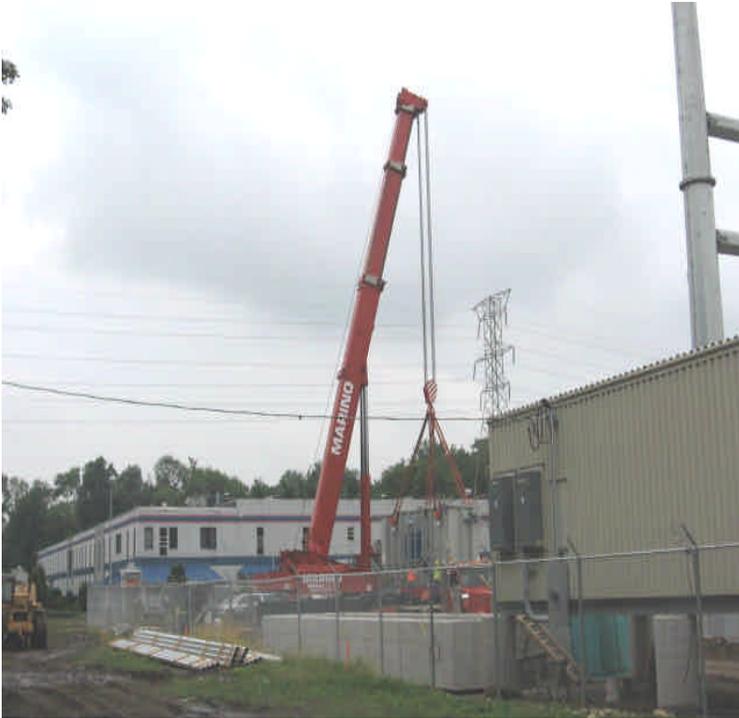
**Norwalk Junction: Photo on the left shows crane work occurring on site. Photo on the right shows significant sediment accumulation in the swale as a result of dewatering. 345kV crews will be cleaning this portion of the swale out but better controls are needed at each culvert. 7/5/06.**

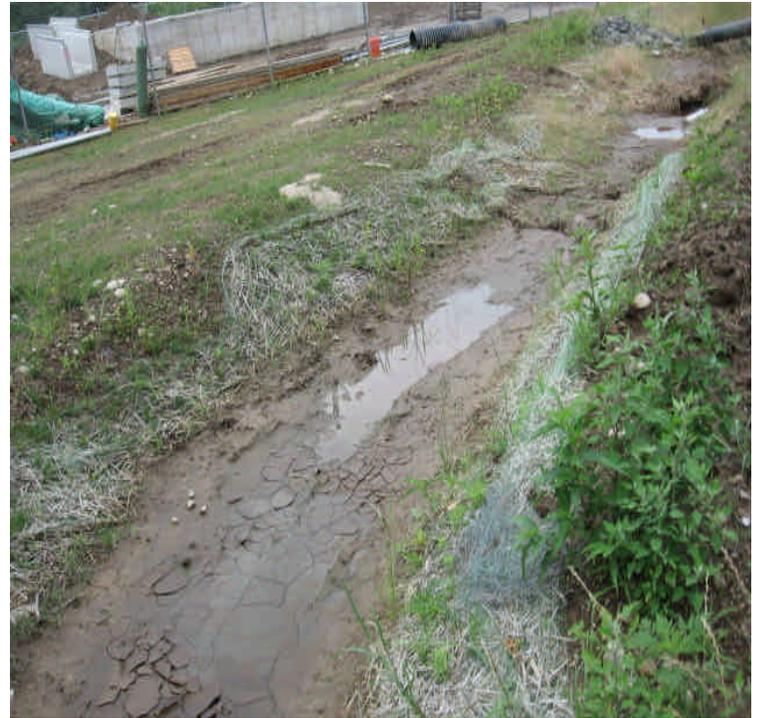
<p>Dewatering</p> <p><b>Archers Lane</b></p> <p><b>Norwalk Junction</b></p>	<p>- Active dewatering was not noted. 7/5/06</p> <p>-Active dewatering was noted in the swale. The haybales are degraded and turbid water was reaching the wetland area. Significant sediment</p>	<p>- The silt fence appeared to be filtering the water well but showed some stress 7/5/06.</p> <p>-Replace haybales and reinforce controls. Some accumulated silt will be removed by 345kV crews. 6/28-7/5/06.</p>	<p>-N/A</p> <p>-N/A</p>

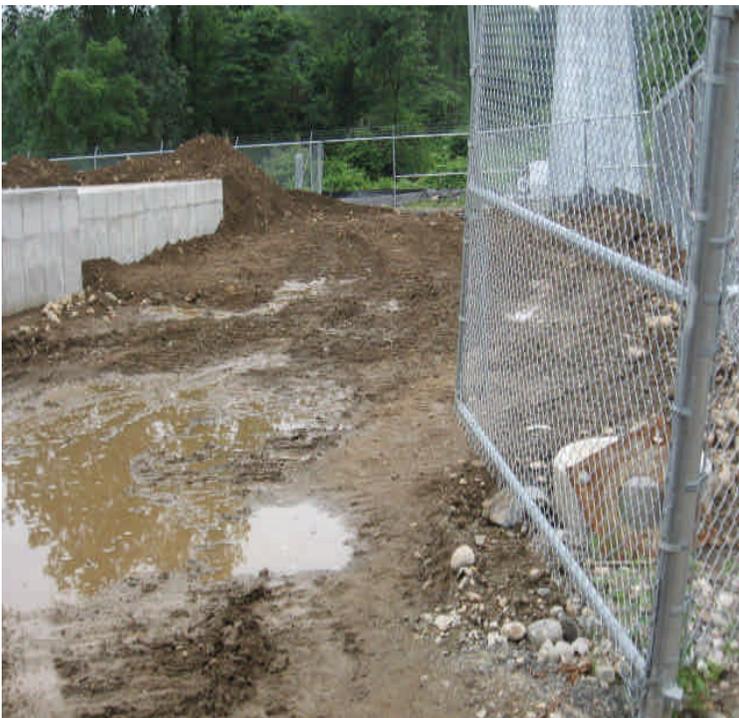
**Photo on the left shows where some large soil stockpiles have been removed. Photo on the right shows the wetland area at the end of the swale near the river filled with pooled turbid water again. 7/5/06.**
