Docket No. 217 – Development and Management Plan Inspection

Northeast Utilities Service Company Certificate of Environmental Compatibility and Public Need for the construction of a 345-kV electric transmission line and reconstruction of an existing 115-kV electric transmission line between Connecticut Light and Power Company's Plumtree Substation in Bethel, through the towns of Redding, Weston, and Wilton, and to the Norwalk Substation in Norwalk, Connecticut.

Date: July 12, 2006

Location: Transition Stations: Hoyts Hill, Archers Lane, Norwalk Junction

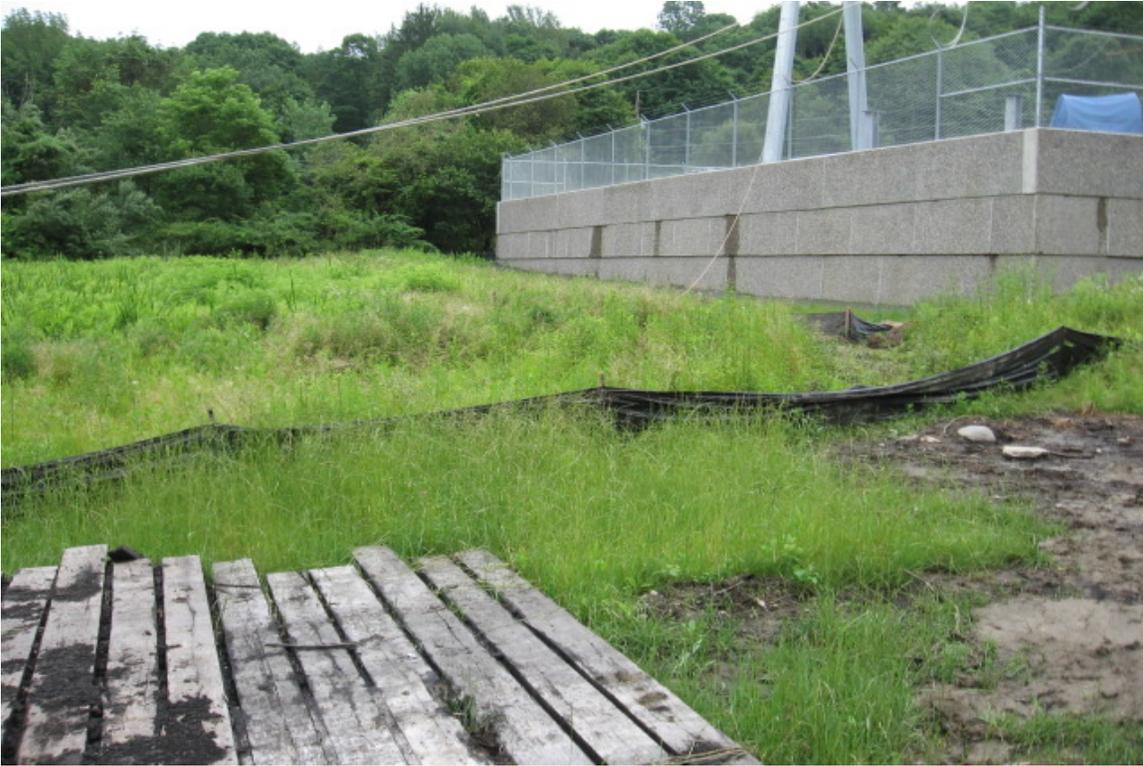
Areas of Inspection	Observation	Recommended Action	Corrected Actions
<p>Erosion and Sediment Controls</p> <p>Erosion and Sediment Controls continued</p>	<p>-Hoyts Hill: The perimeter silt fence along the wetlands at the rear of the station remains in good shape. 4/6-7/12/06.</p> <p>- The areas where the filter bags were removed remains bare with some accumulated sand. 7/5-7/12/06</p> <p>-One gully in the southern slope remains along the stone pad. The rest of the repaired slope is revegetating fairly well. 6/28-7/12/06.</p> <p>- Archers Lane: Silt fence along the access road at the 1st wetland had washed out and sediment has accumulated in the wetland. 7/5-7/12/06</p> <p>- The remaining fence had been holding back significant amounts of pooled run-off but is weakened and some sediment filtered through here as well. 7/5-7/12/06</p>	<p>-Monitor and maintain the fence as necessary. 4/6-7/12/06 Vegetation is growing very well in the adjacent wetland 7/12/06</p> <p>- Plan to revegetate if this does not occur naturally soon. 7/5-7/12/06</p> <p>-The gully will be repaired and the slope reshaped to promote sheet flow. 6/28-7/12/06.</p> <p>-Repair fence ASAP and reinforce with haybales or wire backing. Remove sediment by hand. 7/5-7/12/06</p> <p>- Reinforce the fence where necessary. Any easily accessible deposits of sediment need to be removed. 7/5-7/12/06</p>	<p>- N/A</p> <p>- Needs evaluation</p> <p>- Needs attention when feasible</p> <p>- Needs attention</p> <p>-Needs attention</p>

Hoyts Hill Transition Station: Photo shows a view of the site including the adjacent area of wetlands. Some bare areas remain where the filter bags were removed. Consider reseeding these areas for temporary vegetative cover.

Inland Wetland and Watercourse encroachment and mitigation	<p>- Hoyts Hill: The wetland remains well protected and well vegetated 7/12/06</p> <p>- The areas where the filter bags had been should be restored. 7/5-7/12/06</p> <p>- Mats are in place for</p>	<p>-Continue to monitor this area until slopes are stabilized completely. 7/12/06.</p> <p>- Restore as necessary 7/12/06</p> <p>- Continue to monitor and</p>	<p>- N/A.</p> <p>-N/A at this time</p>

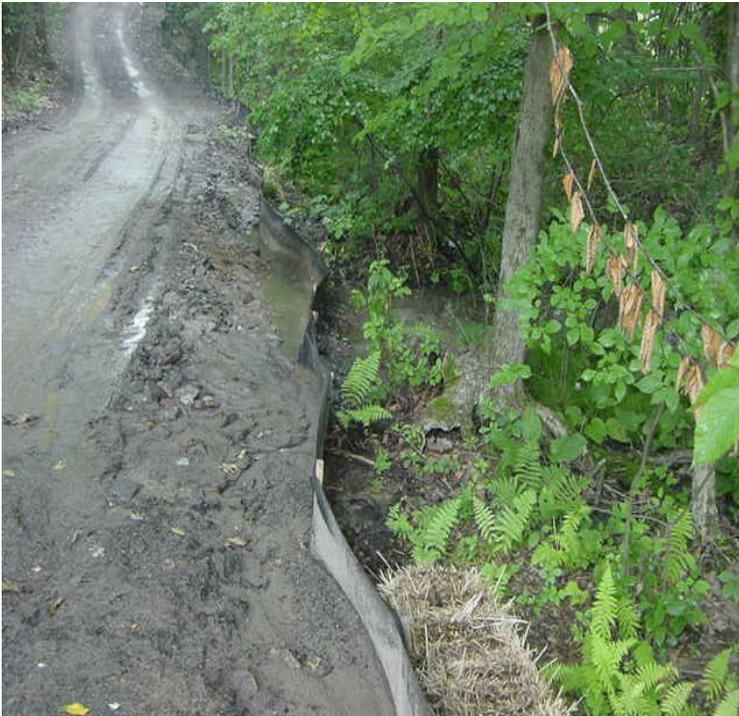
- Archers Lane: Water levels at the wetland crossings on the access road to the ROW are high but appear to remain below problem levels. 7/12/06.	-The 1 st wetland crossing needs some maintenance again. See the EC section. 6/28-7/12/06.	-Needs attention.

Archers Lane: Photo on the left shows the area along the silt fence at the 1st wetland crossing that receives significant run-off from the access road. It appears sediment has accumulated in the wetland again and that more controls are needed here. Photo on the right shows the silt fence in the area where the old process pile had been. The fence needs maintenance as it receives run-off from the access road. 7/12/06.

Areas of Inspection	Observation	Recommended Action	Corrected Actions
	<p>wire pulling access at the wetland off Rt 58. 6/28-7/12/06</p> <p>-Archers Lane: Watch run-off velocity down the completed slopes and walls. Efforts are still needed to remove deposited sediment from the 1st wetland crossing. 6/28-7/12/06.</p> <p>- Norwalk Junction: The outlet of the drainage swale is at the headwall of the wetland area. Wetland vegetation was growing but silt has accumulated and turbid water remains 6/14-7/12/06</p>	<p>do not access the wetland without mats. 6/28-7/12/06</p> <p>- Remove the sediment from the wetland where there are significant buildups. 6/20-7/12/06.</p> <p>Sediment build up had increased. 7/5-7/12/06</p> <p>- Reduce turbidity by controlling its source-disturbed surfaces and dewatering on site. The area does not seem affected but deeper sediment buildup at the outlet should be removed. 5/25-7/12/06.</p>	<p>- Needs attention</p> <p>-Needs attention when feasible</p>

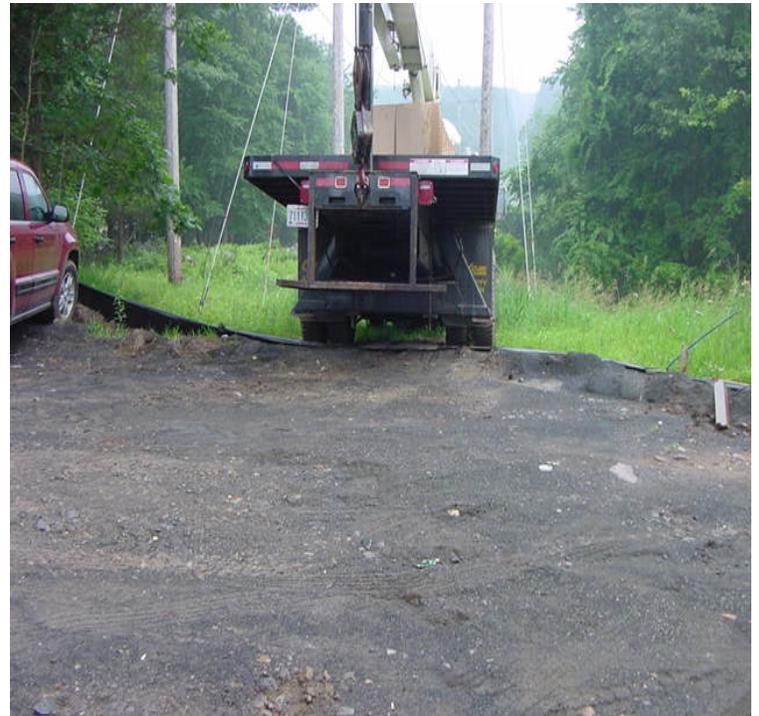
Areas of Inspection	Observation	Recommended Action	Corrected Actions
	<ul style="list-style-type: none"> - The silt fence at the base of the access road near the stonewall also had a washout area but continued to filter the pooled run-off. 7/5-7/12/06 - The silt fence where the process stockpile used to be was also washed down and a vehicle was parked on it. 7/12/06 	<ul style="list-style-type: none"> - Install haybales here for additional control if feasible. 7/5-7/12/06 - Repair silt fence and install haybales to reinforce the area. 7/12/06 	<ul style="list-style-type: none"> - Needs attention - Needs attention if feasible

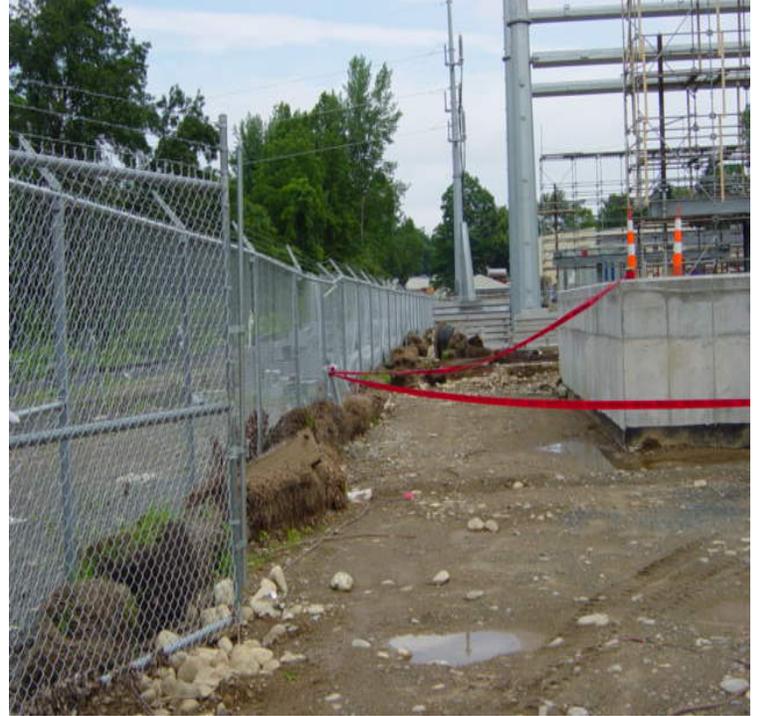
Areas of Inspection	Observation	Recommended Action	Corrected Actions
Erosion and Sediment Controls continued	<p>- Norwalk Junction: Perimeter silt fence remain in good shape along the river. 5/17-7/12/06.</p> <p>- The haybale line along the chain link fence is in disrepair. 7/12/06</p> <p>-The wetland area outside the silt fence adjacent to the river contains accumulated sediment and turbid water. 6/7-7/12/06</p> <p>- All the haybales in the swale culverts remain degraded. 6/28-7/12/06</p> <p>-Significant sediment accumulation was present in the swale due to dewatering. 6/7-7/12/06 The site was also very muddy at this time 7/12/06</p> <p>-Trench plates were placed over the swale for access. 7/12/06</p>	<p>- None at this time. Continue to monitor controls. 5/17-7/12/06.</p> <p>- The haybales are not needed if the silt fence remains in good shape but repairing them would provide another layer of control. 7/12/06</p> <p>- The silt is contained and does not reach the river. Wetland vegetation was also noted growing here, but silt has built up at the stone outlet and should be removed by hand. 6/1-7/12/06</p> <p>-Place new haybales or additional controls at all the culverts for filtration. 6/28-7/12/06</p> <p>- Continue to improve water quality to the swale. 345kV crews will be removing sediment from portions of the swale. 6/1-7/12/06.</p> <p>- The swale is intact at this time but if access causes any damage to the swale it should be repaired. 7/12/06</p>	<p>-N/A</p> <p>-N/A</p> <p>- Needs attention</p> <p>- Needs attention</p> <p>- Needs attention (345kV contractors will be removing some)</p> <p>- N/A at this time</p>

Norwalk Junction: Photo on the left shows an overview of the site work and scaffolding. Photo on the right shows the old haybale line along the fence. These could be replaced as an additional control but are not necessary if the silt fence along the river remains well maintained. 7/12/06.

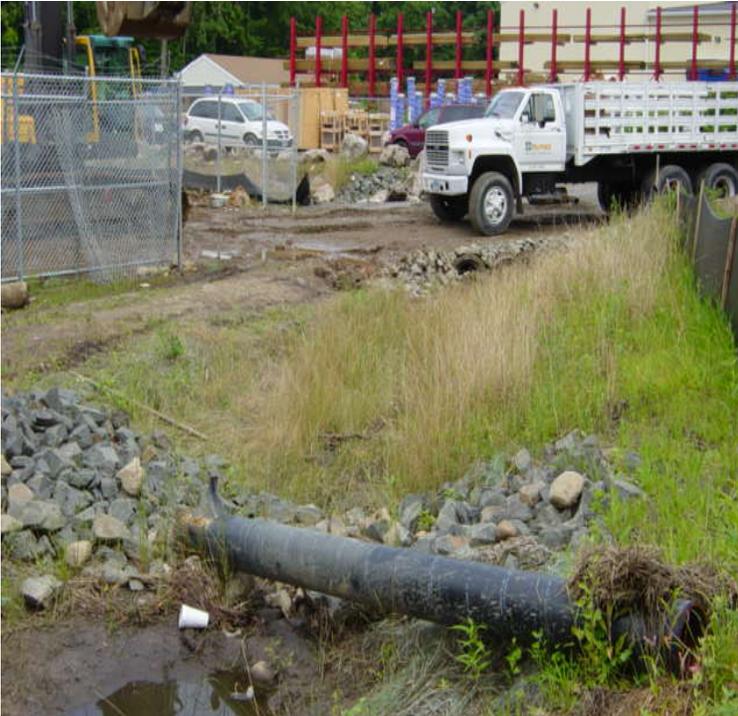
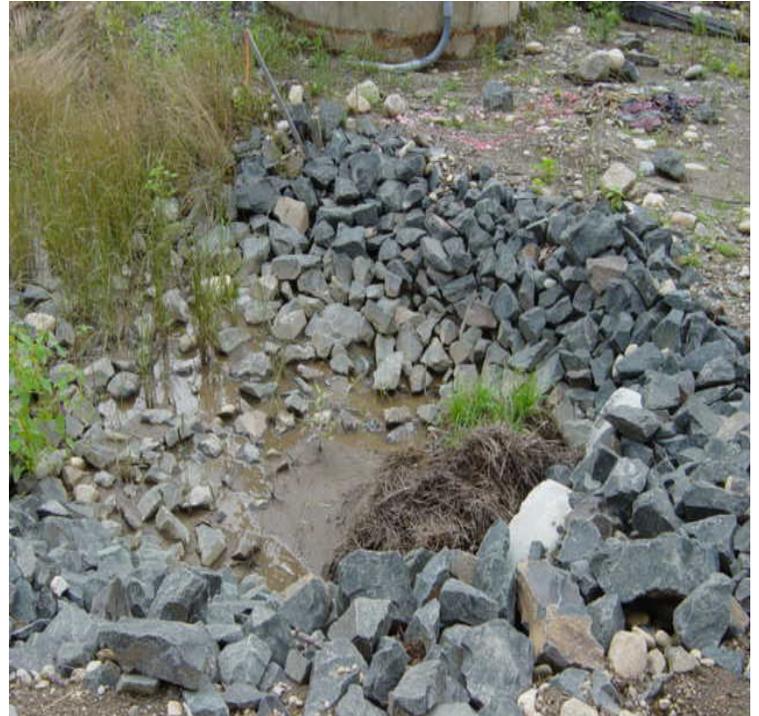
Areas of Inspection	Observation	Recommended Action	Corrected Actions
Norwalk Junction	-Active dewatering was noted in the swale. The haybales are degraded and turbid water was reaching the wetland area. Significant sediment had built up. 7/5-7/12/06.	reinforce controls. Some accumulated silt will be removed by 345kV crews. 6/28-7/12/06.	-N/A
Blasting	- All blasting is complete. 7/12/06	- None at this time.	-N/A
Soils	- A number of soil stockpiles remain at Norwalk Junction as excavation continues although a few were moved 7/12/06.	- Stockpiles remain contained. See erosion control section. 7/12/06. - Controls remain in place near 345kV stockpiles near the entrance to Norwalk	-N/A
Spills and Material Storage	- No obvious spills or equipment leaks were noted at this inspection 7/12/06	- Continue to keep all vehicles maintained well (i.e. no apparent fluid leaks) if they will be used or stored on site - Report spills immediately, even if they are being controlled. - Take care not to get carried away and to be vigilant when refueling. Avoid refueling in the areas near the wetlands. See proper storage for all materials.	-N/A

Both photos show views of the swales along the site. Accumulated sediment remains in several areas and should be cleaned out. Better filtration/controls are also needed at the culverts as the haybales here are degraded. 7/12/06.
