Docket No. 217 – Development and Management Plan Inspection

Northeast Utilities Service Company Certificate of Environmental Compatibility and Public Need for the construction of a 345-kV electric transmission line and reconstruction of an existing 115-kV electric transmission line between Connecticut Light and Power Company's Plumtree Substation in Bethel, through the towns of Redding, Weston, and Wilton, and to the Norwalk Substation in Norwalk, Connecticut.

Date: August 24, 2006

Location: Transition Stations: Hoyts Hill, Archers Lane, Norwalk Junction

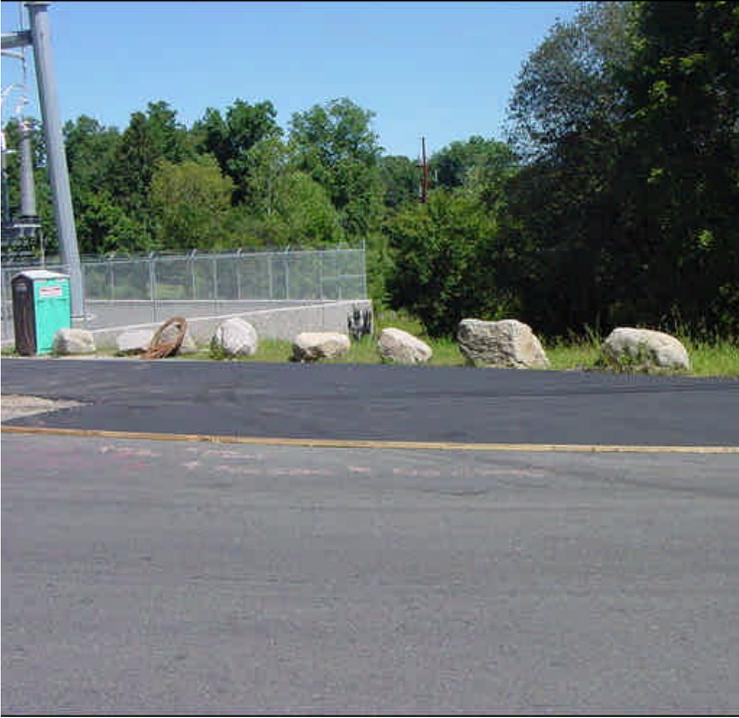
Hoyts Hill Transition Station: Photo on the left shows the newly paved drive up to the station. Photo on the right shows the restored wetland area at the base of the slope near Rt 58. 8/24/06

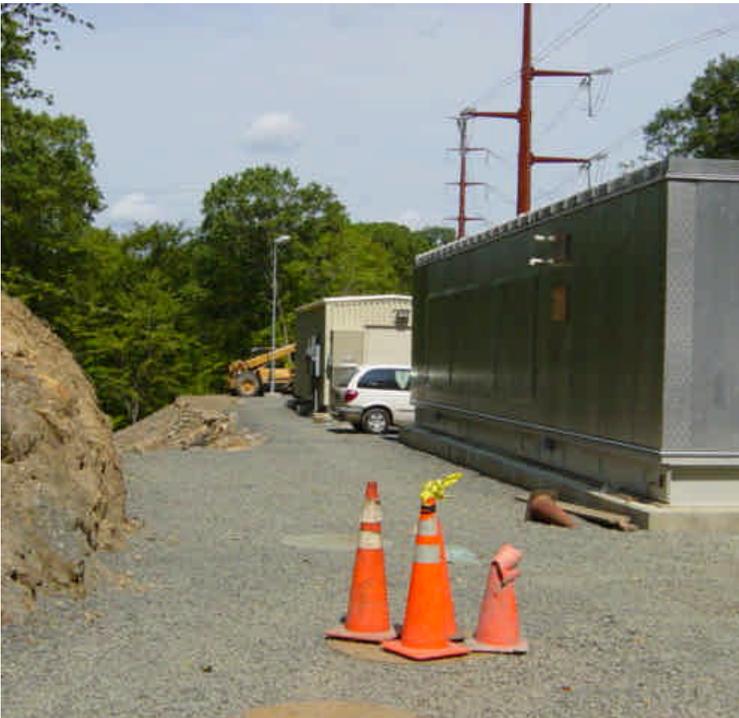
Archers Lane: Photo on the left shows a view at the yard along the remaining ledge. Crushed stone is in place. Photo on the right looks towards the stone swale leading towards the wetlands at the base of slope. 8/24/06

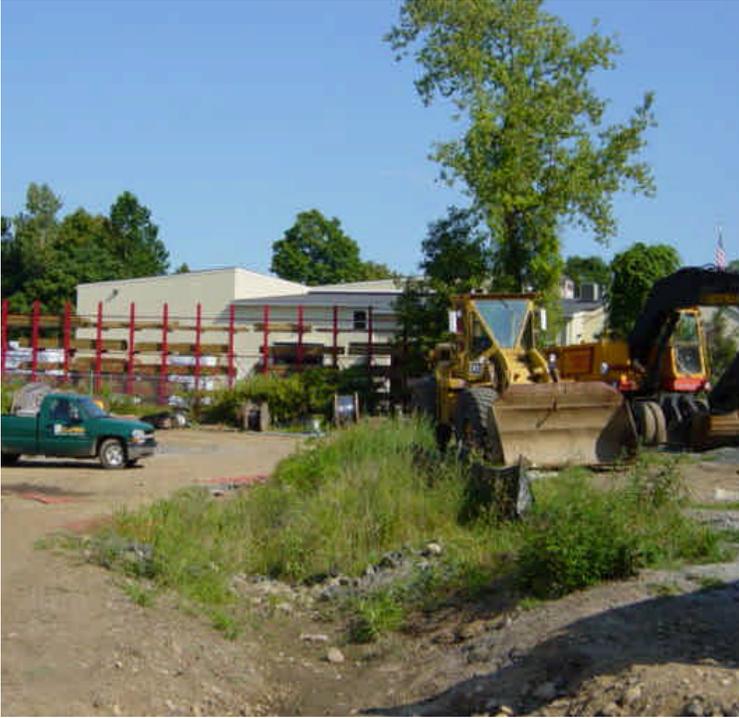
Norwalk Junction: Photo on the left shows an view of the swale which will need to be restored and stabilized. Accumulated sediment should be removed. Photo on the right shows the haybales remaining at the culvert which helps to filter some sediment. However, it is still accumulating in the wetland area at the outlet. 8/24/06.

Vegetative clearing limits or stabilization	<p>-Hoyts Hill: One gully remains through the stone pad on the southern slope. 6/28-8/24/06.</p> <p>- Archers Lane: Consider final stabilization measures for the area so turbid run-off to the wetland will be reduced. 7/26-8/24/06.</p> <p>- Norwalk Junction: -A number of bare soil areas around the perimeter of site should be temporarily stabilized/vegetated due to sediment loading to the swale. 7/26-8/24/06.</p>	<p>- The surrounding area is revegetating. See erosion control section. 6/7-8/24/06.</p> <p>-NU is evaluating potential solutions here. 7/26-8/24/06.</p> <p>- Restore perimeter surfaces wherever feasible (even if it is temporary) 6/1-8/24/06.</p>	<p>-Needs attention when feasible</p> <p>-Needs evaluation</p> <p>-Needs attention</p>
Dewatering Norwalk Junction	-Active dewatering occurs somewhat regularly to the swale. However, some portions need restoration. 8/24/06	-Restore swale when feasible. 8/16-8/24/06.	-Needs attention

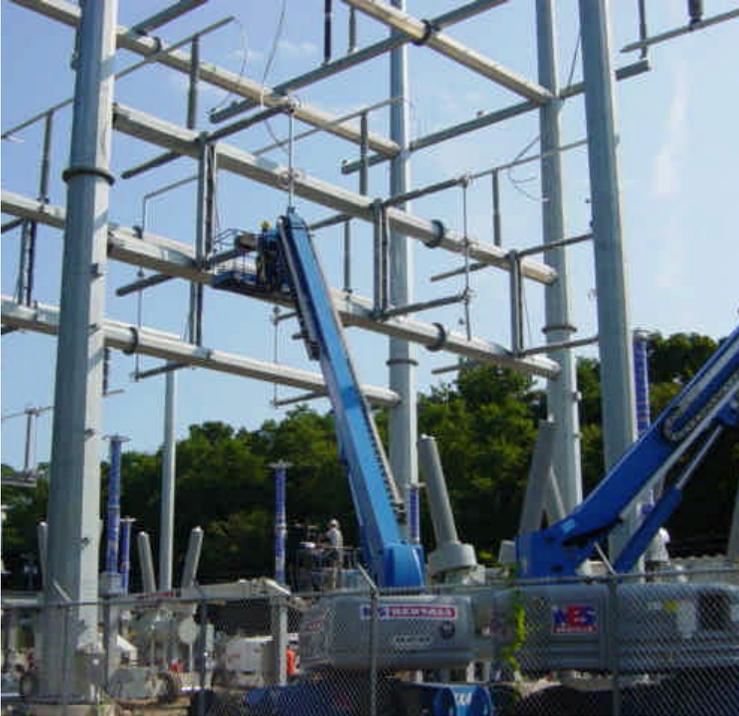
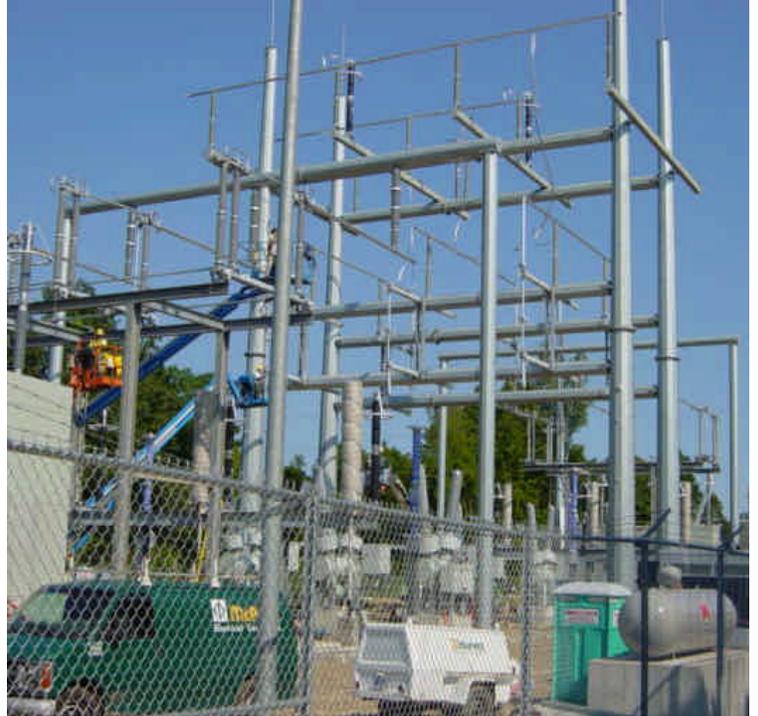
Both photos show the ongoing work on the structures and equipment in the station yard. 8/24/06.
