Docket No. 217 – Development and Management Plan Inspection

Northeast Utilities Service Company Certificate of Environmental Compatibility and Public Need for the construction of a 345-kV electric transmission line and reconstruction of an existing 115-kV electric transmission line between Connecticut Light and Power Company's Plumtree Substation in Bethel, through the towns of Redding, Weston, and Wilton, and to the Norwalk Substation in Norwalk, Connecticut.

Date: September 7, 2006

Location: Transition Stations: Hoyts Hill, Archers Lane, Norwalk Junction

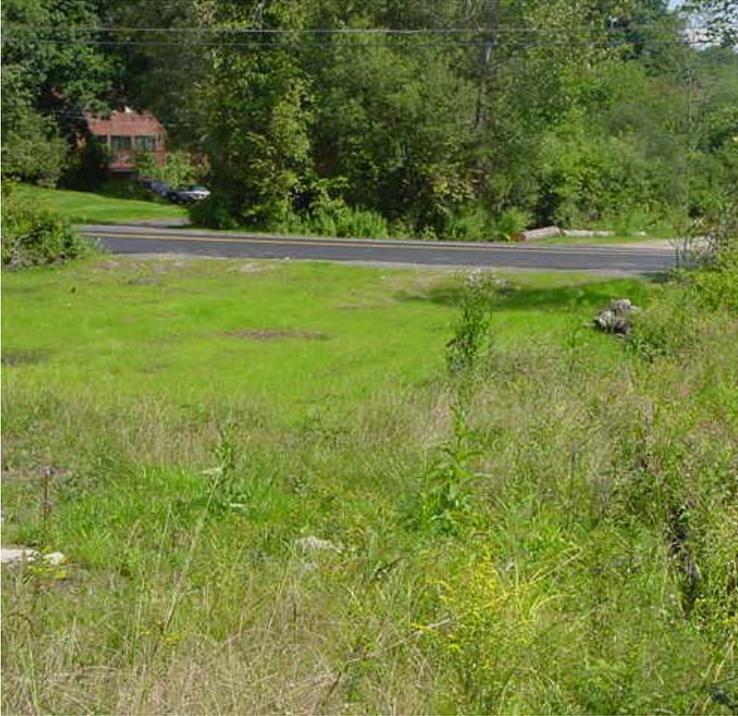
Hoyts Hill Transition Station: Photo on the left shows vegetation returning to the restored wetland area off Rt 58. Archers Lane: Photo on the right shows an overview of the station after the area was landscaped. 9/7/06

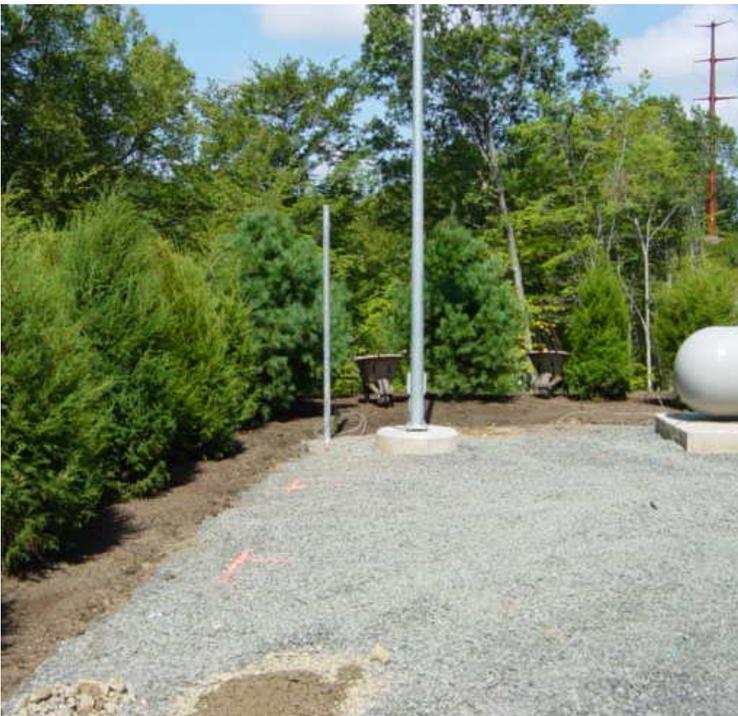
Archers Lane: Photo on the left shows a close-up of the landscaped screening trees. Norwalk Junction: Photo on the right shows the muddy conditions at the entrance to the yard. Tracking was noted on Rt 7. 9/7/06

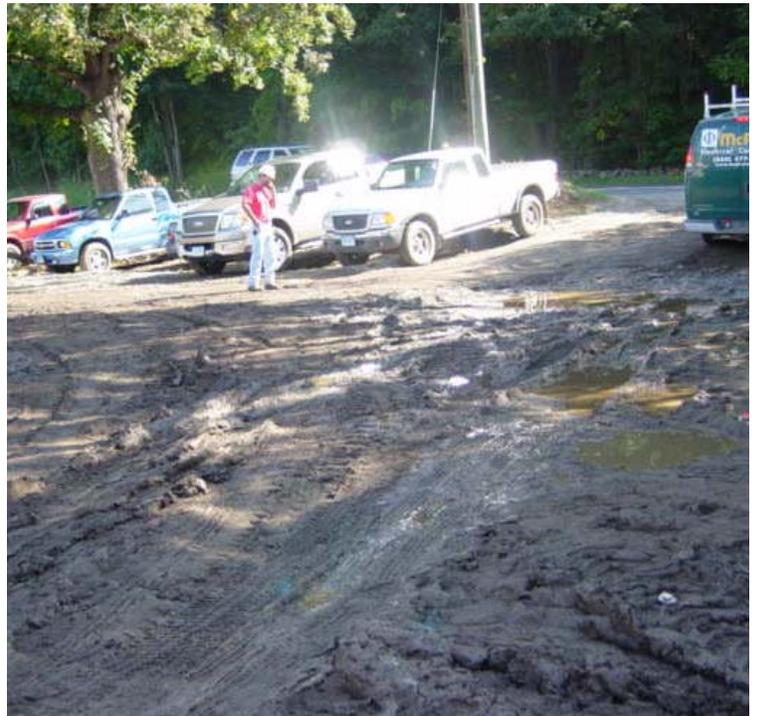
| Areas of Inspection | Observation | Recommended Action | Corrected Actions |
|--|--|--|---|
| Access Roads and Adjacent Roadways continued | <p>remain. 8/16-9/7/06</p> <p>- Haybales remain in place where water had pooled in the access road near the stone wall. 9/7/06</p> <p>- Norwalk Junction: Sediment tracking was noted on Rt 7 due to very muddy conditions at the access to the site. 9/7/06.</p> <p>-The front portion of the yard is largely disturbed due to extensive parking here. 8/30-9/7/06</p> | <p>-Continue to monitor for more permanent solutions if necessary. 9/7/06</p> <p>-Sweep Rt 7 as necessary and improve the construction pad if it can be done safely. 9/7/06</p> <p>- Stabilize any areas as feasible to reduce disturbance. 8/30-9/7/06 Conditions are very muddy.</p> | <p>-N/A</p> <p>-Needs attention</p> <p>- Needs attention</p> |

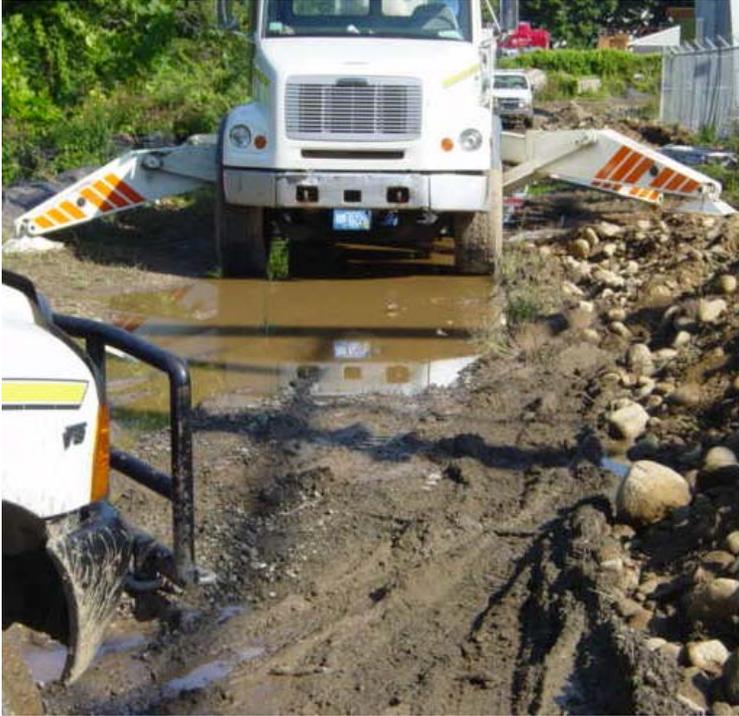
| Areas of Inspection | Observation | Recommended Action | Corrected Actions |
|---|--|--|---|
| | <p>- Increasingly larger areas on site have soil disturbance (due to parking and tracking) leading to additional sediment in the swale. 7/19-9/7/06 This includes the area adjacent to the perimeter chain link fence by the river. 7/26-9/7/06</p> <p>Conditions are extremely muddy at this time and will put increased pressure on controls. 9/7/06</p> | <p>- Remove accumulated sediment from the swale and continue to improve water quality to the swale by restoring areas wherever feasible. 6/1-9/7/06</p> <p>-Reduce disturbance and tracking as much as possible. 9/7/06</p> | <p>- Needs attention</p> <p>- Needs attention</p> |

Norwalk Junction: Photo on the left shows equipment accessing the area beyond the chain link fence. Conditions were very muddy at this time. Photo on the right shows ditching along the perimeter fence. 9/7/06.

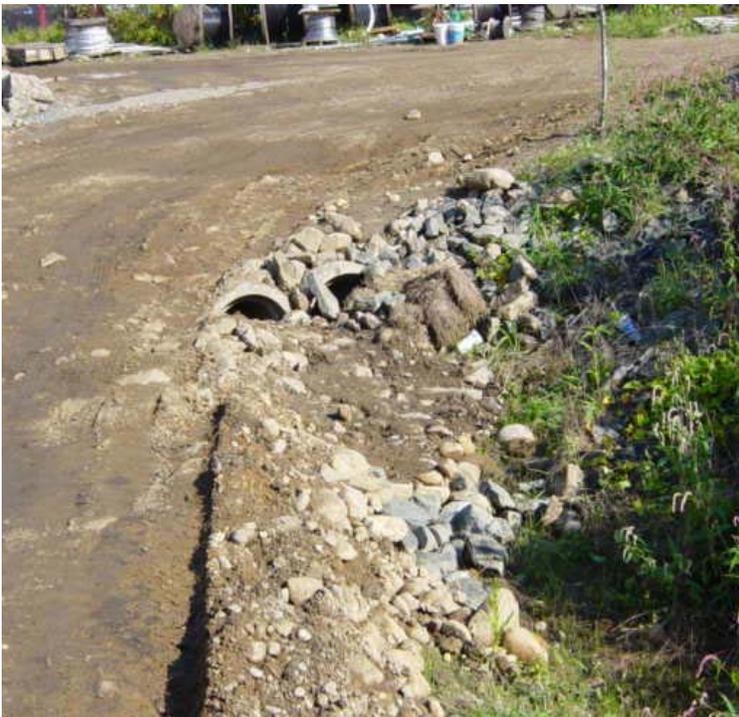
| Areas of Inspection | Observation | Recommended Action | Corrected Actions |
|---|--|--|---|
| | <p>-The portion of the swale that was filled in has been regraded but remains exposed 8/16-9/7/06</p> <p>-Access into the site has caused the culvert in the swale to be partially filled with stone and sediment 9/7/06</p> | <p>-Place stone and revegetate to restore the swale to previous conditions. 8/16-9/7/06</p> <p>-Restore and repair swale. Add additional controls downstream to prevent turbidity. 9/7/06</p> | <p>- Needs attention</p> <p>- Needs attention</p> |

Photo on the left shows access over the swale where sediment and rocks have partially filled in the culvert. This needs to be repaired and the surrounding area stabilized. Photo on the left shows the swale which will need reinforcement and restoration measures. 9/7/06.

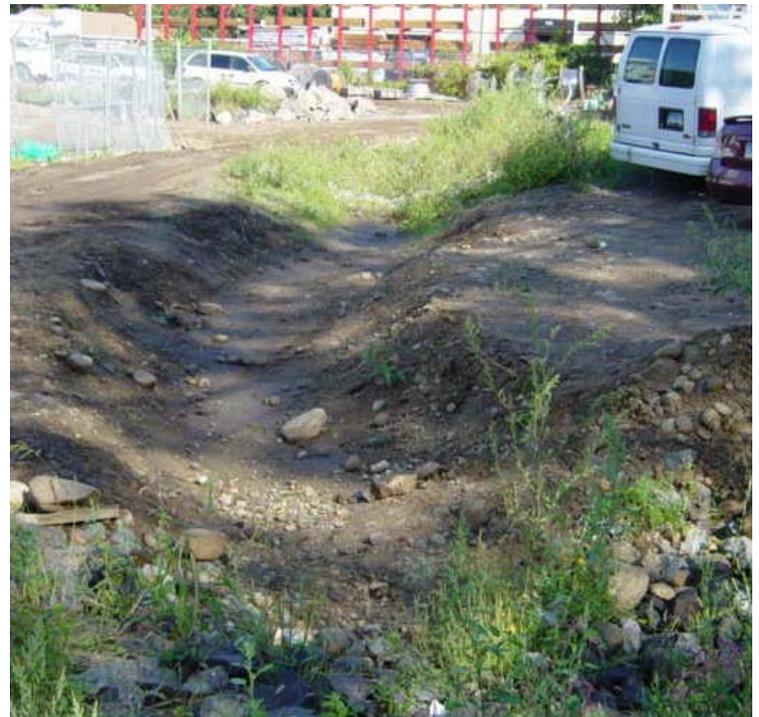
| Areas of Inspection | Observation | Recommended Action | Corrected Actions |
|---|---|---|--|
| Dewatering Norwalk Junction | -No active dewatering was noted at Norwalk Junction. However, several portions of the swale need restoration. 9/7/06 | -Restore swale and increase controls. 8/16-9/7/06. | -Still needs attention |
