**Docket No. 217 – Development and Management Plan Inspection**

Northeast Utilities Service Company Certificate of Environmental Compatibility and Public Need for the construction of a 345-kV electric transmission line and reconstruction of an existing 115-kV electric transmission line between Connecticut Light and Power Company's Plumtree Substation in Bethel, through the towns of Redding, Weston, and Wilton, and to the Norwalk Substation in Norwalk, Connecticut.

**Date:** September 20, 22, 2006

**Location:** Transition Stations: Hoyts Hill, Archers Lane, Norwalk Junction

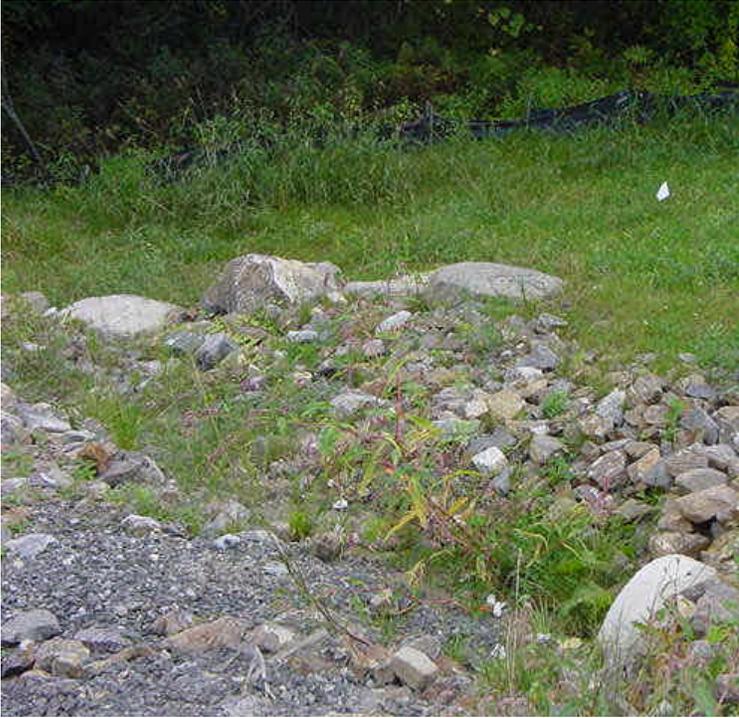
**Hoyts Hill Transition Station: Photo on the left shows the silt fence remaining at the end of the outlet pad and slope. This can be removed when feasible. Photo on the right shows good vegetative growth in the restored wetland area off Rt 58. Some tire tracks were noted here. 9/20/06**

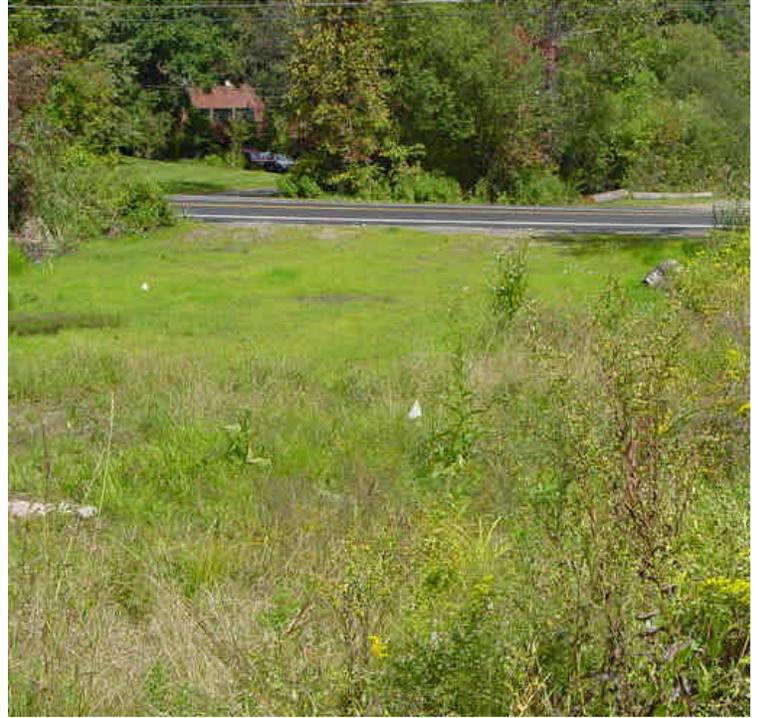
<p>Erosion and Sediment Controls</p>	<p>-<b>Hoyts Hill:</b> The silt fence along the wetlands at the rear of the station remains in good shape. 4/6-9/22/06.</p> <p>- The restored wetland at the base of slope is well vegetated but tire tracks were noted. 8/16-9/22/06</p> <p>-One small gully in the southern slope remains along the stone pad. The surrounding area is</p>	<p>-Silt fence can likely be removed from most areas as adjacent vegetation is stable. 8/24-9/22/06</p> <p>- Continue to monitor as the area stabilizes and restore as necessary. 9/22/06</p> <p>-Determine if the area has stabilized adequately or if the gully still needs</p>	<p>- N/A</p> <p>- N/A.</p> <p>- Needs evaluation when feasible. (no further action may</p>

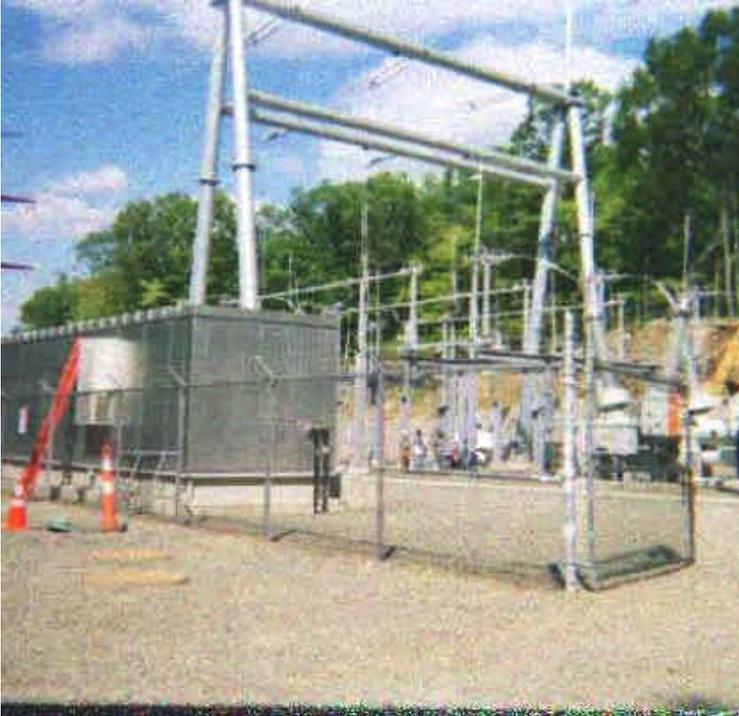
**Archers Lane: Photo on the left shows an overview of the yard with the recently installed perimeter fence. Photo on the right shows the 1<sup>st</sup> wetland area where accumulated sediment has been removed by hand. 9/22/06**

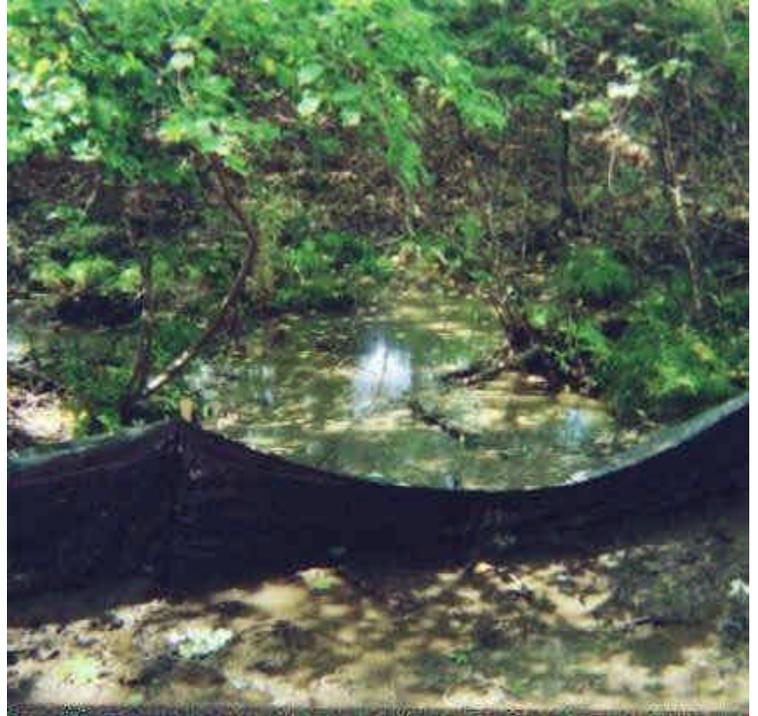
<p>Inland Wetland and Watercourse encroachment and mitigation</p>	<p>- <b>Hoyts Hill:</b> The wetland remains well protected and well vegetated 9/22/06</p> <p>-<b>Archers Lane:</b> Accumulated sediment in the 1<sup>st</sup> wetland crossing has been removed and restoration is occurring. 9/22/06.</p> <p>- <b>Norwalk Junction:</b> The outlet of the drainage swale is at the headwall of the wetland area. Wetland vegetation was growing but silt has accumulated and turbid water remains 6/14-9/22/06</p>	<p>-Erosion controls could likely be removed from most areas. 9/22/06.</p> <p>- Continue to monitor and restore as the stone crossing was removed. 9/22/06.</p> <p>- Reduce turbidity by controlling its source-disturbed surfaces and dewatering on site. Deeper sediment buildup at the outlet and within the basin should be removed. 5/25-9/22/06.</p>	<p>- N/A.</p> <p>-Restoration is underway and sediment was removed.</p> <p>-Needs attention</p>

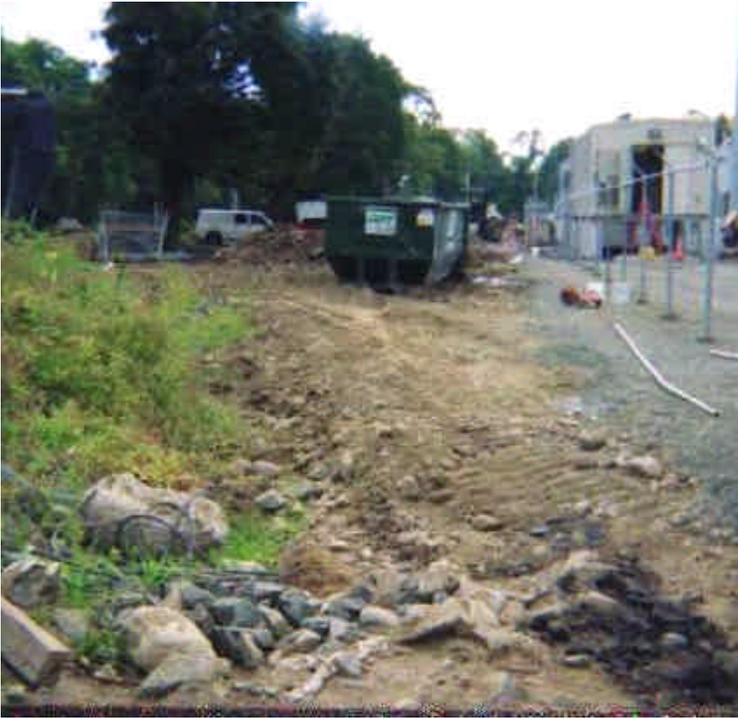
Areas of Inspection	Observation	Recommended Action	Corrected Actions
	<p>- The front portion of the site has extensive areas of soil disturbance (due to parking and tracking) leading to additional sediment in the swale. 6/1-9/22/06</p> <p>-The area adjacent to the perimeter chain link closer to the river is being graded with process. 9/22/06</p>	<p>removed by hand 6/1-9/22/06</p> <p>- Remove accumulated sediment from the swale and continue to improve water quality to the swale by restoring areas wherever feasible. 6/1-9/22/06</p> <p>Revegetate the adjacent area to the extent feasible. 9/7-9/22/06</p>	<p>- Needs attention</p>
	<p>-Access into the site has caused the culvert in the swale to be partially filled with stone and sediment 9/7-9/22/06 and the remainder of the swale is exposed soil 8/16-9/22/06</p>	<p>-Repair the swale and place stone and revegetate to restore to previous conditions. Add additional controls downstream to prevent turbidity. 8/16-9/22/06</p>	<p>- Needs attention</p>

**Norwalk Junction: Photo on the left shows the front portion of the site with disturbed soil resulting from parking. Repair and restoration of the swale are proposed. Photo on the left shows accumulated sediment remaining in the wetland area and at the outlet. 9/22/06.**

Areas of Inspection	Observation	Recommended Action	Corrected Actions
Vegetative clearing limits or stabilization	- <b>Norwalk Junction:</b> -A number of bare soil areas around the perimeter of site should be temporarily stabilized/vegetated due to sediment loading to the swale. 7/26-9/22/06.	- Restore perimeter surfaces wherever feasible (even if it is temporary) 6/1-9/22/06.	-Still needs attention and problem is worse
Dewatering <b>Norwalk Junction</b>	-No active dewatering was noted at Norwalk Junction. However, several portions of the swale need restoration. 9/22/06	-Restore swale and increase controls. 8/16-9/22/06.	-Still needs attention
Blasting	- All blasting is complete. 9/22/06	- None at this time.	-N/A
Soils	- The yard of Norwalk Junction has been paved. Remaining soil was used or removed. 9/22/06.	-None. 9/22/06.	-The area was paved
Spills and Material Storage	- No obvious drips or spills were noted at the inspection. 9/22/06	- Continue to keep all vehicles maintained well (i.e. no apparent fluid leaks) if they will be used or stored on site - Report spills immediately, even if they are being controlled. - Take care not to get carried away and to be vigilant when refueling. Avoid refueling in the areas near the wetlands. See proper storage for all materials.

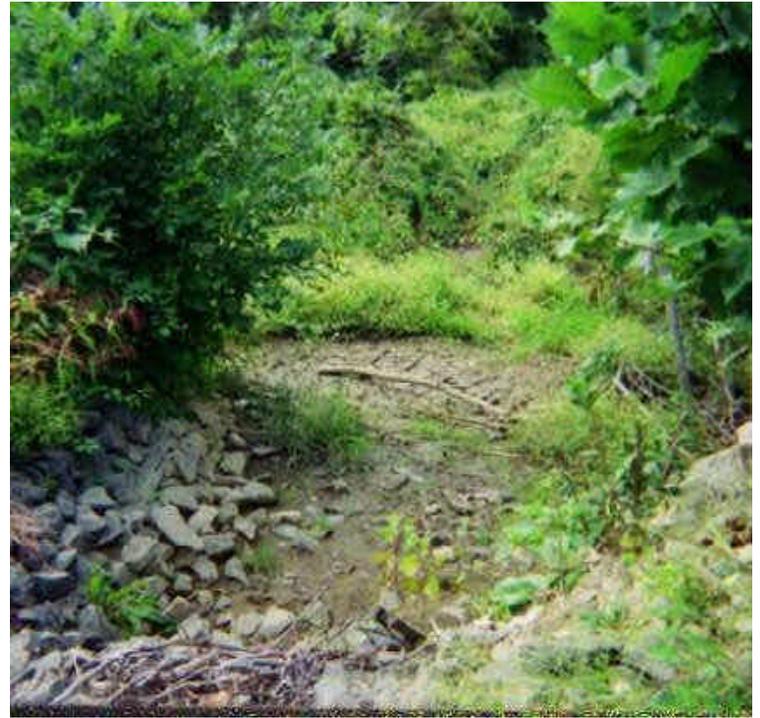
<ul style="list-style-type: none"> <li>- <b>Norwalk Junction:</b> Perimeter silt fence remain in good shape along the river. 5/17-9/22/06.</li> <li>-The wetland area at the end of the swale, outside the silt fence, adjacent to the river contains accumulated sediment. 6/7-9/22/06</li> </ul>	<ul style="list-style-type: none"> <li>- None at this time. Continue to monitor controls. 5/17-9/22/06.</li> <li>- The silt is contained and does not yet reach the river. Wetland vegetation was also noted growing here, but silt has built up significantly at the stone outlet and should be</li> </ul>	<ul style="list-style-type: none"> <li>-N/A</li> <li>- Needs attention</li> </ul>

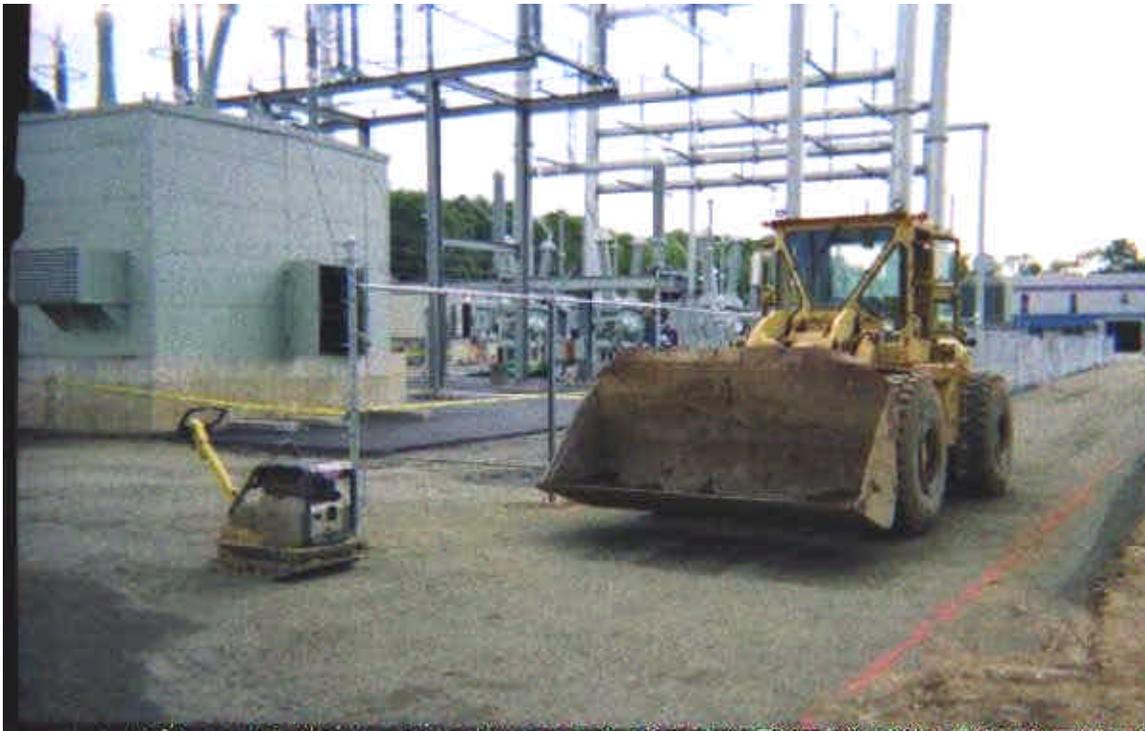
**Photo shows an overview of the yard. Areas around the structures have already been paved and adjacent areas are being graded. 9/22/06.**
