Docket No. 217 – Development and Management Plan Inspection

Northeast Utilities Service Company Certificate of Environmental Compatibility and Public Need for the construction of a 345-kV electric transmission line and reconstruction of an existing 115-kV electric transmission line between Connecticut Light and Power Company’s Plumtree Substation in Bethel, through the towns of Redding, Weston, and Wilton, and to the Norwalk Substation in Norwalk, Connecticut.

Date: October 19, 2005

Location: Transition Stations: Hoyts Hill, Archers Lane, Norwalk Junction

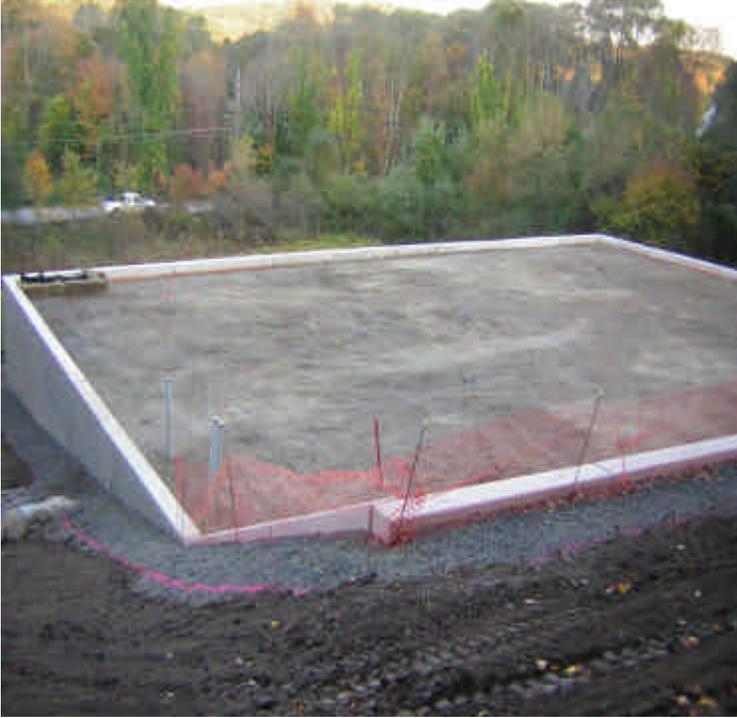
Hoyts Hill Transition Station: Photo on the left shows that the site yard has been backfilled and brought to grade. Photo on the right shows that minor repairs are needed on the perimeter silt fence. 10/19/05

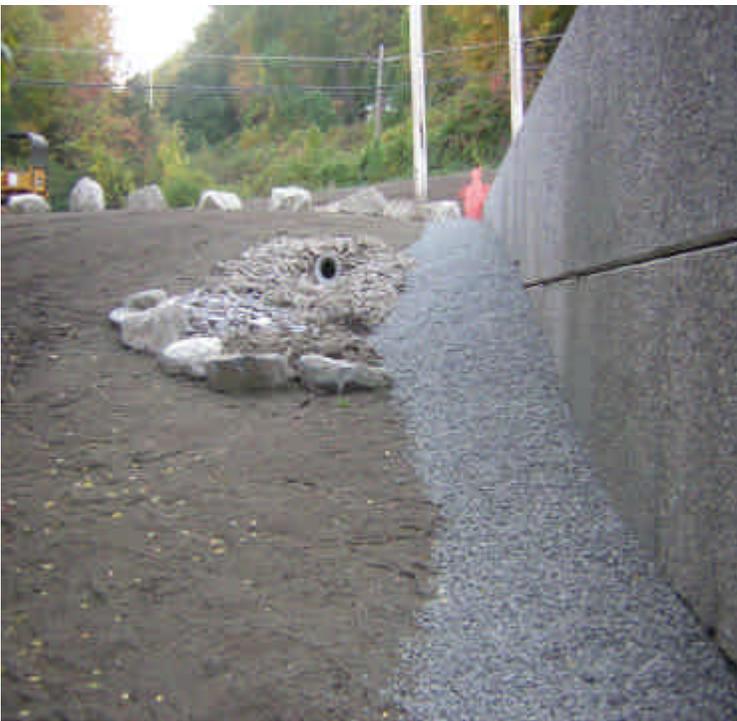
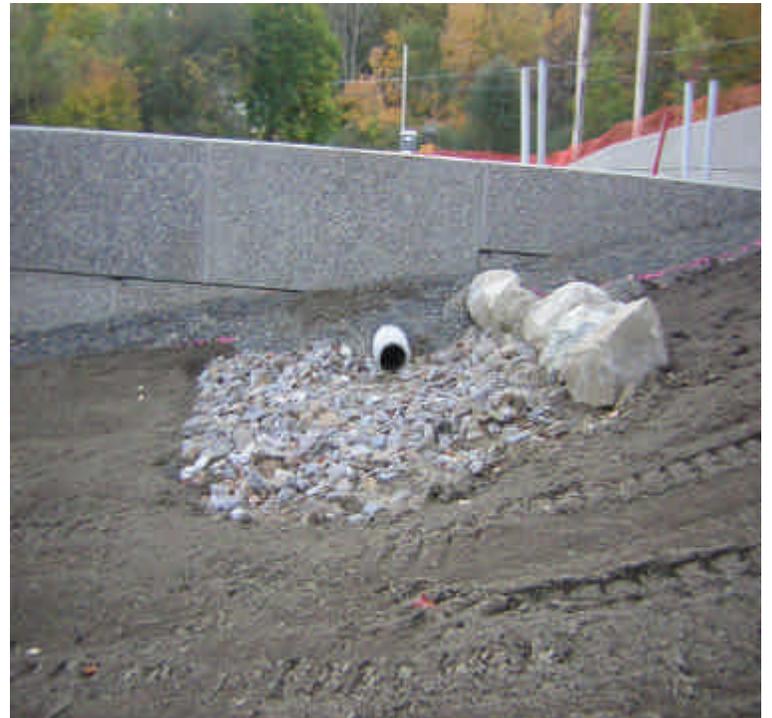
The pipes along the retaining wall have been installed but were not discharging at the time of inspection. Sediment was seen in the riprap pads. 10/19/05

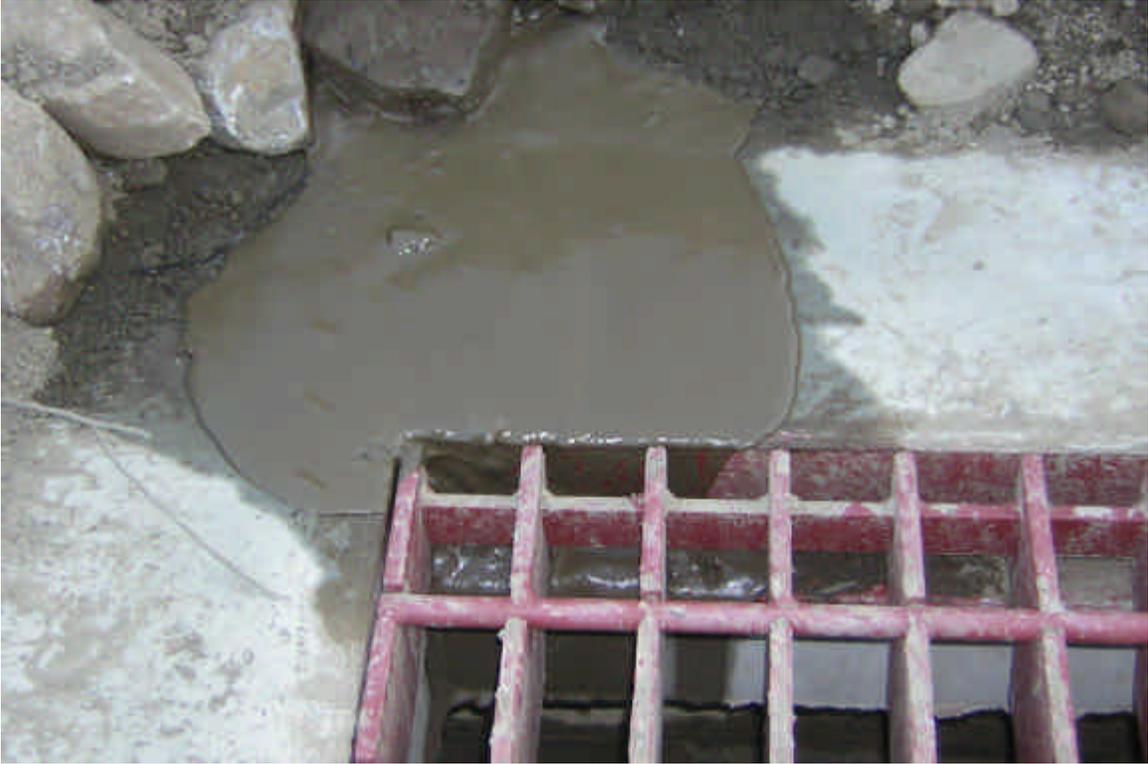
A large amount of sediment was noticed entering and accumulated within the catch basin. The source was unknown. The catch basin should be cleaned out. 10/19/05

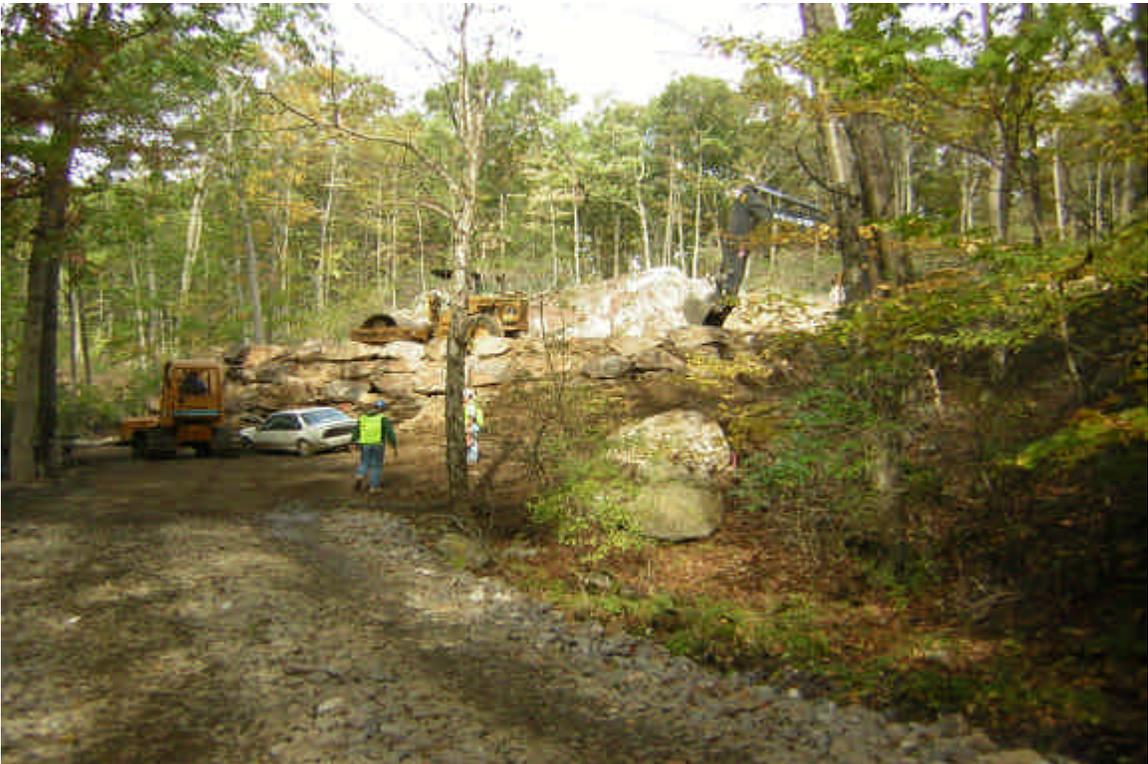
Archers Lane: Blasting and site work continue at Archers Lane. 10/19/05

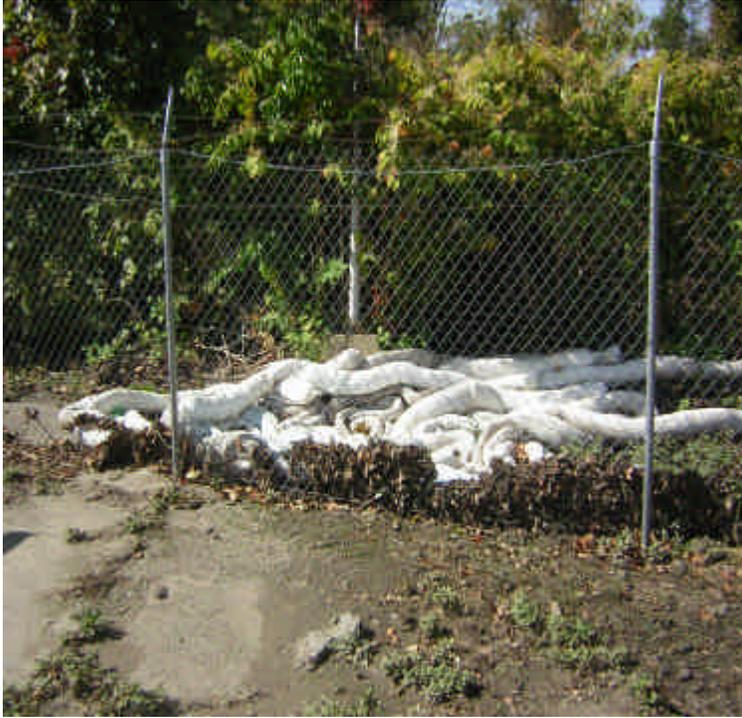
Norwalk Junction: The release from the frac truck associated with the 115kV work has been cleaned, but booms still remain on site and should be removed by 115 contractors. Photo on the right shows a view of the fuel stains beneath the Volvo, excavator. The vehicle appeared to be leaking during the time of inspection.

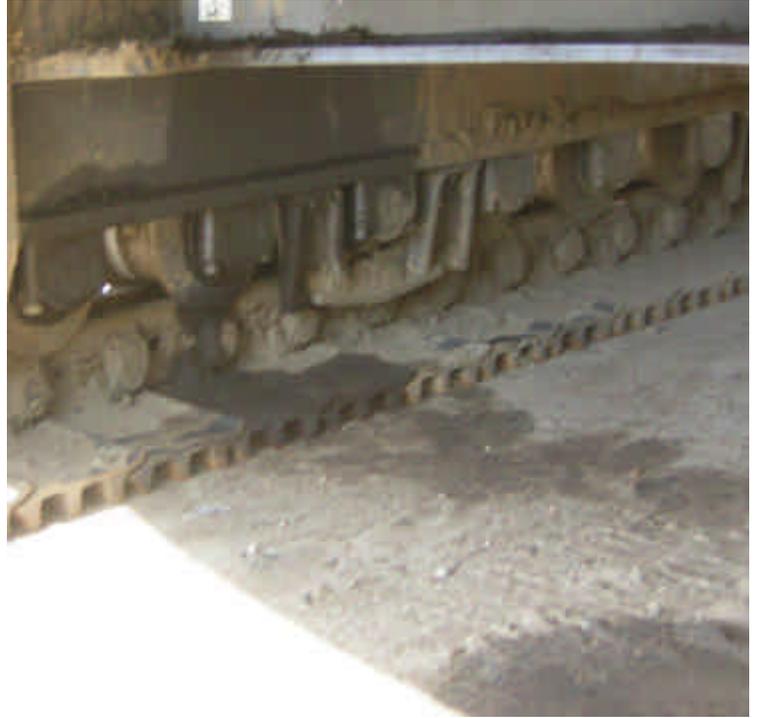
Areas of Inspection	Observation	Recommended Action
Spills and Material Storage	<p>- No further drips or leaks were noted at Archers Lane or Hoyts Hill at the time of the inspection.</p> <p>- Drips/stains were noticed beneath a piece of equipment at Norwalk Junction. It appears that the equipment was leaking but it is possible the leaks were from previous machinery stored in the area. The leak was contained to the asphalt but the machine should be repaired if necessary. 10/19/05.</p>	<p>-Further investigation is needed to accurately determine the source of the fuel.</p> <p>- Continue to keep all vehicles maintained well (i.e. no apparent fluid leaks) if they will be used or stored on site</p> <p>- Report spills immediately, even if they are being controlled.</p> <p>- Take care not to get carried away and to be vigilant when refueling. Avoid refueling in the areas near the wetlands. Se proper storage for all materials.</p>

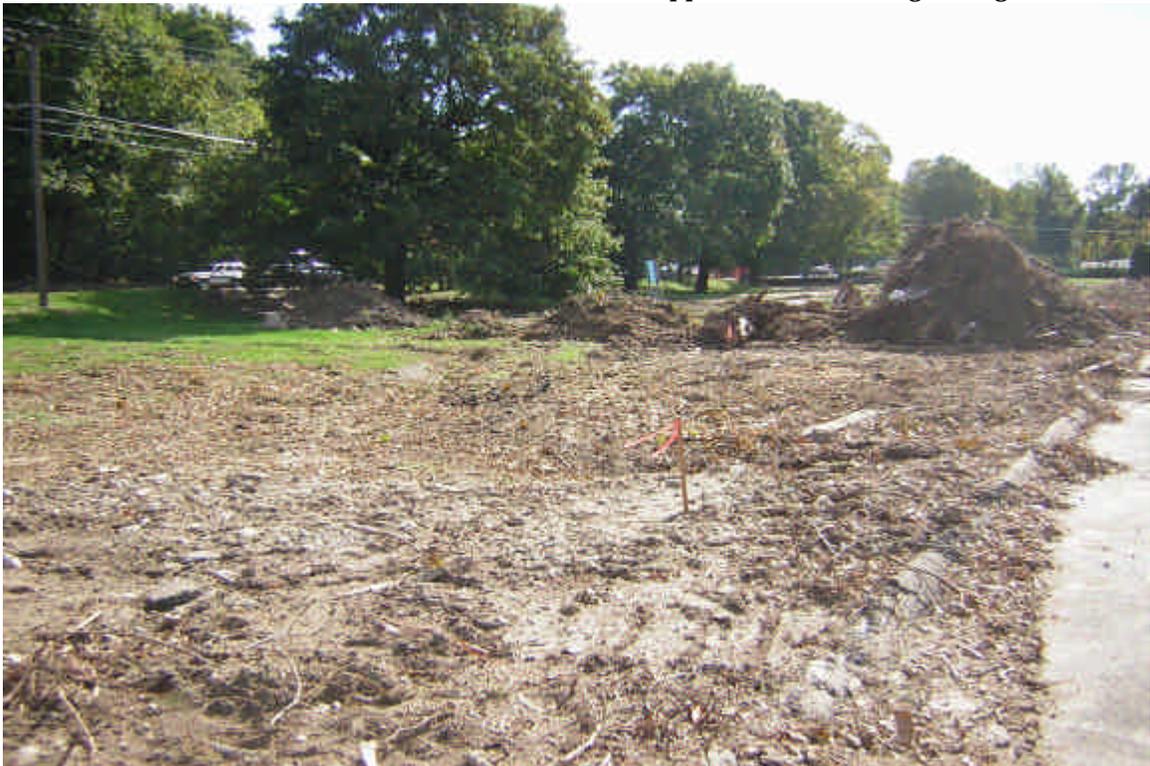
Clearing continues beyond the footprint of the parking area.

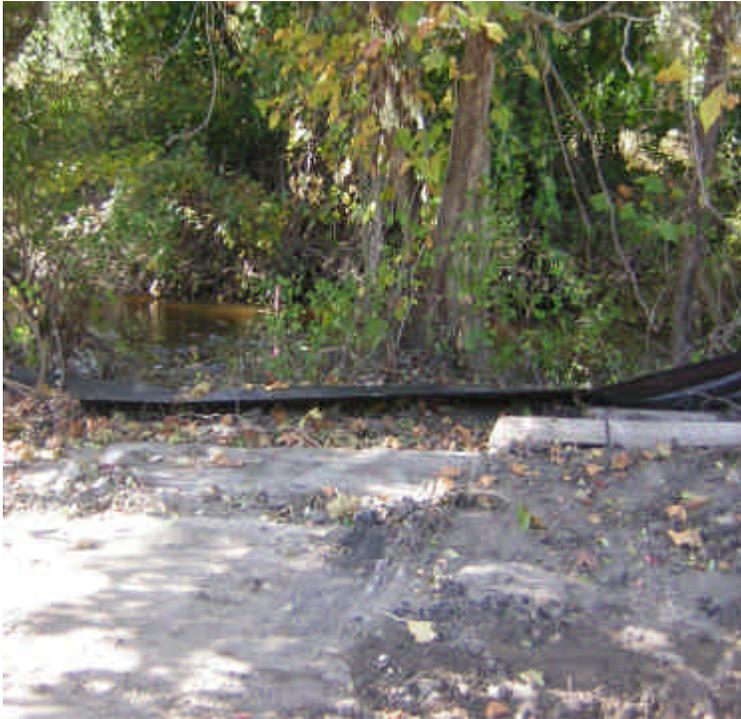
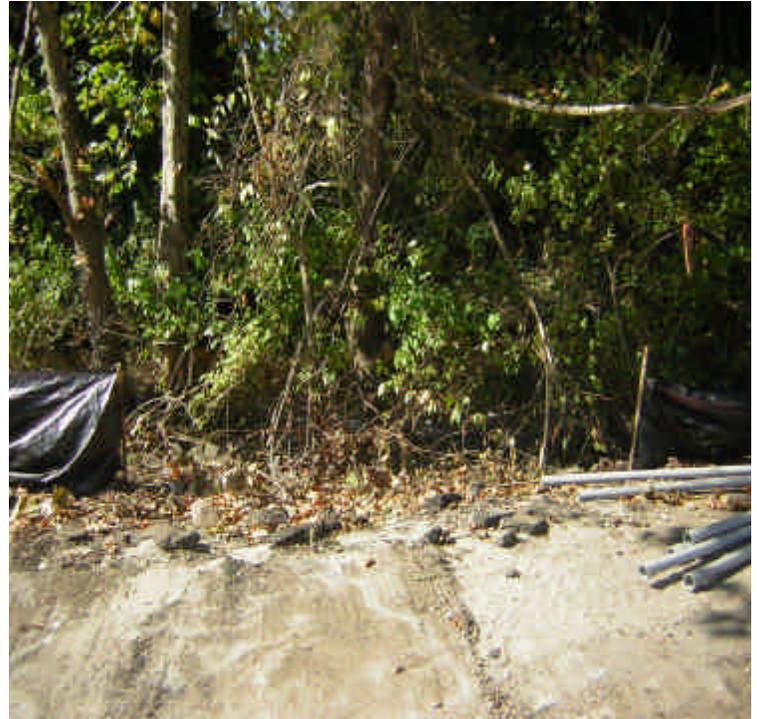
Both photos show the erosion controls associated with the 115kV work are still in need of repair due to the previous flood damage. Good perimeter controls should be installed for the station work. 10/19/05

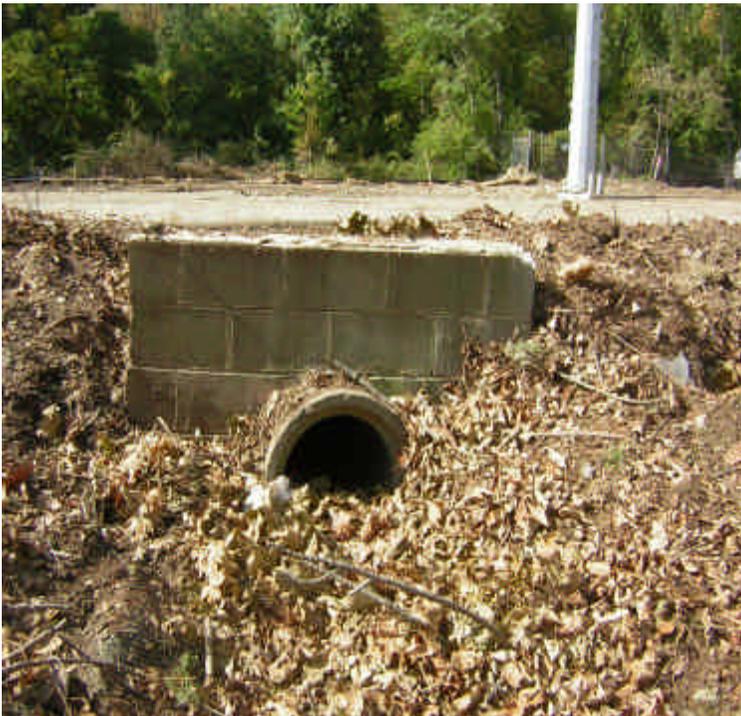
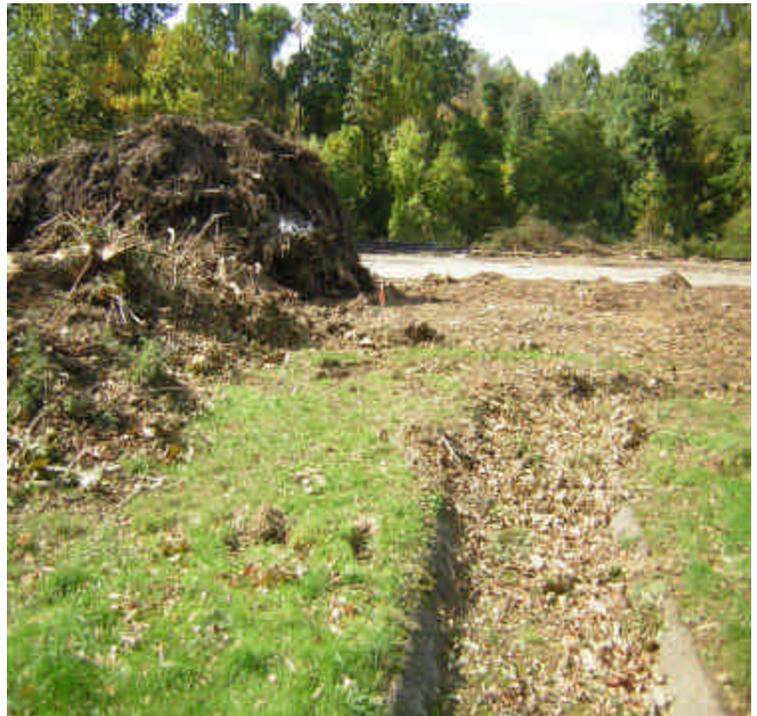
Photo on the left shows a view of inlet associated with a paved swale on site that leads to the wetlands. Photo on the right shows a view of the paved swale and adjacent stockpiles. Sediment control measures are needed here. 10/19/05
