Docket No. 217 – Development and Management Plan Inspection

Northeast Utilities Service Company Certificate of Environmental Compatibility and Public Need for the construction of a 345-kV electric transmission line and reconstruction of an existing 115-kV electric transmission line between Connecticut Light and Power Company's Plumtree Substation in Bethel, through the towns of Redding, Weston, and Wilton, and to the Norwalk Substation in Norwalk, Connecticut.

Date: October 27, 2005

Location: Transition Stations: Hoyts Hill, Archers Lane, Norwalk Junction

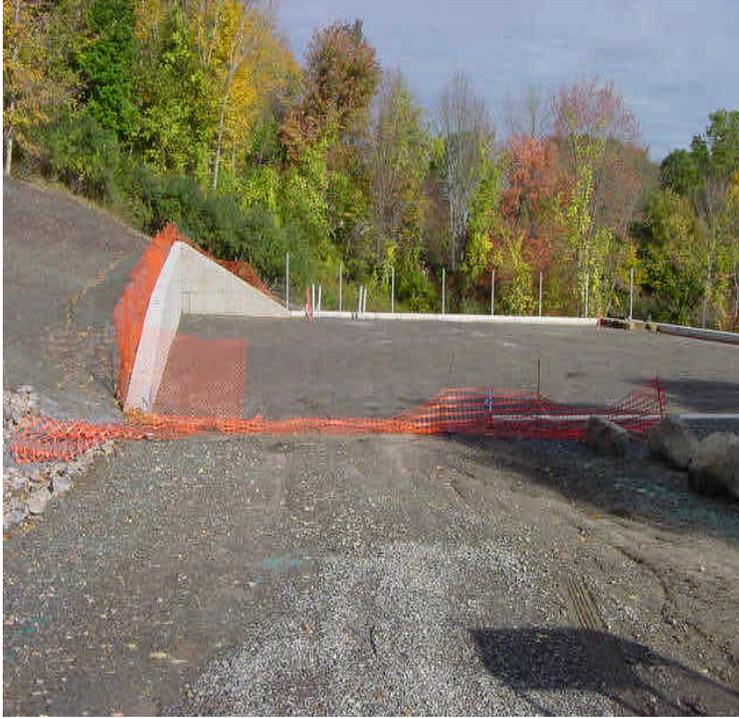
Hoyts Hill Transition Station: Photo on the left shows the overall site yard and recent restoration. Photo on the right shows that minor repairs are needed on the perimeter silt fence. 10/27/05

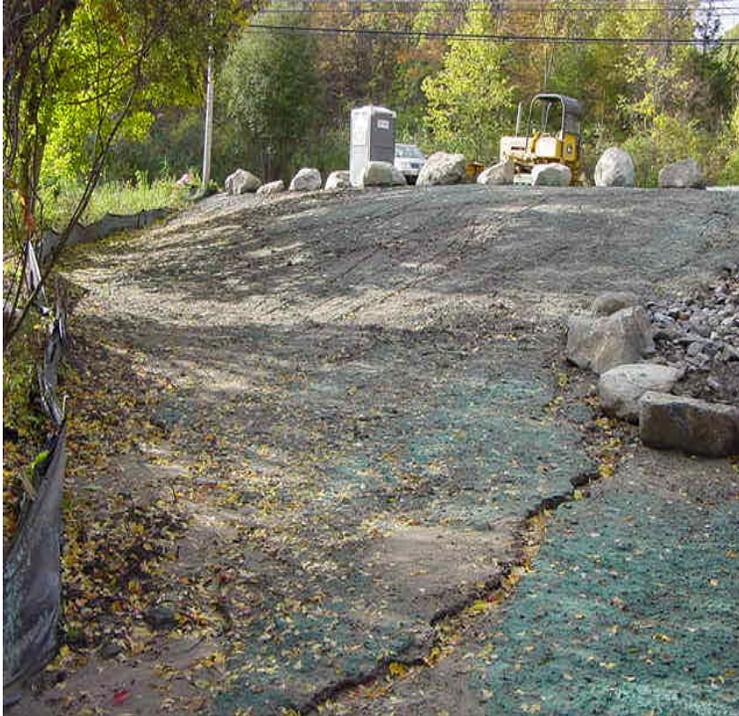
Photo on the left shows where an erosive gully was caused from the heavy flow leaving the outlet pipe. The dissipater pad likely needs to be extended to prevent this and the gully needs repair. Photo on the right shows the recently hydroseeded area. 10/27/05

Foundation construction	<p>- The Hoyts Hill station yard has been backfilled and brought to grade but work has not started on structures yet. 10/27/05.</p> <p>- Additional work may be necessary on the southern side</p>	<p>-None at this time. 10/27/05.</p> <p>-The pad may need to be extended here based on the noted erosion issues. See</p>

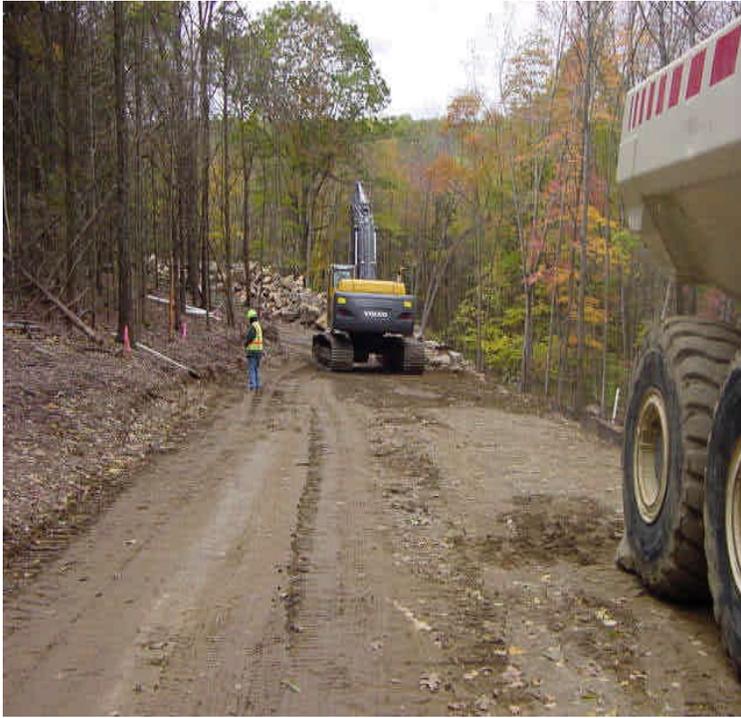
Archers Lane: Photo on the left shows removal of the boulders stockpiled along the access road. Photo on the right shows preparation for blasting along the grade into the site. Blasting should be complete this week. 10/27/05

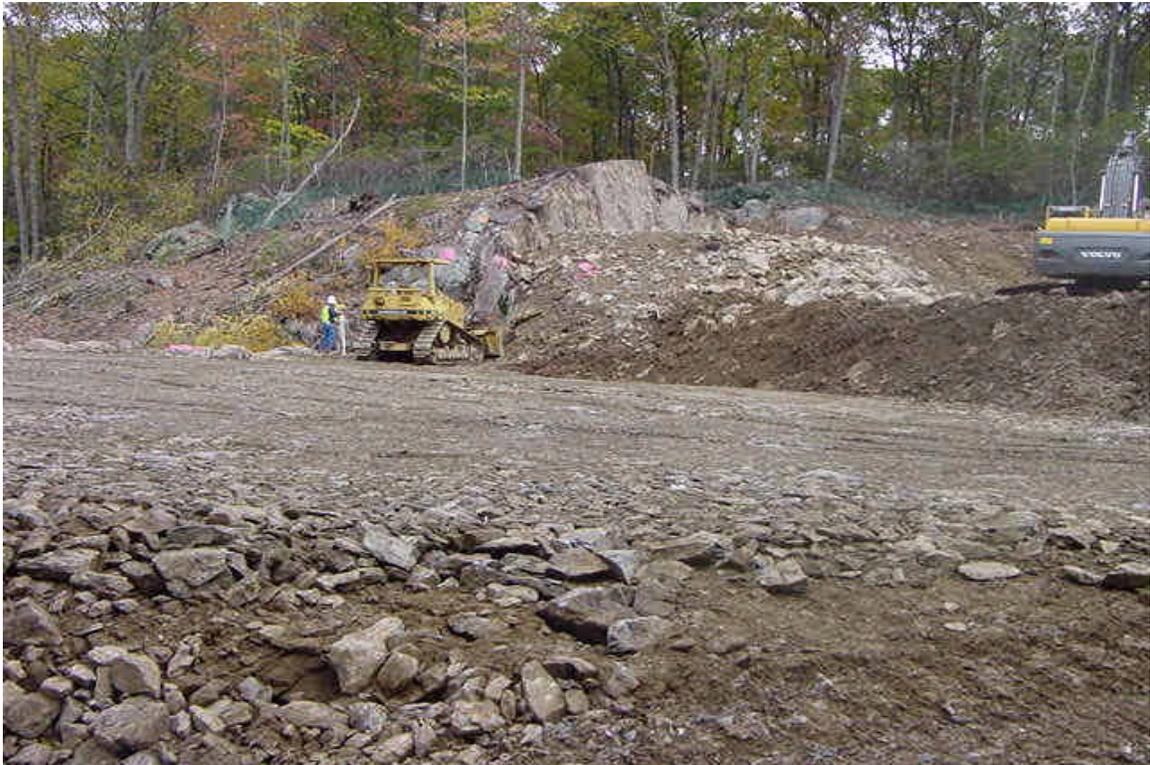
Overview of the site work on the station yard here. 10/27/05

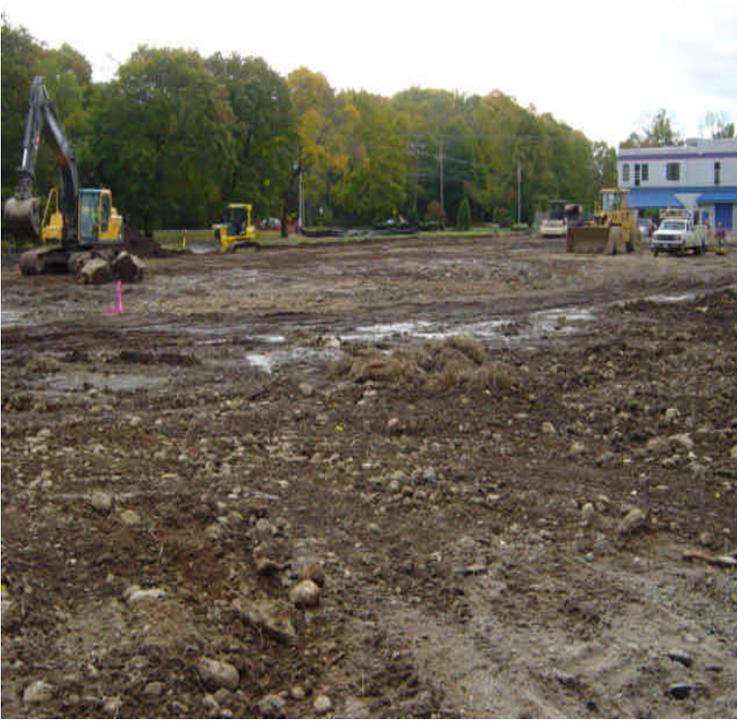
Norwalk Junction: The photo on the left shows an overview of the site following the removal of the existing asphalt. The photo on the right shows the transition structure installed by the 115kV contractors. 10/27/05

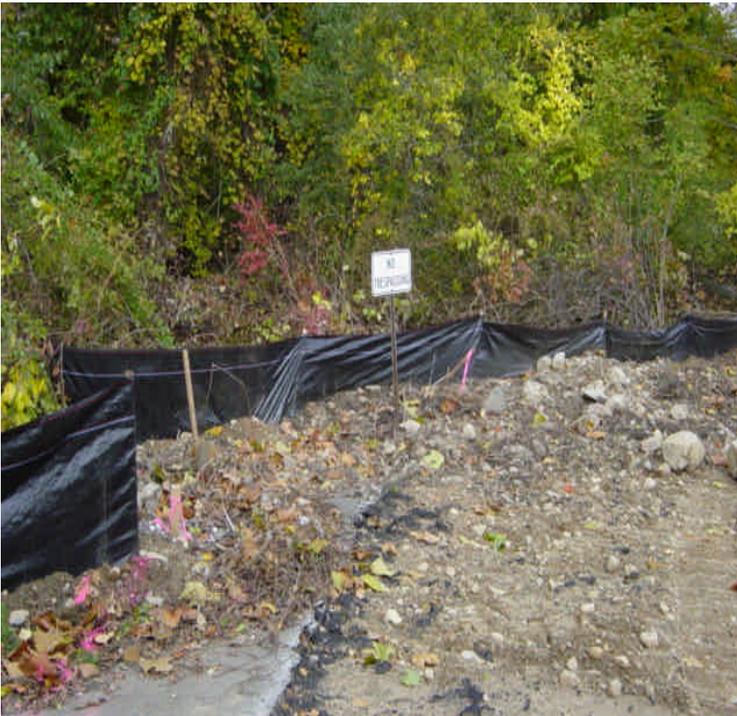
The photo on the left shows where the perimeter erosion controls had been restored for the station work. The photo on the right shows where some maintenance was needed. Controls were repaired during the inspection after contractors were aware of it. 10/27/05

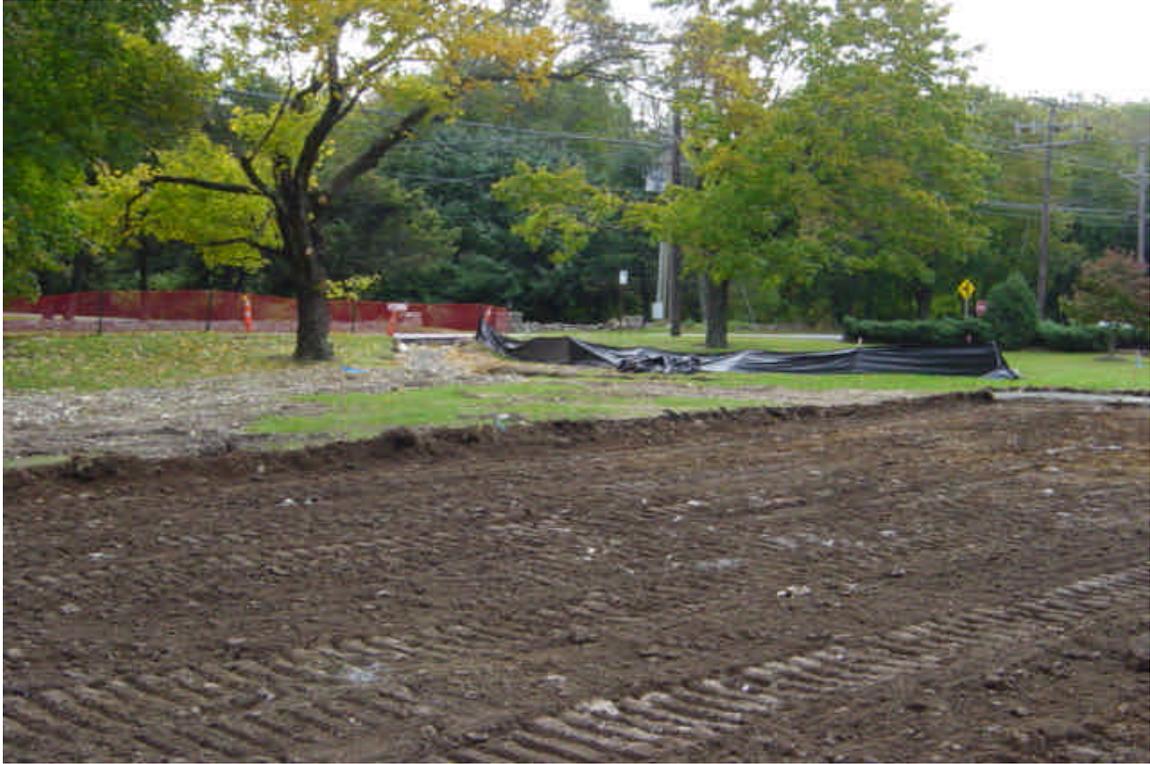
View of the yard looking towards Rt. 7 where some of the brush clearing had been necessary and the existing asphalt has been removed. 10/27/05

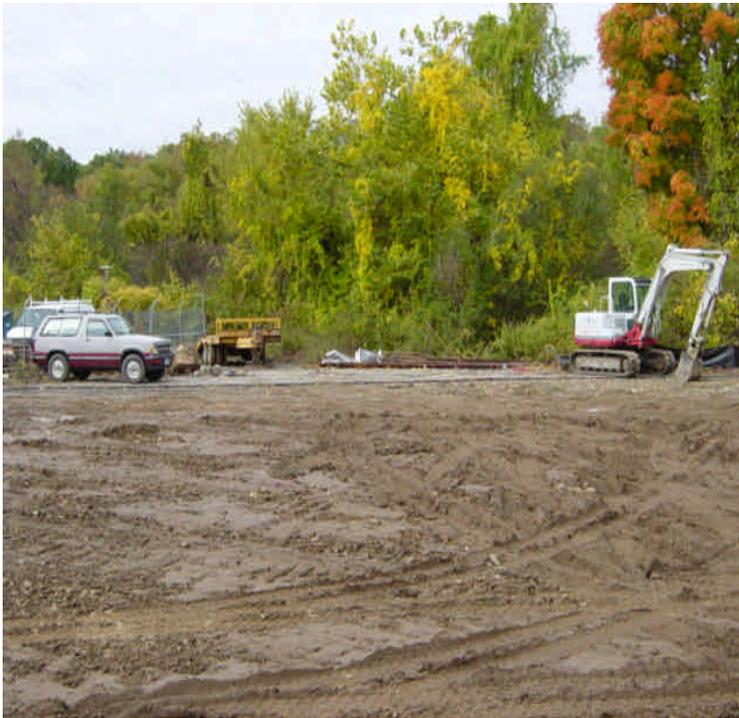
Photo on the left shows a view of the yard where the asphalt was left as the property boundary. Photo on the right shows the edge of the wetlands and standing water beyond the installed silt fence. 10/27/05
