Docket No. 217 – Development and Management Plan Inspection

Northeast Utilities Service Company Certificate of Environmental Compatibility and Public Need for the construction of a 345-kV electric transmission line and reconstruction of an existing 115-kV electric transmission line between Connecticut Light and Power Company's Plumtree Substation in Bethel, through the towns of Redding, Weston, and Wilton, and to the Norwalk Substation in Norwalk, Connecticut.

Date: November 2, 2005

Location: Transition Stations: Hoyts Hill, Archers Lane, Norwalk Junction

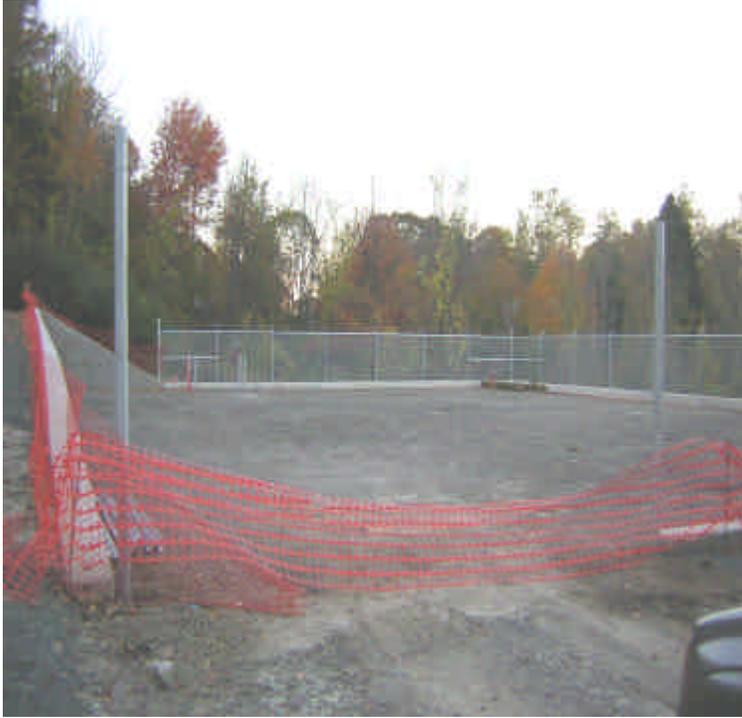
Hoyts Hill Transition Station: The photo on the left shows an overview of the station yard with the chain link fence being installed. Photo on the right shows the catch basin which has been cleaned of the sediment. 11/2/05

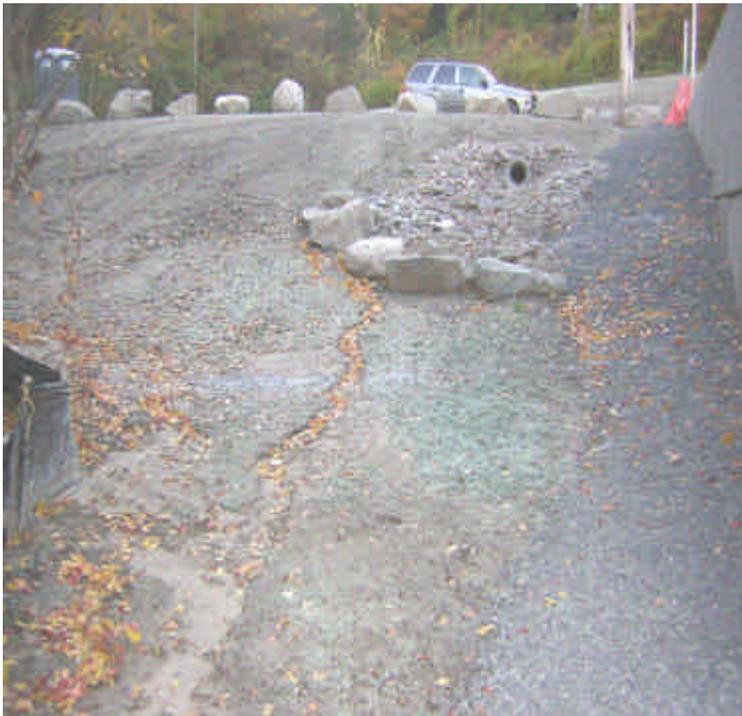
Areas of Inspection	Observation	Recommended Action
<p>Foundation construction continued</p>	<p>- Additional work may be necessary on the southern side outlet/dissipater pad as erosive gullies were noted. 11/02/05</p> <p>-At Archers Lane, blasting is complete and boulders were being removed. Stone is being crushed for use in the construction of the station yard foundation. 11/02/05.</p> <p>-At Norwalk Junction, removal of the existing asphalt had occurred and grading had begun. The existing culvert pipe was not functioning and was likely to be removed within the next day or so. Structure installation had not begun yet. 11/02/05.</p>	<p>-The pad may need to be extended here based on the noted erosion issues. See erosion control section 11/02/05.</p> <p>-None at this time. See erosion control section. 9/15-11/02/05</p> <p>-None at this time. See erosion control section. 11/02/05.</p>
<p>Erosion and Sediment Controls (includes inspection within 24 hours of a storm event)</p>	<p>-Hoyts Hill: The majority of the perimeter silt fence remains in good condition, but one small section near the northern dissipater pad is in need of repair. 10/19-11/02/05. A small amount of sediment has filtered through here as a result 11/2/05</p> <p>- The slopes had been restored with hydroseed but the recent rains have caused rills and small erosive gullies to form. The gullies have caused sediment to deposit all along the base of slope. 10/27-11/02/05.</p> <p>-A larger erosive gully was noted reaching along the southern outlet pipe and dissipater pad. It may be necessary to extend the pad. 11/02/05.</p> <p>- Archers Lane: A portion of silt fence along the access road has been pushed down due to the wayward materials. The</p>	<p>- Continue to monitor the area and be proactive in maintenance of the erosion controls, especially in areas with wetland immediately adjacent. 11/02/05.</p> <p>- Gullies should be repaired and a stronger method of stabilization, such as erosion control mats, should be considered. 11/02/05.</p> <p>-Investigate whether extension of the stone pad would help the situation and restore the erosion caused here. The sediment in the catch basin has been cleaned out. 11/02/05.</p> <p>- Repair erosion controls when feasible. 11/02/05</p>

The photo on the left shows the rills and small gullies forming on the southern side of the station. Photo on the right shows the sediment deposits at the base of the slope as a result of the erosion. 11/2/05

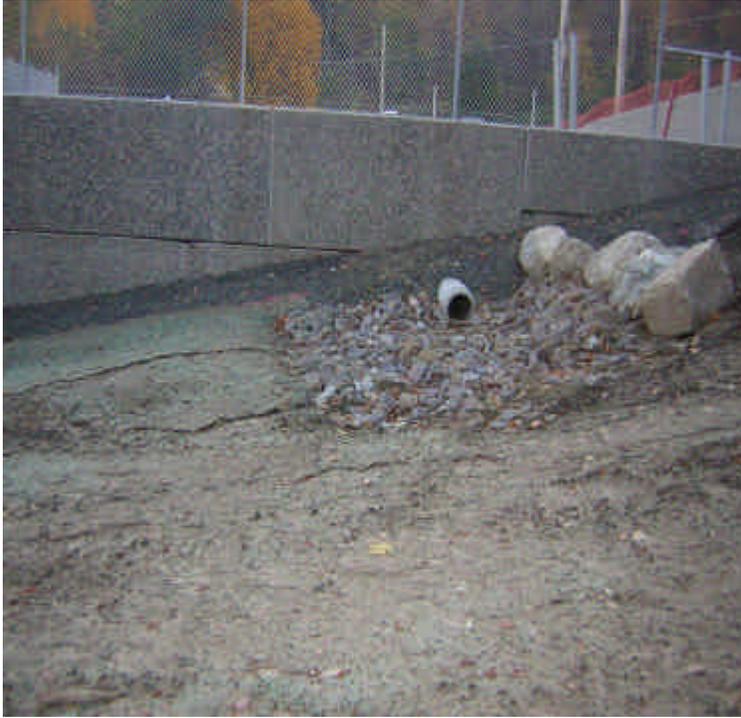
The photo on the left shows the rills and gullies forming on the northern side of the station yard. Photo on the right shows the sediment which has deposited against the silt fence. 11/2/05

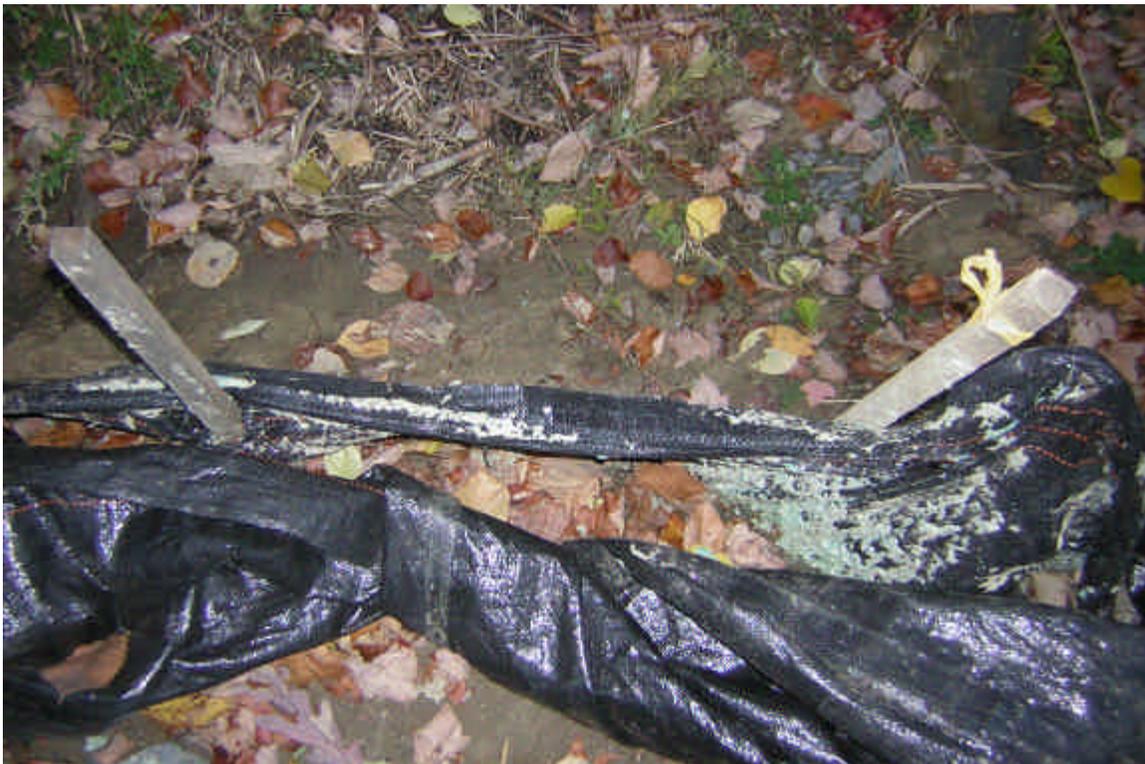
View of where the sediment from the slope has migrated through the silt fence. The fence has to be toed - in/maintained to eliminate this issue. 11/2/05

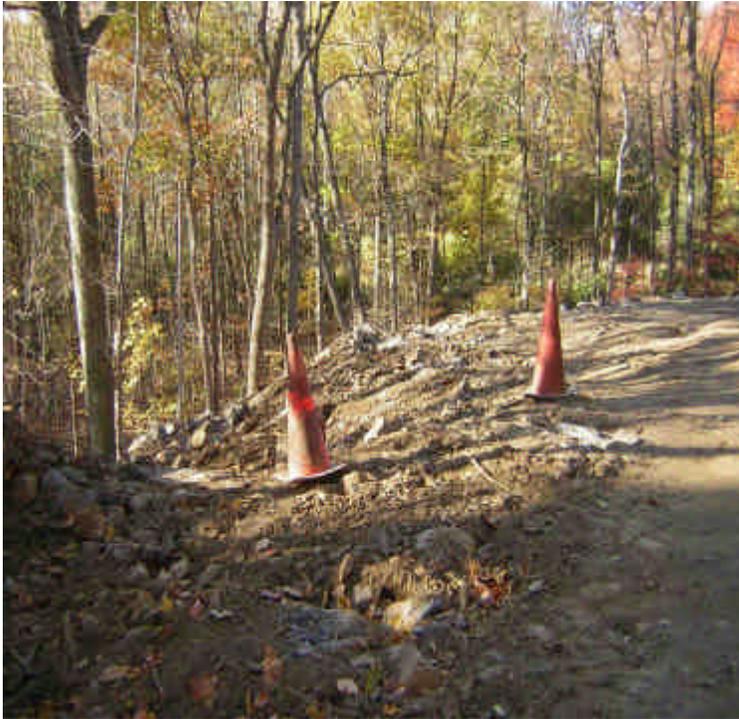
Photo on the left shows where boulders were being removed from the site. Photo on the right shows where boulders were being crushed and stockpiled for future use in the station yard. 11/2/05

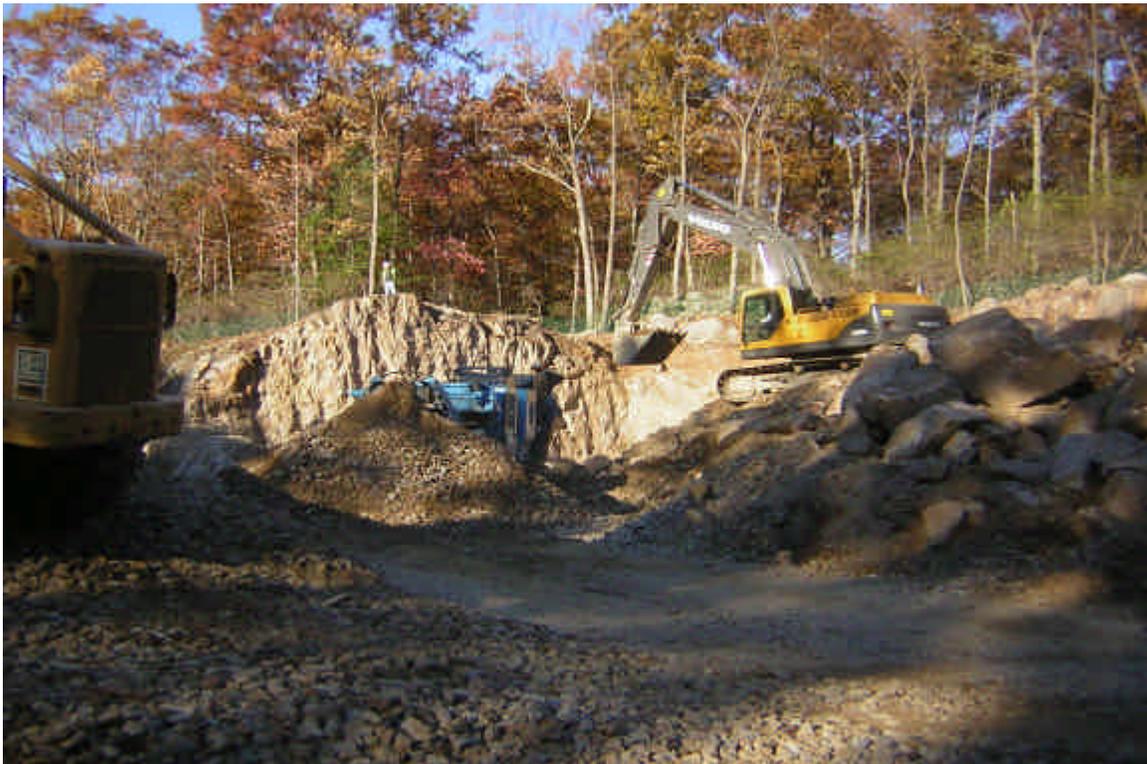
View of the boulder breaking/crushing operation on site. 11/2/05

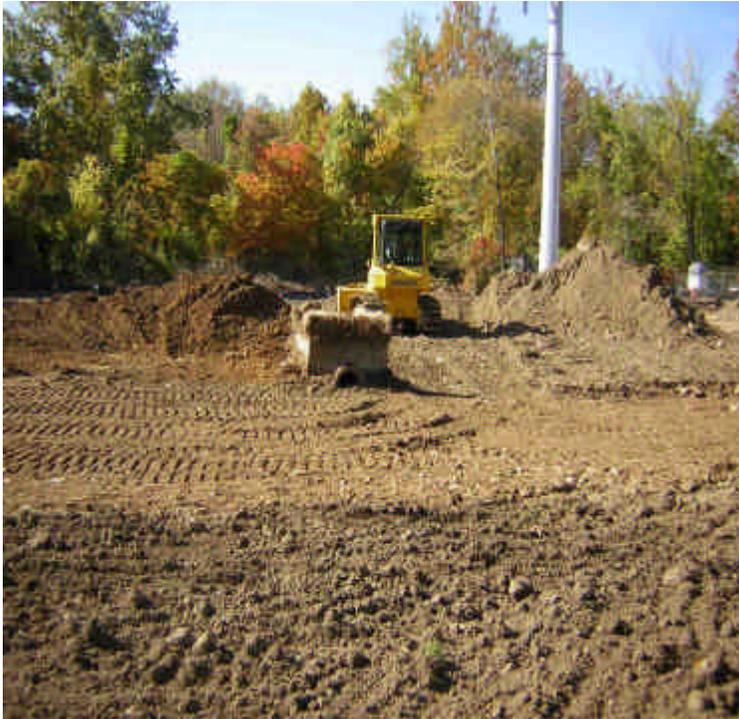
Photo on the left shows the overall view of the grading on the site. Photo on the right shows the new access road out to Rt. 7. 11/2/05

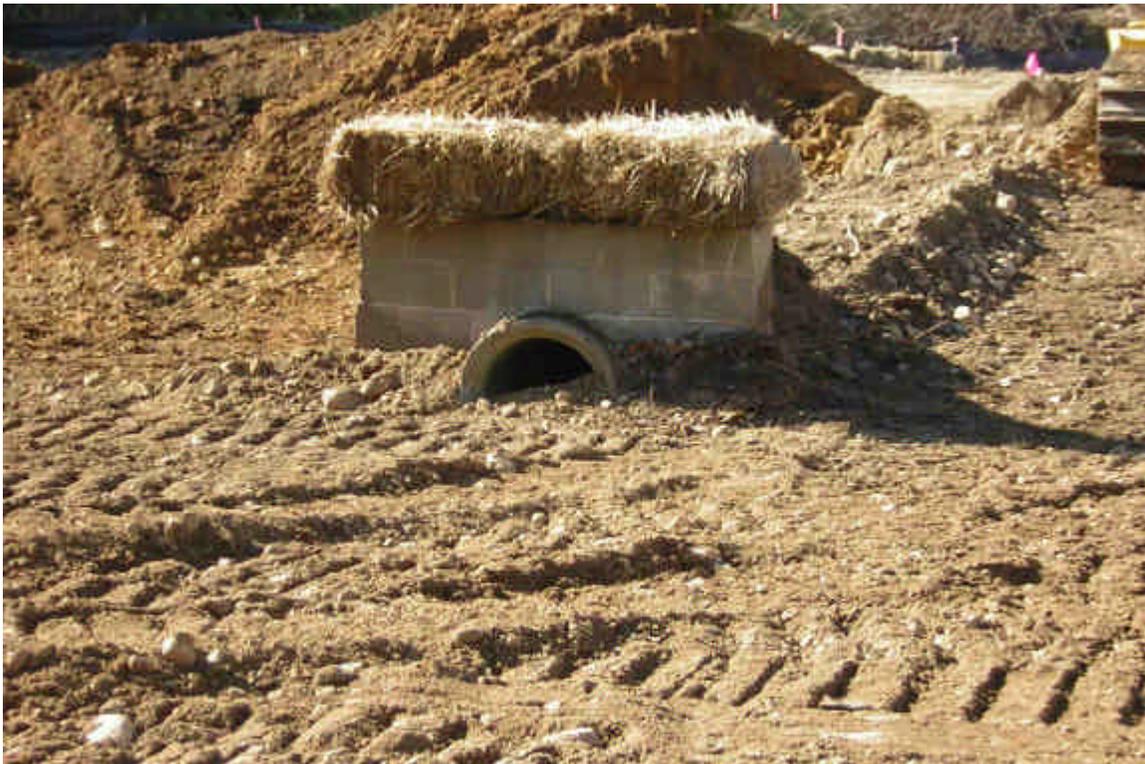
View of the existing culvert which is no longer operational and which will be removed from site soon. 11/2/05
