Docket No. 217 – Development and Management Plan Inspection

Northeast Utilities Service Company Certificate of Environmental Compatibility and Public Need for the construction of a 345-kV electric transmission line and reconstruction of an existing 115-kV electric transmission line between Connecticut Light and Power Company's Plumtree Substation in Bethel, through the towns of Redding, Weston, and Wilton, and to the Norwalk Substation in Norwalk, Connecticut.

Date: November 10, 2005

Location: Transition Stations: Hoyts Hill, Archers Lane, Norwalk Junction

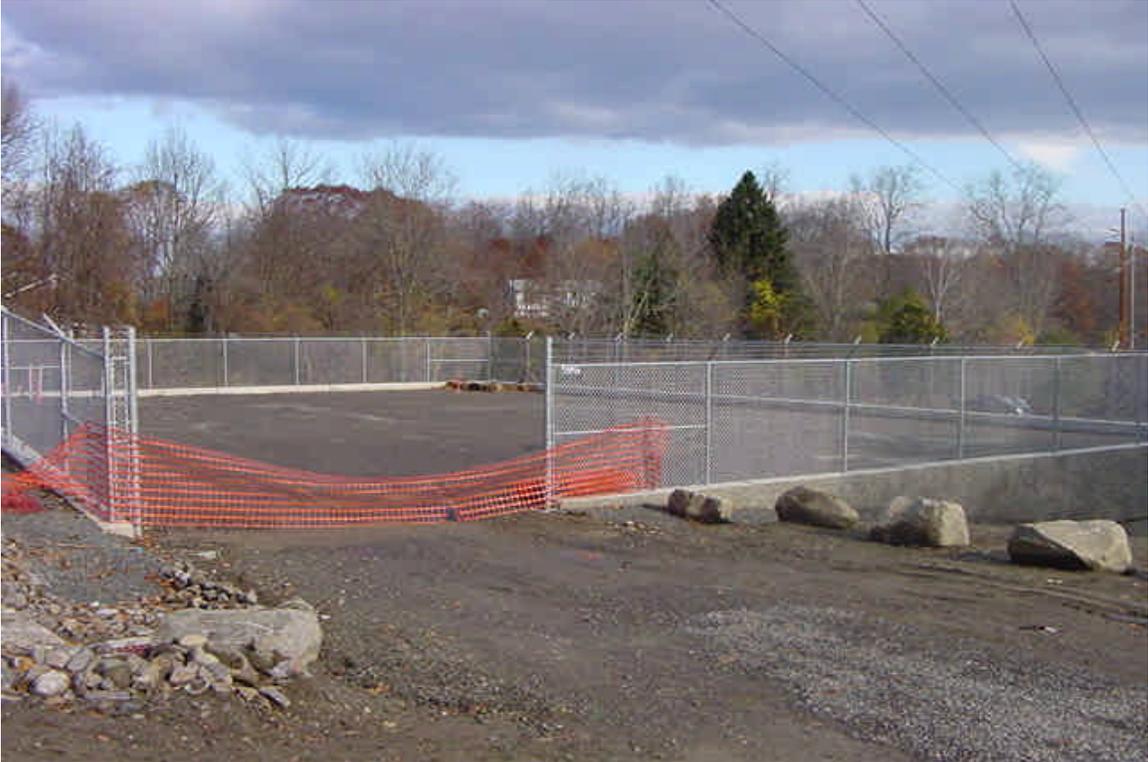
Hoyts Hill Transition Station: The photo on the left shows an overview of the station yard with the chain link fence installed. No further work was ongoing at the time. 11/10/05

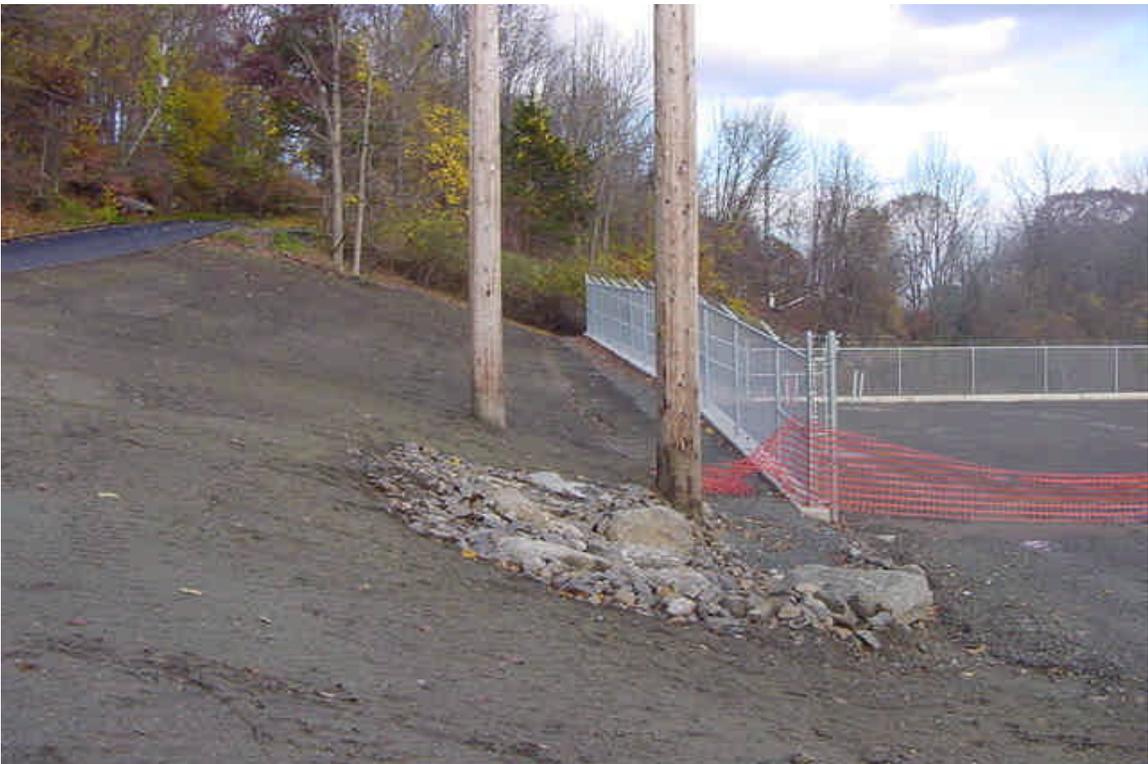
Overall view of the restored grades at the station yard leading from the roadway. Some slight erosive rills were noted but are not as significant as the ones downslope. 11/10/05

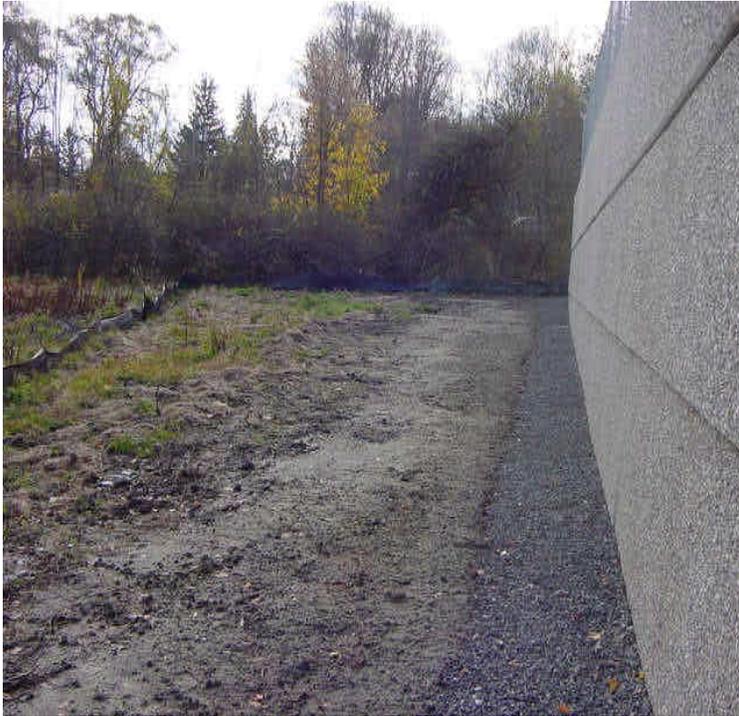
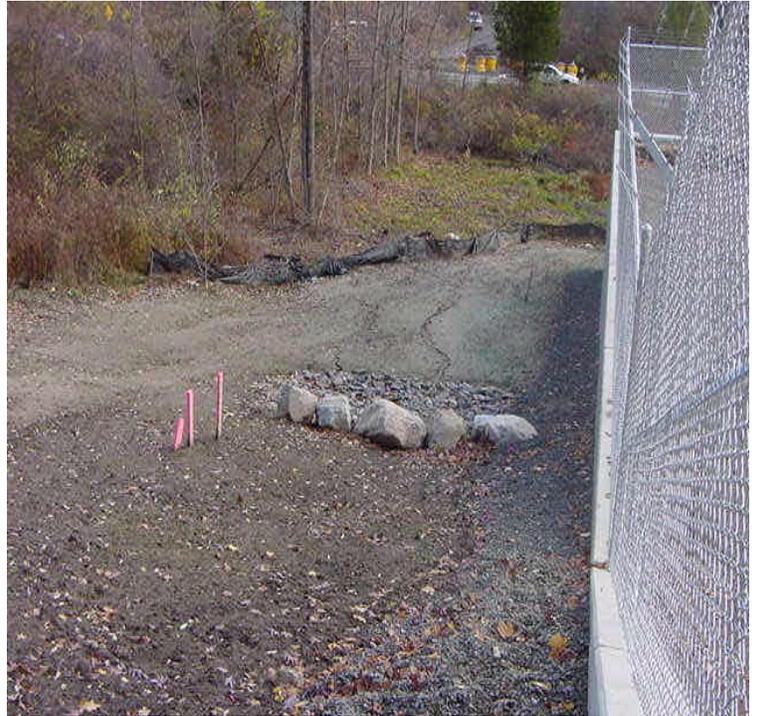
The photo on the left shows the silt fence in place at the wetland edge. Photo on the right shows some of the erosive gullies and rills along the slope. 11/10/05

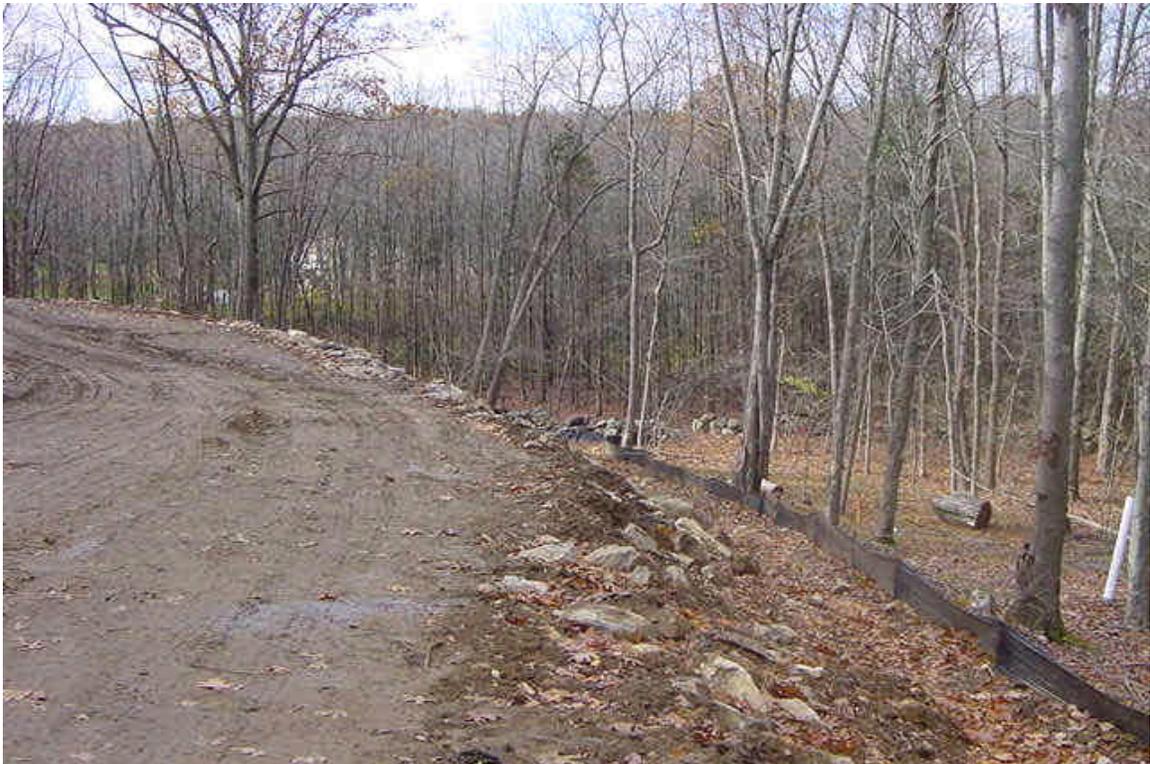
Archers Lane: Overview of the access road where the boulder stockpiles have largely been removed. 11/10/05

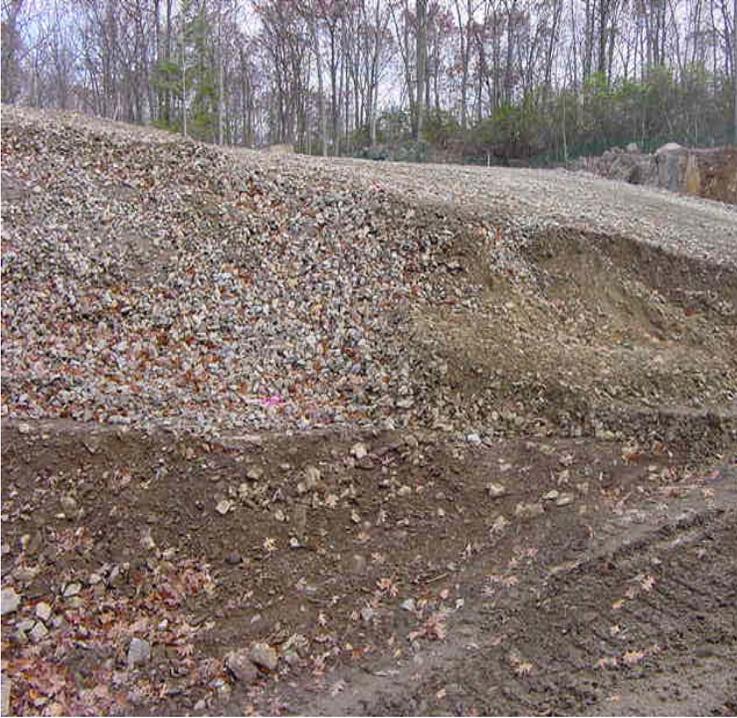
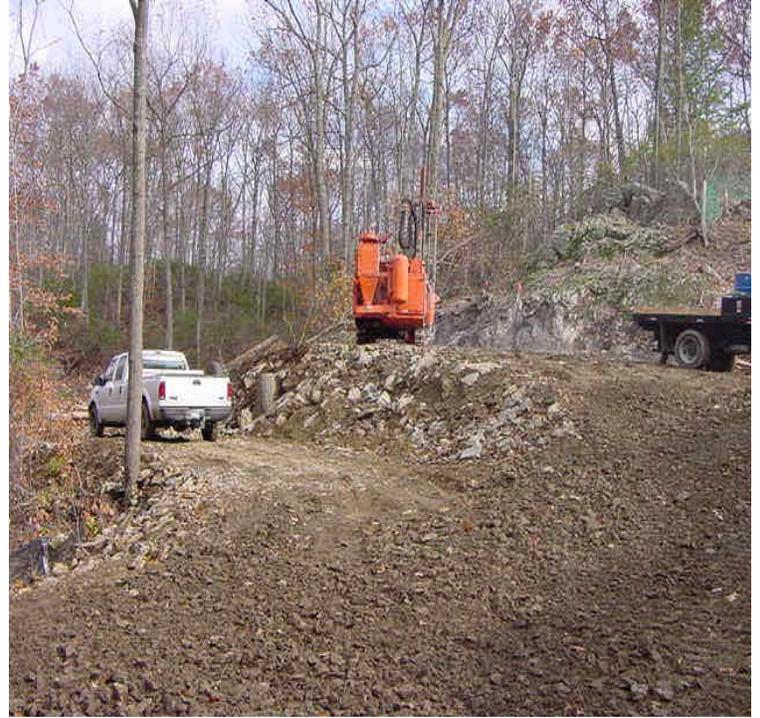
Photo on the left shows the stockpile of crushed boulders/stone to be used on site. Photo on the right shows the area cleared by CL&P and drilling to install a structure at the edge of the station yard. 11/10/05

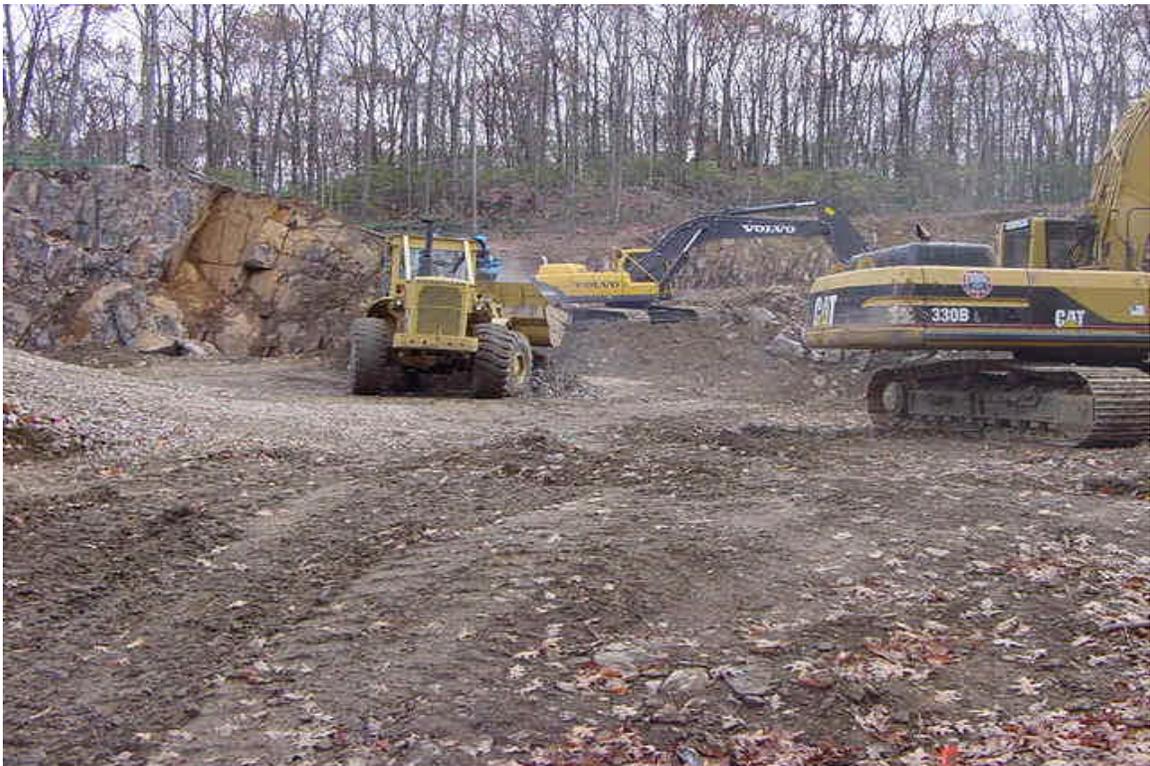
Overall view of the site work and excavation area. 11/10/05

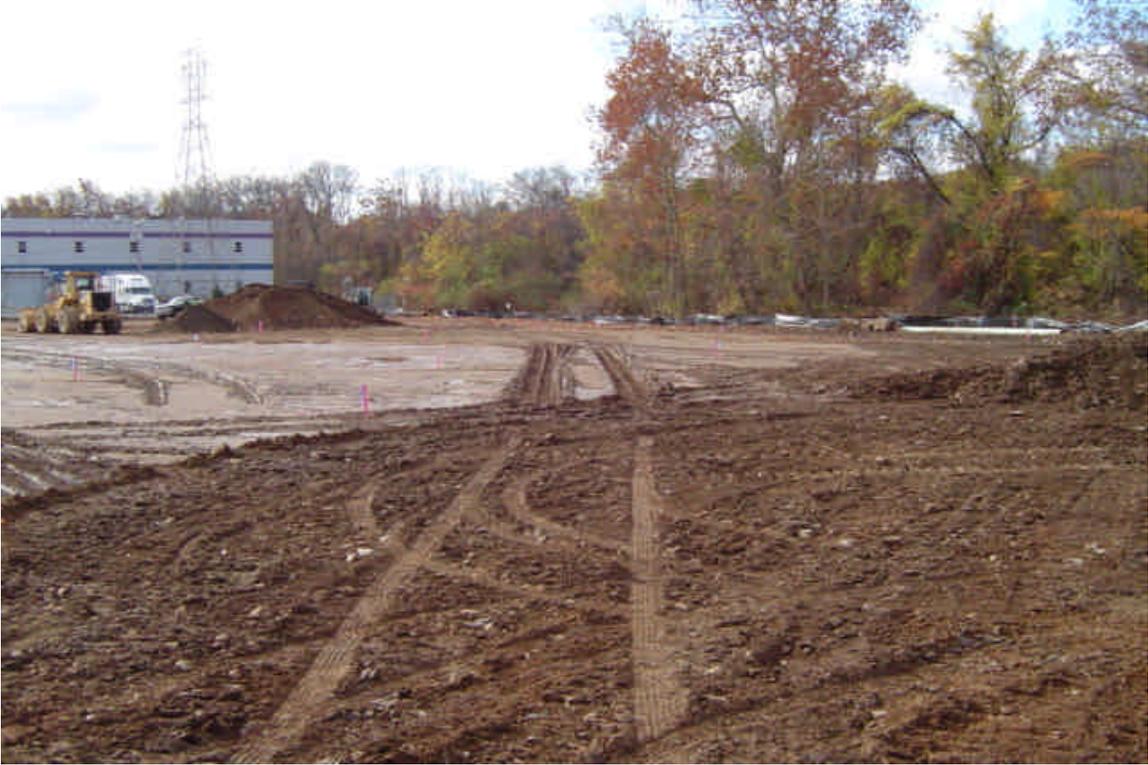
Norwalk Junction: Over all view of the site which has been graded. Most stockpiles are in the process of being removed. 11/10/05

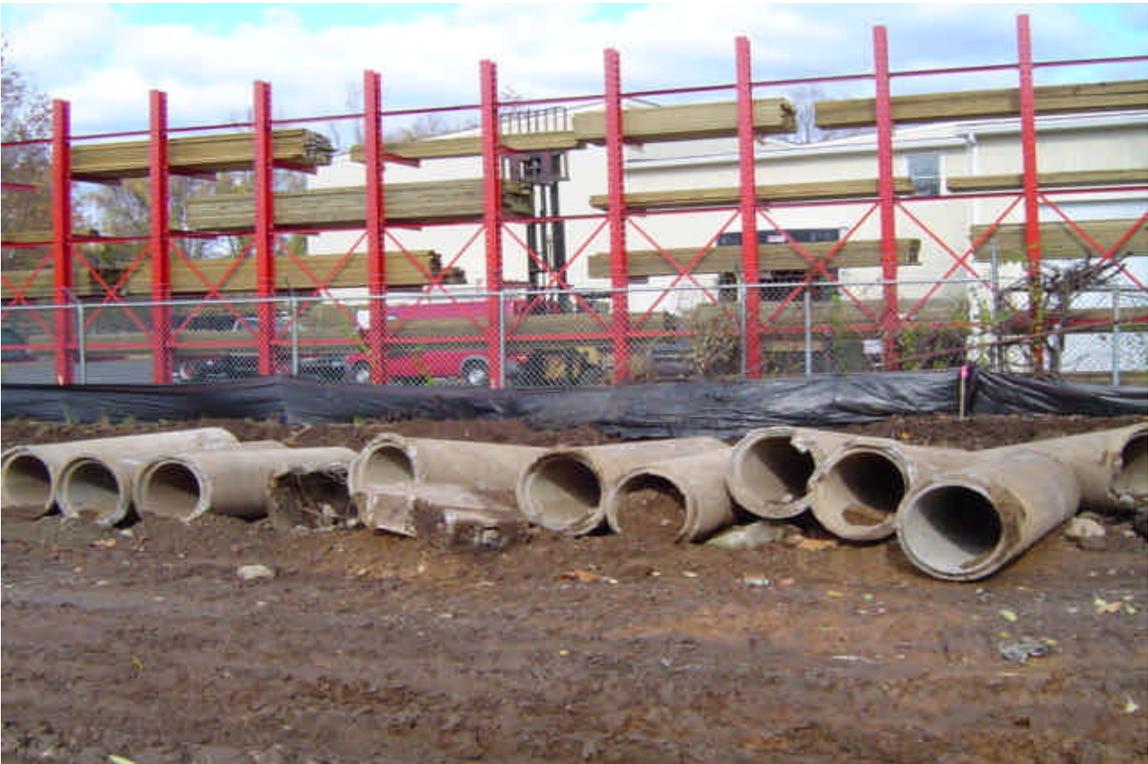
View of the stockpiled pipes from the culvert that was removed. The pipes will eventually be disposed of. 11/10/05
