**Docket No. 217 – Development and Management Plan Inspection**

Northeast Utilities Service Company Certificate of Environmental Compatibility and Public Need for the construction of a 345-kV electric transmission line and reconstruction of an existing 115-kV electric transmission line between Connecticut Light and Power Company’s Plumtree Substation in Bethel, through the towns of Redding, Weston, and Wilton, and to the Norwalk Substation in Norwalk, Connecticut.

**Date:** November 17, 2005

**Location:** Transition Stations: Hoyts Hill, Archers Lane, Norwalk Junction

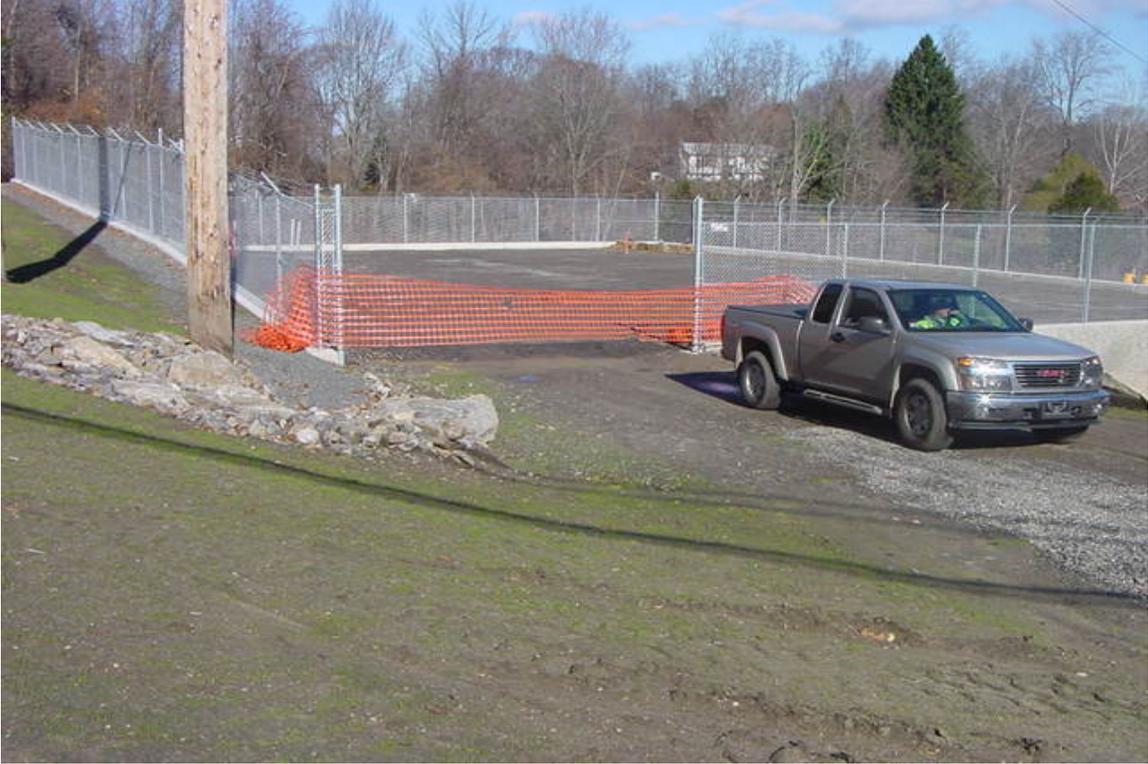
Hoyts Hill Transition Station: Overview of the station yard with the chain link fence installed. With the warm weather, noticeable grass growth had occurred on the site lopes. 11/17/05

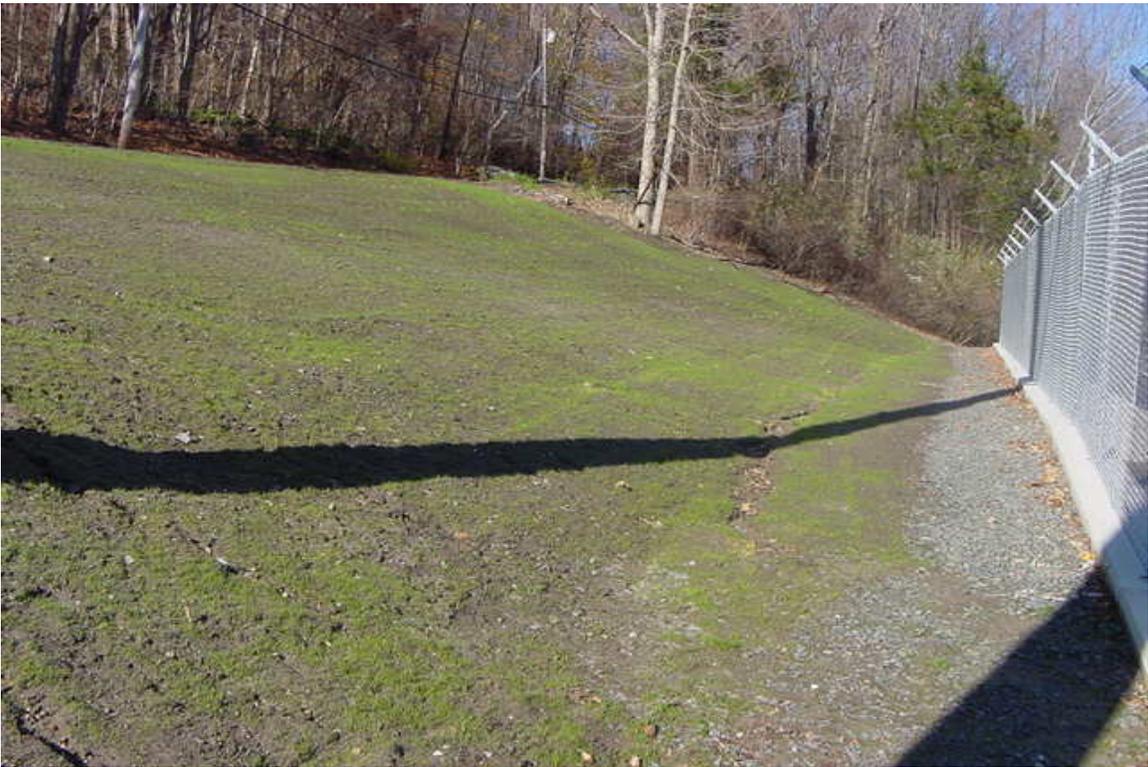
Further view of the new growth on the slope leading from Hoyts Hill Rd. to the station yard. Minimal erosion was noted here. 11/17/05

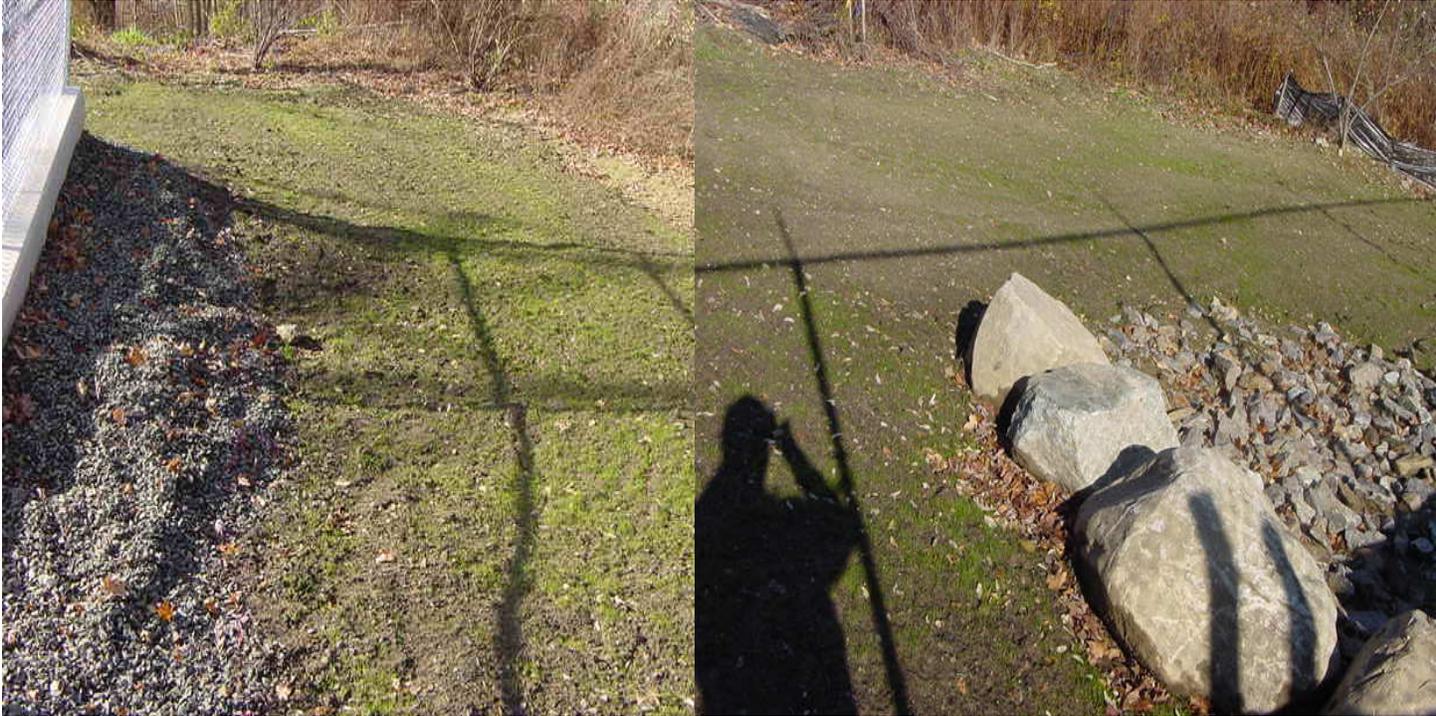
Both photos show views of the noticeable increase in grass growth that occurred along the slopes of the station. 11/17/05

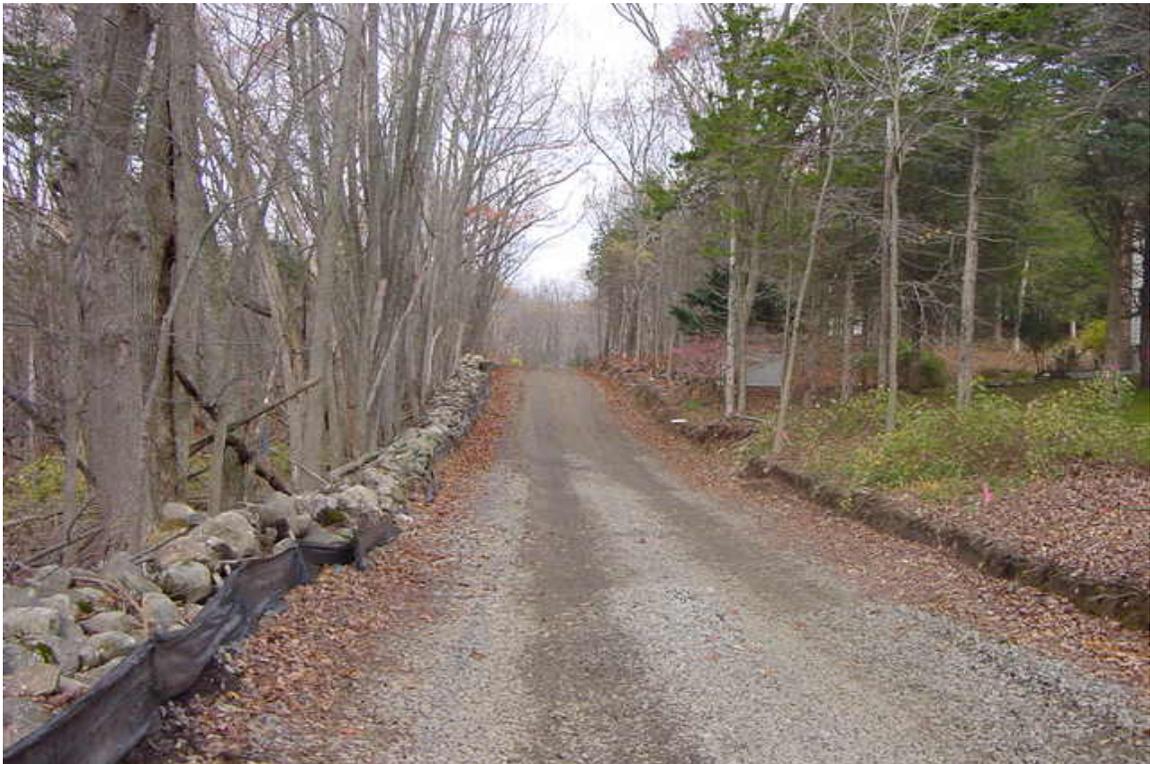
Archers Lane: Overview of the access road leading in from Diamond Hill Rd. Some tracking was noted along the roadway due to increased traffic removing boulders. 11/17/05

Areas of Inspection	Observation	Recommended Action
Access Roads and Adjacent Roadways	<p>- <b>Hoyts Hill:</b> Access is gained off Hoyts Hill Road which was previously repaved and curbed by the DPW. Sediment tracking was not noted. 11/17/05.</p> <p>-<b>Archers Lane:</b> - The majority of the boulders have been removed from the stockpile within the site boundaries along the access road. 11/10-11/17/05.</p> <p>-Some sediment tracking was noted on Diamond Hill Rd. with all the traffic. 11/10-11/17/05</p> <p>- <b>Norwalk Junction:</b> A gravel access road is in place off of Route 7. Some sediment tracking was noted on Rt. 7 last week due to the muddy conditions over most of the yard. 11/17/05.</p> <p>- Changes to drainage and the emergency access road here are proposed. 11/17/05</p>	<p>-Monitor any sediment tracking issues and determine if a pad may be necessary. 9/15-11/17/05.</p> <p>- None at this time. We just need to confirm whether the material at the property line had been removed.11/10-11/17/05.</p> <p>- Street sweeping will be necessary here if problems persist. 11/10-11/17/05</p> <p>-Continue to monitor sediment tracking issues and sweep streets if necessary. 11/17/05.</p>

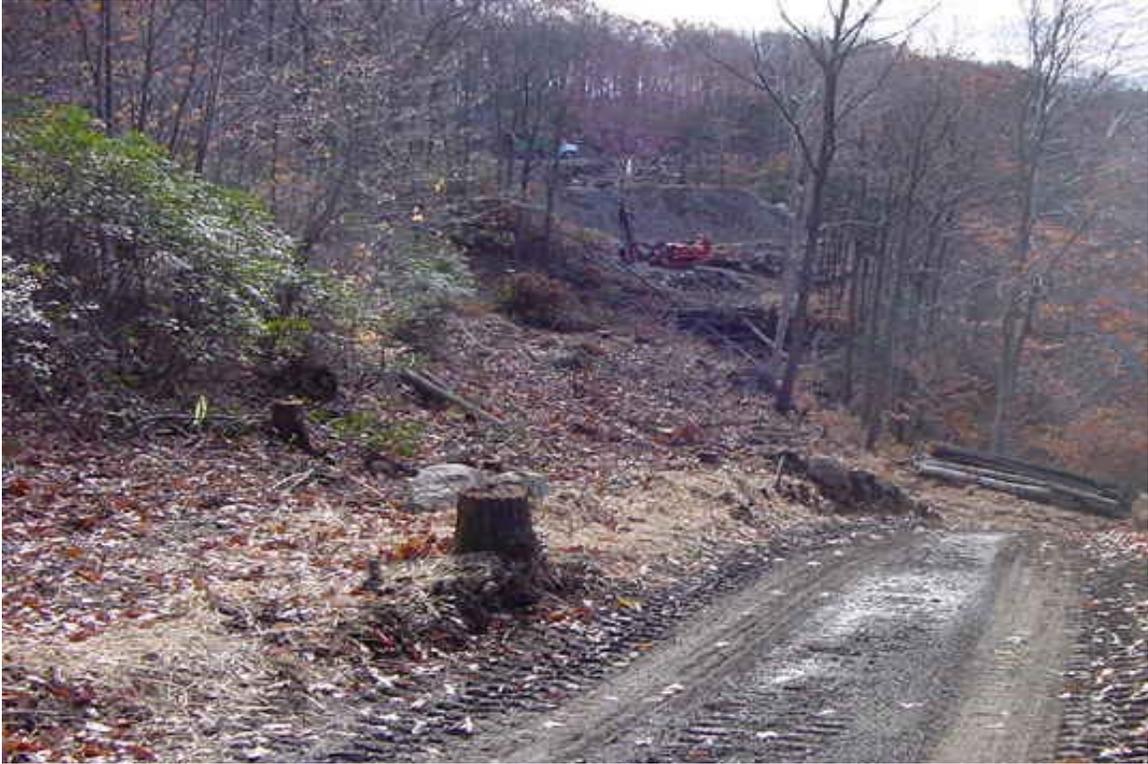
Photo of the cleared view into Archers Lane from the adjacent ROW. 11/17/05

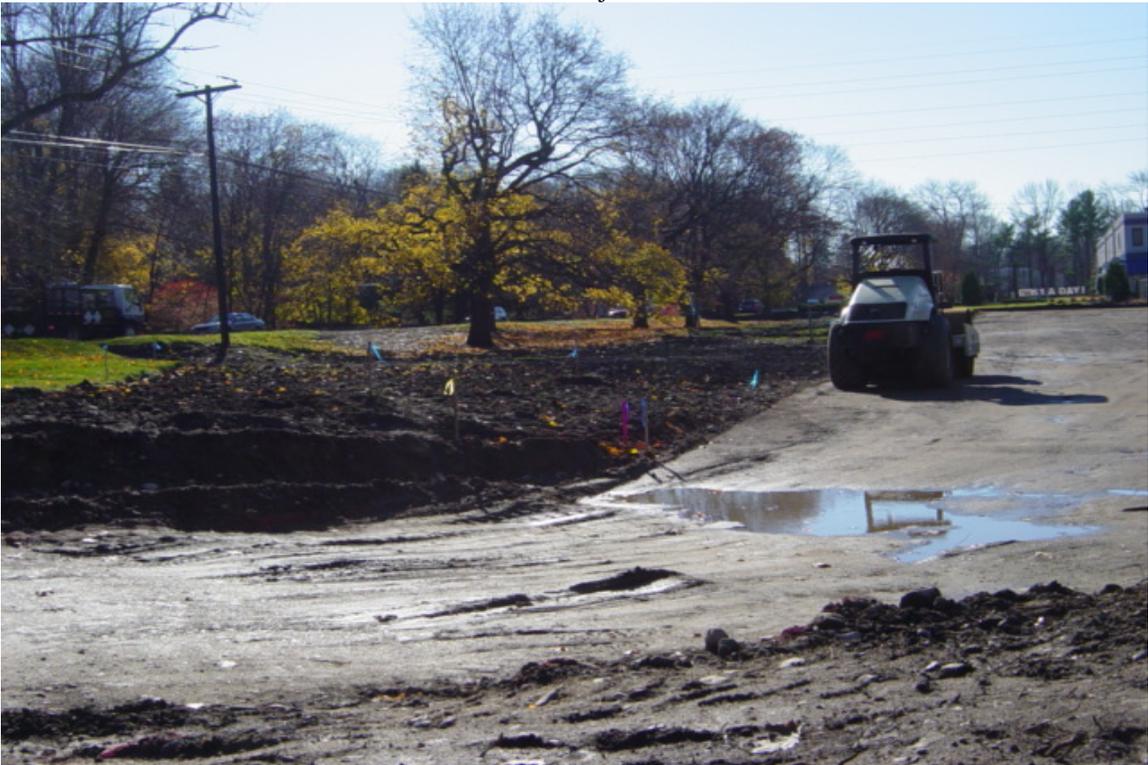
Norwalk Junction: Overall view of the site with ongoing grading/compacting. Areas remain contained at this time and little work was ongoing following evaluation of proposed changes to the station. 11/17/05
