Docket No. 217 – Development and Management Plan Inspection

Northeast Utilities Service Company Certificate of Environmental Compatibility and Public Need for the construction of a 345-kV electric transmission line and reconstruction of an existing 115-kV electric transmission line between Connecticut Light and Power Company’s Plumtree Substation in Bethel, through the towns of Redding, Weston, and Wilton, and to the Norwalk Substation in Norwalk, Connecticut.

Date: December 1, 2005

Location: Transition Stations: Hoyts Hill, Archers Lane, Norwalk Junction

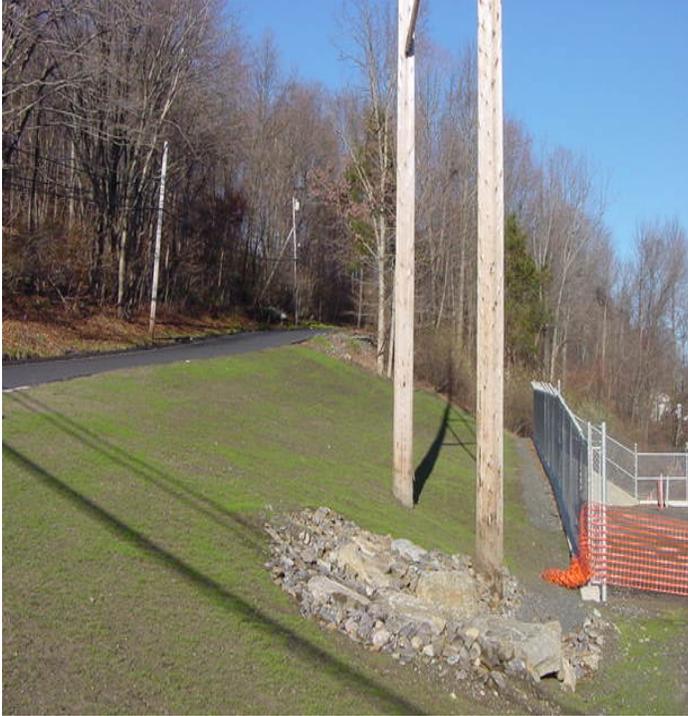
Hoyts Hill Transition Station: Photo to the left shows grass growth on the western slope leading from the road. Photo to the right is a view of the significant ruts and some erosion noted off Hoyts Hill Rd. Additional stone should be installed here. 12/01/05

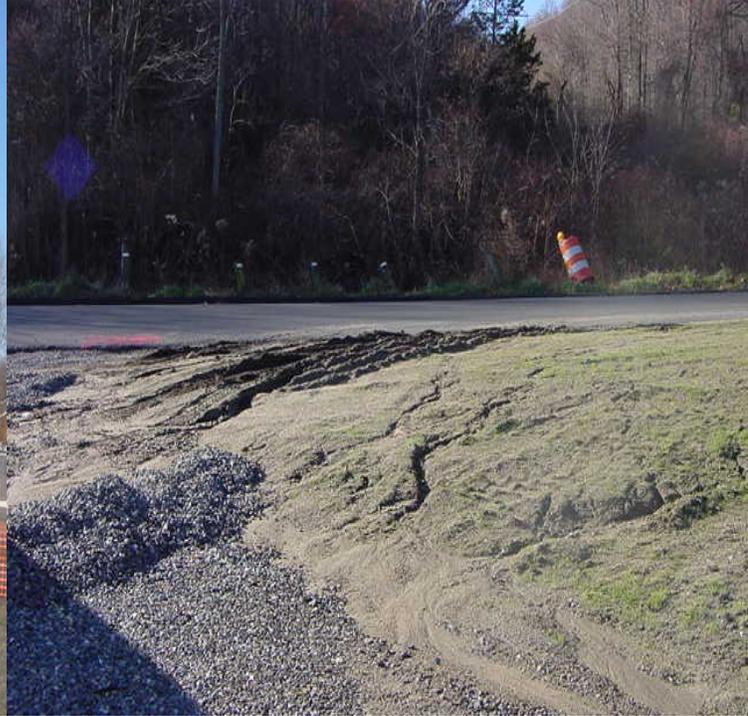
Areas of Inspection	Observation	Recommended Action
Access Roads and Adjacent Roadways	<p>- Hoyts Hill: Access is gained off Hoyts Hill Road. Ruts and erosion were noted beyond the placed stone at the access point 12/01/05.</p> <p>-Archers Lane: - The majority of the boulders and stone on site have been removed and this continues along the upgradient access road. The access road was somewhat muddy. 12/01/05.</p> <p>-Sediment tracking has been noted on Diamond Hill Rd. due to all the traffic, but street sweeping was occurring during the inspection. 12/01/05.</p> <p>- Norwalk Junction: A gravel access road is in place off of Route 7. Sediment tracking was not noted. 12/01/05.</p> <p>- Trenching was occurring along the access road in preparation for installing the new drainage pipe. 12/1/05</p>	<p>-Smooth out ruts and install additional stone along this portion. Large boulders could also be installed here to designate boundaries. 12/01/05.</p> <p>- None at this time.12/01/05.</p> <p>- Street sweeping will need to continue on a regular basis. 12/01/05</p> <p>-Continue to monitor sediment tracking issues and sweep streets if necessary. 12/01/05.</p> <p>- None at this time. 12/01/05</p>

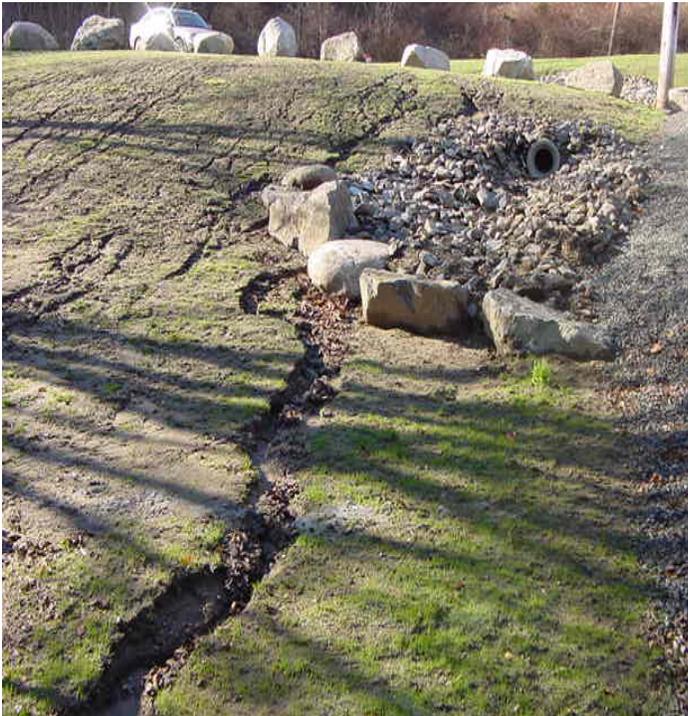
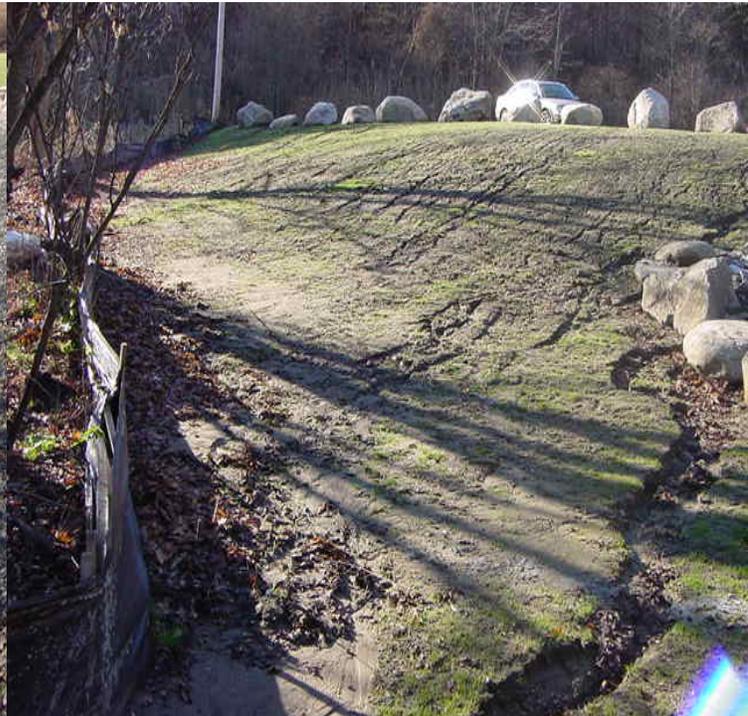
Areas of Inspection	Observation	Recommended Action
Erosion and Sediment Controls continued	<p>the base of slope. 10/27-12/01/05.</p> <p>-Large erosive gullies were noted extending from the outlet pipes and dissipater pads. It may be necessary to extend the pads since they are not reducing velocity appropriately. 11/02-12/01/05.</p> <p>- Archers Lane: The silt fence corner at the base of the access road slope was still intact but some sediment had accumulated. 10/12/05-12/01/05.</p>	<p>work is still proposed. 12/01/05.</p> <p>-Investigate whether extension of the stone pad would help the situation and restore the erosion caused here. 12/01/05.</p> <p>- Continue to monitor this area, especially after significant rain events. Sediment may need to be pulled away after the rains and repairs may be necessary. 12/01/05.</p>
	<p>- Norwalk Junction: The perimeter erosion controls seem mostly in place around the edge of the disturbed site. 12/01/05.</p> <p>-We need to confirm whether the cleared/disturbed soils noted outside the silt fence adjacent to the wetland are still present. 12/01/05</p> <p>- The remaining outlet pipe was protected by erosion controls. 12/01/05</p>	<p>-Maintain erosion controls as long as there is disturbed soil/work on site, especially due to the proximity of the river and wetlands. 12/01/05</p> <p>- This newly disturbed area adjacent to the river should be mulched or erosion controls should be extended to encompass it if not already done. 12/01/05.</p> <p>-Monitor and maintain erosion controls at the outlet pipe, including when the new portion is installed. 12/01/05.</p>

Both photos show a view of the rills and erosive gullies present on the southern side of the site. The photo to the right also shows sediment deposits along the silt fence. 12/01/05.

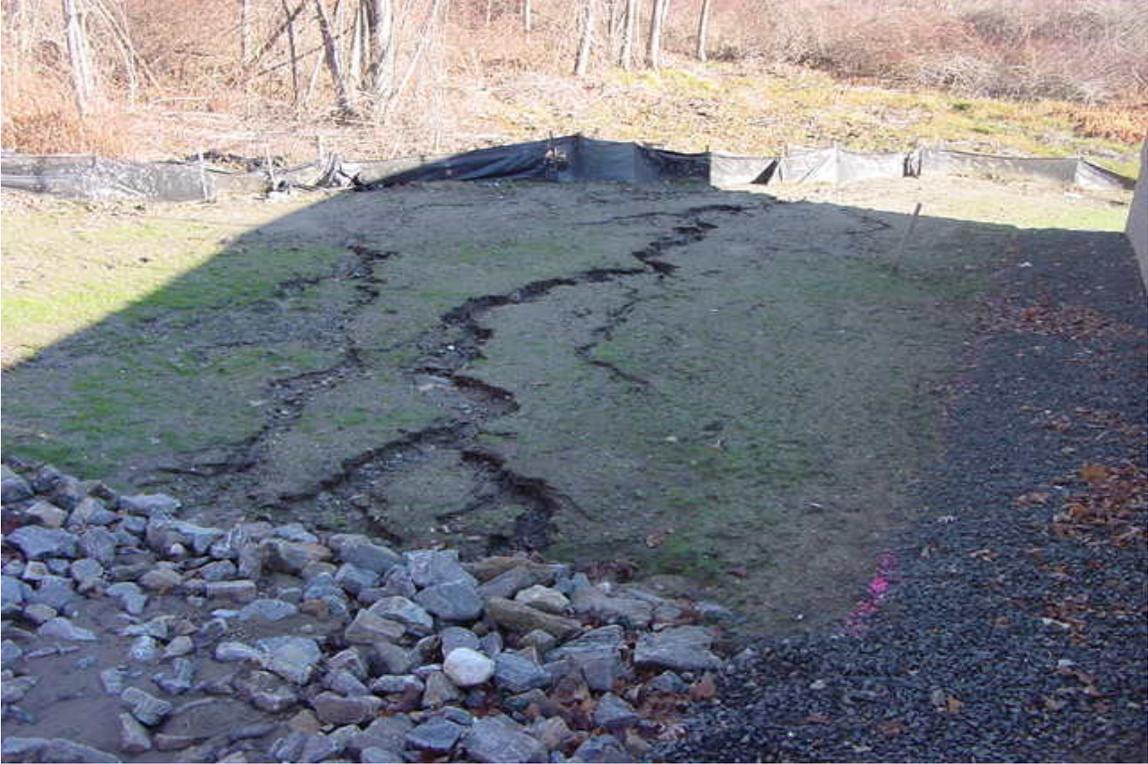
Areas of Inspection	Observation	Recommended Action
<p>Foundation construction continued</p>	<p>wetland edge due to future work here. 11/17-12/01/05.</p> <p>- Additional work may be necessary on the outlet/dissipater pads as erosive gullies continue and appear to have worsened. 12/01/05.</p> <p>-At Archers Lane boulders and stone continue to be removed and excavation and earthwork is ongoing. Most stone has been removed from site. The footings for the foundation were being staked at the time of inspection. 12/01/05.</p> <p>- Drilling for the foundation of a structure has been noted adjacent to the yard. 11/17-12/01/05</p> <p>-At Norwalk Junction, trenching was occurring for the installation of a new pipe extending from the road culvert. The pipe had not yet been delivered at the time of inspection. The remaining portion of the outlet pipe was protected by erosion controls. 12/01/05.</p>	<p>-The pads may need to be extended based on the noted erosion issues. See erosion control section. 12/01/05.</p> <p>-None at this time. 12/01/05</p> <p>- None at this time. 11/17-12/01/05</p> <p>- See additional sections for more information. 12/01/05.</p>

The photo shows the apparently worsening erosive gullies present on the northern portion of the site. The existing pad may not be long enough to reduce velocity of exiting stormwater. 12/01/05.

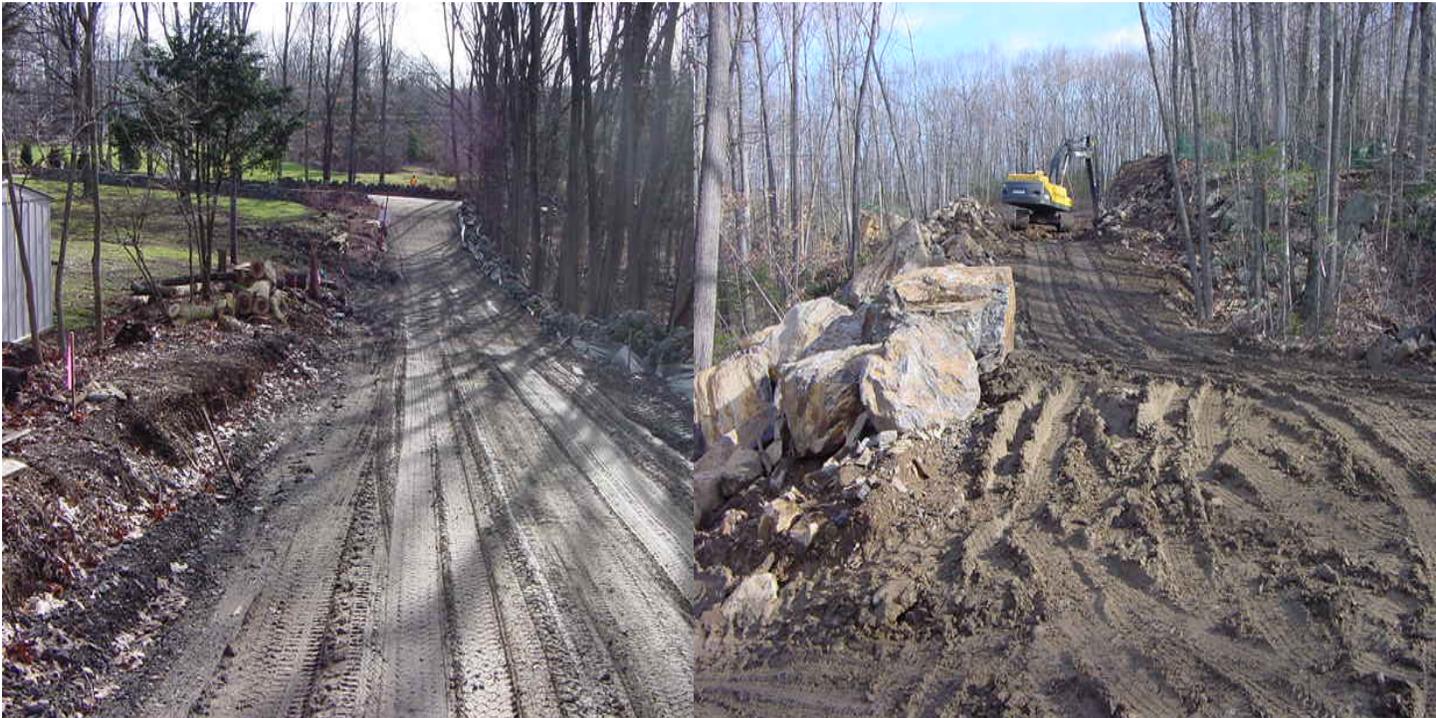
Archers Lane: Photo on the left shows the access road, looking toward Diamond Hill Road. Photo to the right shows the upgradient access road to the transition station pad. The site was very muddy at the time of inspection. 12/01/05.

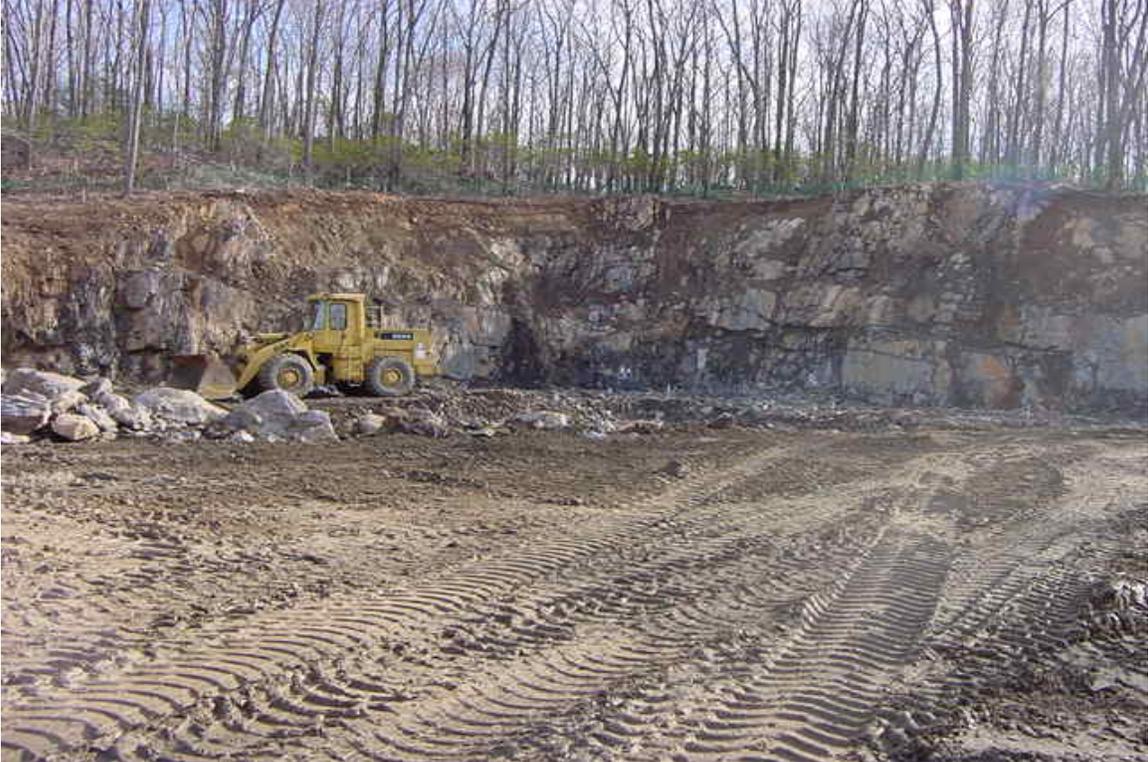
The photos show an overall view of the pad where most stone and boulders have been removed. Foundation footings were being staked. 12/01/05

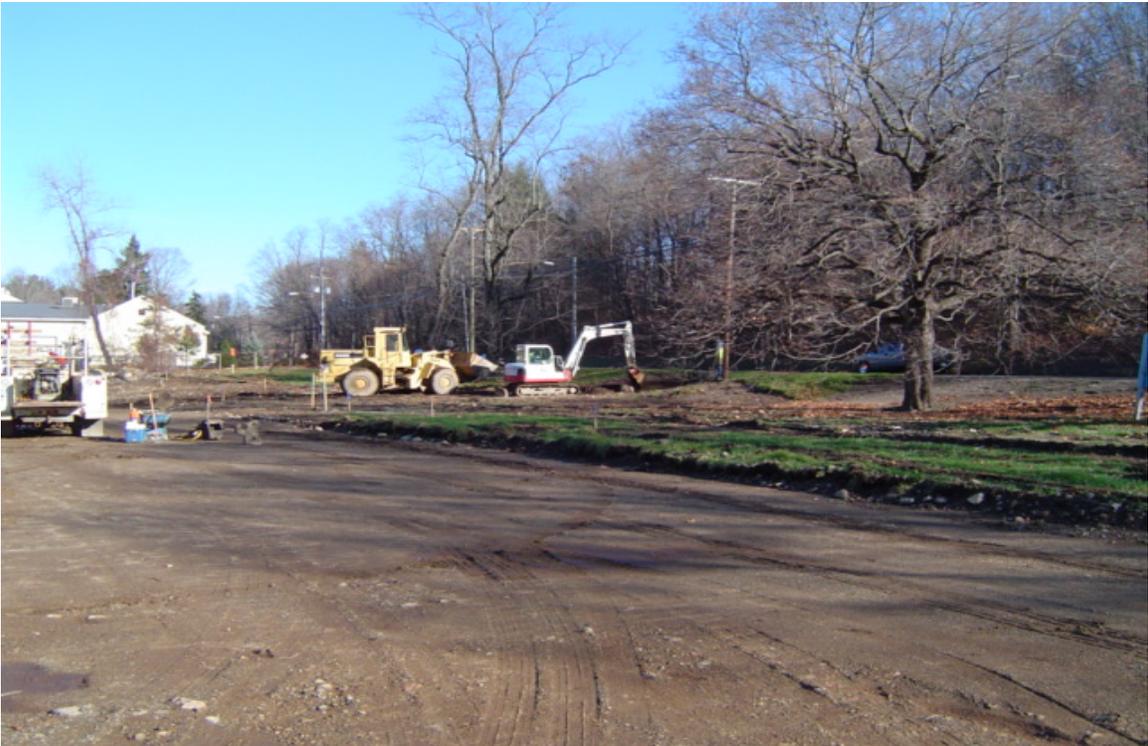
Norwalk Junction: Overall view of the trenching for the installation of new pipe to connect to the road culvert. 12/01/05
