Docket No. 217 – Development and Management Plan Inspection

Northeast Utilities Service Company Certificate of Environmental Compatibility and Public Need for the construction of a 345-kV electric transmission line and reconstruction of an existing 115-kV electric transmission line between Connecticut Light and Power Company's Plumtree Substation in Bethel, through the towns of Redding, Weston, and Wilton, and to the Norwalk Substation in Norwalk, Connecticut.

Date: December 22, 2005

Location: Transition Stations: Hoyts Hill, Archers Lane, Norwalk Junction

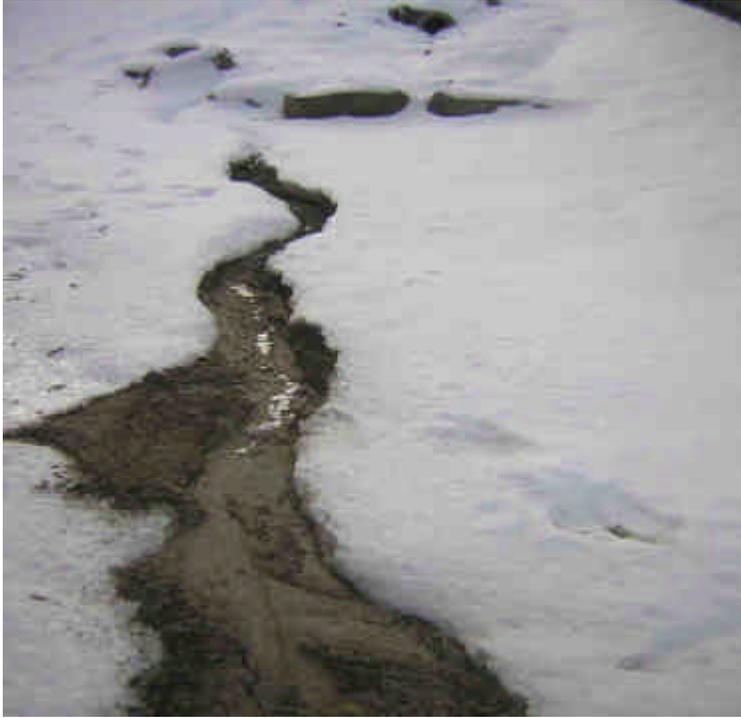
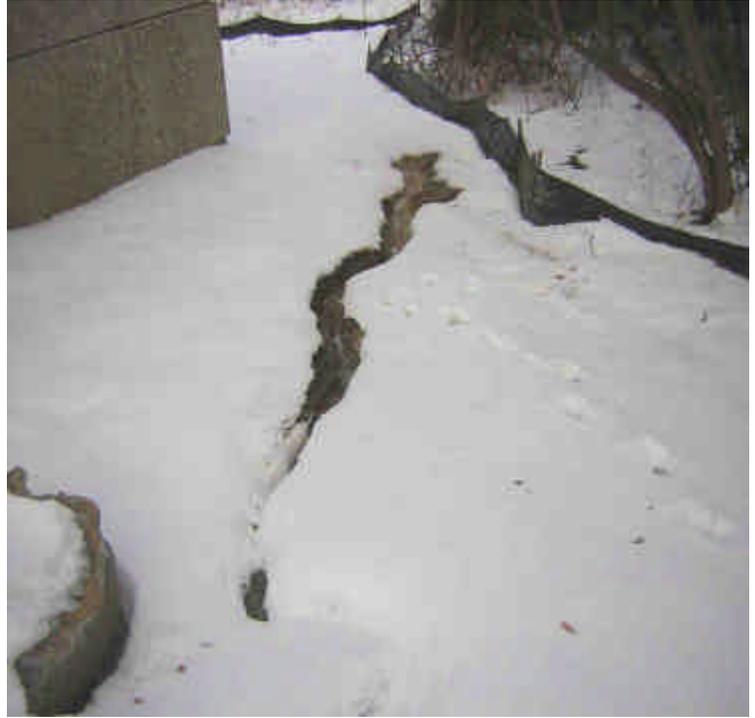
Hoyts Hill Transition Station: Both photos show views of the gullies establishing even through the snow cover on the southern side of the site. Sedimentation along the gully is resulting. 12/22/05

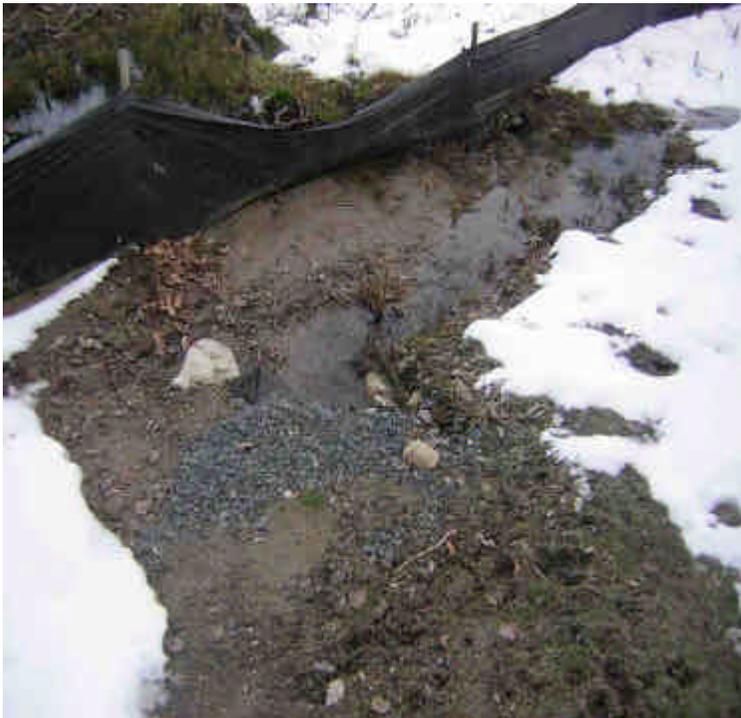
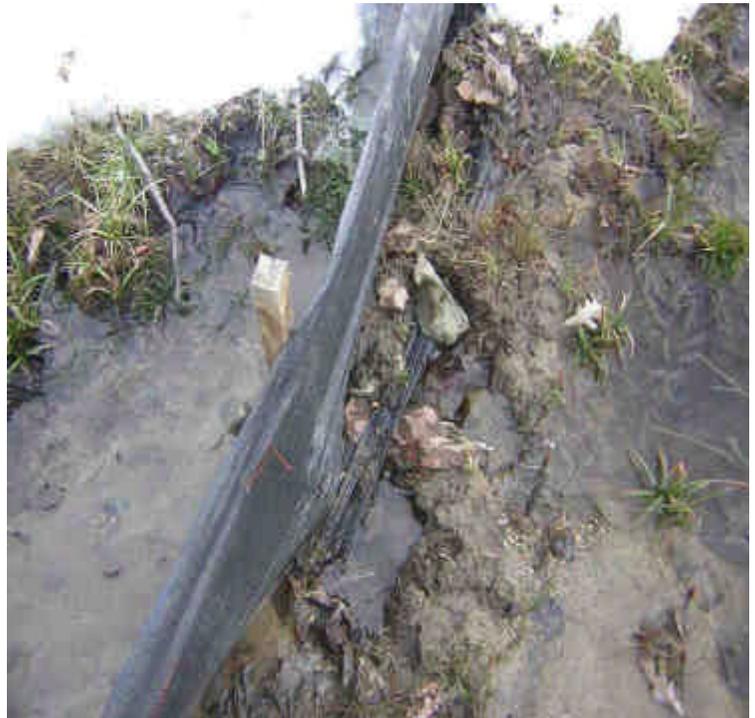
Both photos are of a spot along the perimeter fence where clear water is running through to the wetlands at this time but some minor sedimentation had previously occurred. 12/22/05.

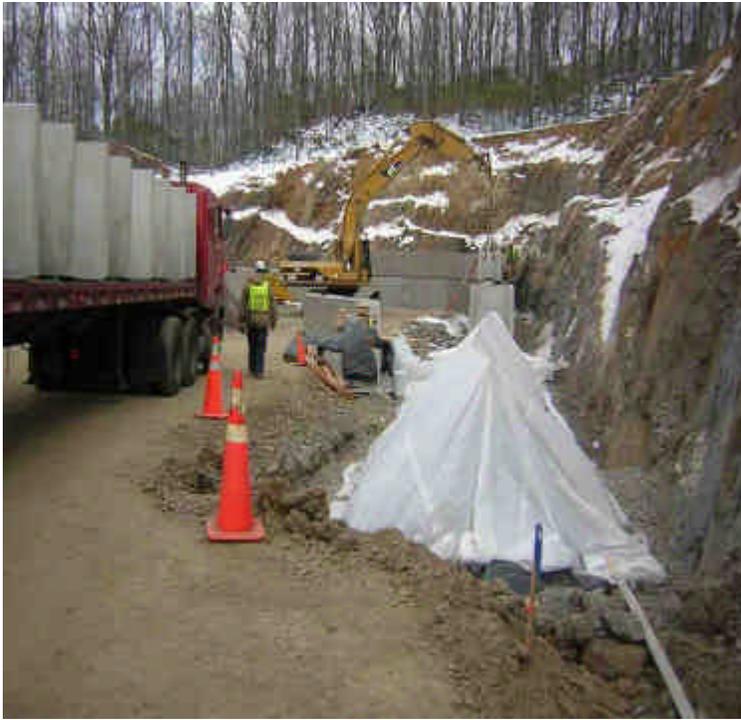
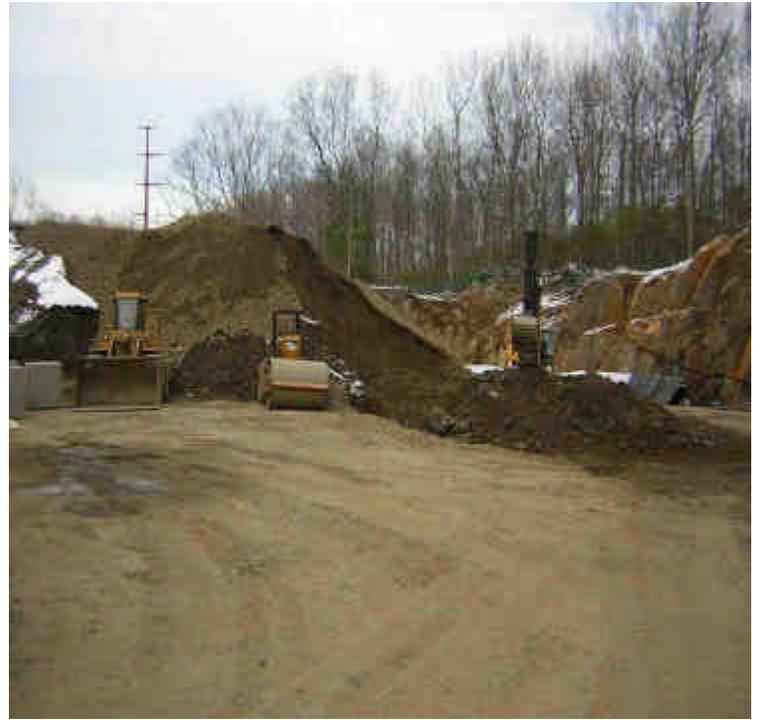
Archers Lane: both photos show the ongoing earthwork and construction of retaining walls on site. Photo on the right shows some of the resulting stockpiles. 12/22/05.

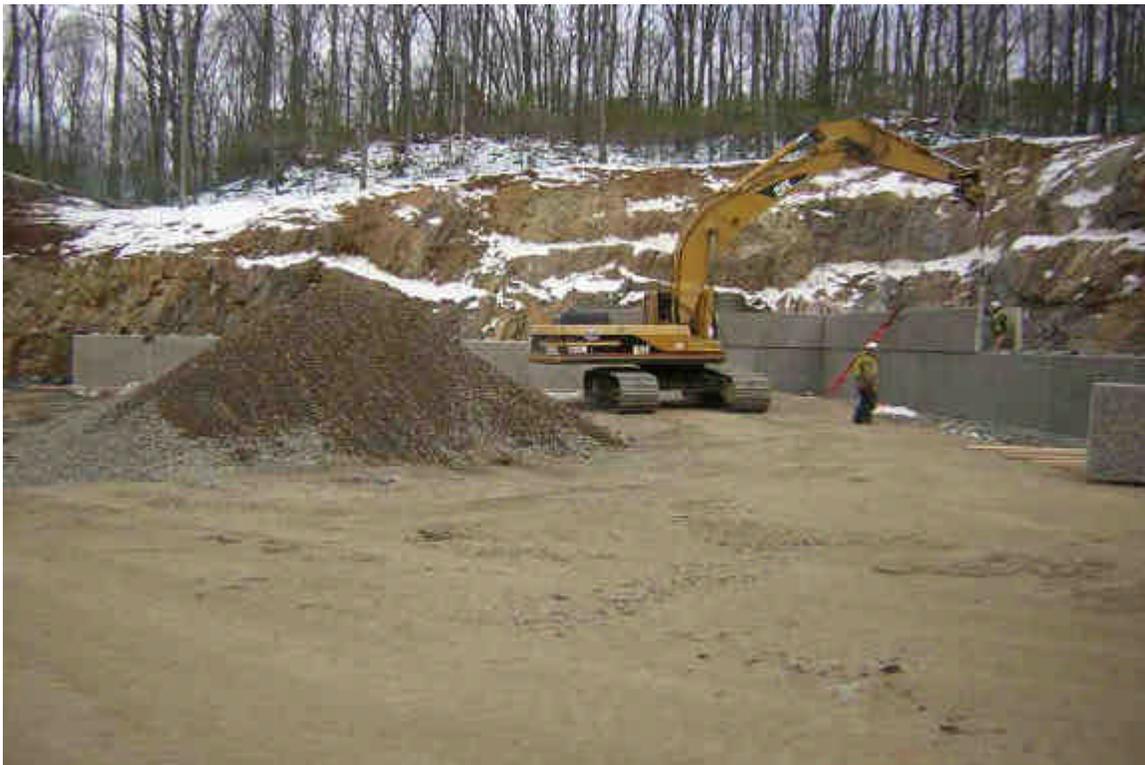
Overview of the site and the progress being made on the retaining walls and foundations. 12/22/05.

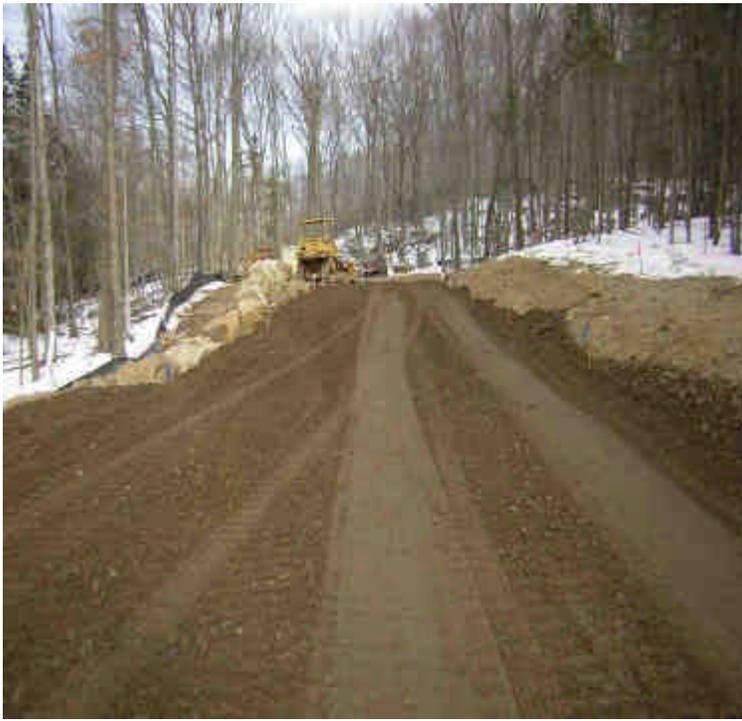
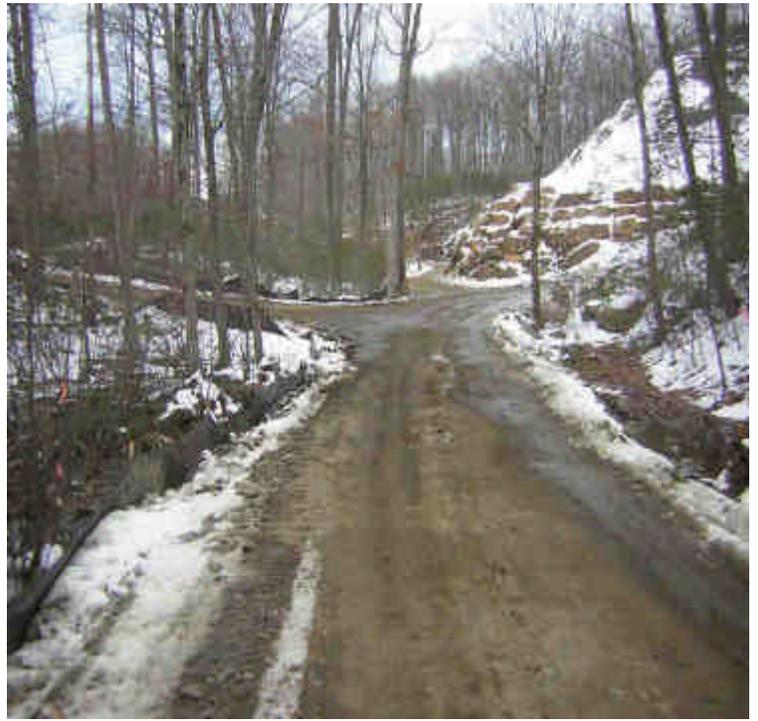
Photo on the left shows regarding of the access drive into site where a vault has recently been installed. Photo on the right shows the access road past the site where it splits towards the ROW and towards the station. 12/22/05

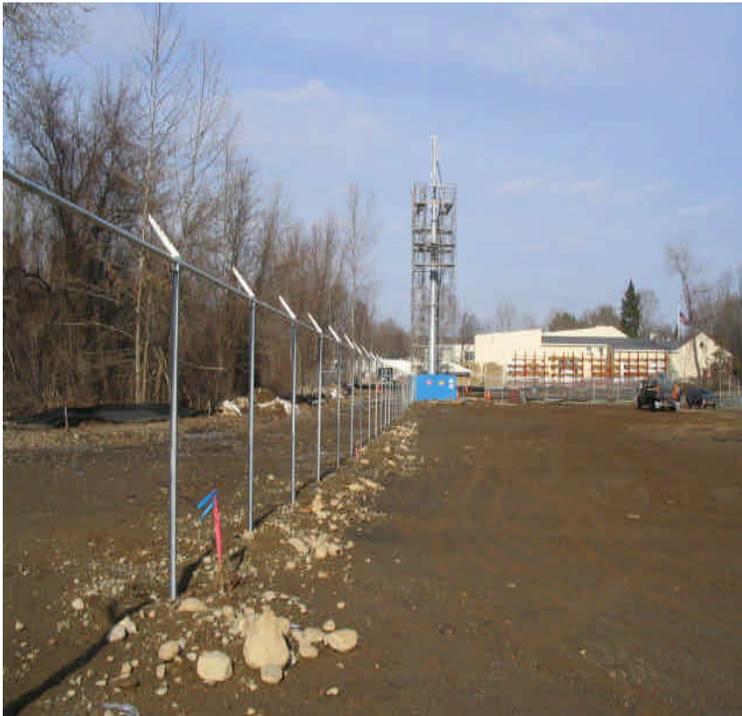
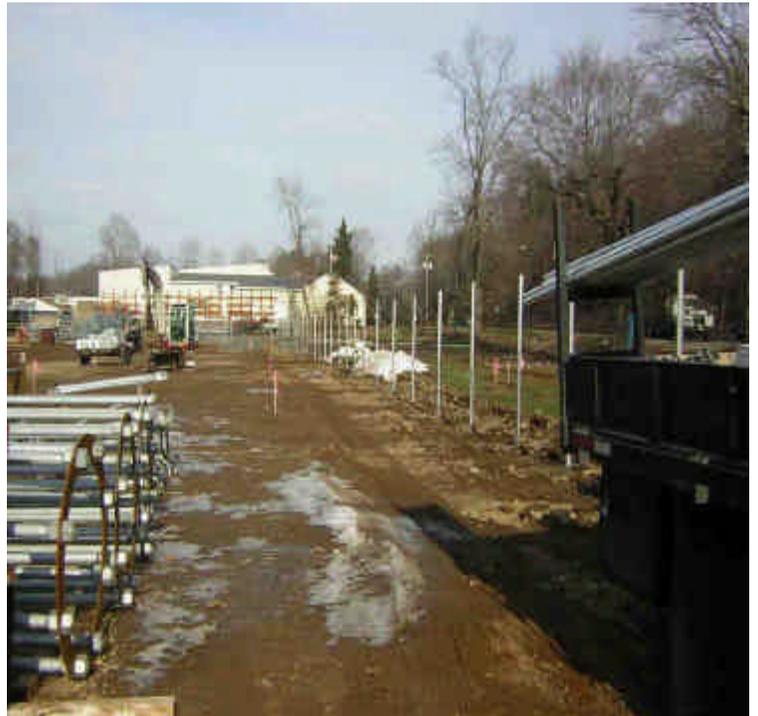
Norwalk Junction: Overall view of the site and the recent progress on the station work. The perimeter chain link fence has been staked out and is being installed. 12/22/05

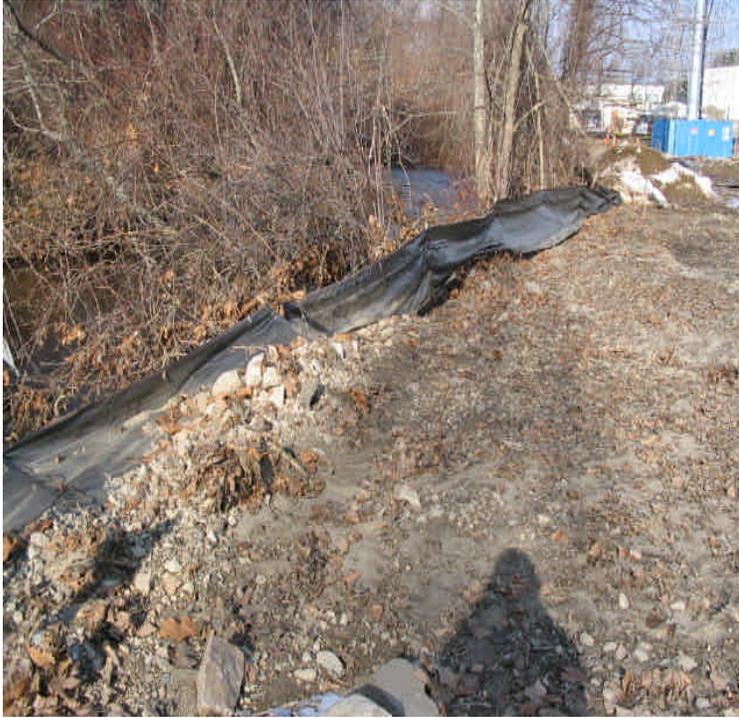
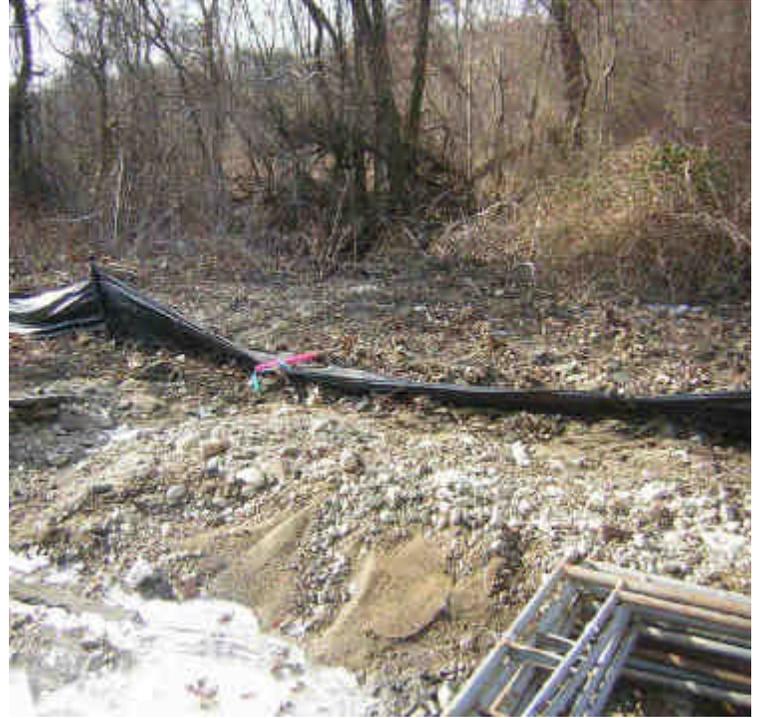
Views of the perimeter silt fence which is down in most areas along the river. Some is attributable to snow plowing but other areas have come down or come un-toed over time. The controls need repair as soon as possible due to the proximity of the river. If the ground is too frozen for digging, haybales or berms should be used. 12/22/05

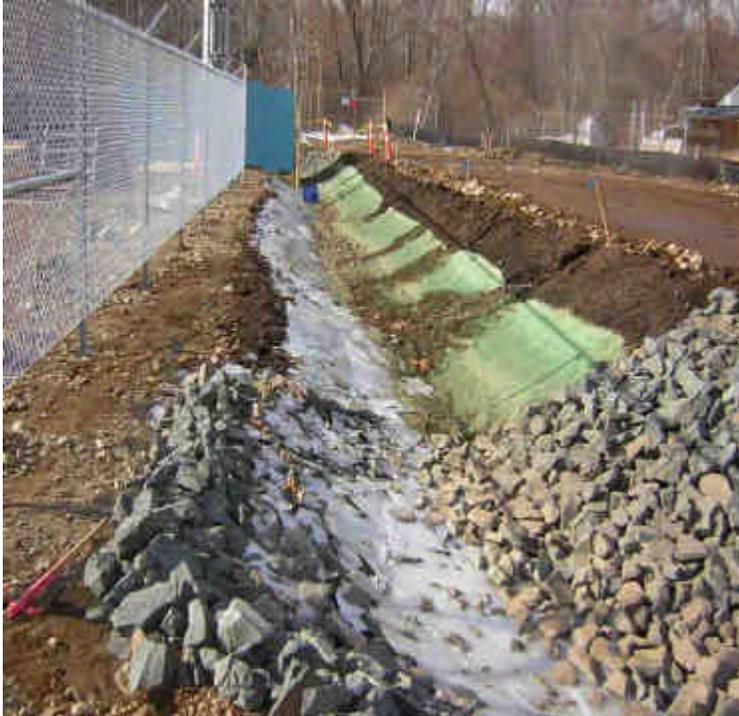
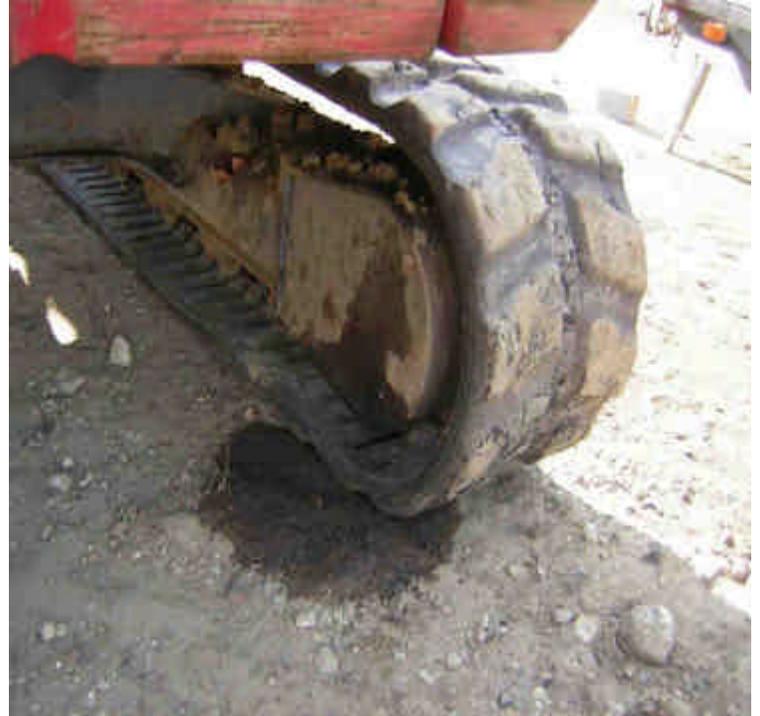
Photo on the left shows the completed drainage swale along the access road. Photo on the right shows where a small leak, likely due to over-fueling occurred under a small excavator on site. 12/22/05

Areas of Inspection	Observation	Recommended Action
Blasting	- All blasting is complete at Archers Lane. 12/22/05.	- None at this time.
Spills and Material Storage	-A small spill spot was noted under an excavator at Norwalk Junction, likely as a result of over- fueling. The soil should be picked up. 12/22/05.	<ul style="list-style-type: none"> - Continue to keep all vehicles maintained well (i.e. no apparent fluid leaks) if they will be used or stored on site - Report spills immediately, even if they are being controlled. - Take care not to get carried away and to be vigilant when refueling. Avoid refueling in the areas near the wetlands. Se proper storage for all materials.
Additional Observations
