Docket No. 217 – Development and Management Plan Inspection

Northeast Utilities Service Company Certificate of Environmental Compatibility and Public Need for the construction of a 345-kV electric transmission line and reconstruction of an existing 115-kV electric transmission line between Connecticut Light and Power Company’s Plumtree Substation in Bethel, through the towns of Redding, Weston, and Wilton, and to the Norwalk Substation in Norwalk, Connecticut.

Date: October 18, 2006

Location: 345kV XLPE Component

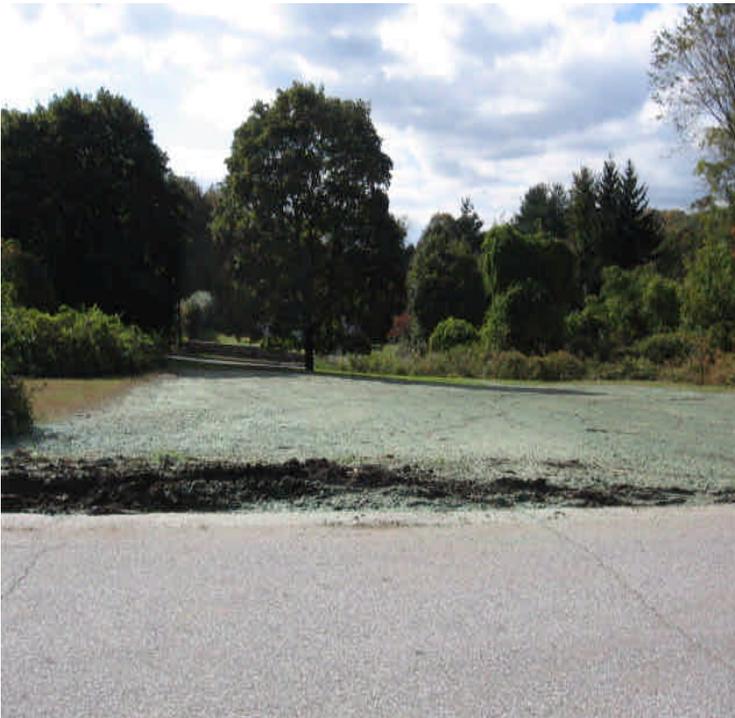
345kV XLPE: Photo on the left shows the demobilized contractor yard in the Bethel Ed Park which was recently graded and hydroseeded. Little grass growth was noted this week. Photo on the right shows the stream bank with patchy vegetation returning. Additional seed or alternative stabilization measures may be needed here. 10/18/06

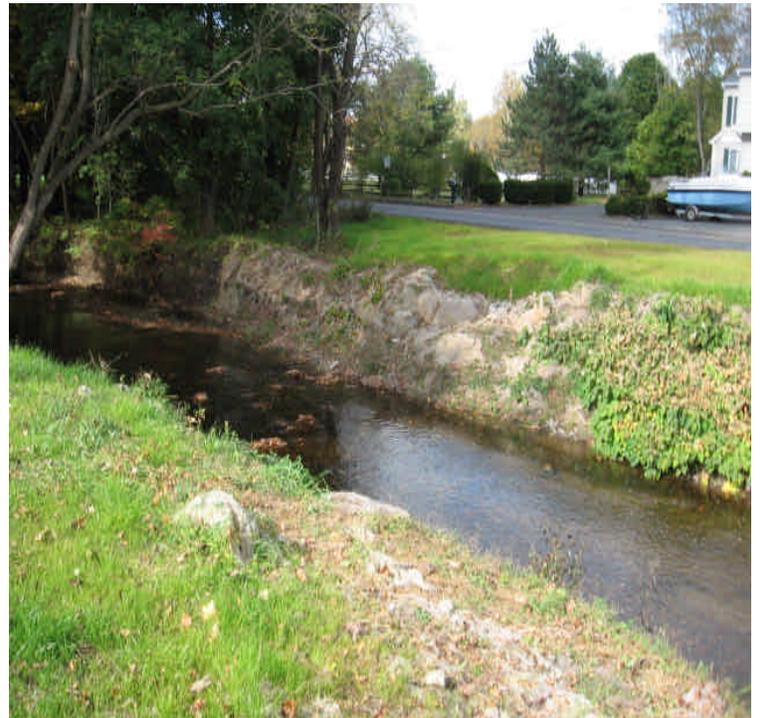
Areas of Inspection	Observation	Recommended Action	Corrective Action
Erosion and Sediment Controls continued	<p>- The area at vault 2A&B has further stabilized with grass cover. This area will no longer be inspected. 10/18/06.</p> <p>-The erosion control blankets remained in place along the streambank, but vegetation remains sparse. 9/13-10/18/06</p> <p>-The contractor yard on Whittlesey Dr was loamed and hydro-seeded. 10/18/06.</p>	<p>-None. 10/18/06</p> <p>-Consider additional stabilization measures along the banks since additional vegetative cover is not likely at this point. 10/18/06</p> <p>- Continue to monitor for final stabilization. 10/18/06.</p>	<p>-Area is stable.</p> <p>-May need attention.</p> <p>- The area was hydroseeded and temporarily stabilized.</p>
Inland Wetland and Watercourse encroachment and mitigation	<p>-The banks of East Swamp Brook remain in good shape but additional stabilization measures may be necessary. Vegetation is sparse here. 9/7-10/18/06.</p>	<p>-Consider additional stabilization measures along the banks since additional vegetative cover is not likely at this point. 10/18/06</p>	<p>May need attention.</p>

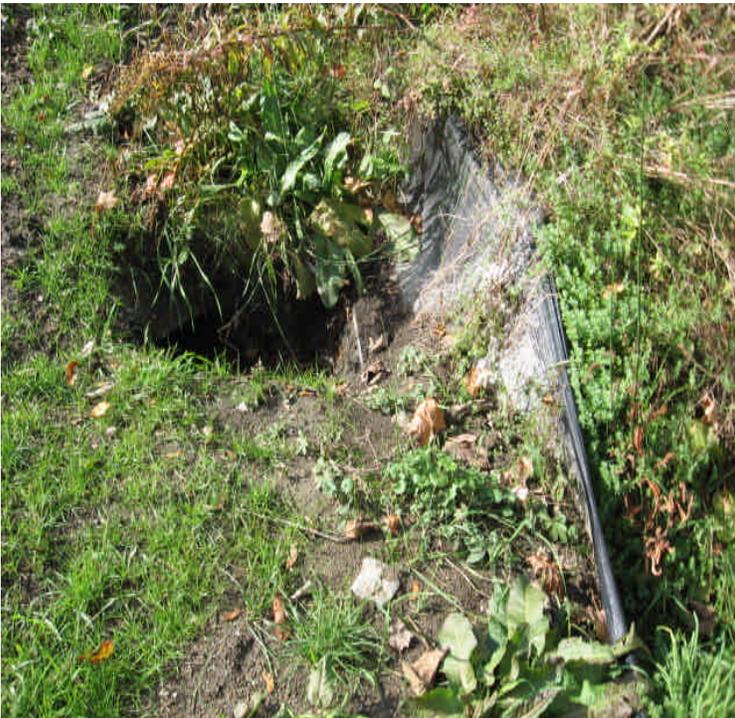
Photo on the left shows a section of silt fence at the jack and bore which may need to be replaced with haybales as a precautionary measure. The silt fence can be removed completely. Photo on the right shows that grass growth has increased significantly in the vault 2 area. 10/18/06

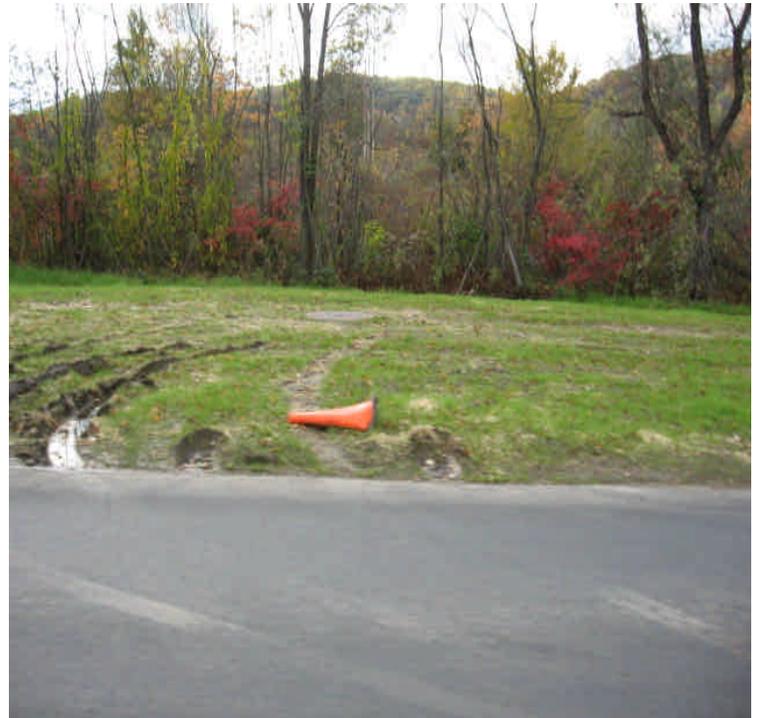
Areas of Inspection	Observation	Recommended Action	Corrective Action
Access Roads and Adjacent Roadways	<p>- Increased grass growth was noted within at vault 2. All adjacent roadside areas have re-vegetated. 10/18/06</p> <p>- Vault access areas along Whittlesey Drive have stabilized with vegetation and will no longer be inspected. 10/18/06.</p>	<p>-Area has achieved the amount of cover expected prior to the winter and is at least temporarily stable. 10/18/06</p> <p>-None at this time. 10/18/06.</p>	<p>- Vault area is largely stable.</p> <p>- Vault access areas are stable.</p>
Trench and foundation construction	<p>- Active work appears complete on this section of the project. All areas are restored well. 10/18/06</p> <p>-The contractor yard was demobilized and the area was graded and hydroseeded. 10/18/06</p>	<p>-None. 10/18/06</p> <p>-None 10/18/06</p>	<p>- N/A</p> <p>- N/A</p>
Erosion and Sediment Controls (includes inspection within 24 hours of a storm event)	<p>- The jack & bore area is stable with well established grass cover. The erosion control matting remains in good shape but grass has not established as quickly here. 10/4-10/18/06</p>	<p>-Silt fence could be removed completely here but a few haybales should be added in strategic locations as a precaution. 10/18/06</p>	<p>-The area appears stable. (remove silt fence)</p>
