**Docket No. 217 – Development and Management Plan Inspection**

Northeast Utilities Service Company Certificate of Environmental Compatibility and Public Need for the construction of a 345-kV electric transmission line and reconstruction of an existing 115-kV electric transmission line between Connecticut Light and Power Company's Plumtree Substation in Bethel, through the towns of Redding, Weston, and Wilton, and to the Norwalk Substation in Norwalk, Connecticut.

**Date:** October 13, 2006

**Location:** Overhead Line (Composite 345kV and 115kV Gallows Hill to Archers Lane, 345kV H-Frame Hoyts Hill to Gallows Hill, and Norwalk Section)

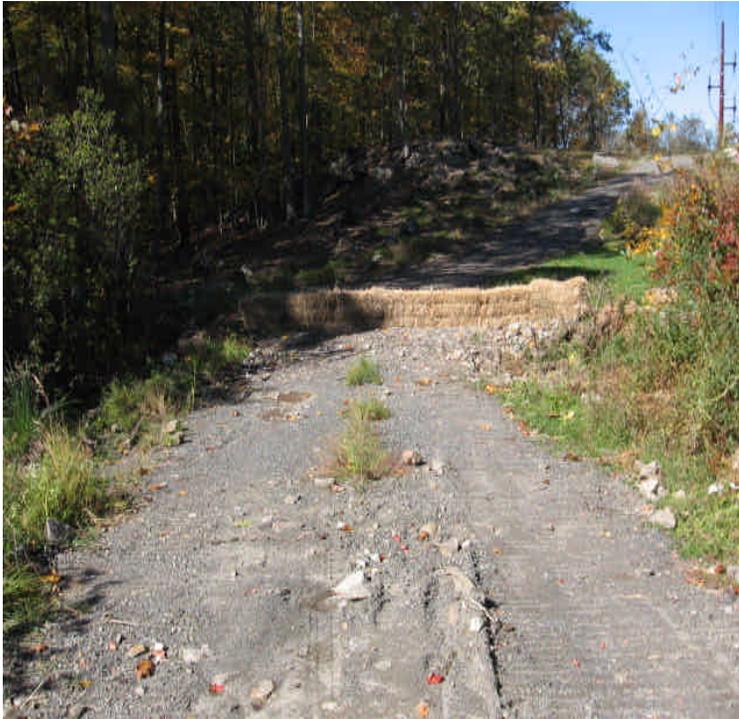
**(Composite Section):** Photo on the left shows a hay bale check dam placed along the access road slope near the restored wetland crossing at Gallows Hill. Photo on the right shows a view of the restored crossing. The stone and fabric were removed, but it appears this area may not have been restored to original grade in all spots. Continue to monitor this area. 10/13/06.

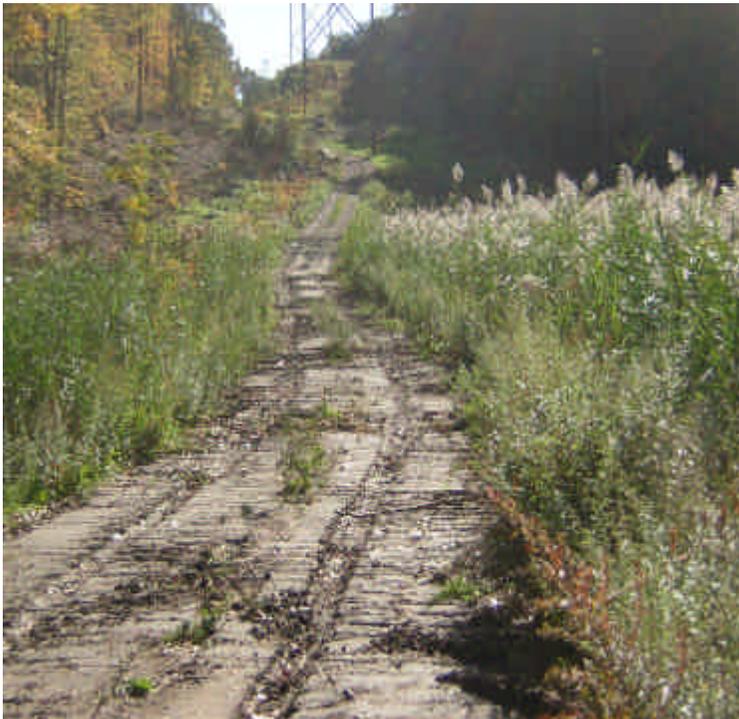
**(345kV H-Frame):** Both photos show the views within the ROW in the Bethel Reservoir section. Photo on the left shows a view of the first wetland crossing where mats have been removed. Photo on the right shows pieces of mat and lumber stored within the ROW. 10/13/06.

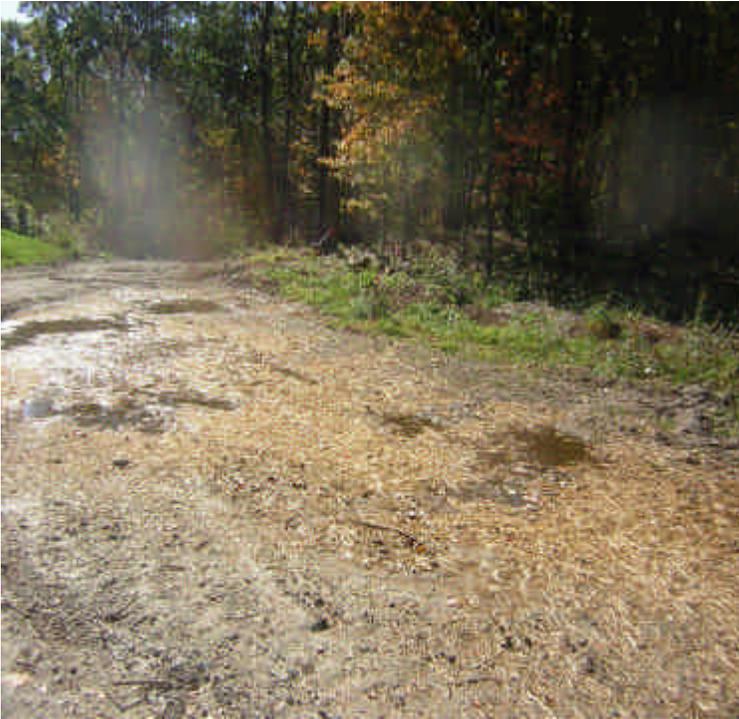
Photo on the left shows the restored area at structure #10. Stockpiles were removed and disturbed areas were seeded and mulched with hay. Photo on the right shows the disturbed area at structure #9, which was graded to original conditions, seeded and mulched. 10/13/06

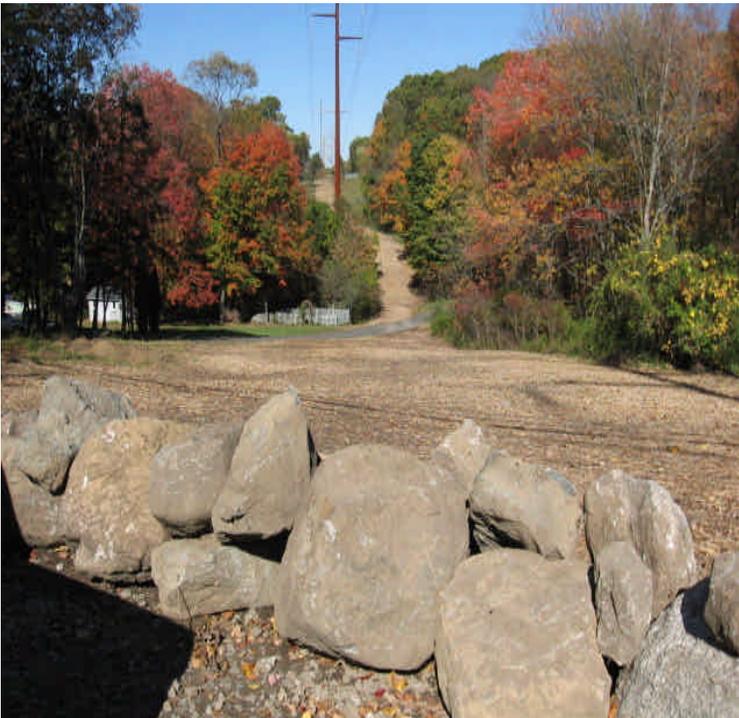
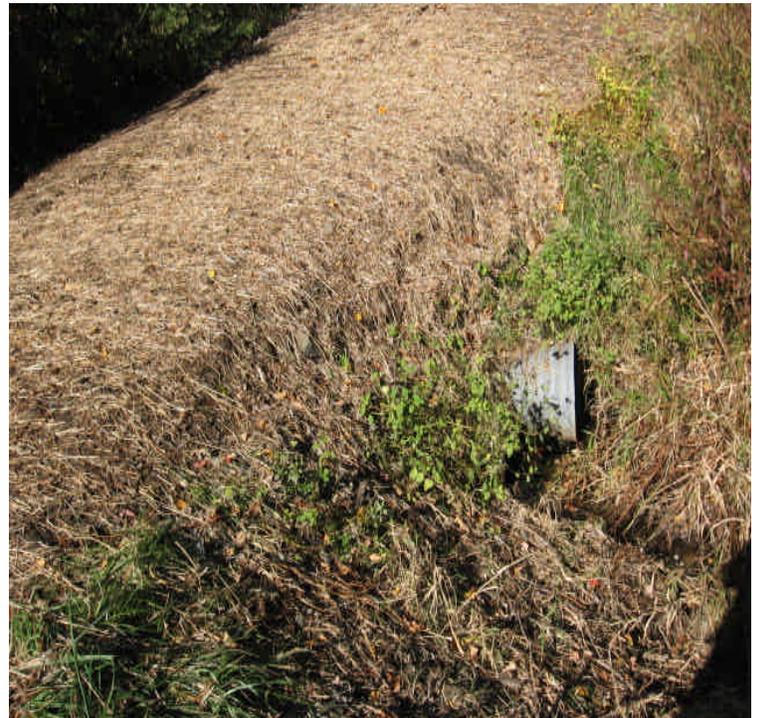
Both photos show the restored access road and stream crossing in the ROW off Chestnut Ridge Road. Photo on the left shows the entire access road graded to original conditions with seed and mulch applied. Mats were removed from the stream crossing here. Photo on the right shows a close up of the restoration work near the stream crossing. 10/13/06.

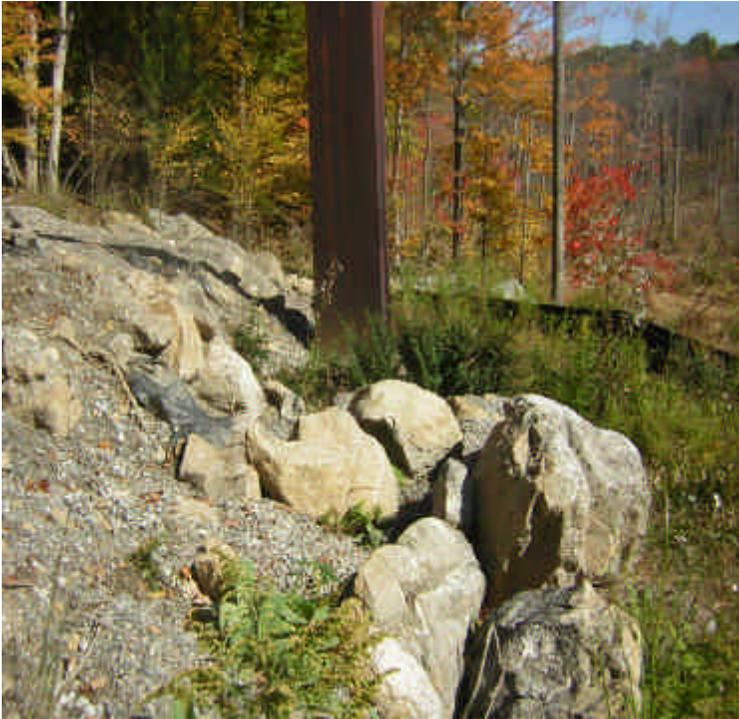
**Photo on the left shows a portion of the potentially unstable slope near the wetland at structure #24 off John Todd Way. Photo on the right shows disturbed areas have re-vegetated within the ROW here. 10/13/06**

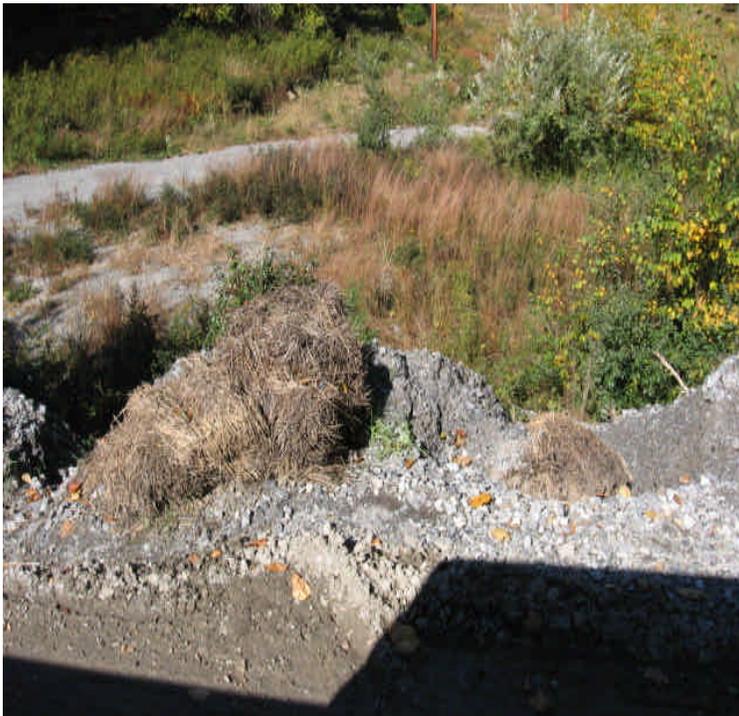
<p><b>Norwalk Section</b></p>	<p>- Erosion continues along the access road near structure #31 but hay bales seem to be containing sediment. 7/19-10/13/06.</p> <p>- No sediment tracking was noted in Kent Road from the ROW access to the north this week. There was no active work here at the time of inspection. 10/13/06.</p> <p>-It appears that restoration activities have not yet begun in the Kent Road north section of</p>	<p>-Continue to monitor and keep stone out of any resource areas. Hay bales currently contain the sediment. 7/26-10/13/06.</p> <p>- Continue to maintain this entrance and sweep street when necessary. Add more clean stone if needed. 7/19-10/13/06.</p> <p>- Continue restoration and clean up in previously disturbed areas. Restore as near as possible to original conditions. 10/13/06.</p>	<p>-NA</p> <p>- N/A</p> <p>-Needs attention</p>

**Photo on the left shows a view of the erosion continuing in the access road near structure #31 off Costa Lane. Photo on the right shows the access road graded to original conditions. Crews were applying seed and mulch to remaining disturbed areas at the time of inspection. 10/13/06.**

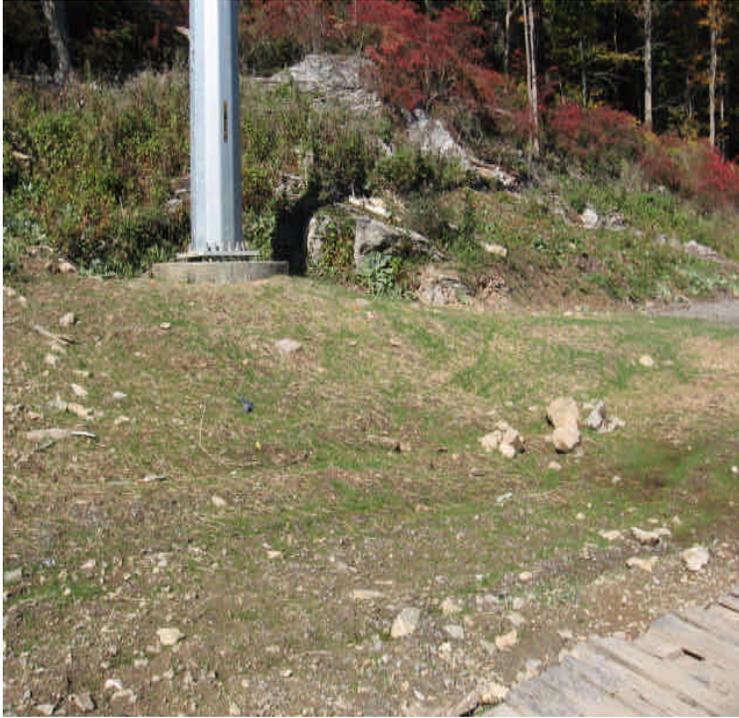
**(Norwalk Section):** Photo on the left shows grass growth in a restored area off Kent Road south. All disturbed areas are re-vegetating here. Photo on the right shows washouts continuing along the access road. Stone remains in the wetland in many areas. 10/13/06.

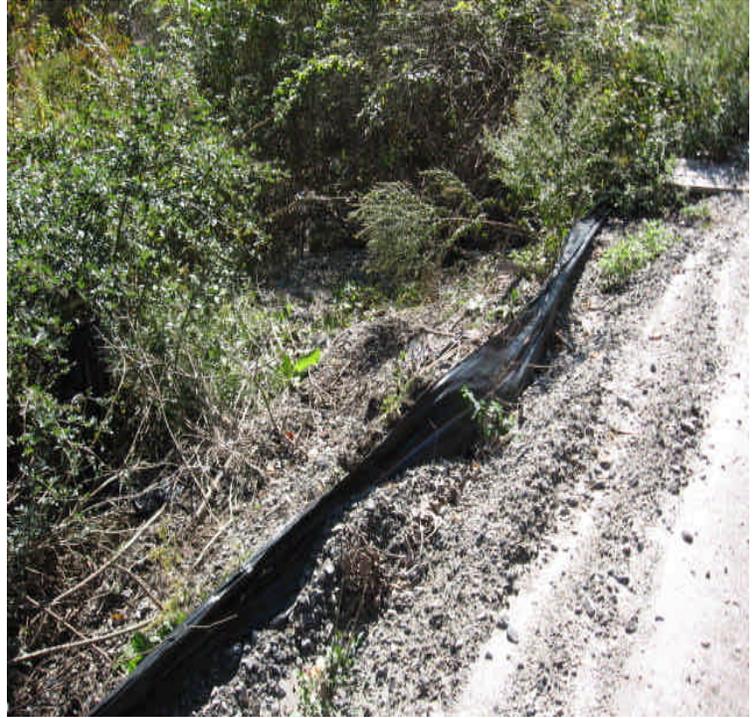
Areas of Inspection	Observation	Recommended Action	Corrective Action
	<p>still need to be removed. 9/29-10/13/06. Grass growth was noted in restored areas. 10/13/06.</p> <p>- Stone from the access road continues to washout beyond the erosion controls into the wetland. Silt fence/ haybales here are deteriorating. 9/29-10/13/06.</p>	<p>- Stabilization options for the stone access road should be evaluated. 9/29-10/13/06. These areas will be difficult to control during heavy rain due to the drainage patterns. 7/12-10/13/06.</p>	<p>-Needs attention</p>
<p>Inland Wetland and Watercourse encroachment and mitigation <b>Composite</b></p> <p><b>345kV H-Frame</b></p>	<p>-The stone and mats have been removed from the wetland crossings along the Archers Lane ROW and the road has been re-graded to original condition. 9/29-10/13/06.</p> <p>-The stone was removed from the wetland crossing near structure #34 off Gallows Hill Road. It appears some spots may not have been re-graded to original conditions and hydrology. 10/13/06.</p> <p>-The matted crossings have been removed from wetlands in the Bethel Reservoir ROW. Bare soil remains where the mats were located 10/13/06.</p> <p>- All crossings were removed within the Chestnut Ridge Section. 10/13/06. The existing stream culvert appears to be in original condition. This area will no longer</p>	<p>Silt fence will be removed when vegetation has established (or replaced with haybales in appropriate locations). 9/29-10/13/06.</p> <p>- Monitor the hydrology within the crossing to be sure this area continues to function properly. 10/13/06.</p> <p>- Continue to monitor until stabilized. Silt fence should be replaced with haybales in appropriate locations. Wetland vegetation should return by the next growing season. 10/13/06.</p> <p>-NA</p>	<p>-N/A</p> <p>-The crossing was removed.</p> <p>- Mats were removed.</p> <p>-Restoration is complete in this section and it will no longer be inspected.</p>

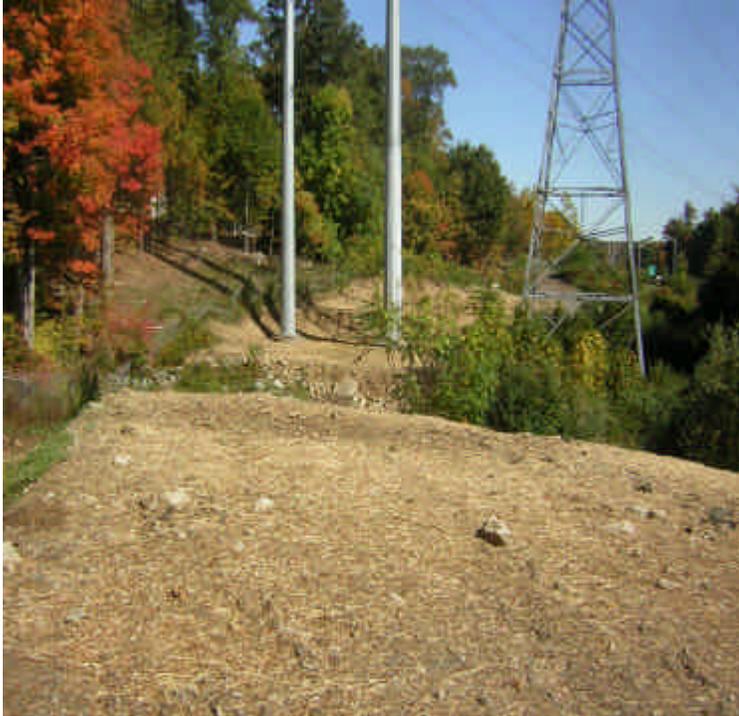
**Both photos show views of the restored area at structure #11064 off North Seir Hill Road. Photo on the left shows seed and hay mulch were applied to the access road and disturbed slopes. Photo on the right shows a close up of the stream channel at the base of the slope, which is not protected by erosion controls yet. Erosion control mats may be necessary here on the slopes.**

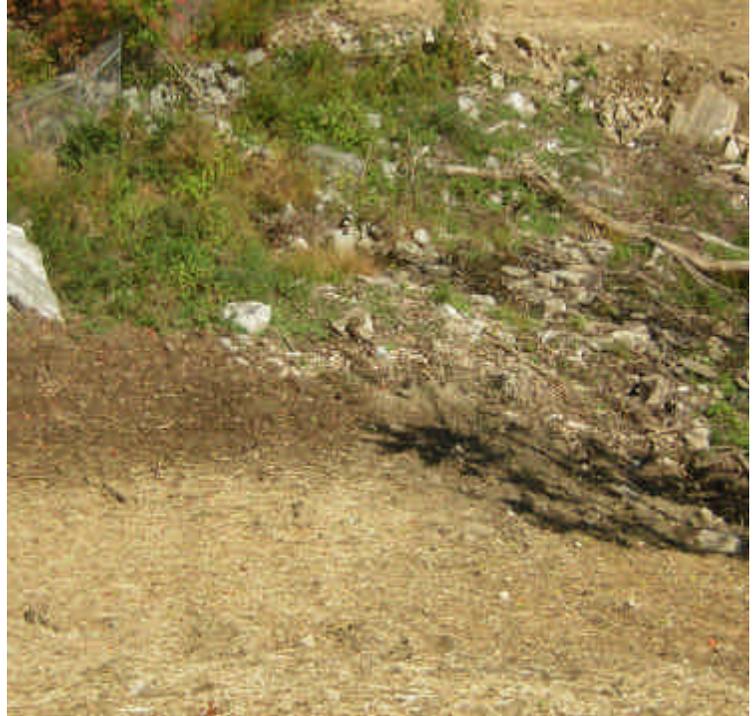
Areas of Inspection	Observation	Recommended Action	Corrective Action
Kent Rd. (North)	<p>10/13/06.</p> <ul style="list-style-type: none"> <li>- The disturbed/cleared slopes adjacent to the stream bank at structure #11064 have been seeded and mulched but the stream is not protected by erosion controls. 10/13/06.</li> <li>- Grass growth was noted at structure #11080 near the substation but washouts in the mulch continue. The silt fence here is stressed. 10/04-10/13/06</li> <li>- Grass growth was noted in the restored areas off Broad Street, Perry Ave south, and the Rt 7 extension following restoration. Perry Ave south has stabilized and will no longer be inspected. 10/13/06</li> <li>- The disturbed areas at Kent Road (north) have not been seeded or mulched. Some areas don't appear to have been graded back to original conditions. 9/29-10/13/06.</li> </ul>	<p>grass growth for final stabilization. Install and maintain hay bales along both sides of the stream to prevent sediment from entering the stream channel. 10/13/06.</p> <ul style="list-style-type: none"> <li>- Repair silt fence and monitor until the area is stabilized with vegetation. 10/13/06.</li> <li>-Continue to monitor but the area is becoming stable. 10/13/06</li> <li>-These areas should be restored/seeded as soon as possible. Generally, the end of fall seeding is Oct 15<sup>th</sup>. 10/13/06.</li> </ul>	<ul style="list-style-type: none"> <li>-Restoration noted but still needs attention.</li> <li>- Restoration was noted but still needs attention</li> <li>-Grass growth was noted in some areas.</li> <li>- Perry Ave south has stabilized and will no longer be inspected.</li> <li>-Needs attention</li> </ul>

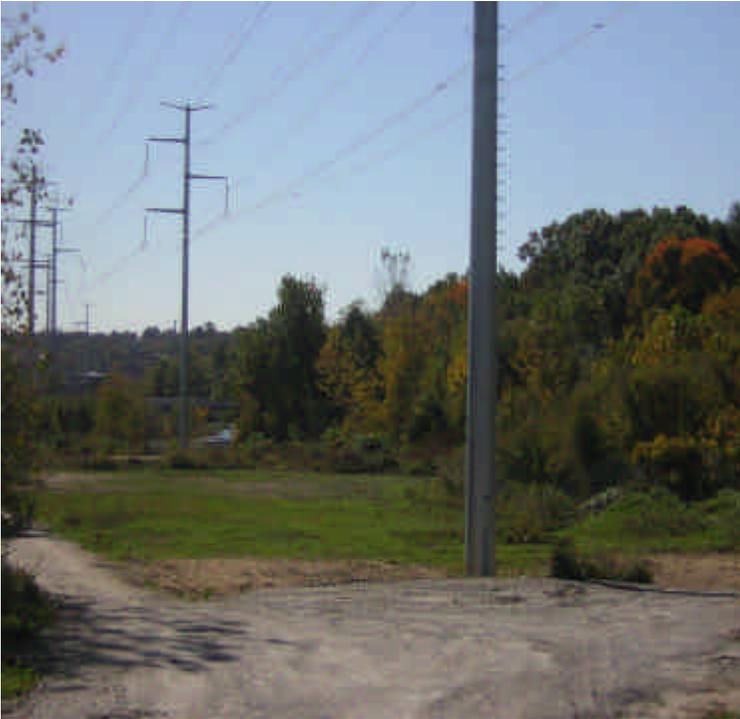
**Photo on the left shows disturbed areas have re-vegetated well in the ROW off Perry Ave (south). Photo on the right shows seed and hay mulch were applied at structure #11079 off Broad Street (north). 10/13/06.**

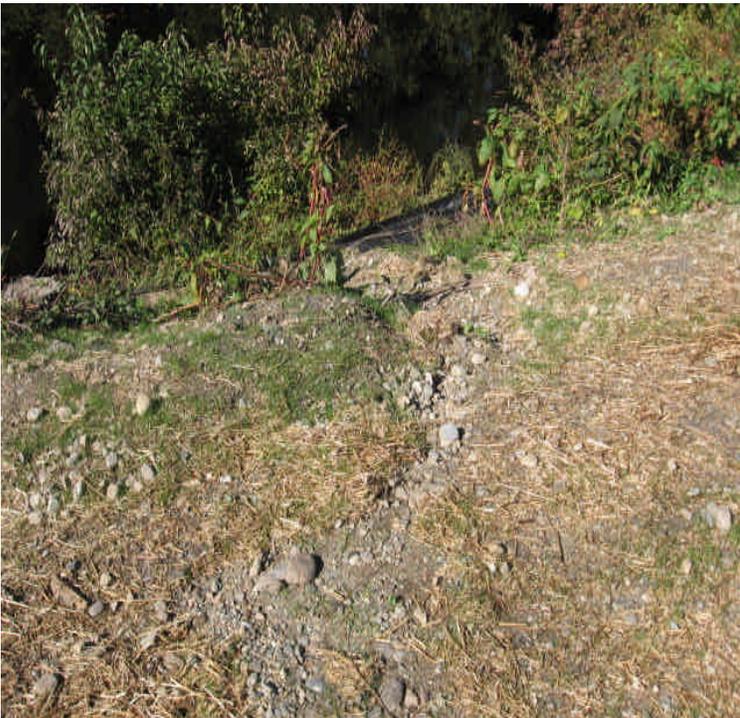
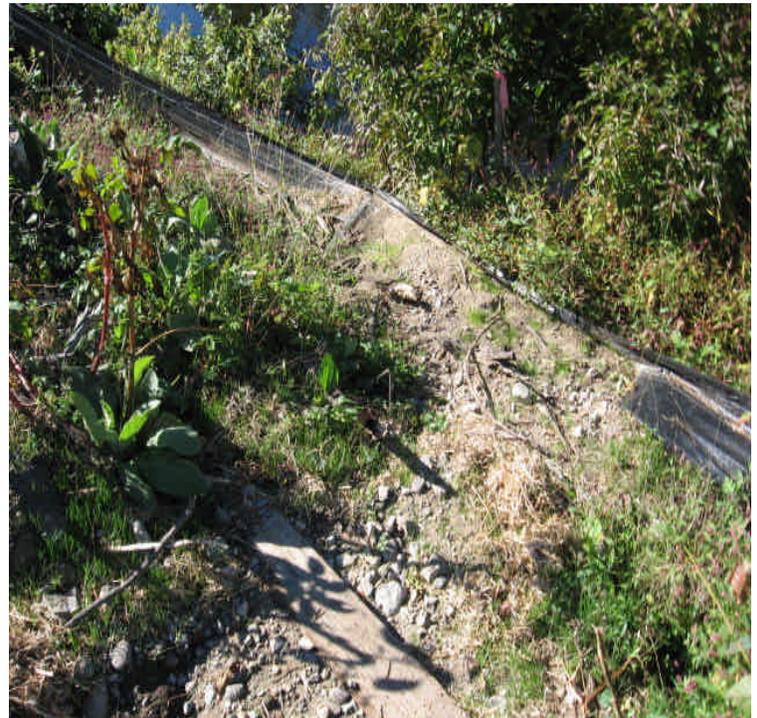
**Both photos show views of the washout occurring on the slope at structure #11080 near Norwalk substation. Photo on the left shows a gully forming along the slope due to storm water runoff from the paved bike path. Photo on the right shows sediment beginning to overwhelm erosion controls here. 10/13/06.**
