**Docket No. 217 – Development and Management Plan Inspection**

Northeast Utilities Service Company Certificate of Environmental Compatibility and Public Need for the construction of a 345-kV electric transmission line and reconstruction of an existing 115-kV electric transmission line between Connecticut Light and Power Company's Plumtree Substation in Bethel, through the towns of Redding, Weston, and Wilton, and to the Norwalk Substation in Norwalk, Connecticut.

**Norwalk Substation**

**Date:** October 18, 2006

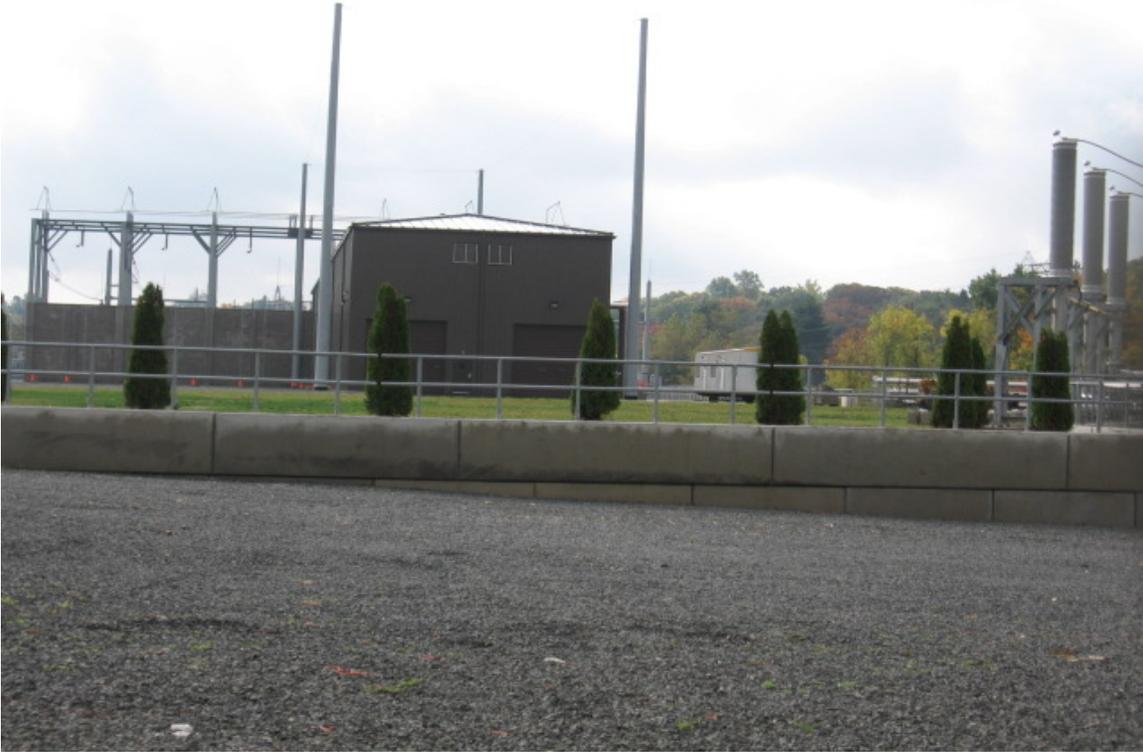
(Norwalk Substation): Photo shows a view of the substation yard. No active work was occurring here this week. 10/18/06

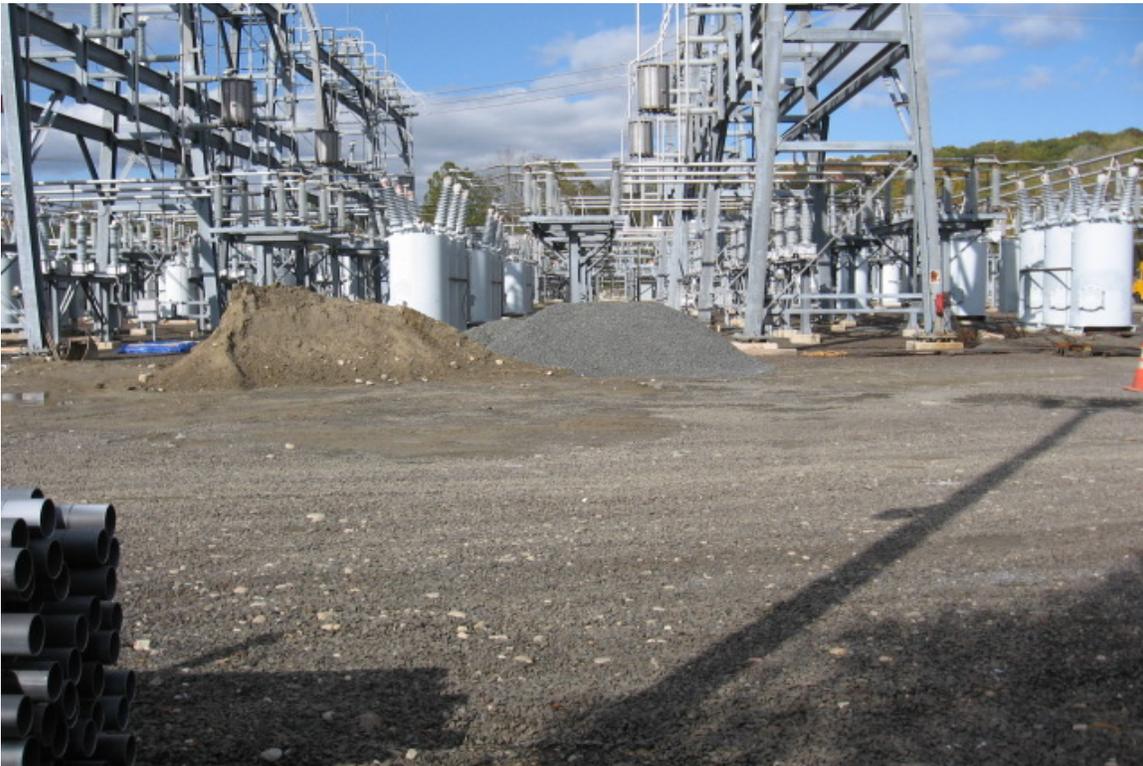
Areas of Inspection	Observation	Recommended Action	Corrected Action
Foundation construction	- Foundation excavation within the southern portion of the substation was noted, but is not under jurisdiction of this project. 10/18/06.	-N/A. 10/18/06.	-Non-jurisdictional.
Erosion and Sediment Controls (includes inspection within 24 hours of a storm event)	- The site has been graded on an even level to the perimeter stone berm towards the north of the site. 7/19-10/18/06  -At least one stockpile and some materials remain on site from previous B/N work. 9/20-10/18/06.	- The berm must remain maintained as sediment control. It may need to be built up with stone in order to filter effectively. 7/19-10/18/06.  -Continue to monitor. 9/20-10/18/06.	- Needs evaluation  -N/A at this time.
Inland Wetland and Watercourse encroachment and mitigation	- Wetlands are located around the outskirts of the substation yard. 10/18/06	- Maintain perimeter berm. Vegetation adjacent to the yard is thick and helps filter run-off. 10/18/06.	N/A.

(Plumtree Substation): Photo shows a view of the substation yard. Stockpiles remain from the excavation occurring in the southern portion of the substation yard. This is not project jurisdictional. 10/18/06.
