Docket No. 217 – Development and Management Plan Inspection

Northeast Utilities Service Company Certificate of Environmental Compatibility and Public Need for the construction of a 345-kV electric transmission line and reconstruction of an existing 115-kV electric transmission line between Connecticut Light and Power Company's Plumtree Substation in Bethel, through the towns of Redding, Weston, and Wilton, and to the Norwalk Substation in Norwalk, Connecticut.

Date: October 4, 2006

Location: Transition Stations: Hoyts Hill, Archers Lane, Norwalk Junction

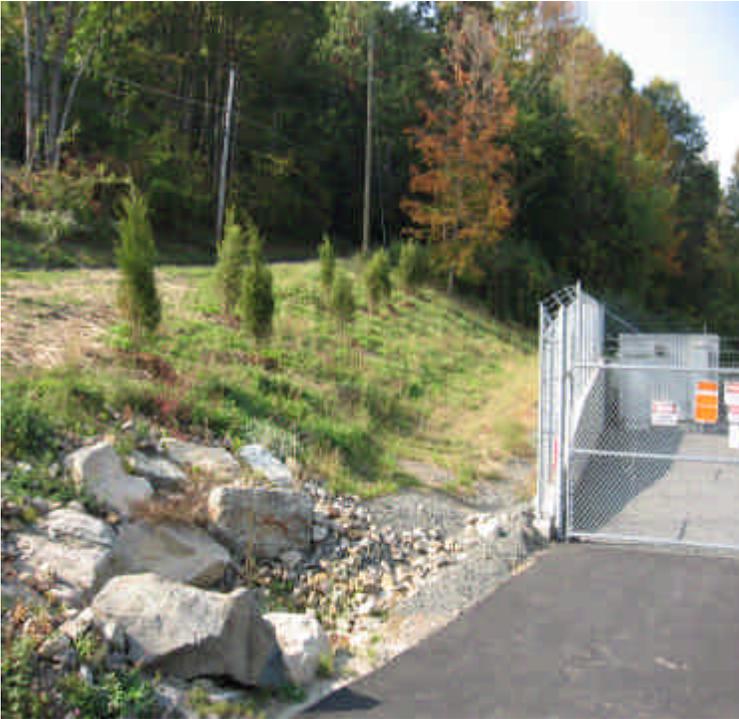
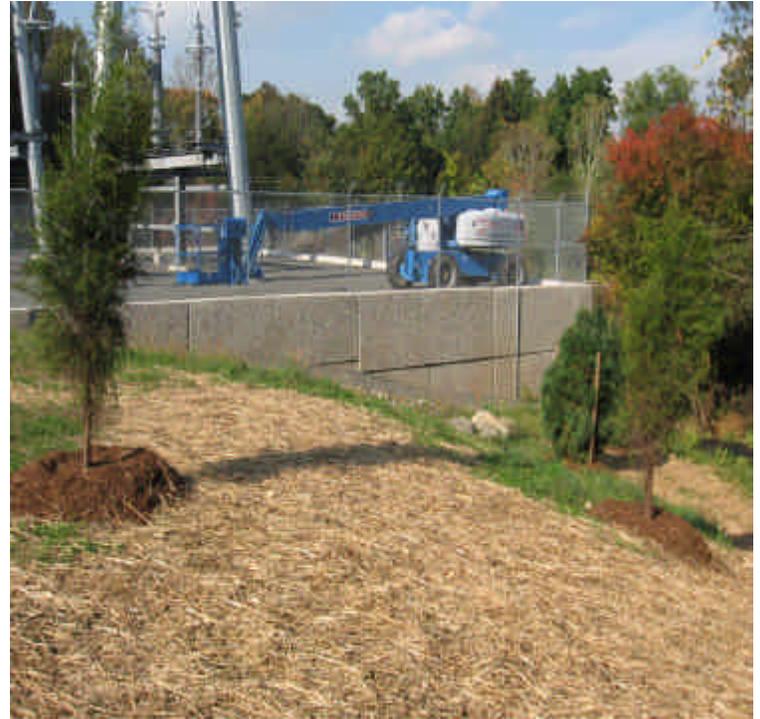
Hoyts Hill Transition Station: Photo on the left shows the restored area along the western slope adjacent to Hoyts Hill Road. This area has re-vegetated rapidly. Photo on the right shows restoration, mulch and landscaping along the southern slope. Grass growth is increasing here. 10/04/06

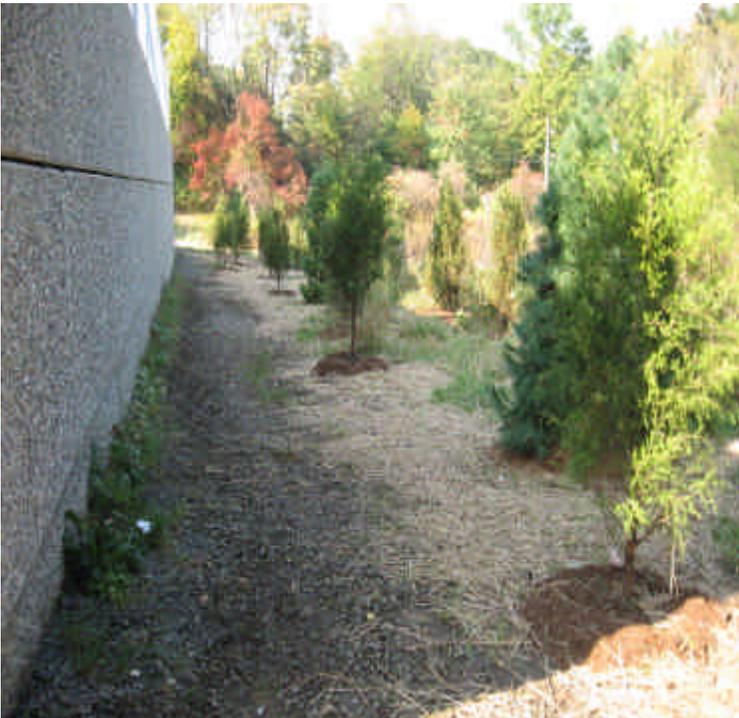
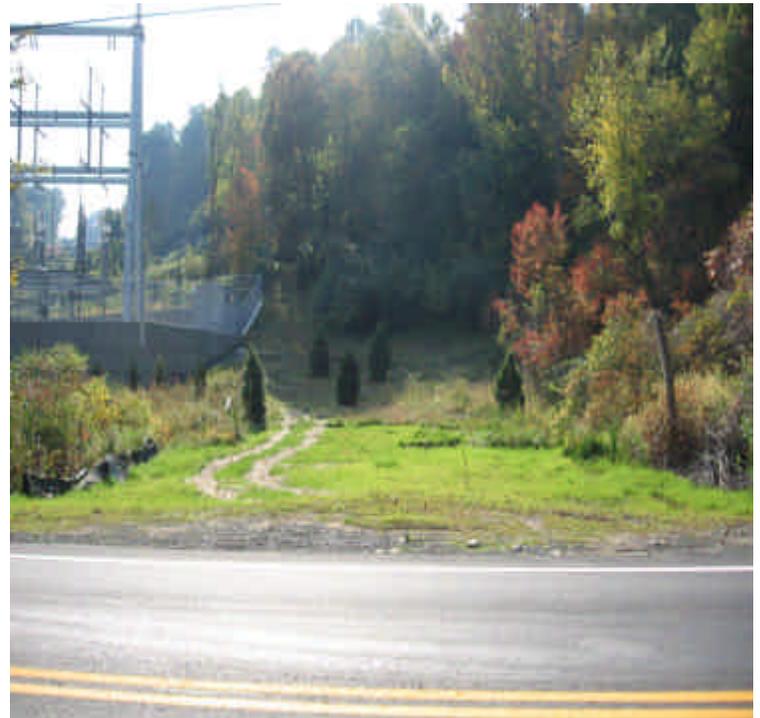
Photo on the left shows the landscaping along the edge of the wetland below the retaining wall. Photo on the right shows another view of the landscaping from Rt 58. Tire tracks in the wetland area were restored and mulched. Silt fence should be removed from the wetland here and along the eastern edge of the station. 10/04/06

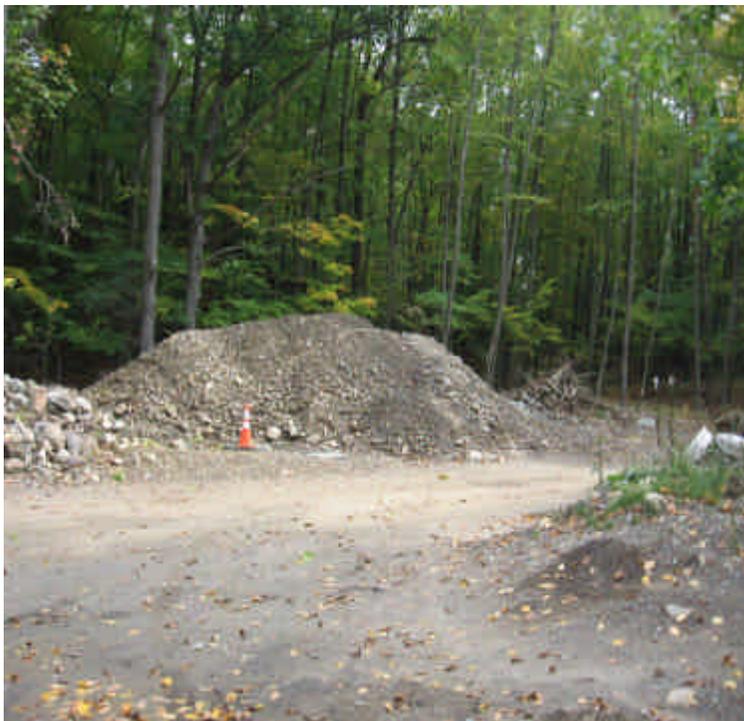
Archers Lane: Photo on the left shows some remaining stockpiles along the access drive. These areas should be restored/vegetated to the extent feasible. Photo on the right shows an overview of the yard. The line and stations will be energized soon. 10/04/06

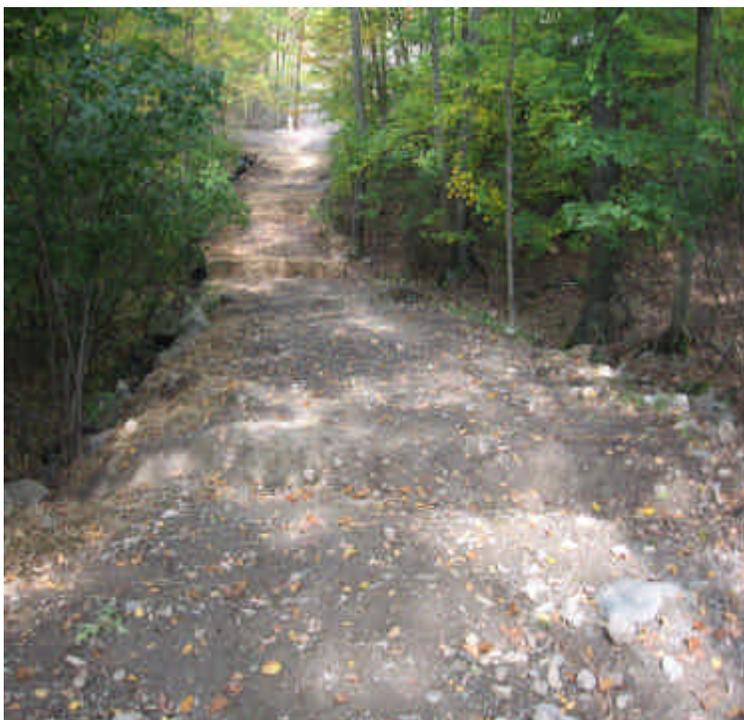
Photo on the left shows the waterbars installed near the first wetland crossing. Haybales should be placed at the outlets to prevent sediment flow into wetlands. Photo on the right shows grass growth in the restored areas. Silt fence remains in good condition. 10/04/06

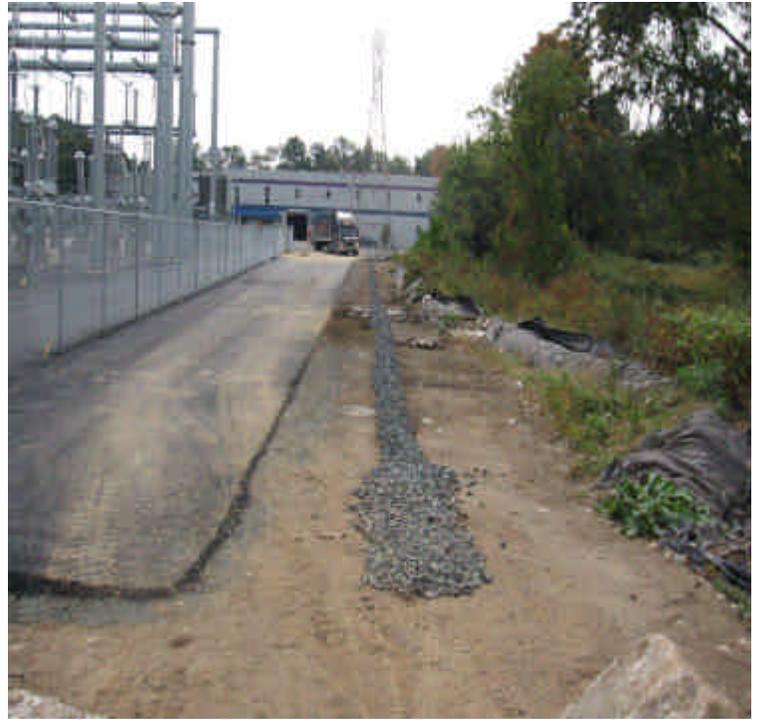
<p>- Norwalk Junction: Perimeter silt fence remain in good shape along the river. 5/17-10/04/06. The adjacent, non-project related berm is degrading</p>	<p>- None at this time. Continue to monitor controls. 5/17-10/04/06.</p> <p>- If feasible, work with adjacent landowner to</p>	<p>-N/A</p> <p>-Needs evaluation if feasible (not</p>

Norwalk Junction: Photo on the left shows the view of the paved station yard. No active work was occurring here during the inspection. Photo on the right shows the paved area adjacent to the yard. The disturbed soil surface should be vegetated to the extent feasible. The non-project related berm is degrading. 10/04/06.

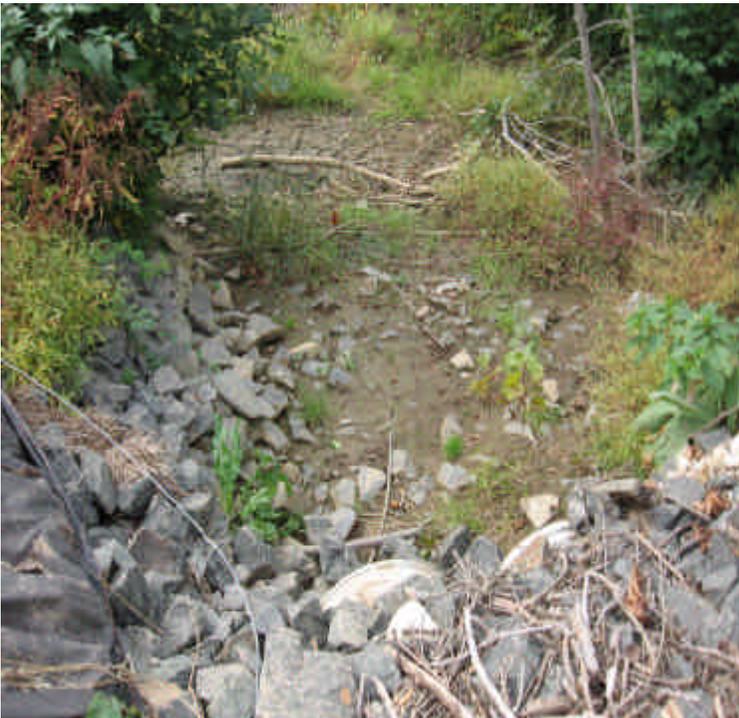
Areas of Inspection	Observation	Recommended Action	Corrected Actions
	<p>areas are restored. Grass growth was noted in restored in areas. 10/04/06.</p> <p>- Norwalk Junction: The outlet of the drainage swale is at the headwall of the wetland area. Wetland vegetation was growing but silt has accumulated and turbid water remains 6/14-10/04/06</p>	<p>- Reduce turbidity by controlling its source-disturbed surfaces and dewatering on site. Deeper sediment buildup at the outlet and within the basin should be removed. 5/25-10/04/06.</p>	<p>-Needs attention</p>
<p>Vegetative clearing limits or stabilization</p>	<p>Hoyts Hill: Landscaping with screening trees had occurred along the perimeter of the station. 9/29-10/04/06</p> <p>- Norwalk Junction: -A number of bare soil areas around the perimeter of site should be temporarily stabilized/vegetated. 7/26-10/04/06.</p>	<p>- Continue to monitor for final stabilization. Portions of adjacent slopes were restored with mulch. 10/04/06</p> <p>- Restore perimeter surfaces wherever feasible (even if it is temporary) 6/1-10/04/06.</p>	<p>- Areas were landscaped</p> <p>-Still needs attention</p>

Photo on the left shows sediment remaining in the wetland located at the swale outlet. Photo on the right shows new sedimentation in the swale adjacent to Rt 7. Disturbed areas still need to be restored/vegetated. 10/04/06.
