Docket No. 217 – Development and Management Plan Inspection

Northeast Utilities Service Company Certificate of Environmental Compatibility and Public Need for the construction of a 345-kV electric transmission line and reconstruction of an existing 115-kV electric transmission line between Connecticut Light and Power Company's Plumtree Substation in Bethel, through the towns of Redding, Weston, and Wilton, and to the Norwalk Substation in Norwalk, Connecticut.

Date: October 13, 2006

Location: Transition Stations: Hoyts Hill, Archers Lane, Norwalk Junction

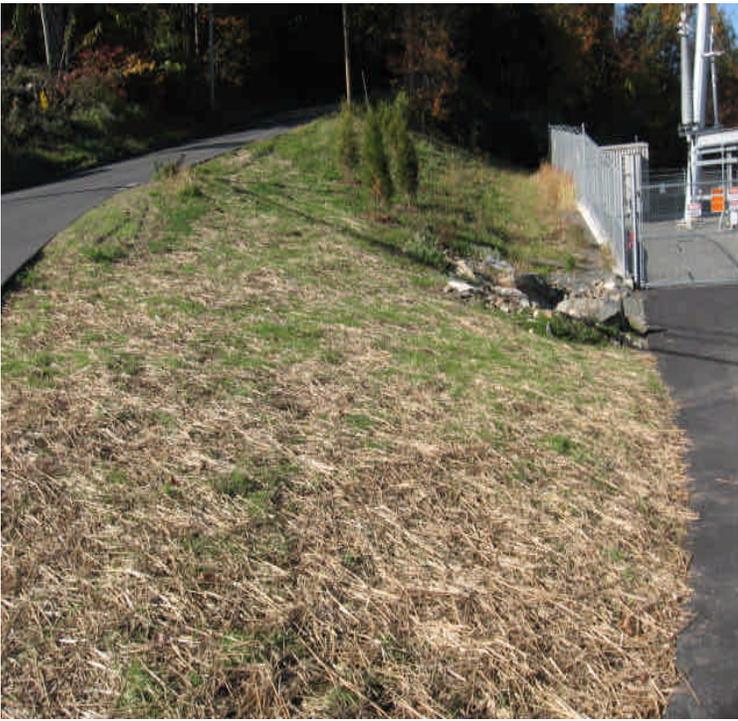
Hoyts Hill Transition Station: Photo on the left shows the restored area along the western slope adjacent to Hoyts Hill Road. Grass growth is increasing here. Photo on the right shows vehicle tracks in the restored area adjacent to the access drive caused by a stored piece of equipment. 10/13/06.

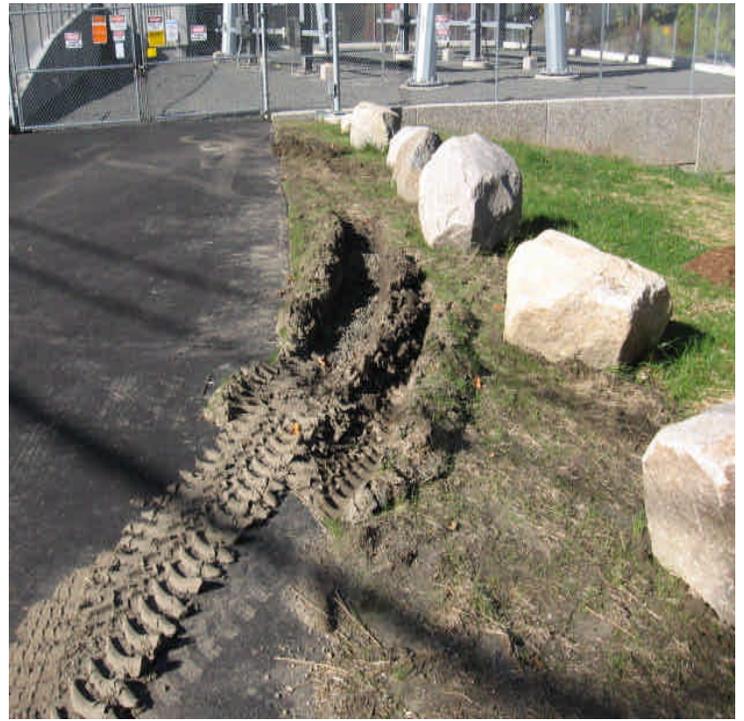
Areas of Inspection	Observation	Recommended Action	Corrected Actions
Access Roads and Adjacent Roadways	- Hoyts Hill: Access is gained off Hoyts Hill Road. Vehicle tracks resulting from a stored piece of equipment were noted in the previously restored area adjacent to the access drive. 10/13/06.	-Recently seeded and mulched slopes continue to revegetate. Repair vehicle tracking if feasible. 10/13/06.	-N/A

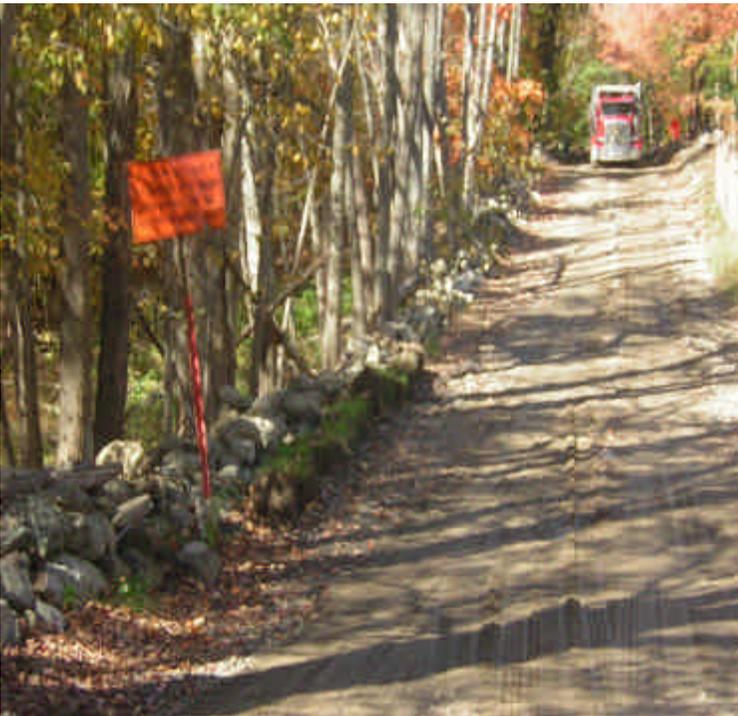
- Crews appeared to be grading the access drive off Diamond Hill Road, in preparation for paving.	-Continue to monitor until final stabilization is complete in this area. 10/13/06.	-N/A

Archers Lane Transition Station: Photo on the left shows crews grading the access road and preparing to pave. **Norwalk Junction:** Photo on the right shows significant sediment within the paved access drive. Some sediment tracking was noted on Route 7 but was supposed to be swept by the end of the day. 10/13/06.

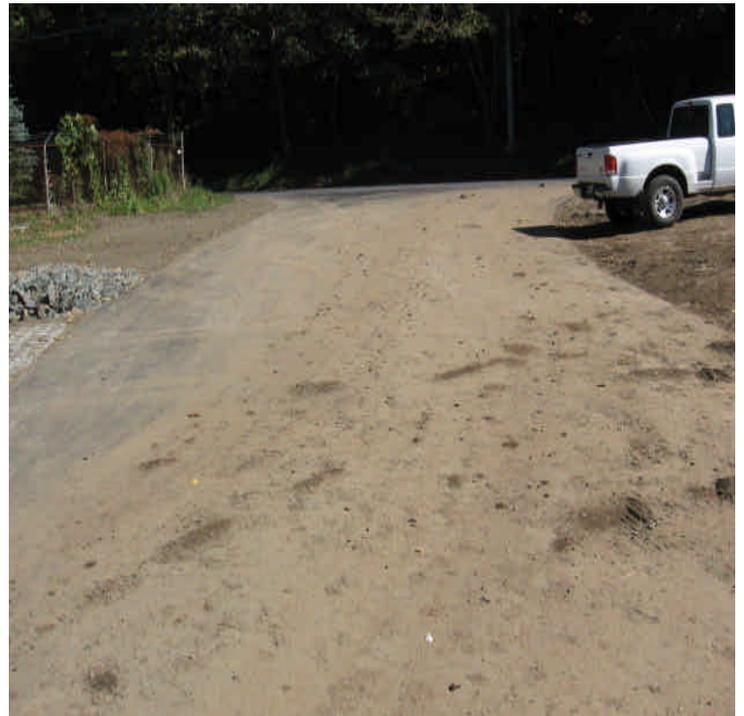
Areas of Inspection	Observation	Recommended Action	Corrected Actions
<p>Access Roads and Adjacent Roadways continued</p>	<p>10/13/06. Haybales remain in place where water had pooled in the access road near the stone wall. 10/13/06.</p> <p>- Norwalk Junction: Sediment tracking was noted on the access drive and Rt 7. Although the access drive and station yard are paved, a large portion of the site consists of disturbed soils currently undergoing restoration. 10/13/06.</p> <p>-Crews were installing pervious pavers, continuing from the access drive during the inspection. 10/13/06.</p> <p>-The front portion of the yard remains disturbed but topsoil was being placed for final restoration. 10/13/06</p>	<p>-The sediment should be swept at the end of each day. 10/13/06.</p> <p>-Continue to stabilize surrounding areas to reduce the area of disturbance. 10/13/06.</p> <p>- Continue to provide restoration to areas to reduce disturbance. 10/13/06</p>	<p>-Needs attention. (Contractor planned to attend to it)</p> <p>-Restoration is underway.</p> <p>- Restoration is underway</p>

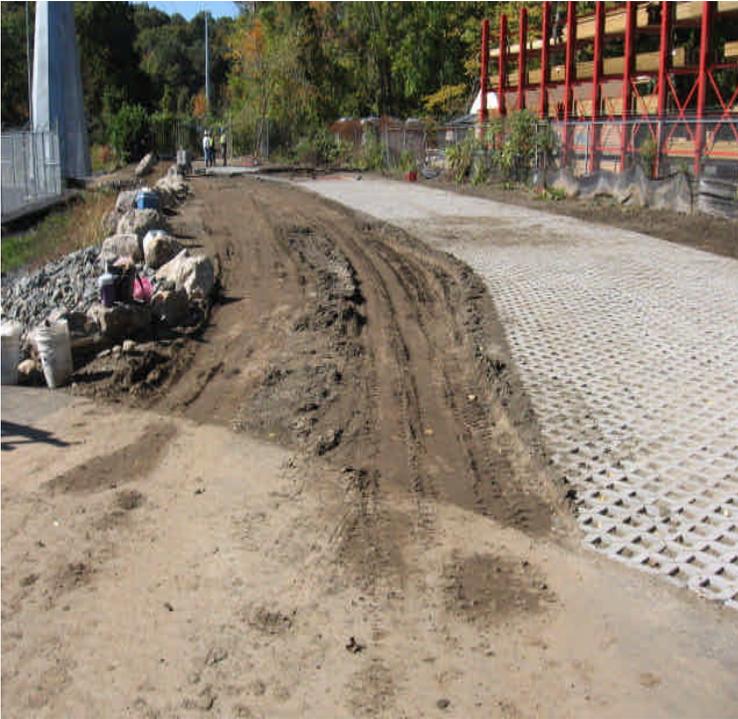
Photo on the left shows the pervious pavers installed as part of the access drive. Disturbed areas remain on both sides of the drive here but are scheduled to be restored. Photo on the right shows disturbed areas remaining adjacent to the swale nearest Route 7. Topsoil was being placed at this time. 10/13/06.

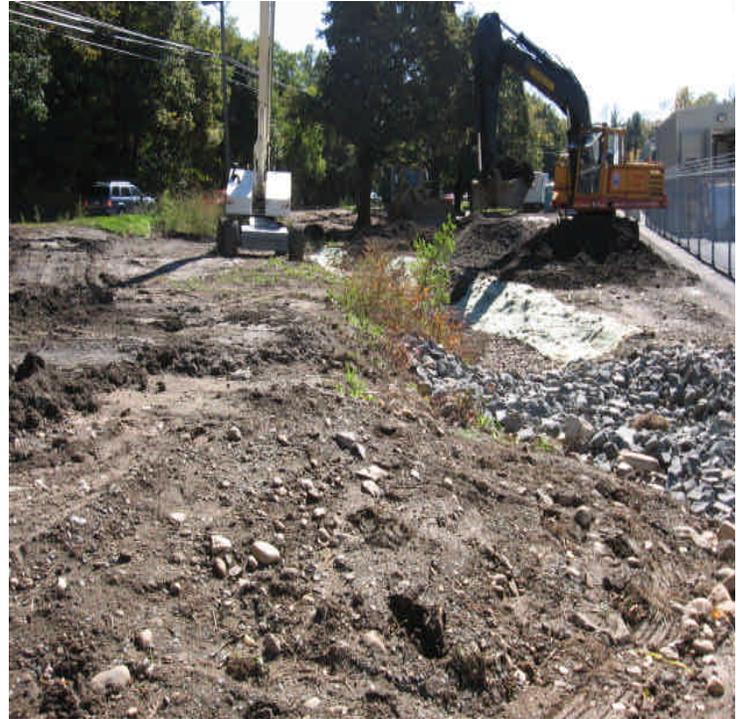
<p>- More stone was placed at the bottom of the swale leading to the outlet. Portions of the swale remains as exposed soil but were being restored at this time. 10/13/06.</p>	<p>-Continue to revegetate/stabilize the remaining swale as soon as feasible. 8/16-10/13/06</p>	<p>- Restoration was currently underway</p>
<p>Inland Wetland and Watercourse encroachment and mitigation</p>	<p>- Hoyts Hill: The wetland remains well protected and well vegetated. 10/13/06.</p> <p>-Archers Lane: Grass growth was noted in restored wetland areas. 10/13/06.</p> <p>- Norwalk Junction: Sediment was removed from within the wetland located at the outlet of the</p>	<p>-Erosion controls could be removed from the wetland along the eastern edge of the station and at the area adjacent to Rt 58. 10/13/06.</p> <p>- Continue to monitor until final stabilization. 10/13/06.</p> <p>- Continue to reduce turbidity and sedimentation by controlling the source-</p>	<p>- Erosion controls can be removed.</p> <p>-Grass growth was noted</p> <p>-Sediment was removed from wetland.</p>

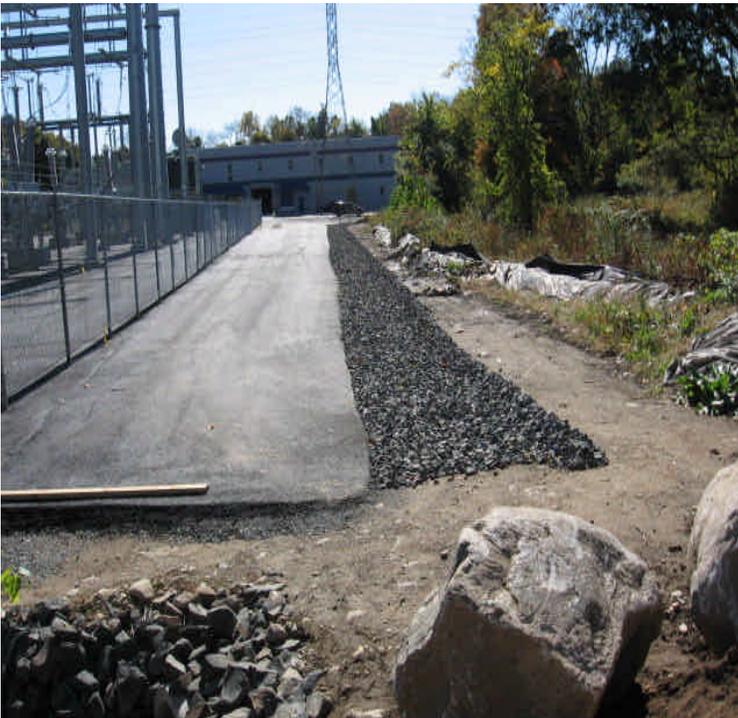
Areas of Inspection	Observation	Recommended Action	Corrected Actions
	<p>along the river. 5/17-10/13/06. The adjacent, non-project related, berm is degrading and presents a potential source of sedimentation. 10/13/06. -The majority of the sediment was removed by hand from the wetland area located at the swale outlet and clean stone is present. 10/13/06.</p> <p>- The front portion of the site has remaining areas of disturbed soil but topsoil was being spread for final restoration efforts. 10/13/06</p> <p>-Stone was spread out between the perimeter chain link fence and the river but the adjacent area remains disturbed. 10/13/06</p>	<p>- If feasible, work with adjacent landowner to determine final stabilization of the area. 9/29-10/13/06 - Continue to monitor until surrounding areas are stabilized. 10/13/06.</p> <p>- Continue to improve water quality to the swale by stabilizing areas wherever feasible. 6/1-10/13/06</p> <p>Re-vegetate the adjacent area to the extent feasible. 9/7-10/13/06</p>	<p>-Needs evaluation if feasible (not project jurisdictional).</p> <p>- Sediment was removed from the wetland.</p> <p>- Restoration is underway</p> <p>-Needs attention if feasible</p>

Photo on the right shows the paved area adjacent to the yard. Stone has been spread along the pavement between the wetland and station yard. The non-project related berm is still degrading. Photo on the right shows a view of the wetland located at the swale outlet. Sediment was removed by hand and clean stone is in place. 10/13/06.
