Docket No. 272 – Development and Management Plan Inspection

Beseck Switching Station Inspection

Date: November 13, 2007

Location: Beseck Switching Station

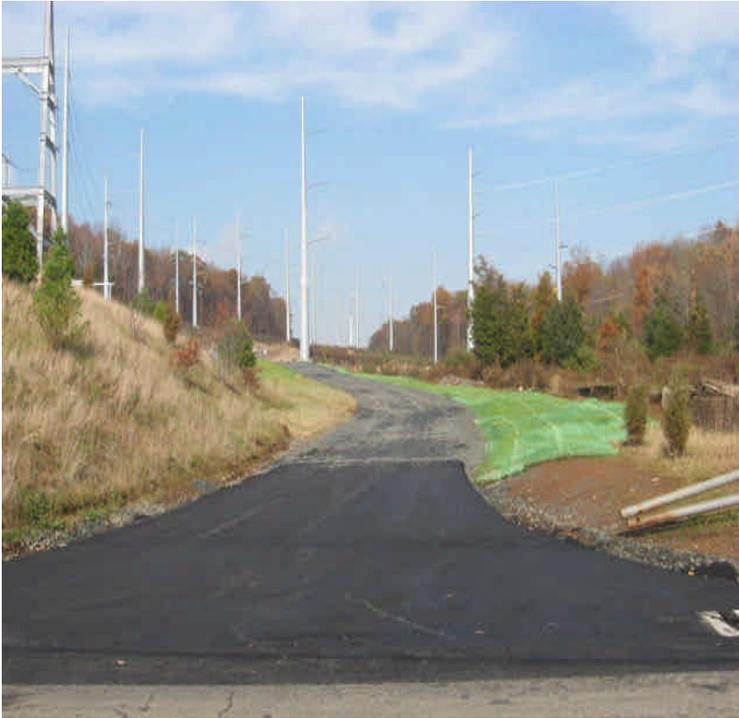
Eastern side of the site, view from Carpenter Lane. The entrance has been paved and erosion control mats and seed remain in place along the shoulders. However, turbid run-off continues to leave the site during rain events.

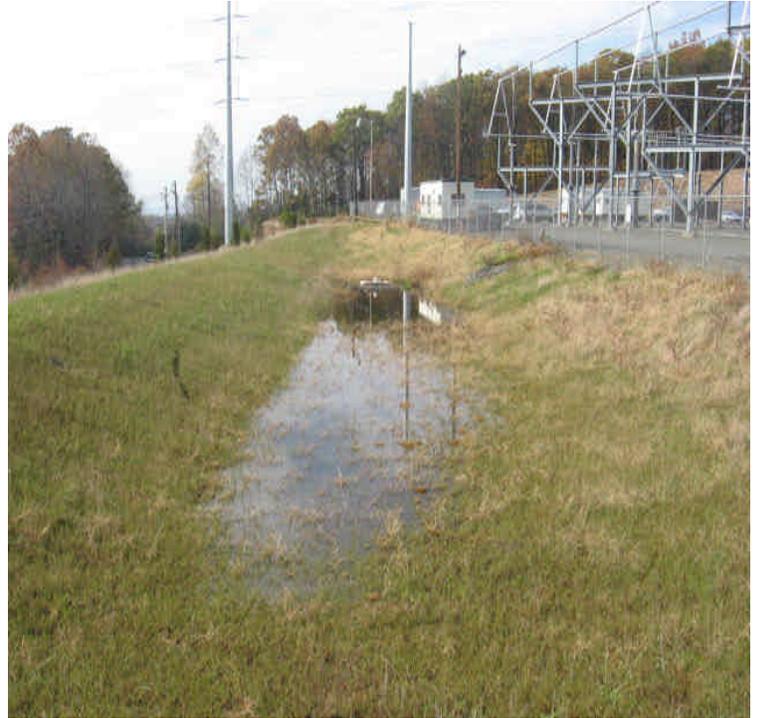
Clear, standing water noted at the drain inlets within the detention basin.

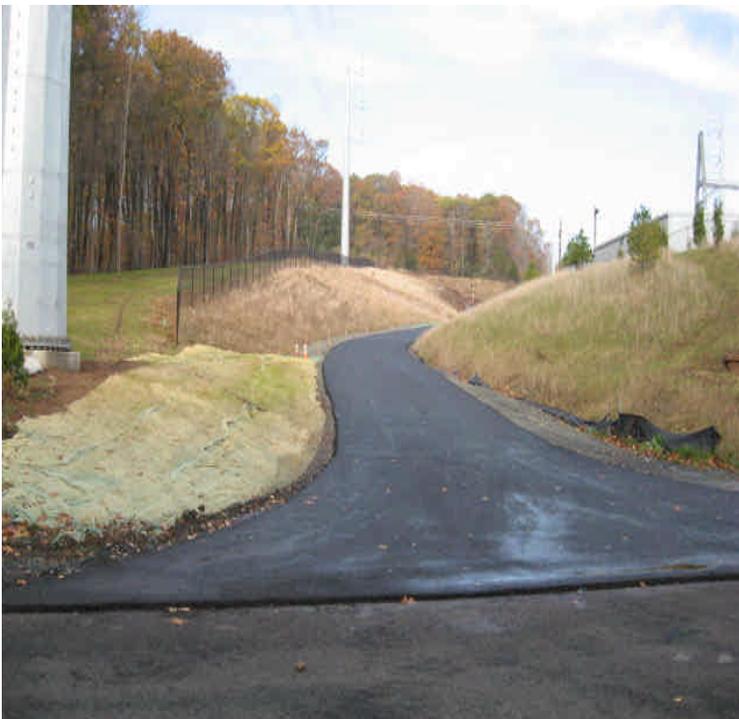
The western site access has been paved. Erosion control mats remain in place along the shoulders. Clear run-off was currently noted at the access but continue to monitor during rain events.
