**Docket No. 272 – Development and Management Plan Inspection**

**Beseck Switching Station Inspection**

**Date:** November 20, 2007

**Location:** Beseck Switching Station

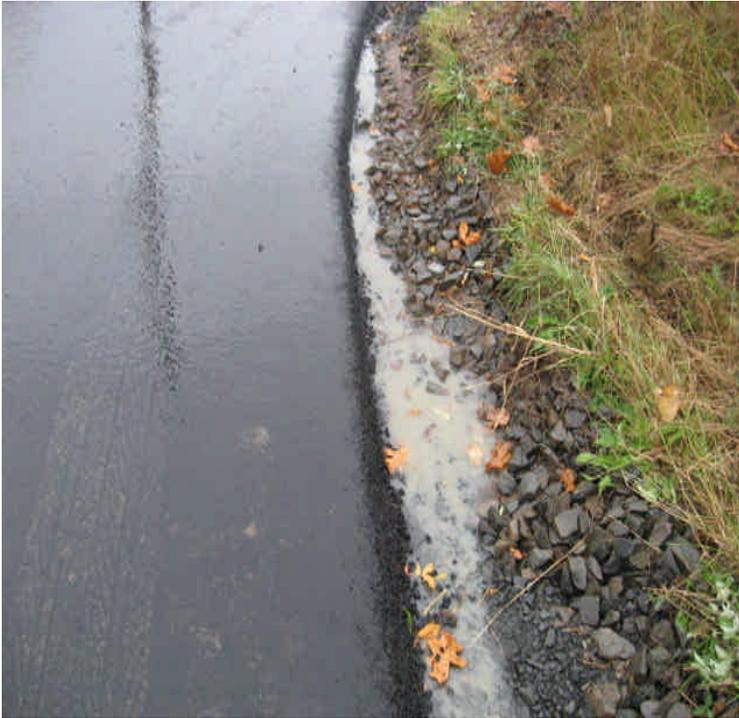
**Eastern side of the site, view along the paved drive. Erosion control mats and seed remain in place along the shoulders. However, some turbid run-off continues to leave the site during rain events.**

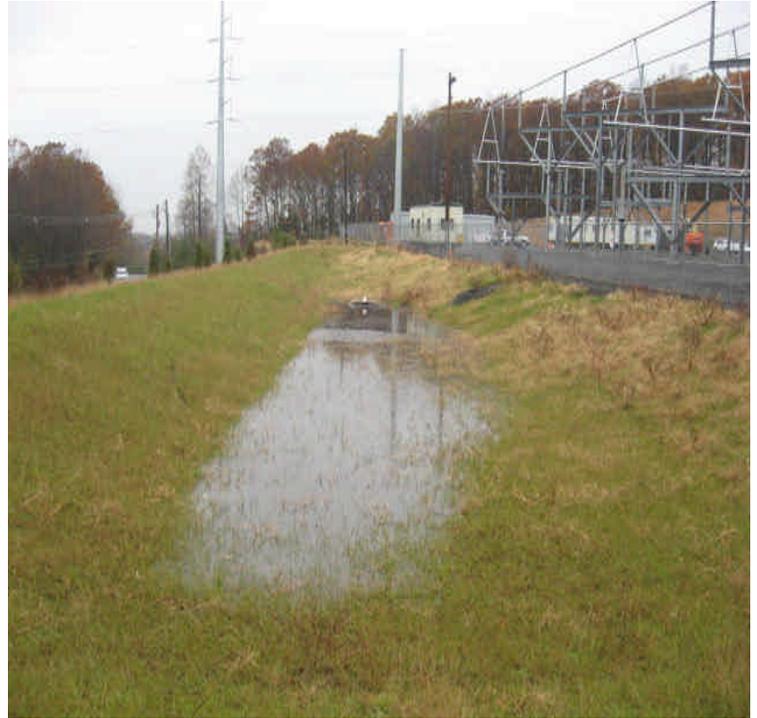
**Clear standing water noted at the drain inlets within the detention basin.**

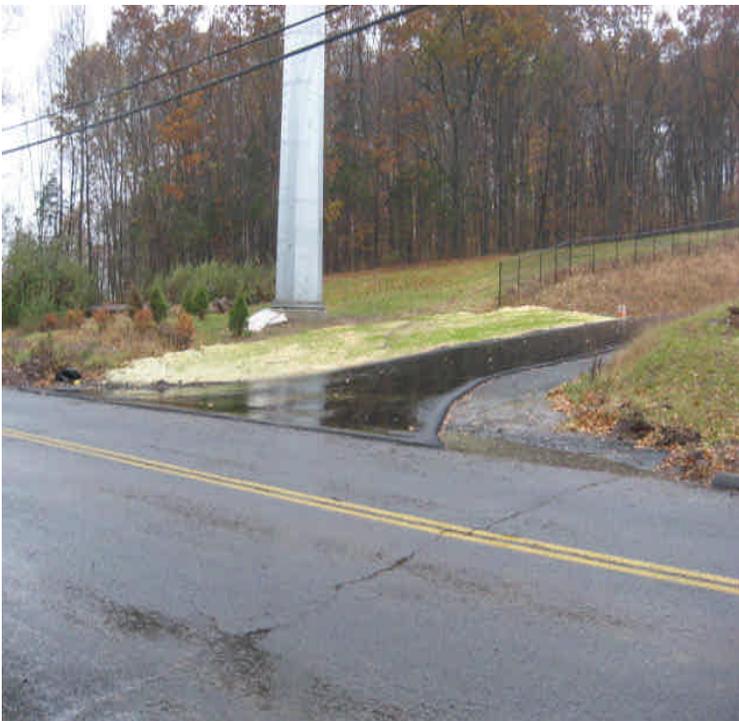
**Western site access is at final grade and pavement. Clear run-off was noted leaving the site from this access. Continue to monitor during rain events.**

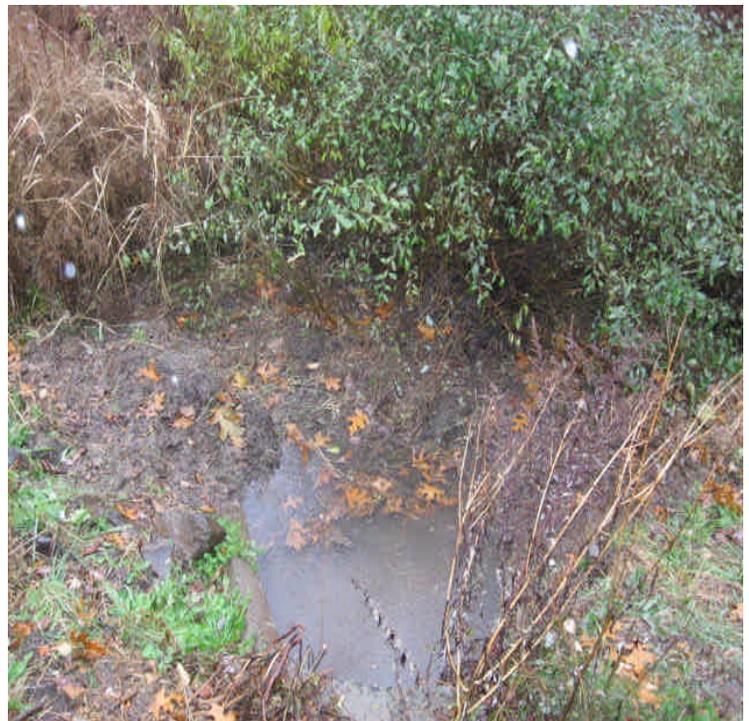
**View of the outlet across Carpenter Lane where slightly turbid water was noted in the wetlands following a small rain event. Efforts should be made to remove all visible, settled sediment at the outlet and within the pipe. Seed the disturbed area with wetland mix.**
